**DUKE SWAMP WETLAND AND STREAM
RESTORATION PROJECT**
ANNUAL MONITORING REPORT FOR 2011 (YEAR 4)

Contract Number D06065-A

Prepared by: Michael Baker Engineering, Inc.

December 2011

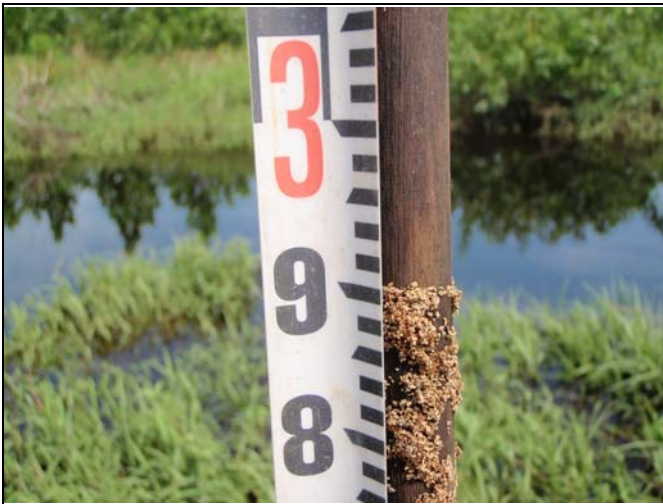
Crest Gauge – 2.90 feet, following Hurricane Irene
(Storm event occurred on August 27, 2011)

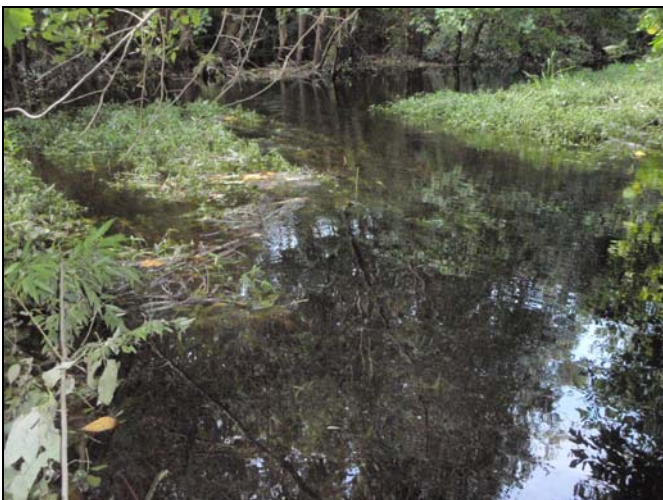
UT2 flowing south across fill area to UT1b
(Storm event occurred in August 27, 2011)
