**Dula Thoroughfare Stream and Wetland Restoration
Project No. 65
2009 Monitoring Report: Year 3 of 5**

February 2010 (Revised April 2010)

Prepared for: NCDENR-EEP
1652 Mail Service Center
Raleigh, NC 27699-1652

Prepared by: Jordan, Jones & Goulding
9101 Southern Pine Blvd., Suite 160
Charlotte, NC 28273

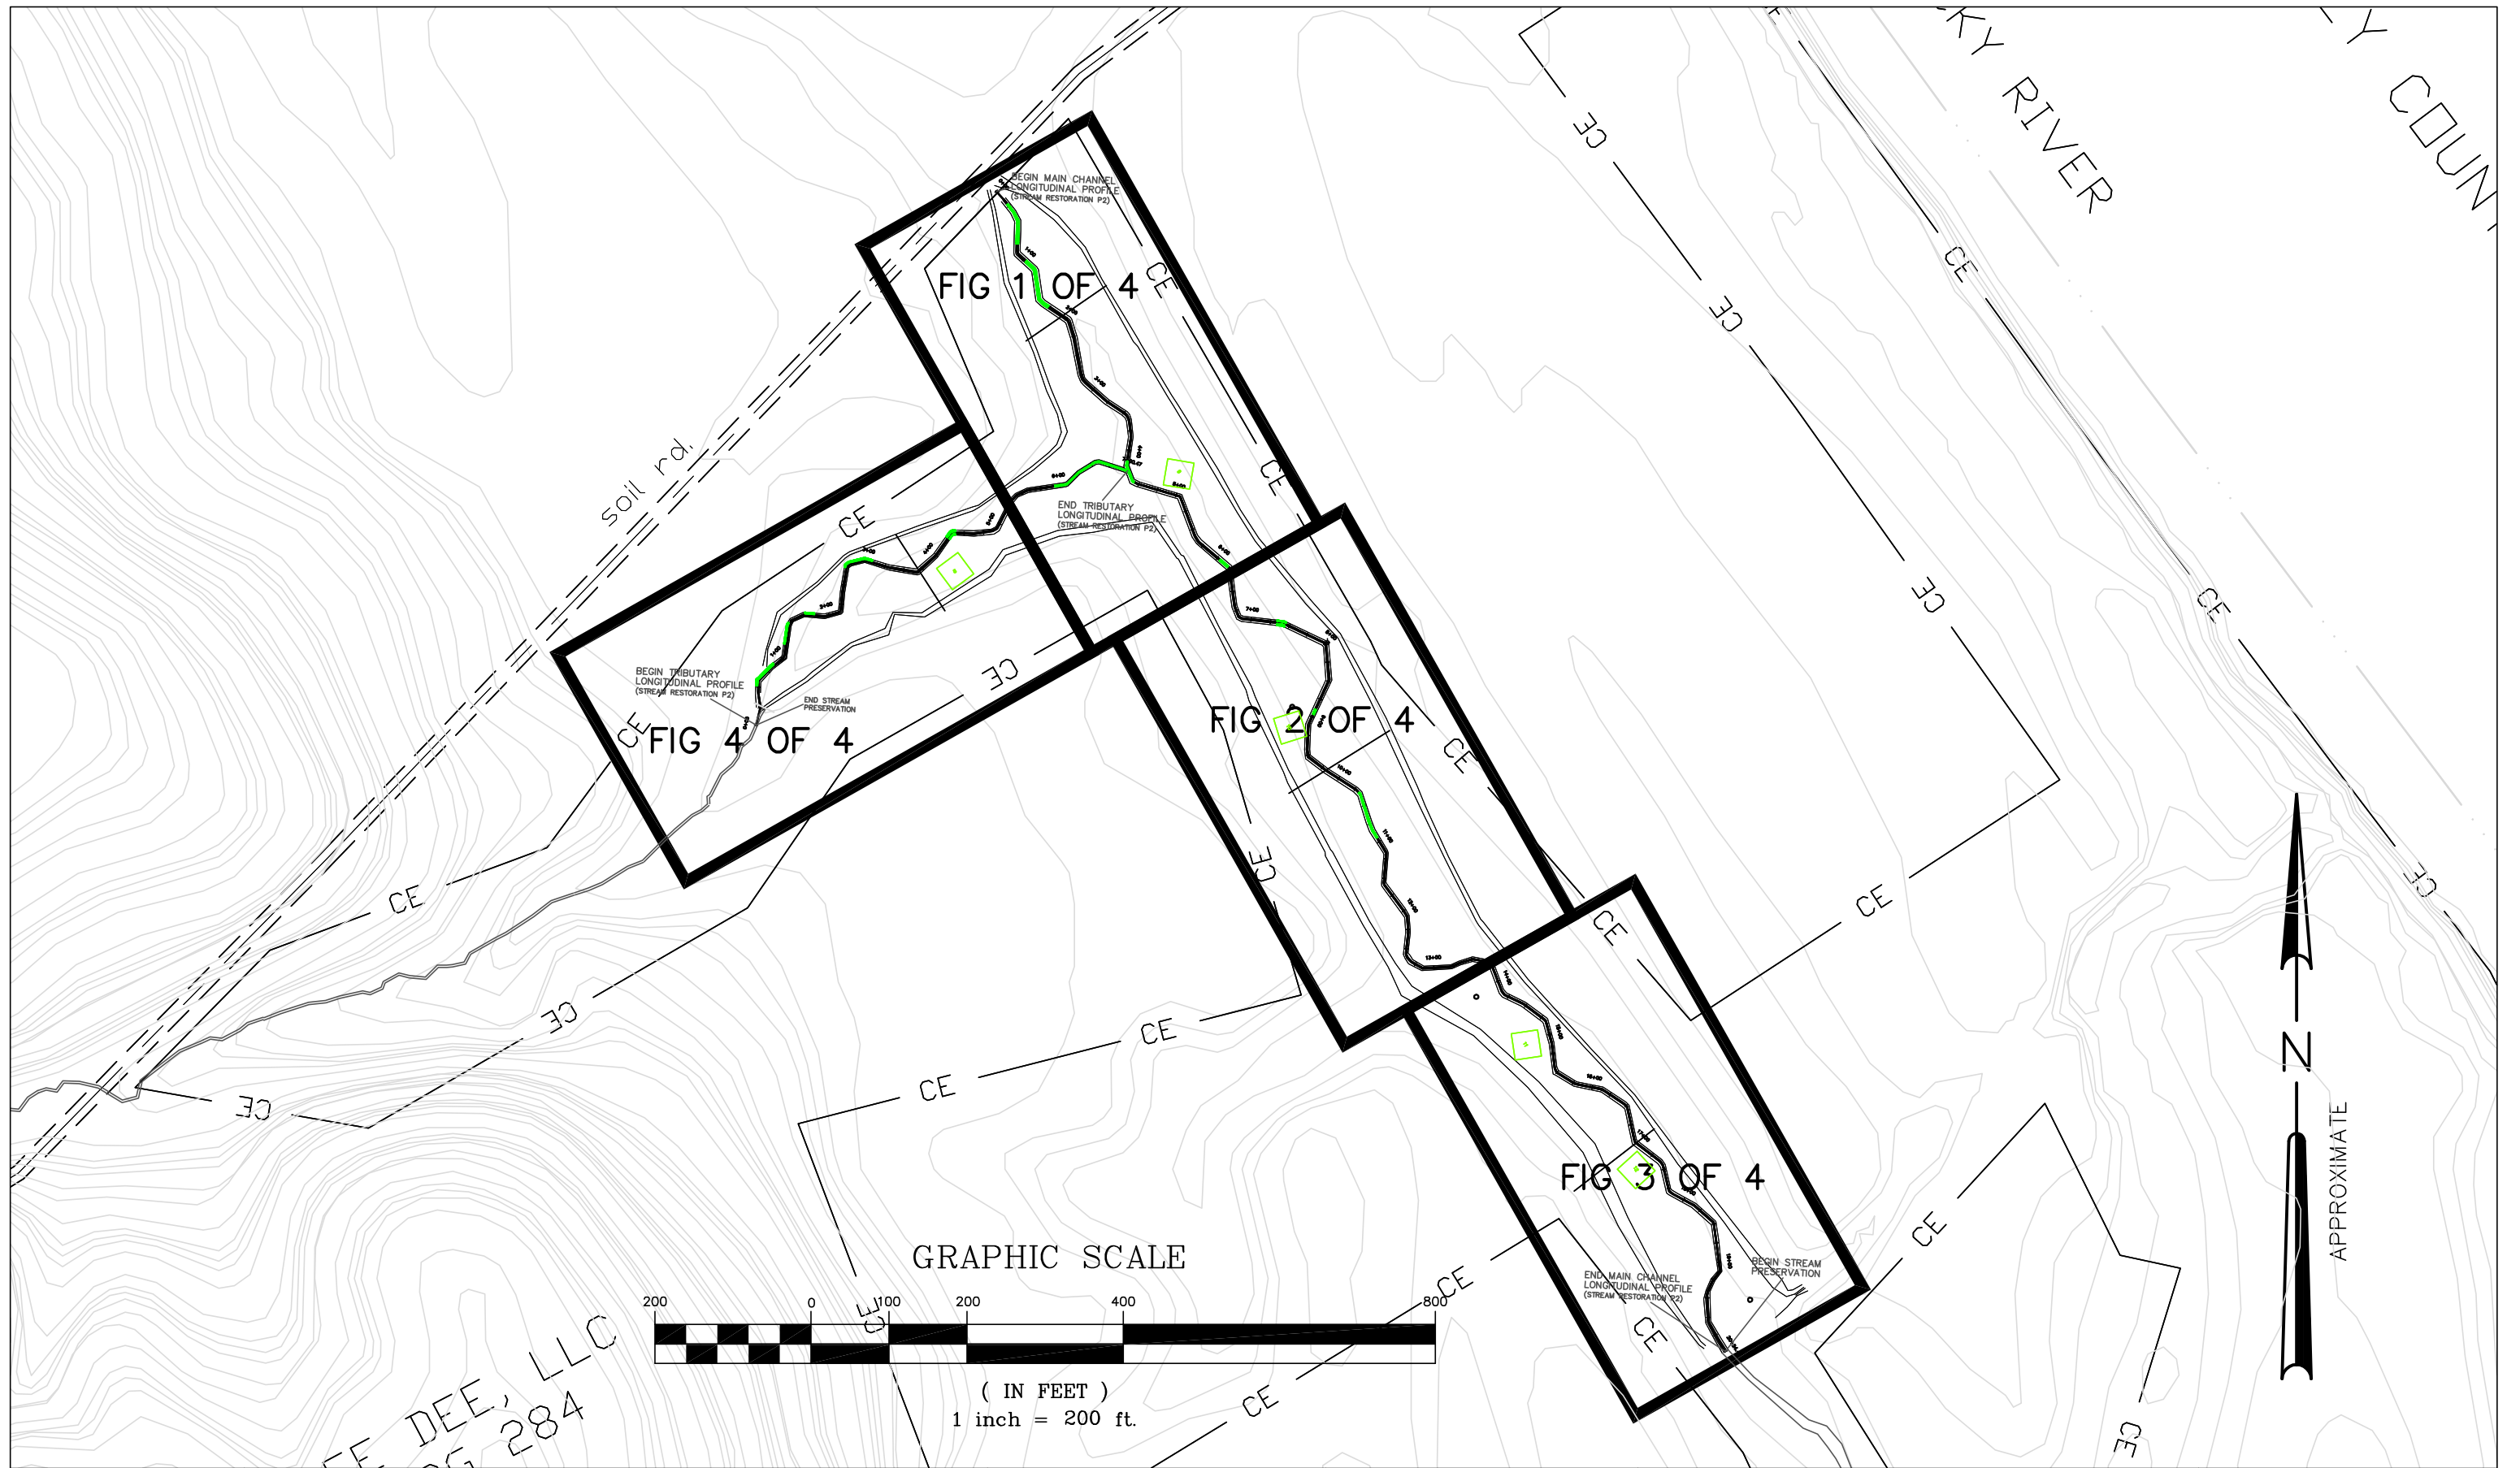
FIGURE 1.2a
 CURRENT CONDITION PLAN VIEW

Based on current monitoring data and the visual inspection, the channel appears to be functioning properly and maintaining stability. No erosion failure was observed along this reach. In-stream vegetation and poor streambank vegetation cover were observed and noted in the Current Condition Plan View (CCPV, Appendix 1.2). The substrate along the entire reach was dominated by silt deposition.

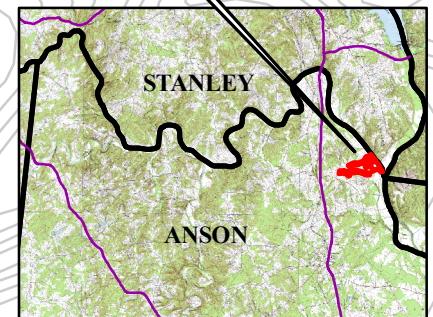
Appendix 1. General Figures and Plan Views
Figure 1.2b. Current Condition Plan View Map
UT to Dula Thoroughfare Stream Restoration
Anson County, NC
Year 3 of 5

During JJG's assessment, the channel had normal flow conditions with riffles, runs, and pools present. Approximately midway down the project reach (between the first and second cross-vane triplets), the water in the channel disappears and then reappears 50 ft downstream. All cross-vanes triplets appear to be stable and are not showing any signs of erosion or piping.

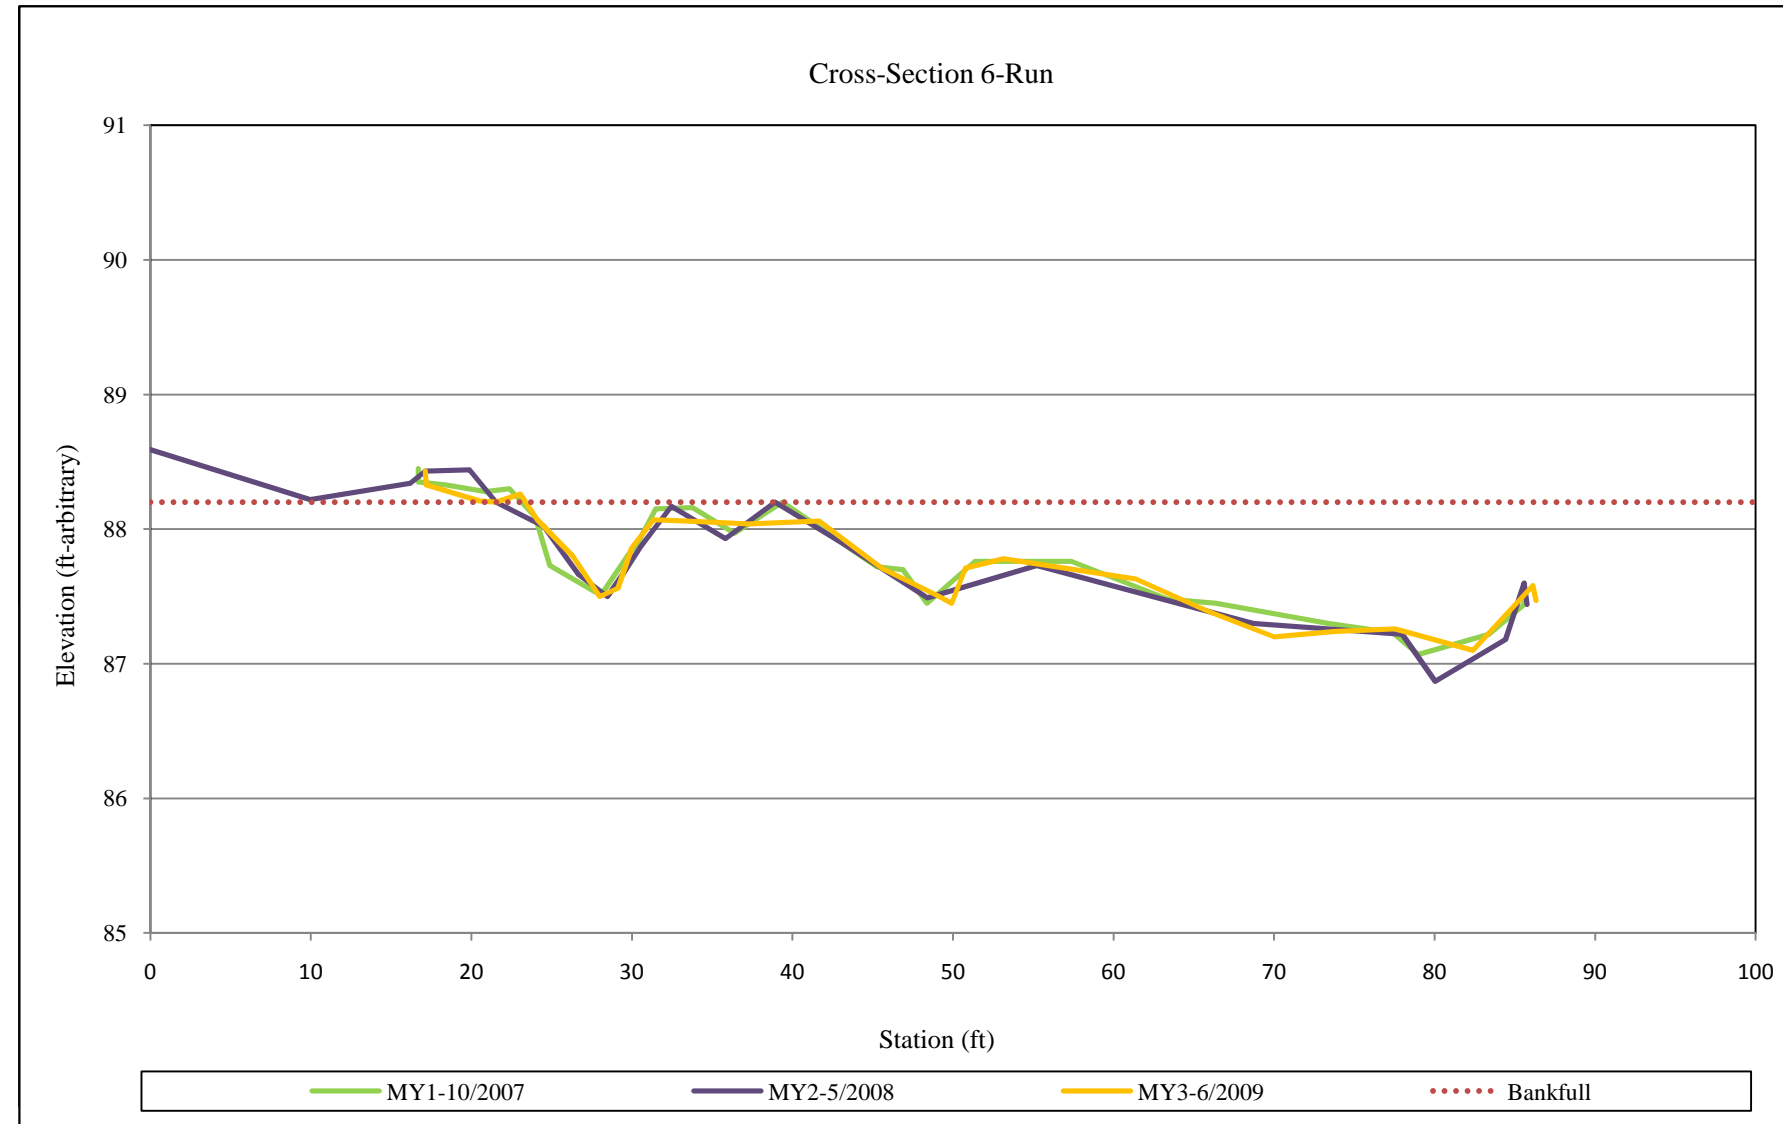
Summary Data	
Bankfull Cross-sectional Area (ft ²)	4.17
Bankfull Width (ft)	15.56
Bankfull Mean Depth (ft)	0.27
Bankfull Max Depth (ft)	1.10
Width/Depth Ratio	57.63
Entrenchment Ratio	5.50

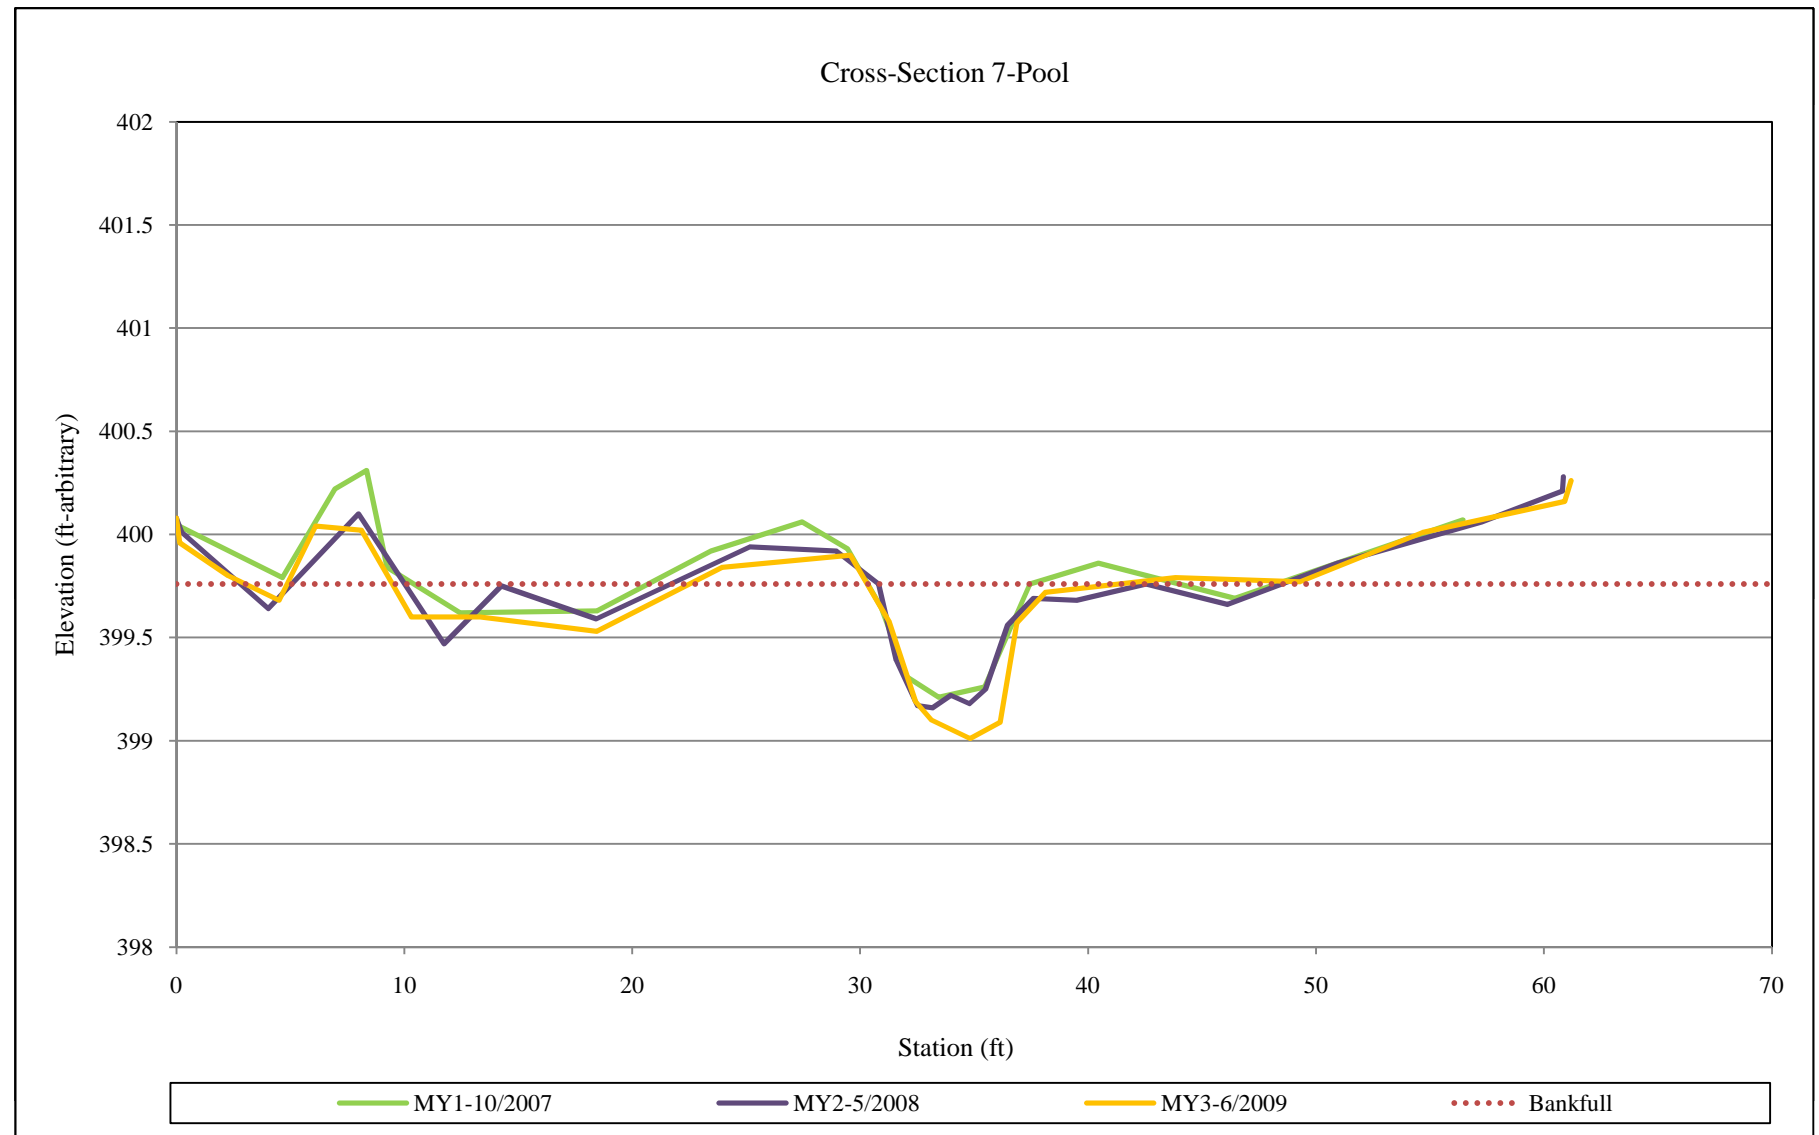
Summary Data	
Bankfull Cross-sectional Area (ft ²)	3.24
Bankfull Width (ft)	7.62
Bankfull Mean Depth (ft)	0.43
Bankfull Max Depth (ft)	0.71
Width/Depth Ratio	17.72
Entrenchment Ratio	8.00

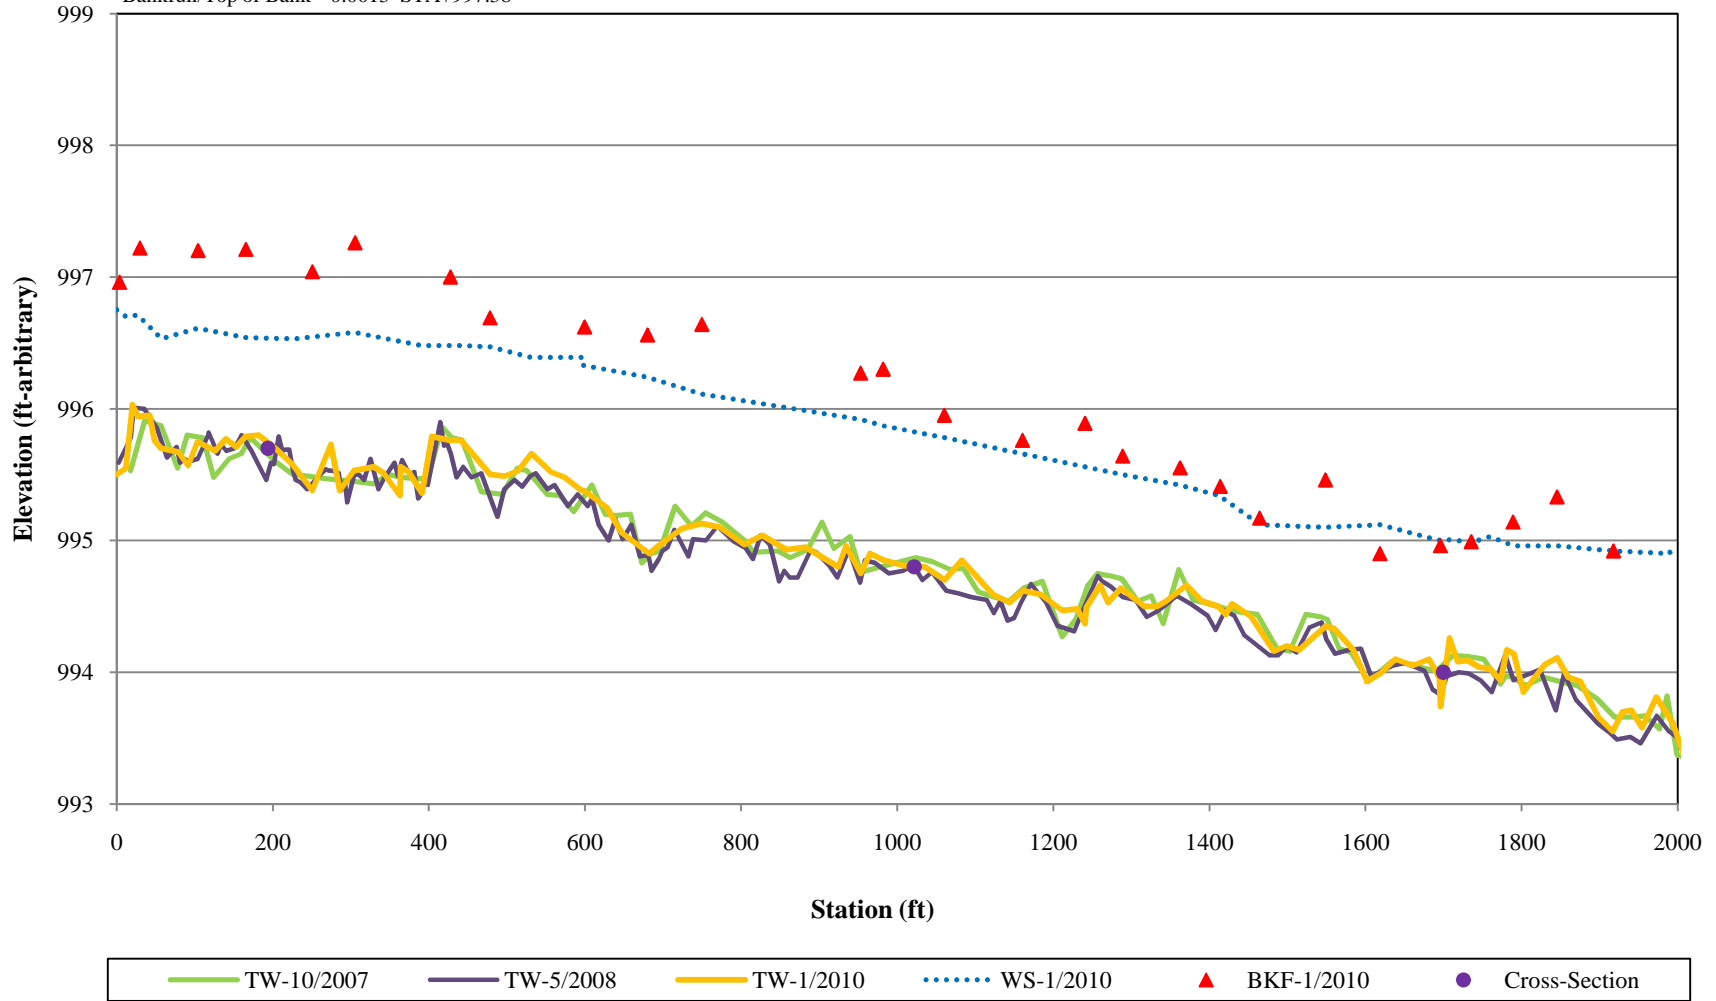
**Dula Thoroughfare-Main Channel
Longitudinal Profile
2009 Monitoring Year**

Water Surface=-0.0010*STA+996.82
Bankfull/Top of Bank=-0.0013*STA+997.38

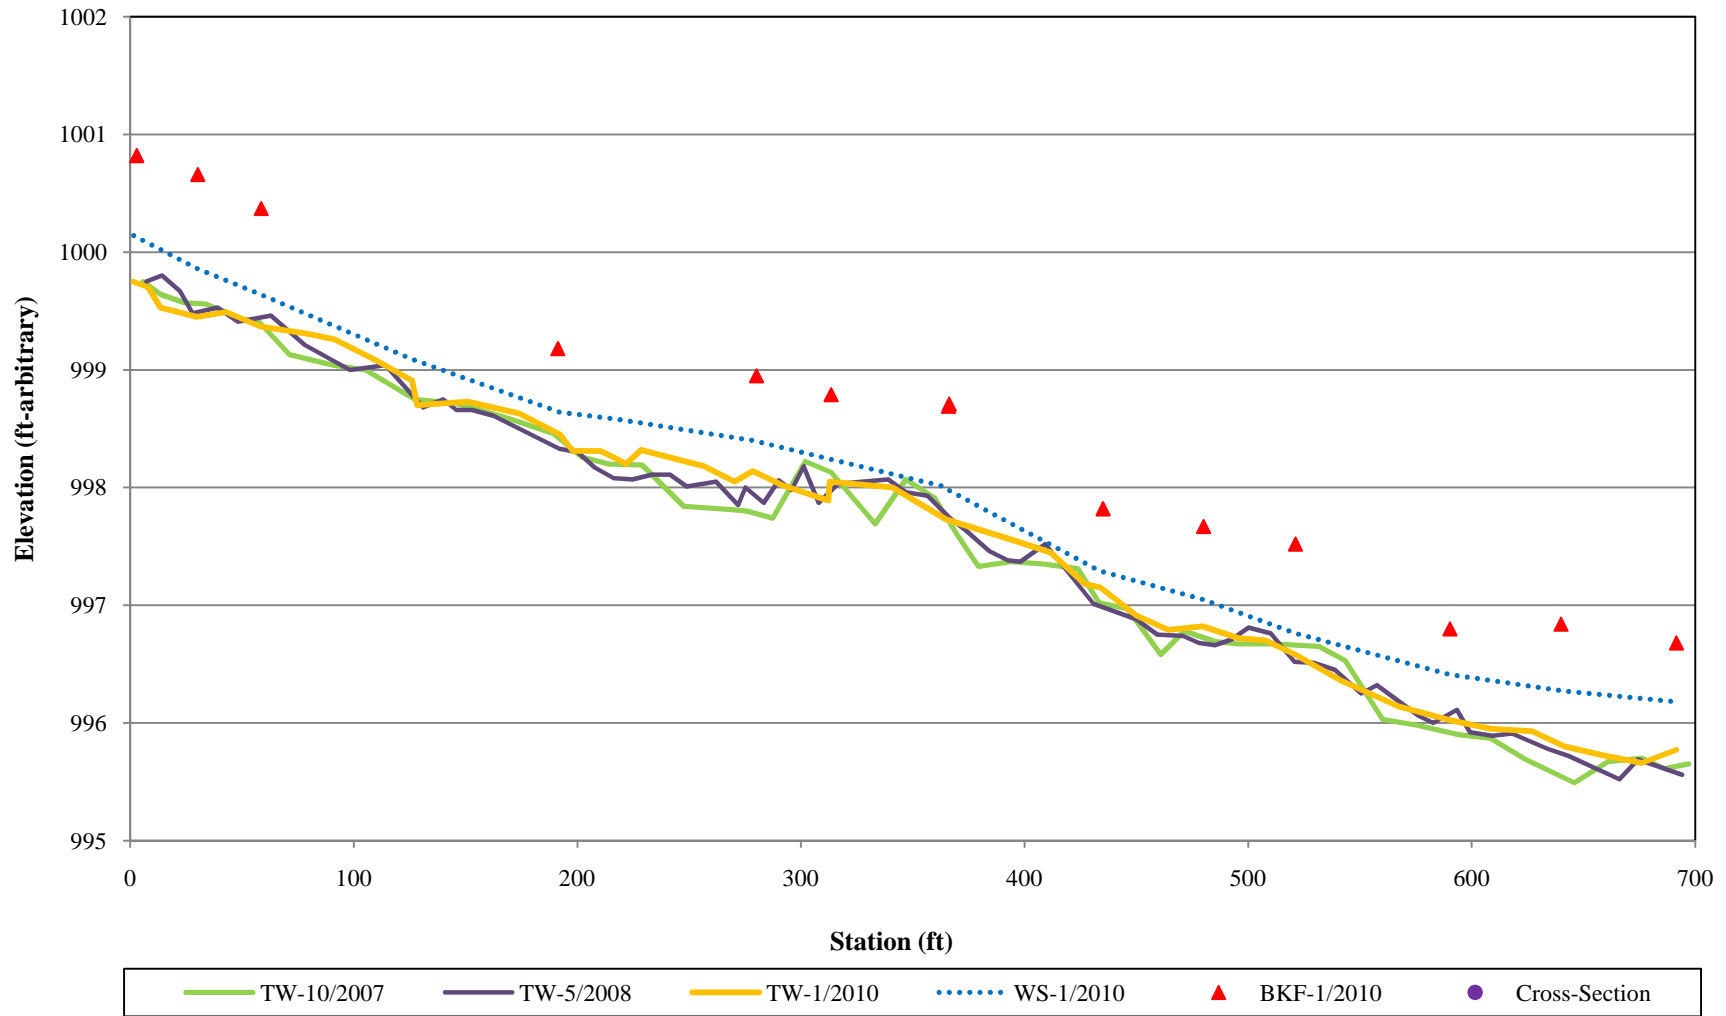
**Dula Thoroughfare-Tributary
Longitudinal Profile
2009 Monitoring Year**

Water Surface=-0.0058*STA+999.96
Bankfull/Top of Bank=-0.0062*STA+1000.7

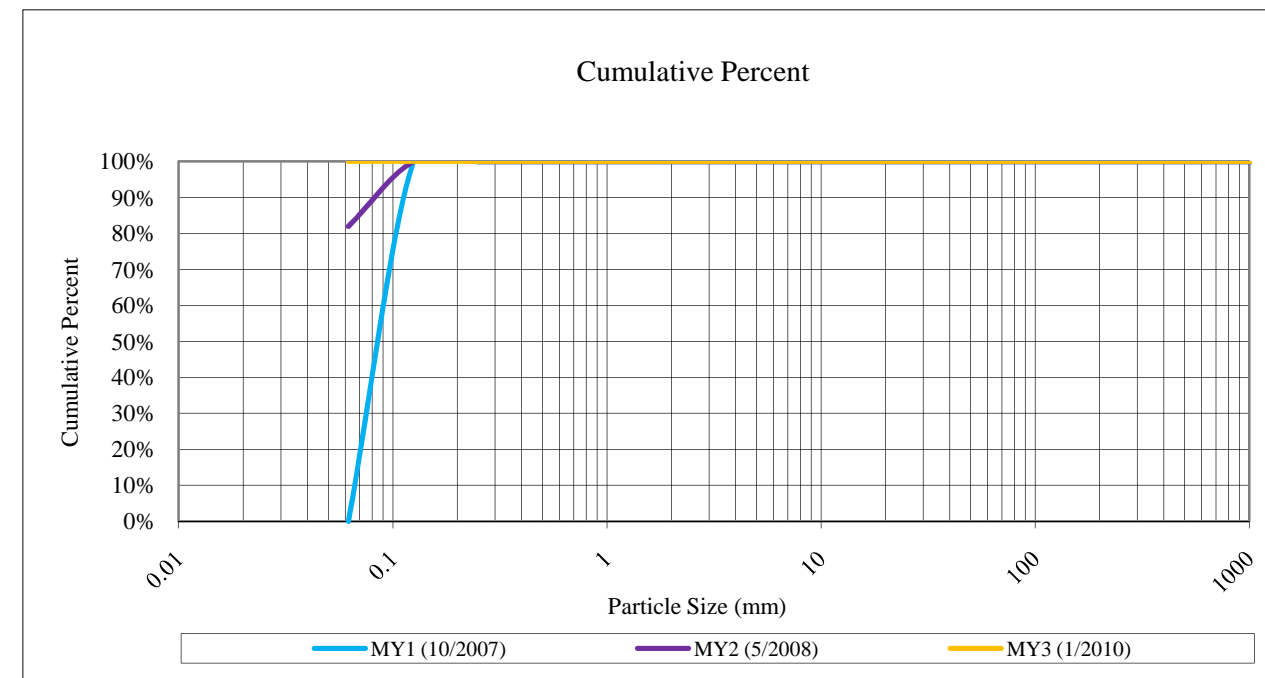
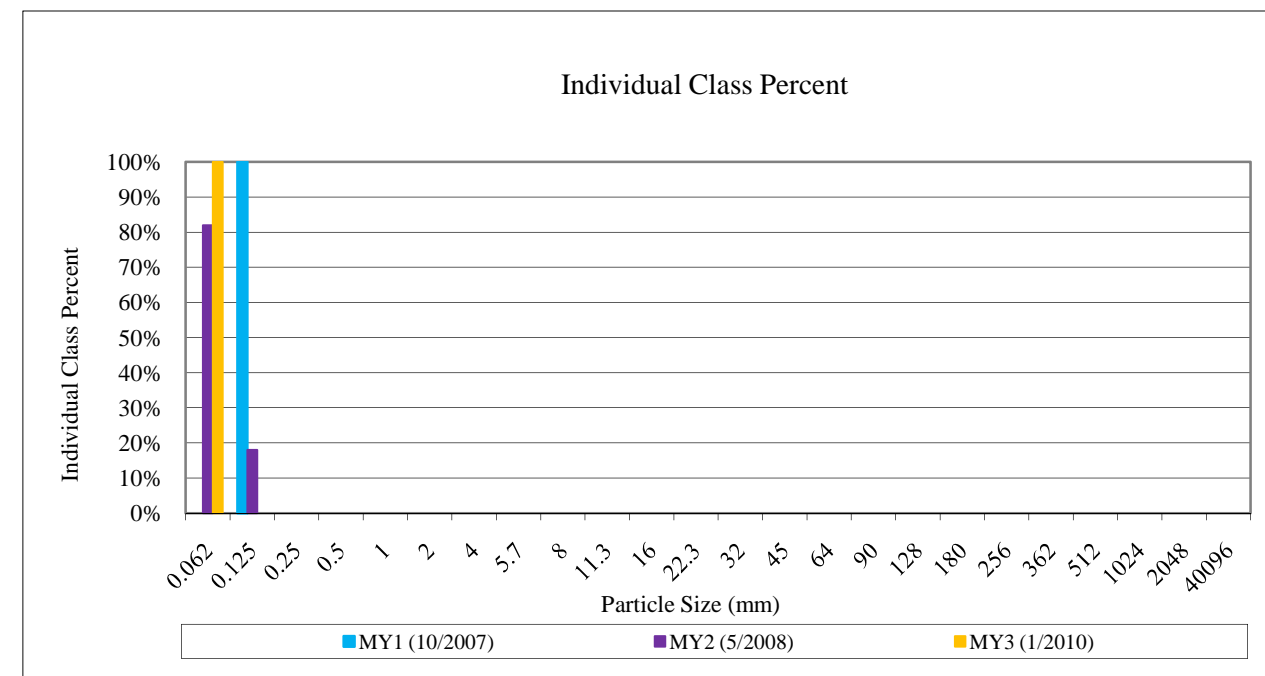
Project Name: Dula Thoroughfare-Main Channel					
Cross-Section: 1					
Feature: Pool					
MY3-1/2010					
Description	Material	Size (mm)	Total #	Item %	Cum %
Silt/Clay	silt/clay	0.062	100	100%	100%
Sand	very fine sand	0.125	0	0%	0%
	fine sand	0.250	0	0%	0%
	medium sand	0.50	0	0%	0%
	coarse sand	1.00	0	0%	0%
	very coarse sand	2.0	0	0%	0%
Gravel	very fine gravel	4.0	0	0%	0%
	fine gravel	5.7	0	0%	0%
	fine gravel	8.0	0	0%	0%
	medium gravel	11.3	0	0%	0%
	medium gravel	16.0	0	0%	0%
	course gravel	22.3	0	0%	0%
	course gravel	32.0	0	0%	0%
	very coarse gravel	45	0	0%	0%
	very coarse gravel	64	0	0%	0%
Cobble	small cobble	90	0	0%	0%
	medium cobble	128	0	0%	0%
	large cobble	180	0	0%	0%
	very large cobble	256	0	0%	0%
Boulder	small boulder	362	0	0%	0%
	small boulder	512	0	0%	0%
	medium boulder	1024	0	0%	0%
	large boulder	2048	0	0%	0%
Bedrock	bedrock	40096	0	0%	0%
TOTAL % of whole count			100	100%	100%

Summary Data	
D50	0.03
D84	0.05
D95	0.06

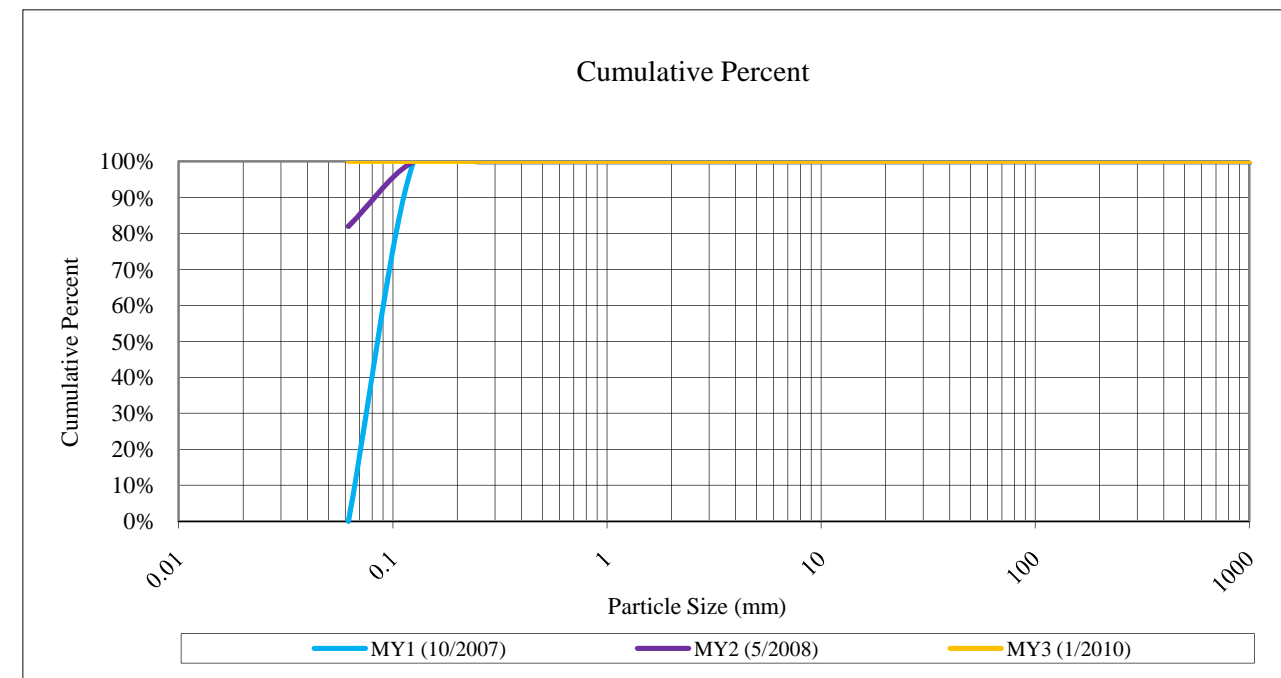
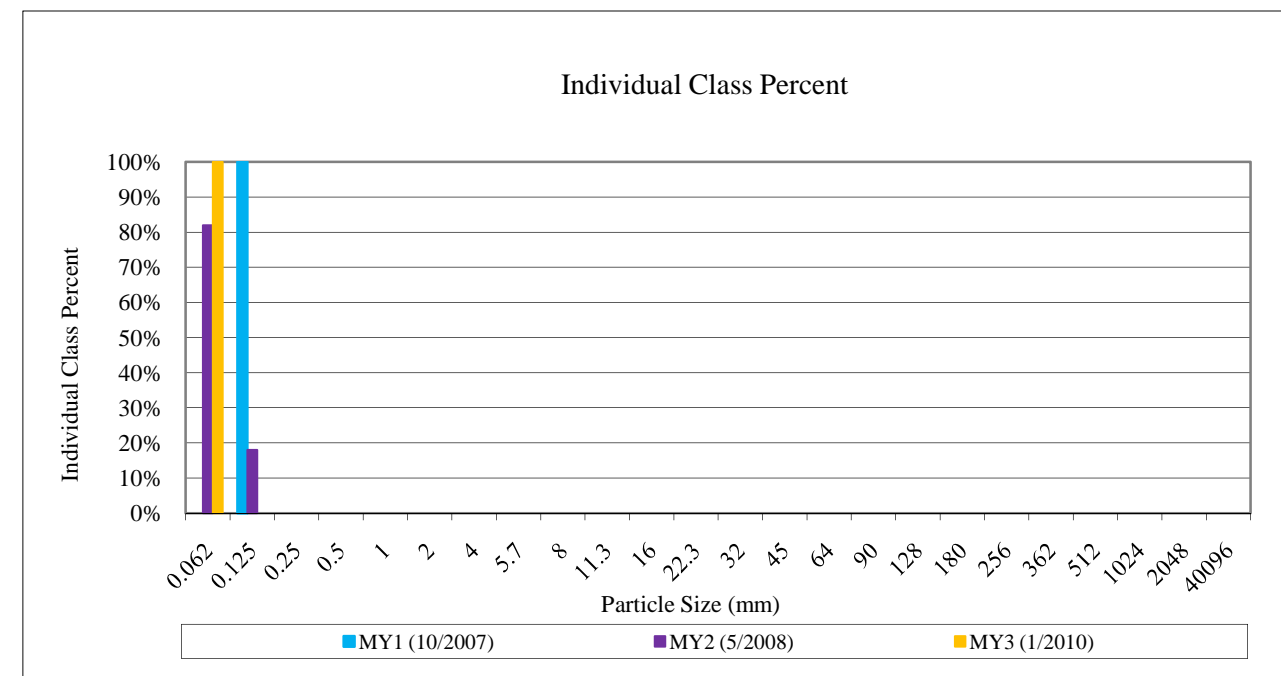
Project Name: Dula Thoroughfare-Main Channel					
Cross-Section: 2					
Feature: Run					
MY3-1/2010					
Description	Material	Size (mm)	Total #	Item %	Cum %
Silt/Clay	silt/clay	0.062	100	100%	100%
Sand	very fine sand	0.125	0	0%	0%
	fine sand	0.250	0	0%	0%
	medium sand	0.50	0	0%	0%
	coarse sand	1.00	0	0%	0%
	very coarse sand	2.0	0	0%	0%
Gravel	very fine gravel	4.0	0	0%	0%
	fine gravel	5.7	0	0%	0%
	fine gravel	8.0	0	0%	0%
	medium gravel	11.3	0	0%	0%
	medium gravel	16.0	0	0%	0%
	course gravel	22.3	0	0%	0%
	course gravel	32.0	0	0%	0%
	very coarse gravel	45	0	0%	0%
	very coarse gravel	64	0	0%	0%
Cobble	small cobble	90	0	0%	0%
	medium cobble	128	0	0%	0%
	large cobble	180	0	0%	0%
	very large cobble	256	0	0%	0%
Boulder	small boulder	362	0	0%	0%
	small boulder	512	0	0%	0%
	medium boulder	1024	0	0%	0%
	large boulder	2048	0	0%	0%
Bedrock	bedrock	40096	0	0%	0%
TOTAL % of whole count			100	100%	100%

Summary Data	
D50	0.03
D84	0.05
D95	0.06

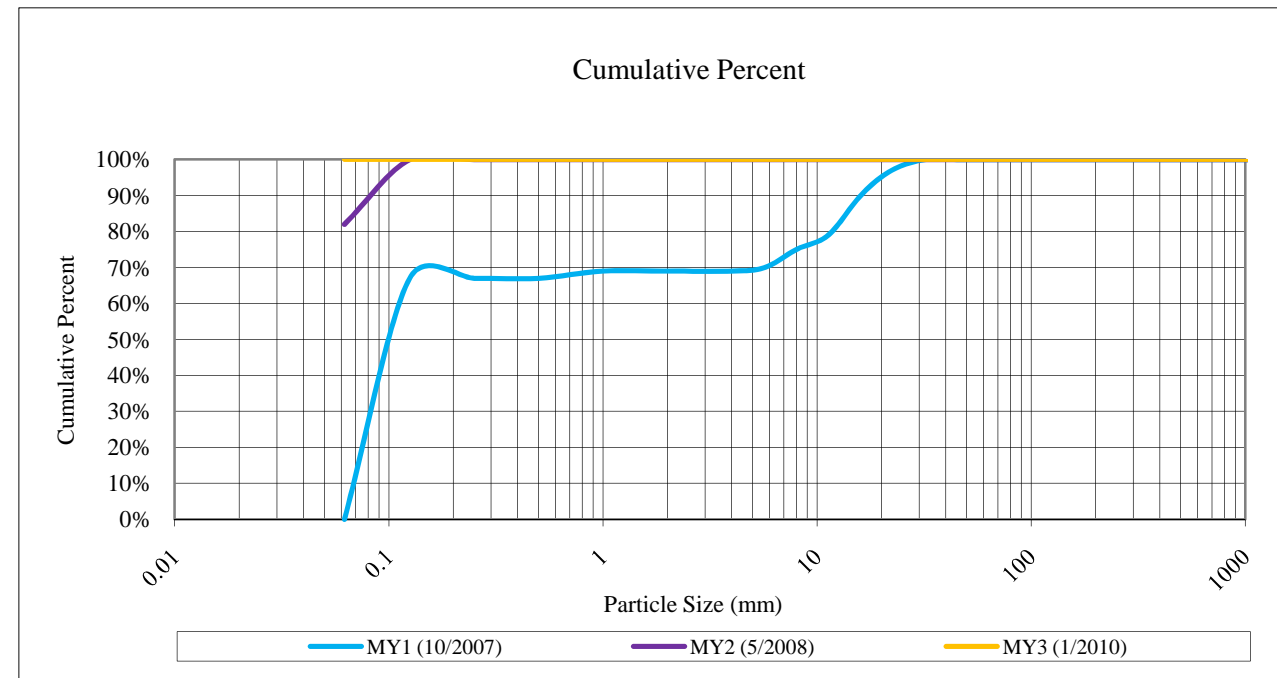
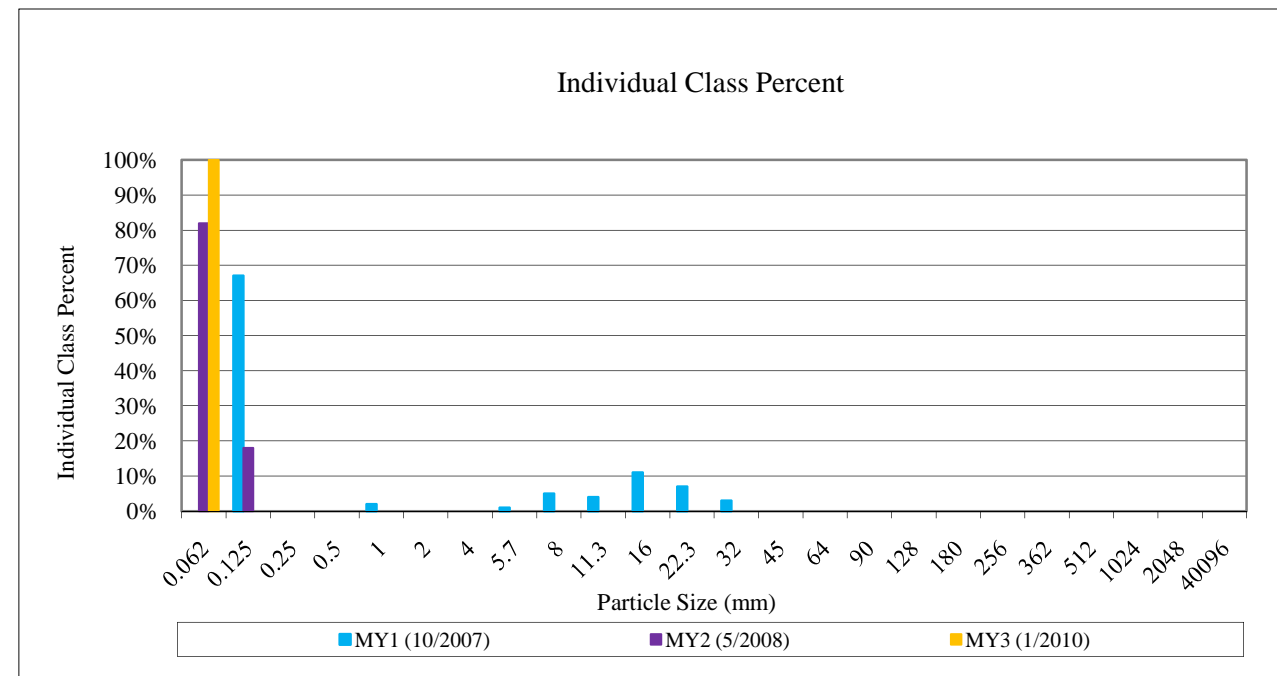
Project Name: Dula Thoroughfare-Tributary					
Cross-Section: 4					
Feature: Run					
MY3-1/2010					
Description	Material	Size (mm)	Total #	Item %	Cum %
Silt/Clay	silt/clay	0.062	100	100%	100%
Sand	very fine sand	0.125	0	0%	0%
	fine sand	0.250	0	0%	0%
	medium sand	0.50	0	0%	0%
	coarse sand	1.00	0	0%	0%
	very coarse sand	2.0	0	0%	0%
Gravel	very fine gravel	4.0	0	0%	0%
	fine gravel	5.7	0	0%	0%
	fine gravel	8.0	0	0%	0%
	medium gravel	11.3	0	0%	0%
	medium gravel	16.0	0	0%	0%
	course gravel	22.3	0	0%	0%
	course gravel	32.0	0	0%	0%
	very coarse gravel	45	0	0%	0%
	very coarse gravel	64	0	0%	0%
Cobble	small cobble	90	0	0%	0%
	medium cobble	128	0	0%	0%
	large cobble	180	0	0%	0%
	very large cobble	256	0	0%	0%
Boulder	small boulder	362	0	0%	0%
	small boulder	512	0	0%	0%
	medium boulder	1024	0	0%	0%
	large boulder	2048	0	0%	0%
Bedrock	bedrock	40096	0	0%	0%
TOTAL % of whole count			100	100%	100%

Summary Data	
D50	0.03
D84	0.05
D95	0.06

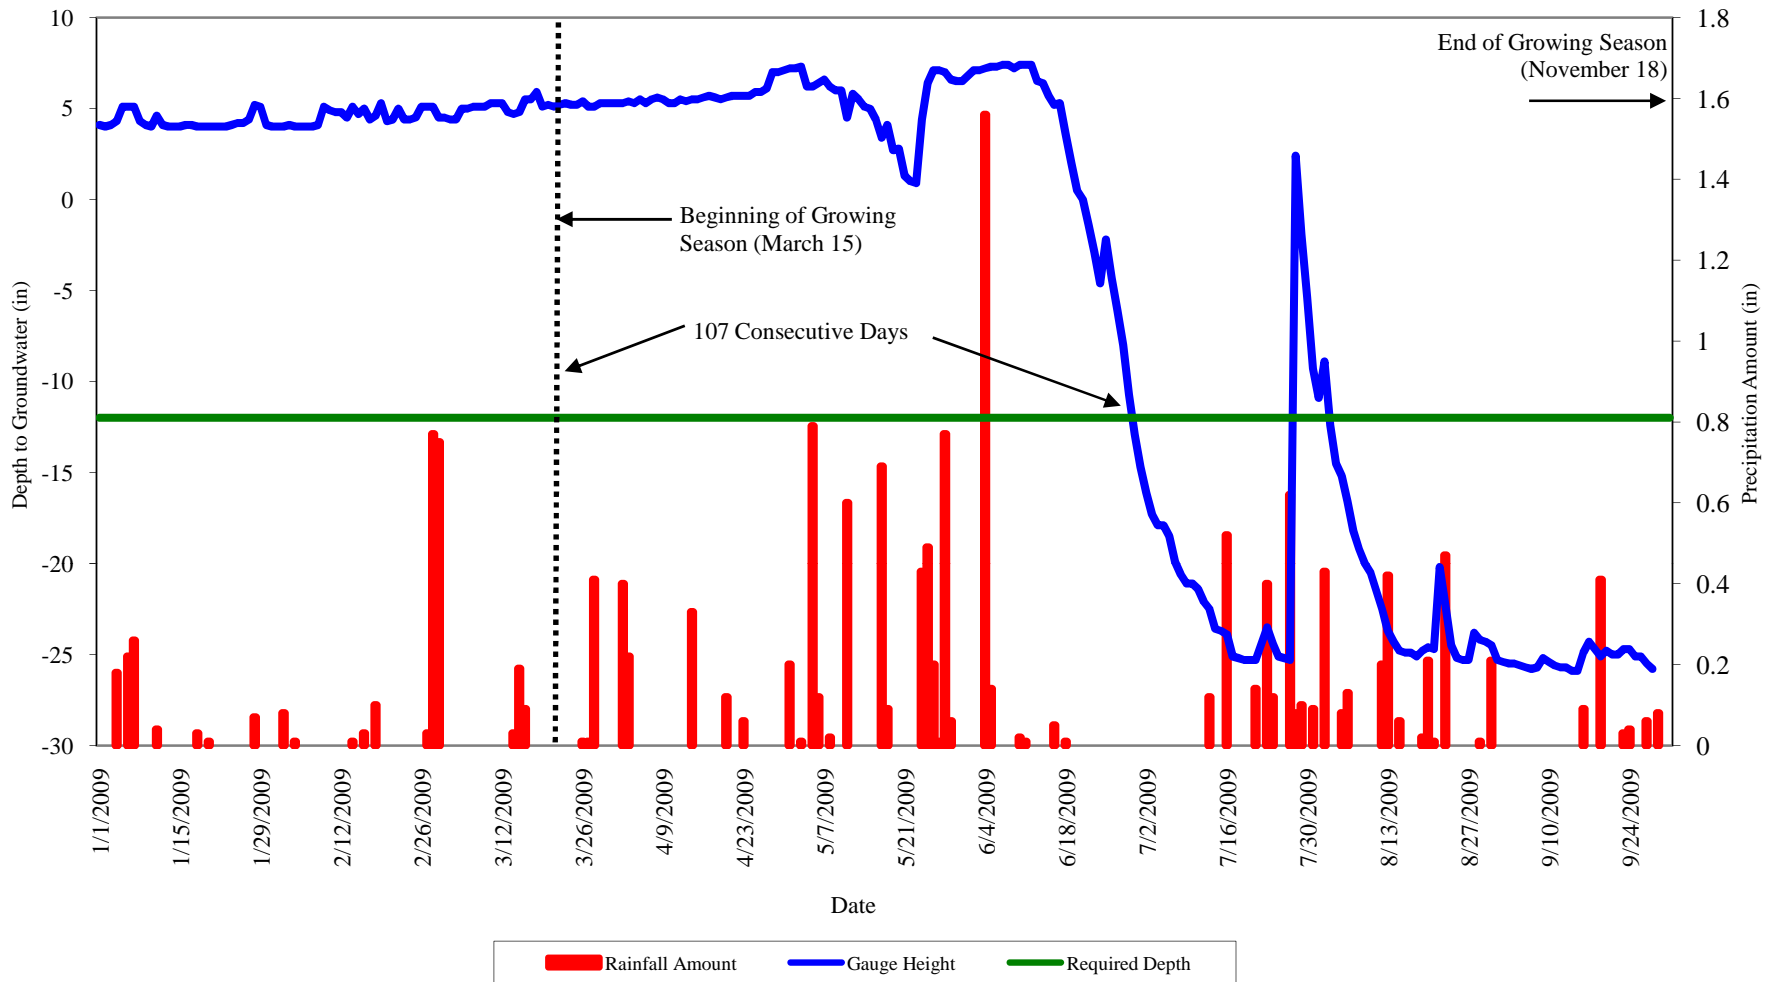
Dula Thoroughfare Hydrology Monitoring Groundwater Gauge 1

Summary of Groundwater Gauge Results for Years 1 through 5					
Gauge	Success Criteria Achieved/Max Consecutive Days During Growing Season (Percentage)				
	Year 1 (2007)	Year 2 (2008)	Year 3 (2009)	Year 4 (2010)	Year 5 (2011)
GW1	N/A*	Yes/81 Days (76%)	Yes/117 Days (57%)^		
GW2	Yes/41 Days (16%)**	Yes/69 Days (49%)	Yes/99 Days (44%)		
GW3	Yes/42 Days (17%)**	Yes/80 Days (70%)	Yes/96 Days (43%)
