Dula Thoroughfare Stream and Wetland Restoration Project No. 65 2010 Monitoring Report: Year 4 of 5

June 2011

Prepared for: NCDENR-EEP
1652 Mail Service Center
Raleigh, NC 27699-1652

Prepared by: Jordan, Jones & Goulding
309 E. Morehead St., Suite 110
Charlotte, NC 28202

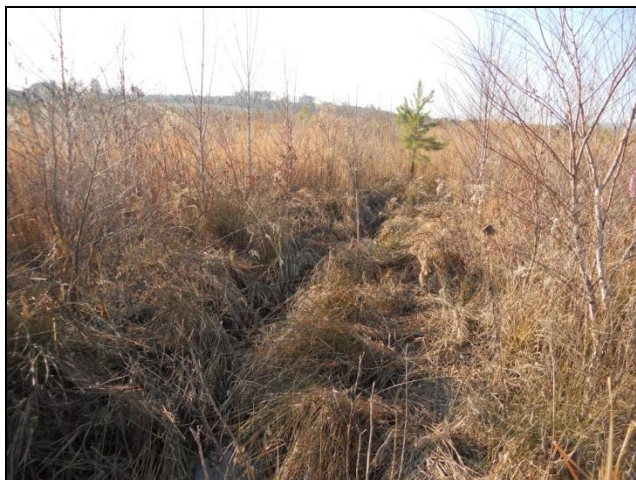
Cross-Section 1-Upstream
Dula Thoroughfare (2/2011)

Overall, the present stream dimensions along DT appear stable. The surveyed cross-sections 1-3 have had some minor adjustments over the past year but have remained stable. The dimension values of cross-section 1 differ from last year due to an adjustment in what was considered bankfull. The right pin for cross-section 3 could not be located in 2009, and a new pin was established. However, the right pin for cross-section 3 again could not be located in 2010, which resulted in a different cross-sectional survey in 2010. The average bankfull and water surface slopes for the 2010 monitoring year were calculated as 0.0012 ft/ft and 0.0011 ft/ft, respectively. Due to the lack of well defined bed features, riffle slopes were not calculated. Several areas

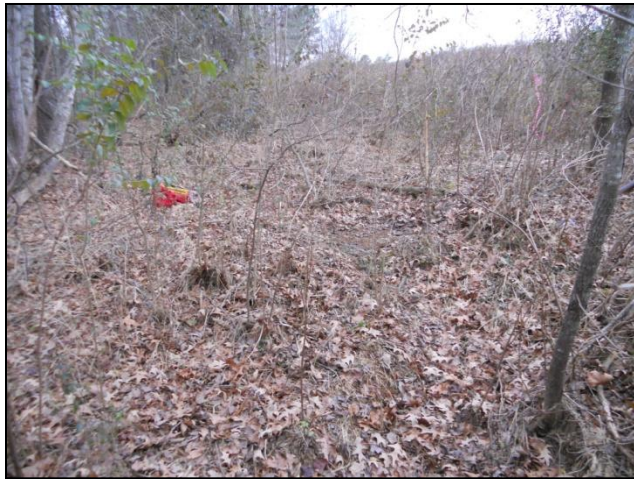
Cross-Section 6-Upstream
UT Dula Thoroughfare (2/2011)

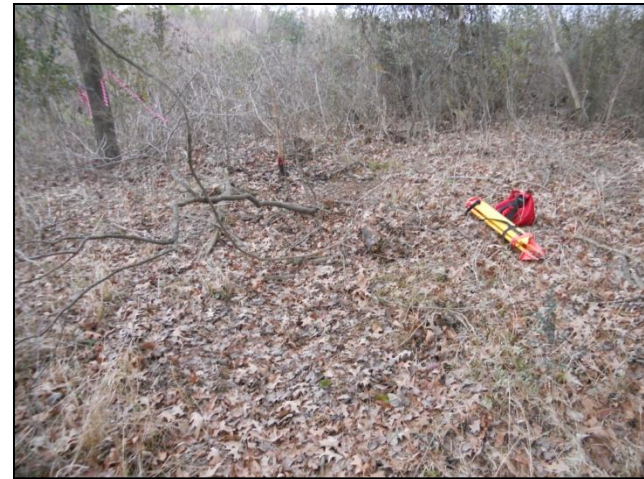
Cross-Section 6-Downstream
UT Dula Thoroughfare (2/2011)

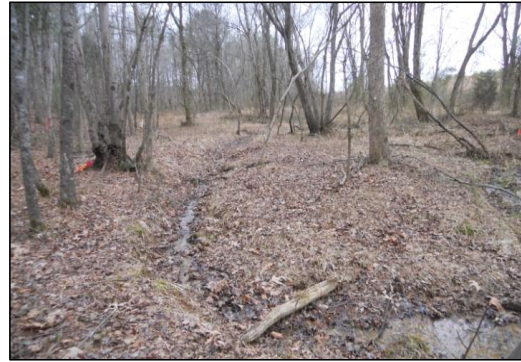
XS-7: View Upstream

During JJG's assessment, the channel was generally dry until approximately 200 feet upstream of cross-section 7. Beyond cross-section 7, the channel had normal flow conditions with riffles, runs, and pools present. Approximately midway down the project reach (between the first and second cross-vane triplets), the water in the channel disappears and then reappears 50 ft downstream. All cross-vanes triplets appear to be stable and are not showing any signs of erosion or piping. The surveyed cross-sections have remained stable over the last year.
