Camp Branch Stream Restoration

EEP Project No. 92350
2011 Final Monitoring Report: Year 5 of 5

Construction Completed: February 2007
Submission Date: March 2012

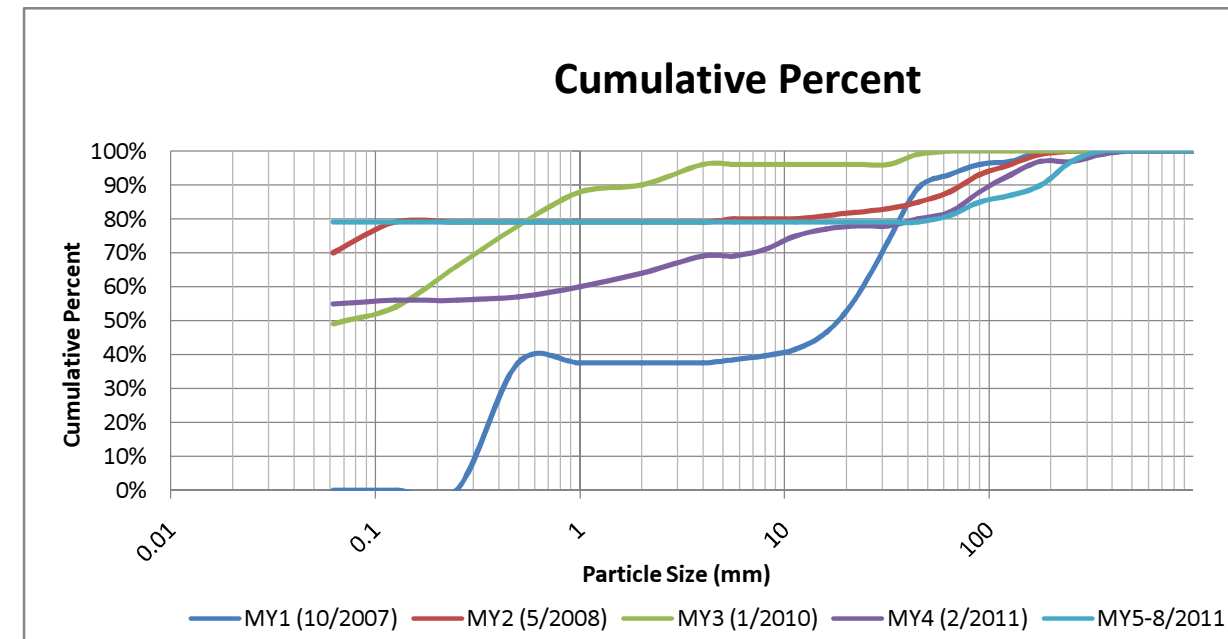
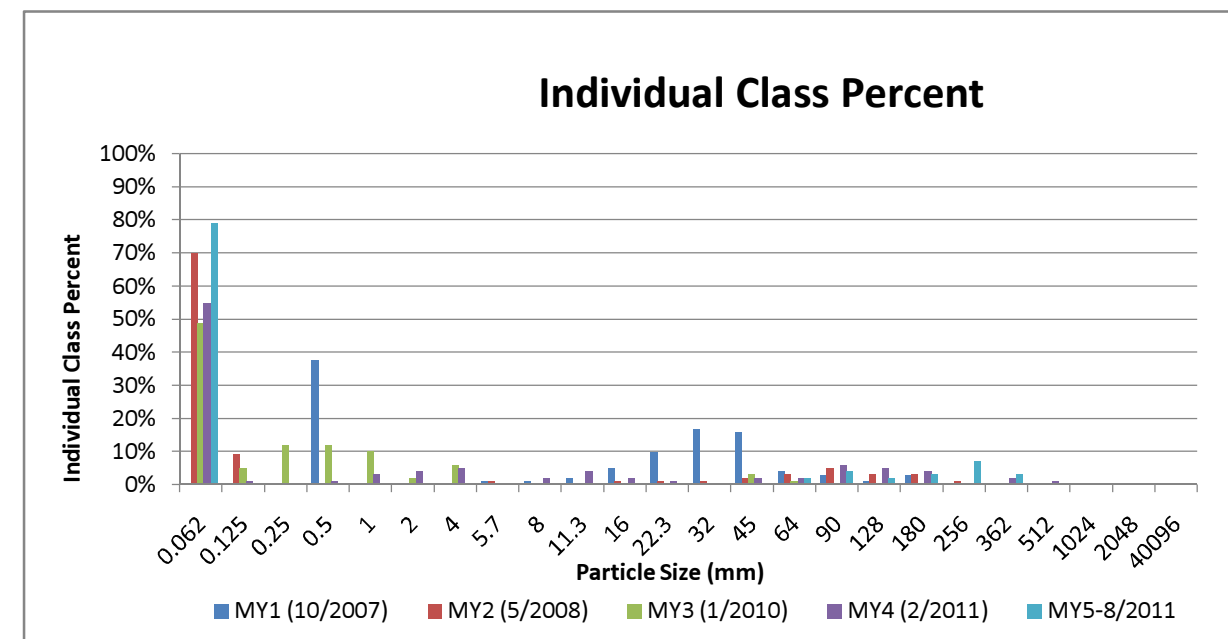
Figure 5c: Pebble Count Plots with Annual Overlays

Project Name: Camp Branch-Tributary					
Cross-Section: 3					
Feature: Riffle					
MY5-8/2011					
Description	Material	Size (mm)	Total #	Item %	Cum %
Silt/Clay	silt/clay	0.062	79	79%	79%
Sand	very fine sand	0.125	0	0%	79%
	fine sand	0.250	0	0%	79%
	medium sand	0.50	0	0%	79%
	coarse sand	1.00	0	0%	79%
	very coarse sand	2.0	0	0%	79%
Gravel	very fine gravel	4.0	0	0%	79%
	fine gravel	5.7	0	0%	79%
	fine gravel	8.0	0	0%	79%
	medium gravel	11.3	0	0%	79%
	medium gravel	16.0	0	0%	79%
	course gravel	22.3	0	0%	79%
	course gravel	32.0	0	0%	79%
	very coarse gravel	45	0	0%	79%
	very coarse gravel	64	2	2%	81%
Cobble	small cobble	90	4	4%	85%
	medium cobble	128	2	2%	87%
	large cobble	180	3	3%	90%
	very large cobble	256	7	7%	97%
Boulder	small boulder	362	3	3%	100%
	small boulder	512	0	0%	100%
	medium boulder	1024	0	0%	100%
	large boulder	2048	0	0%	100%
Bedrock	bedrock	40096	0	0%	100%
TOTAL % of whole count			100	100%	100%

Summary Data	
D50	0.04
D84	83.5
D95	234.29

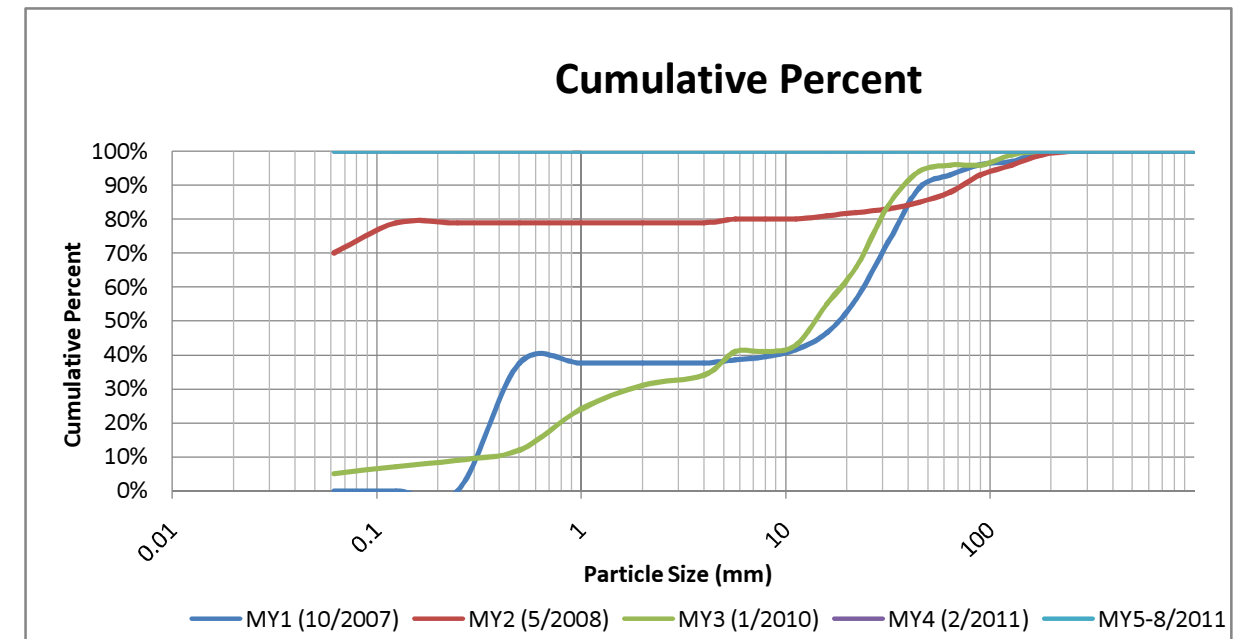
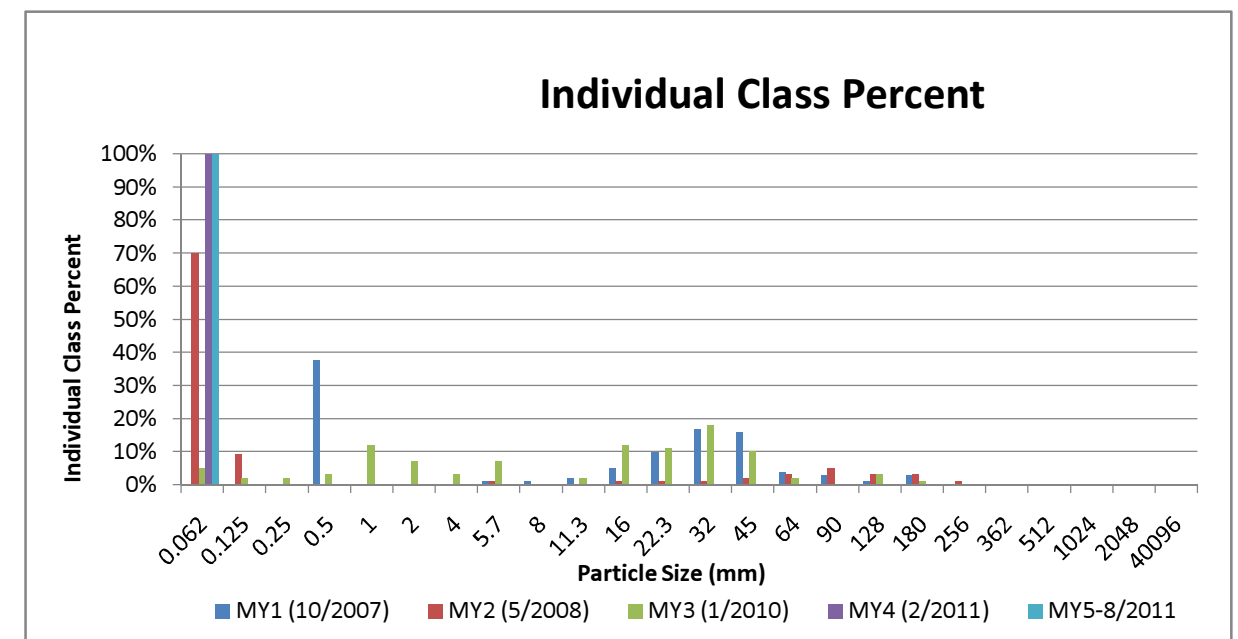
Figure 5d: Pebble Count Plots with Annual Overlays

Project Name: Camp Branch-Tributary					
Cross-Section: 4					
Feature: Pool					
MY5-8/2011					
Description	Material	Size (mm)	Total #	Item %	Cum %
Silt/Clay	silt/clay	0.062	100	100%	100%
Sand	very fine sand	0.125	0	0%	100%
	fine sand	0.250	0	0%	100%
	medium sand	0.50	0	0%	100%
	coarse sand	1.00	0	0%	100%
	very coarse sand	2.0	0	0%	100%
Gravel	very fine gravel	4.0	0	0%	100%
	fine gravel	5.7	0	0%	100%
	fine gravel	8.0	0	0%	100%
	medium gravel	11.3	0	0%	100%
	medium gravel	16.0	0	0%	100%
	course gravel	22.3	0	0%	100%
	course gravel	32.0	0	0%	100%
	very coarse gravel	45	0	0%	100%
Cobble	very coarse gravel	64	0	0%	100%
	small cobble	90	0	0%	100%
	medium cobble	128	0	0%	100%
	large cobble	180	0	0%	100%
Boulder	very large cobble	256	0	0%	100%
	small boulder	362	0	0%	100%
	small boulder	512	0	0%	100%
	medium boulder	1024	0	0%	100%
Bedrock	large boulder	2048	0	0%	100%
	bedrock	40096	0	0%	100%
TOTAL % of whole count			100	100%	100%

Summary Data	
D50	0.03
D84	0.05
D95	0.06

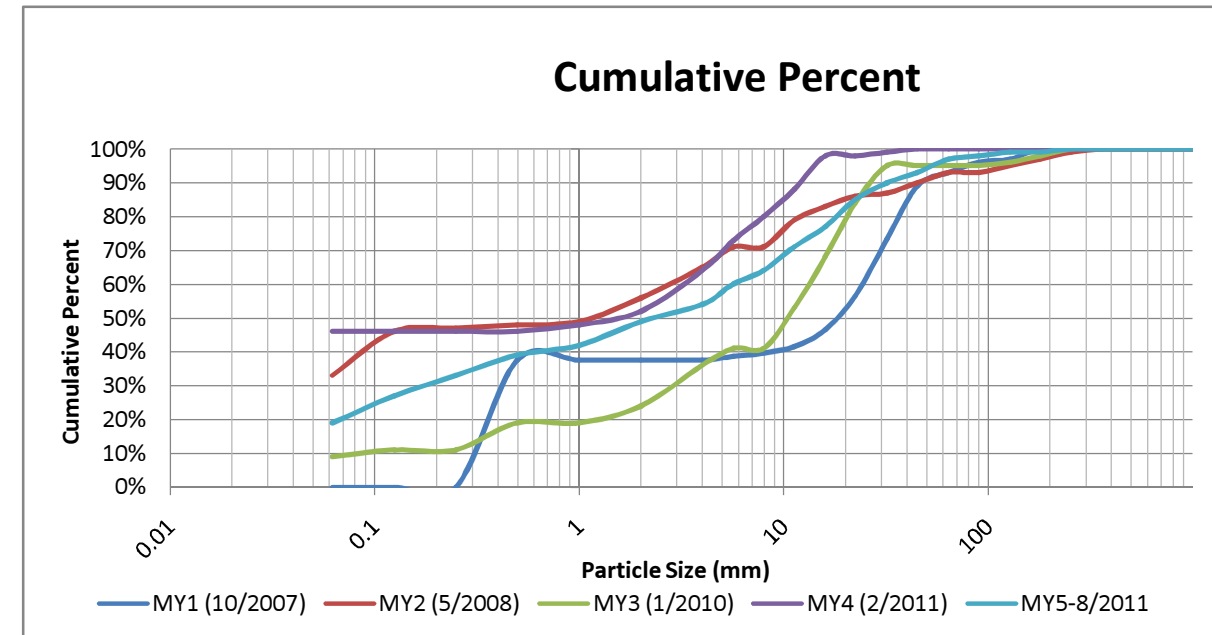
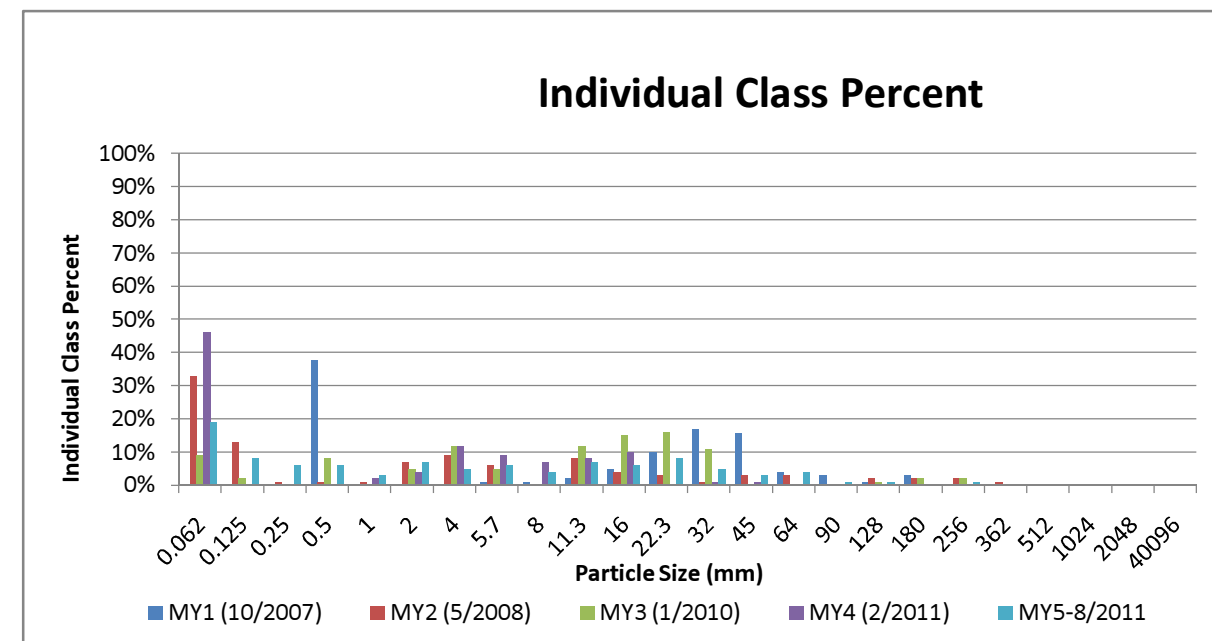
Figure 5e: Pebble Count Plots with Annual Overlays

Project Name: Camp Branch-Main Channel					
Cross-Section: 5					
Feature: Riffle					
MY5-8/2011					
Description	Material	Size (mm)	Total #	Item %	Cum %
Silt/Clay	silt/clay	0.062	19	19%	19%
Sand	very fine sand	0.125	8	8%	27%
	fine sand	0.250	6	6%	33%
	medium sand	0.50	6	6%	39%
	coarse sand	1.00	3	3%	42%
	very coarse sand	2.0	7	7%	49%
Gravel	very fine gravel	4.0	5	5%	54%
	fine gravel	5.7	6	6%	60%
	fine gravel	8.0	4	4%	64%
	medium gravel	11.3	7	7%	71%
	medium gravel	16.0	6	6%	77%
	course gravel	22.3	8	8%	85%
	course gravel	32.0	5	5%	90%
	very coarse gravel	45	3	3%	93%
	very coarse gravel	64	4	4%	97%
Cobble	small cobble	90	1	1%	98%
	medium cobble	128	1	1%	99%
	large cobble	180	0	0%	99%
	very large cobble	256	1	1%	100%
Boulder	small boulder	362	0	0%	100%
	small boulder	512	0	0%	100%
	medium boulder	1024	0	0%	100%
	large boulder	2048	0	0%	100%
Bedrock	bedrock	40096	0	0%	100%
TOTAL % of whole count			100	100%	100%

Summary Data	
D50	2.4
D84	21.78
D95	54.5

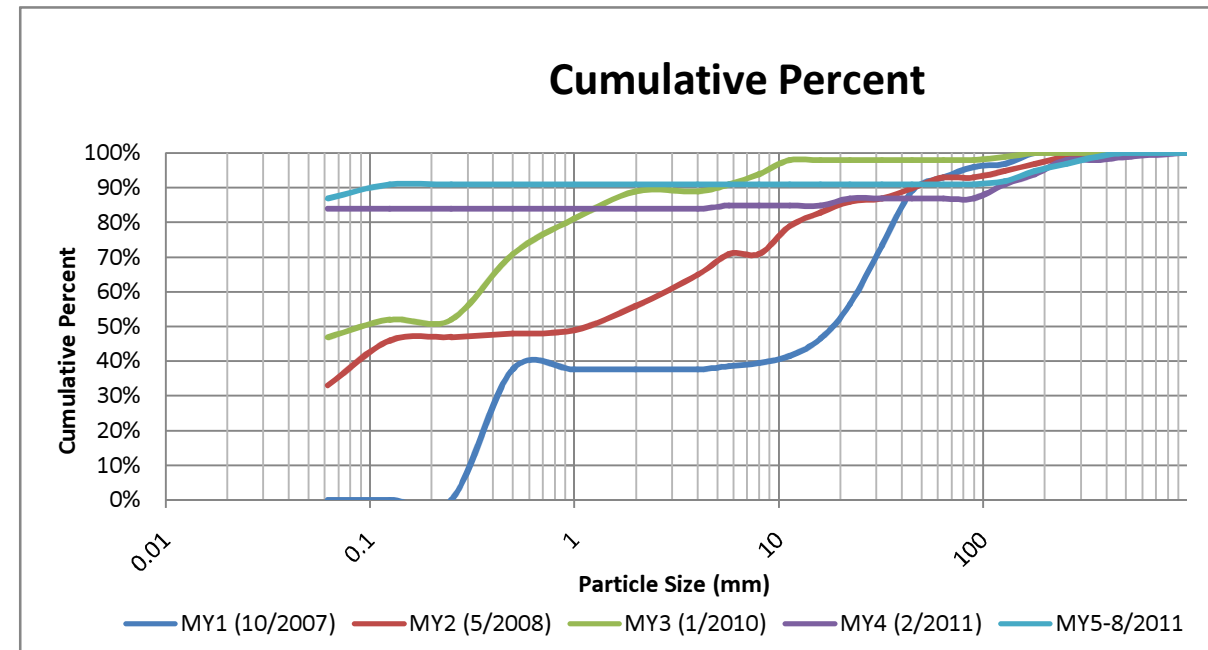
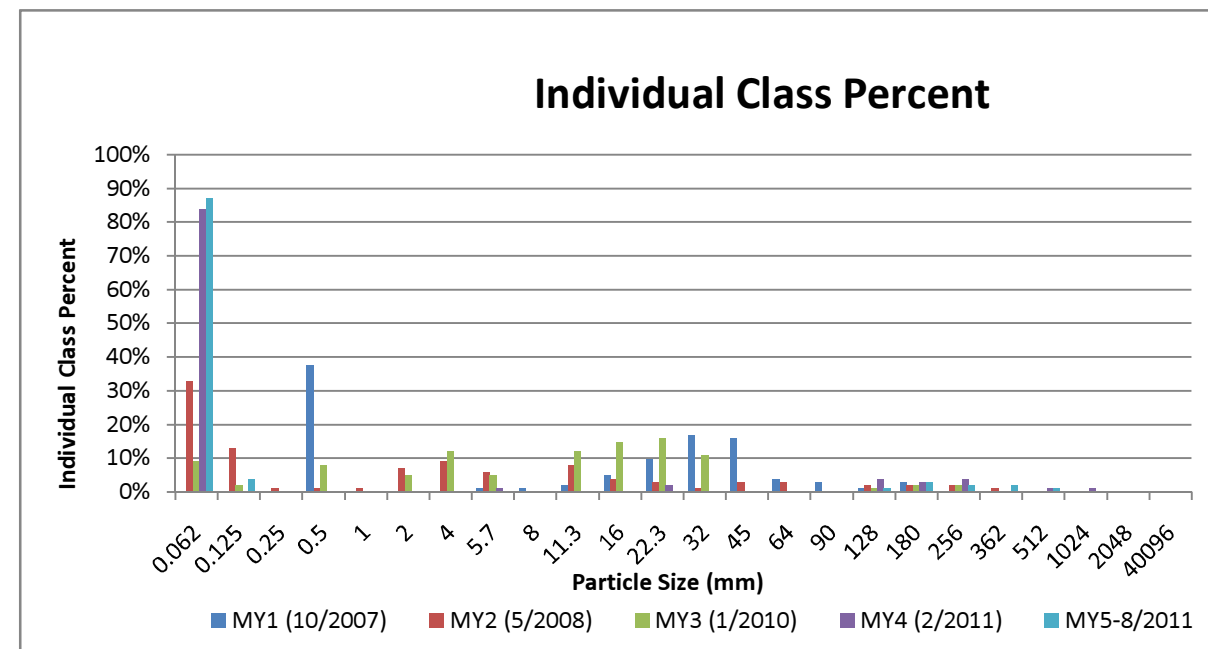
Figure 5f: Pebble Count Plots with Annual Overlays

Project Name: Camp Branch-Main Channel					
Cross-Section: 6					
Feature: Pool					
MY5-8/2011					
Description	Material	Size (mm)	Total #	Item %	Cum %
Silt/Clay	silt/clay	0.062	87	87%	87%
Sand	very fine sand	0.125	4	4%	91%
	fine sand	0.250	0	0%	91%
	medium sand	0.50	0	0%	91%
	coarse sand	1.00	0	0%	91%
	very coarse sand	2.0	0	0%	91%
Gravel	very fine gravel	4.0	0	0%	91%
	fine gravel	5.7	0	0%	91%
	fine gravel	8.0	0	0%	91%
	medium gravel	11.3	0	0%	91%
	medium gravel	16.0	0	0%	91%
	course gravel	22.3	0	0%	91%
	course gravel	32.0	0	0%	91%
	very coarse gravel	45	0	0%	91%
	very coarse gravel	64	0	0%	91%
Cobble	small cobble	90	0	0%	91%
	medium cobble	128	1	1%	92%
	large cobble	180	3	3%	95%
	very large cobble	256	2	2%	97%
Boulder	small boulder	362	2	2%	99%
	small boulder	512	1	1%	100%
	medium boulder	1024	0	0%	100%
	large boulder	2048	0	0%	100%
Bedrock	bedrock	40096	0	0%	100%
TOTAL % of whole count			100	100%	100%

Summary Data	
D50	0.04
D84	0.06
D95	180

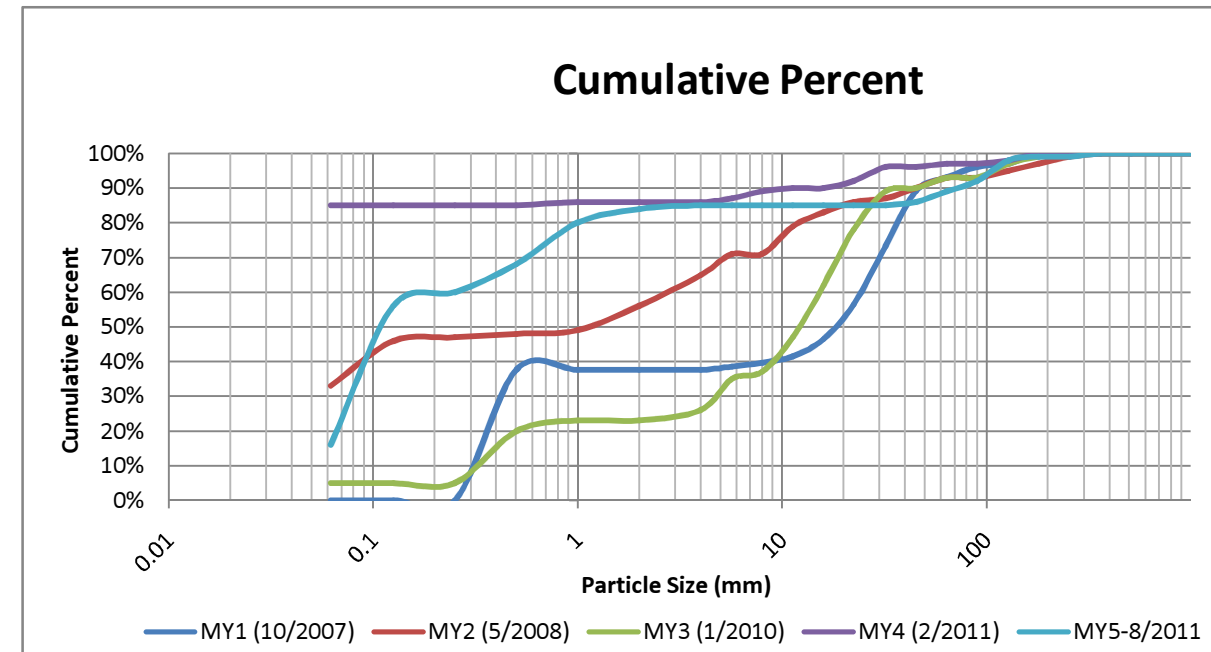
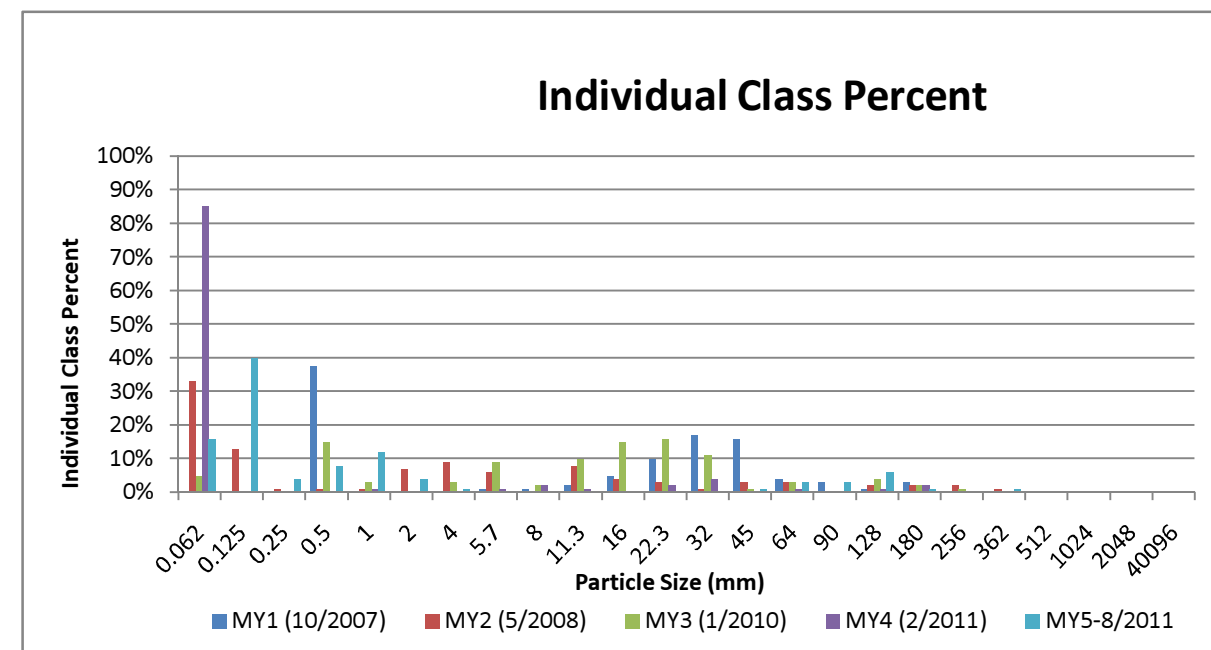
Figure 5g: Pebble Count Plots with Annual Overlays

Project Name: Camp Branch-Main Channel					
Cross-Section: 7					
Feature: Riffle					
			MY5-8/2011		
Description	Material	Size (mm)	Total #	Item %	Cum %
Silt/Clay	silt/clay	0.062	16	16%	16%
Sand	very fine sand	0.125	40	40%	56%
	fine sand	0.250	4	4%	60%
	medium sand	0.50	8	8%	68%
	coarse sand	1.00	12	12%	80%
	very coarse sand	2.0	4	4%	84%
Gravel	very fine gravel	4.0	1	1%	85%
	fine gravel	5.7	0	0%	85%
	fine gravel	8.0	0	0%	85%
	medium gravel	11.3	0	0%	85%
	medium gravel	16.0	0	0%	85%
	course gravel	22.3	0	0%	85%
	course gravel	32.0	0	0%	85%
	very coarse gravel	45	1	1%	86%
	very coarse gravel	64	3	3%	89%
	Cobble	small cobble	90	3	3%
medium cobble		128	6	6%	98%
large cobble		180	1	1%	99%
very large cobble		256	0	0%	99%
Boulder	small boulder	362	1	1%	100%
	small boulder	512	0	0%	100%
	medium boulder	1024	0	0%	100%
	large boulder	2048	0	0%	100%
Bedrock	bedrock	40096	0	0%	100%
TOTAL % of whole count			100	100%	100%

Summary Data	
D50	0.12
D84	2
D95	109

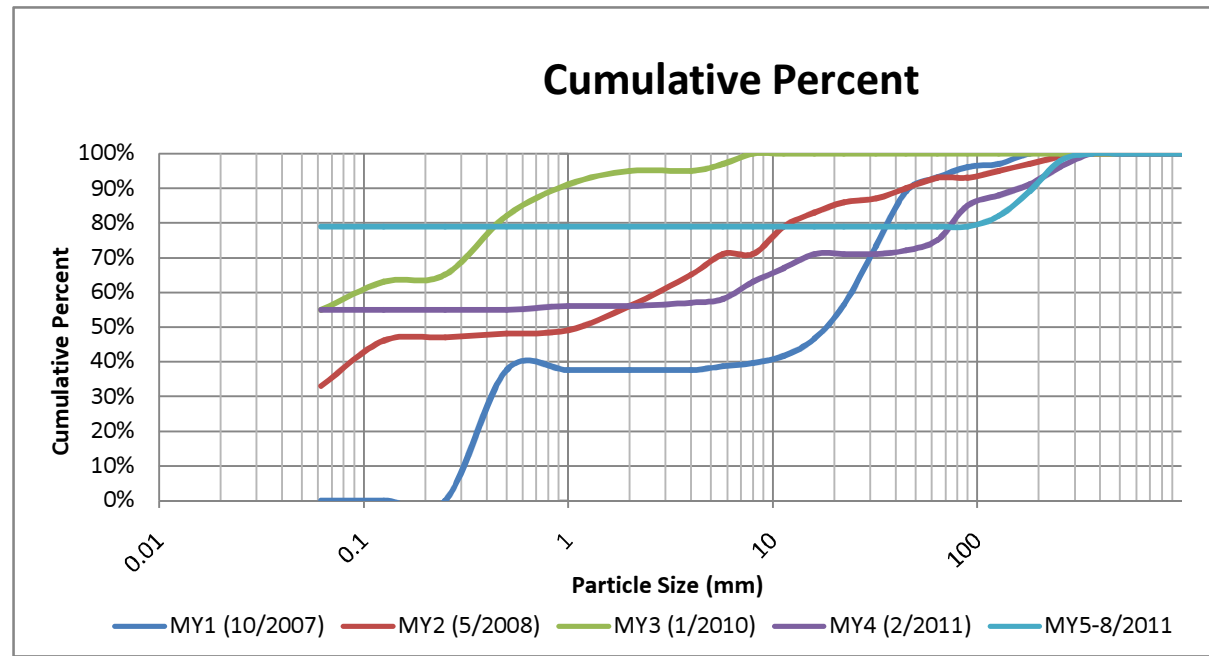
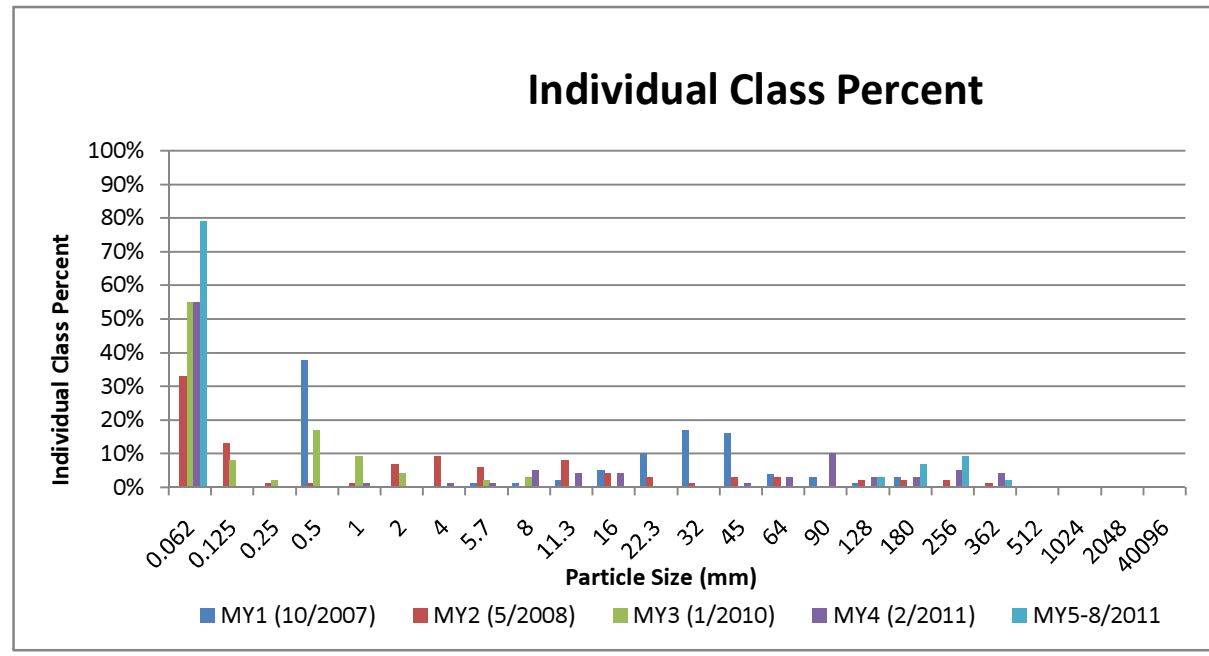
Figure 5h: Pebble Count Plots with Annual Overlays

Project Name: Camp Branch-Main Channel					
Cross-Section: 8					
Feature: Pool					
			MY5-8/2011		
Description	Material	Size (mm)	Total #	Item %	Cum %
Silt/Clay	silt/clay	0.062	79	79%	79%
Sand	very fine sand	0.125	0	0%	79%
	fine sand	0.250	0	0%	79%
	medium sand	0.50	0	0%	79%
	coarse sand	1.00	0	0%	79%
	very coarse sand	2.0	0	0%	79%
Gravel	very fine gravel	4.0	0	0%	79%
	fine gravel	5.7	0	0%	79%
	fine gravel	8.0	0	0%	79%
	medium gravel	11.3	0	0%	79%
	medium gravel	16.0	0	0%	79%
	course gravel	22.3	0	0%	79%
	course gravel	32.0	0	0%	79%
	very coarse gravel	45	0	0%	79%
	very coarse gravel	64	0	0%	79%
	Cobble	small cobble	90	0	0%
medium cobble		128	3	3%	82%
large cobble		180	7	7%	89%
very large cobble		256	9	9%	98%
Boulder	small boulder	362	2	2%	100%
	small boulder	512	0	0%	100%
	medium boulder	1024	0	0%	100%
	large boulder	2048	0	0%	100%
Bedrock	bedrock	40096	0	0%	100%
TOTAL % of whole count			100	100%	100%

Summary Data	
D50	0.04
D84	143
D95	362
