**Dye Branch II  
Stream Restoration  
NCEEP Project Number: 92255  
Monitoring Year 1  
2011 Final Report**

**Submitted to  
North Carolina Ecosystem Enhancement Program  
North Carolina Department of Environment and Natural Resources  
January 2012**

**Dye Branch II Stream Restoration  
2011 Monitoring Report (MY 1)**

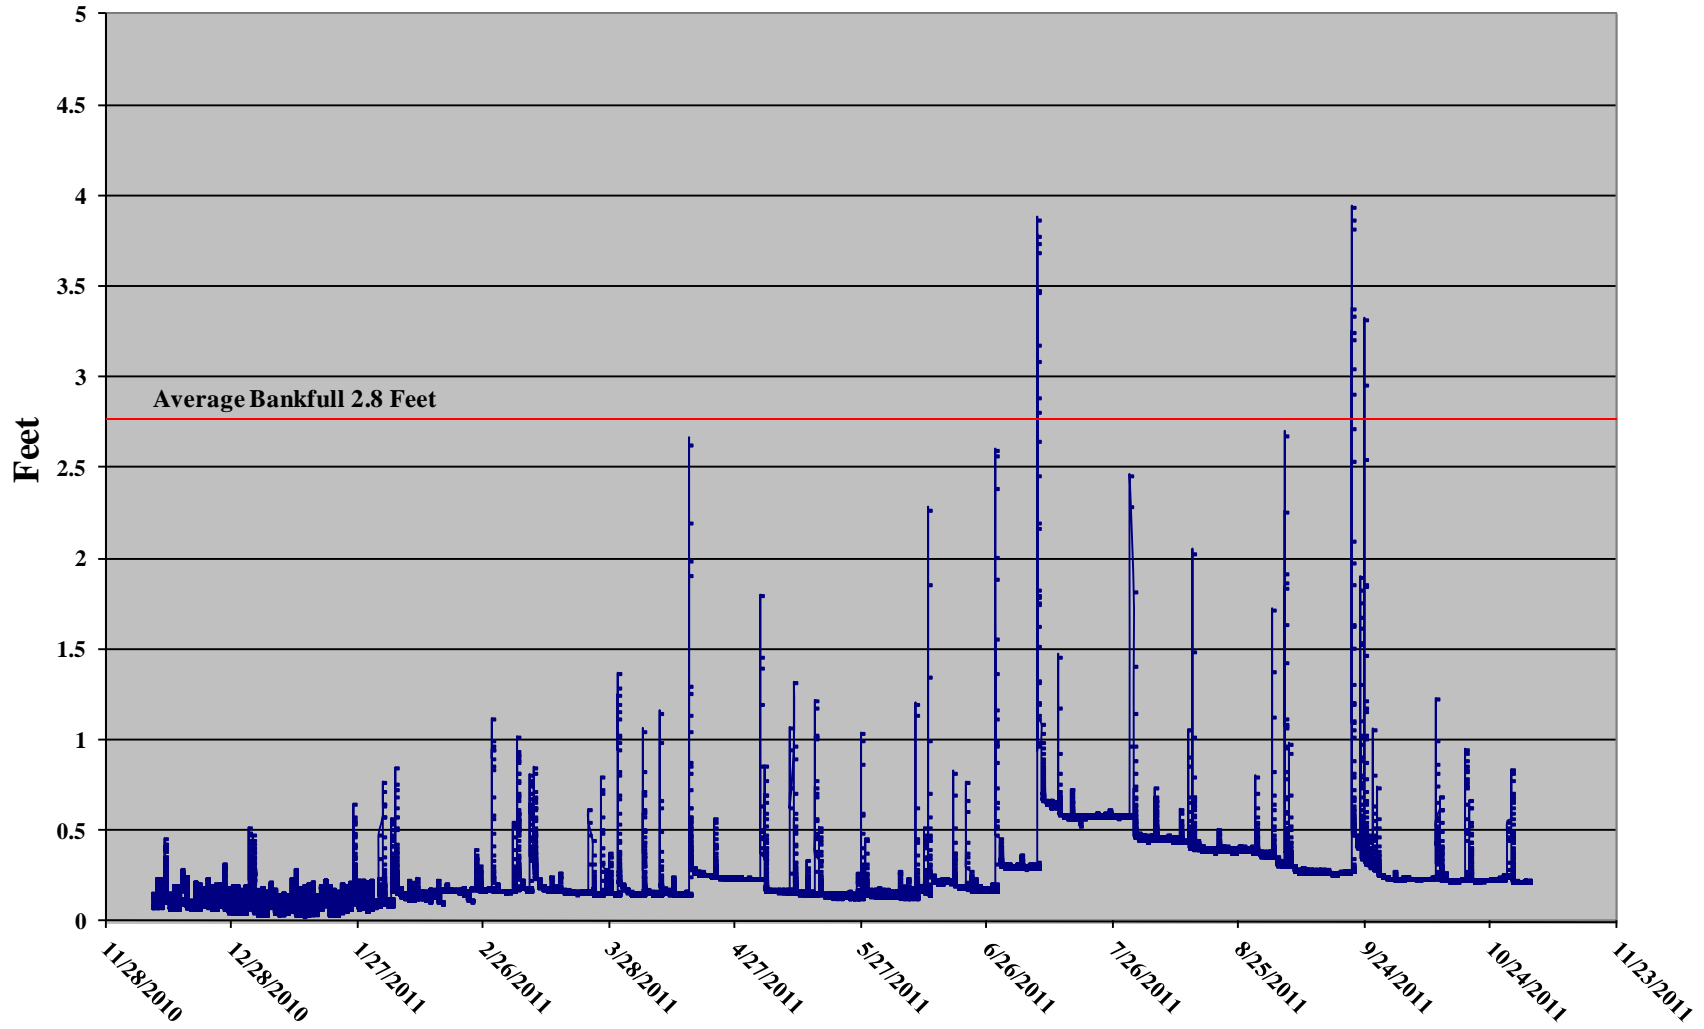
Figure 3. Dye Branch Water Level Logger Chart

<b>Table 12. Verification of Bankfull Events Dye Branch II / Project No. 92255</b>		
<b>Date of Occurrence</b>	<b>Method</b>	<b>Feet Above Average Bankfull Elevation</b>
7/8/2011	Water level logger	1.07
9/21/2011	Water level logger	1.14
9/24/2011	Water level logger	0.52
