**Dye Branch II
Stream Restoration
NCEEP Project Number: 92255
Monitoring Year 2
Monitoring Contract Number: 004523
2012 Final Report**

**Submitted to
North Carolina Ecosystem Enhancement Program
North Carolina Department of Environment and Natural Resources
November 2012**

Dye Branch II Stream Restoration 2012 Monitoring Report (MY 2)

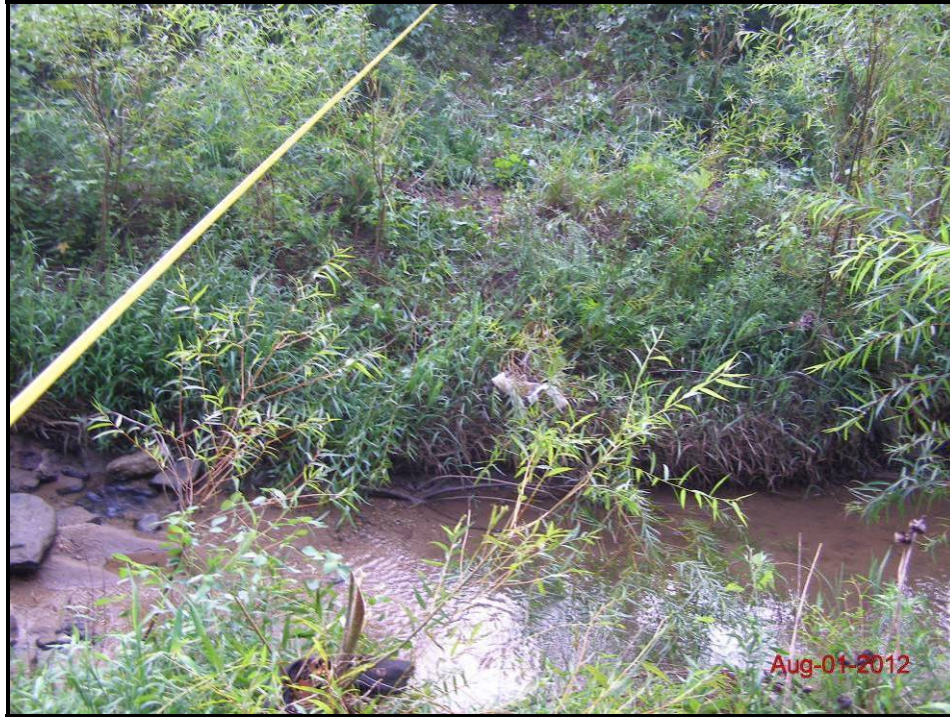
Dye Branch Downstream Reach – Cross-Section 8 – Riffle
Left Bank Descending
Monitoring Year 2 – August 1, 2012

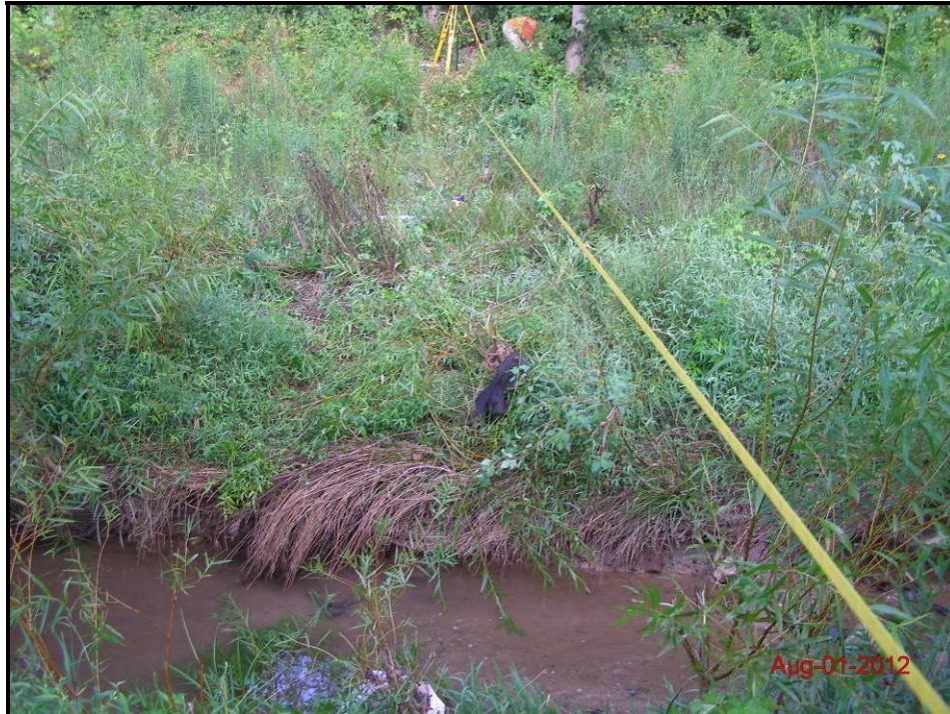
Dye Branch Downstream Reach – Cross-Section 8 – Riffle
Right Bank Descending
Monitoring Year 2 – August 1, 2012

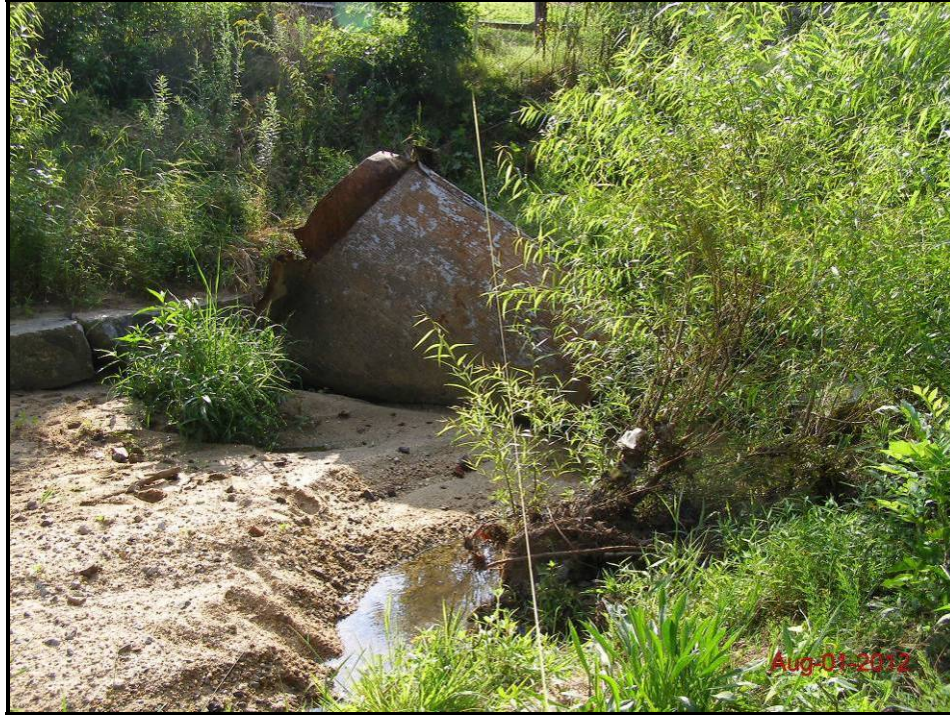
Dye Branch Downstream Reach – Cross-Section 9 – Pool
Left Bank Descending
Monitoring Year 2 – August 1, 2012

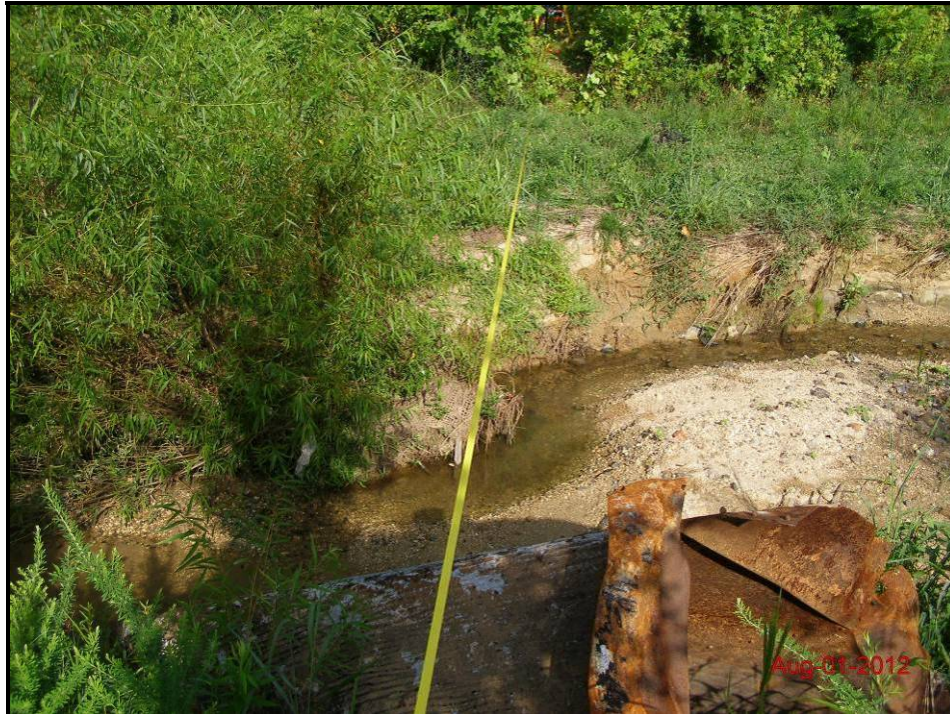
Dye Branch Downstream Reach – Cross-Section 9 – Pool
Right Bank Descending
Monitoring Year 2 – August 1, 2012

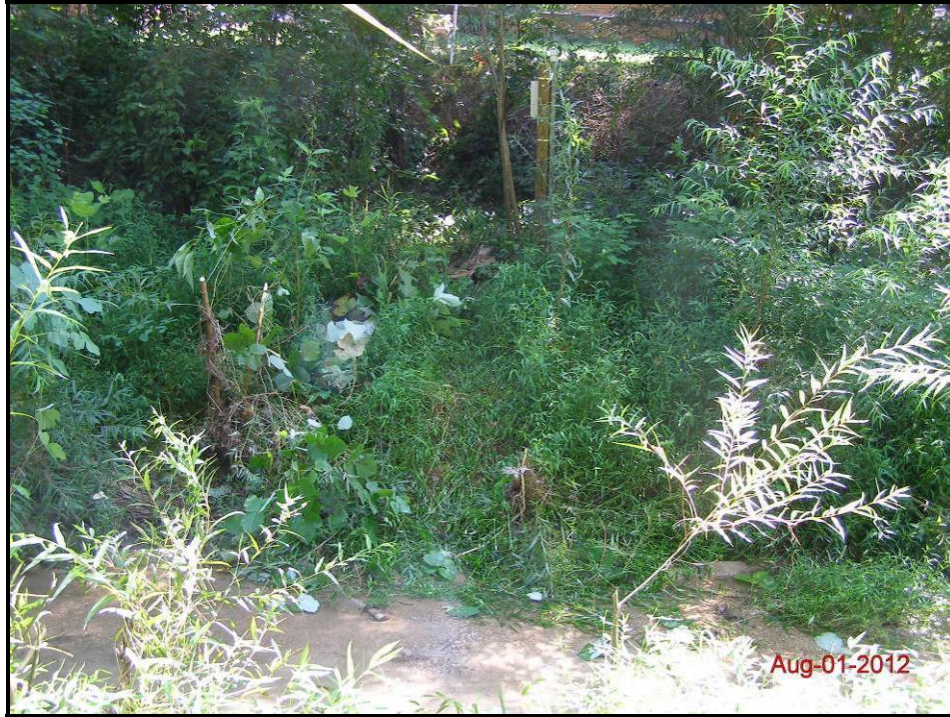
Dye Branch Downstream Reach – Cross-Section 10 – Riffle
Left Bank Descending
Monitoring Year 2 – August 1, 2012

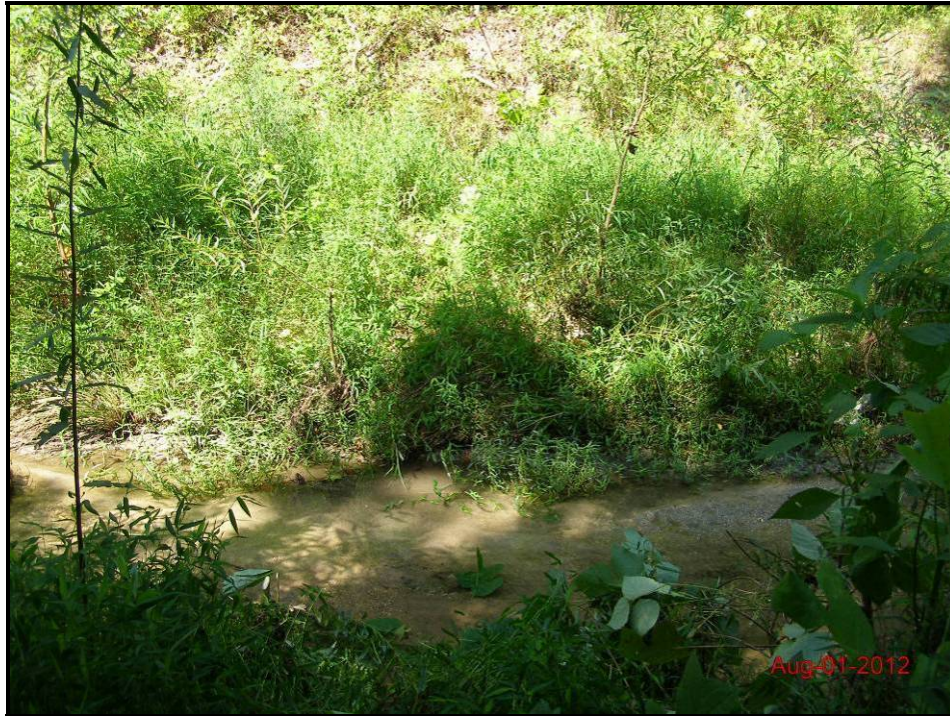
Dye Branch Downstream Reach – Cross-Section 10 – Riffle
Right Bank Descending
Monitoring Year 2 – August 1, 2012
