**Dye Branch II  
Stream Restoration  
NCEEP Project Number: 92255  
Monitoring Year 3  
Monitoring Contract Number: 004523  
2013 Final Report**

**Submitted to  
North Carolina Ecosystem Enhancement Program  
North Carolina Department of Environment and Natural Resources  
November 2013**

# **Dye Branch II Stream Restoration 2013 Monitoring Report (MY 3)**

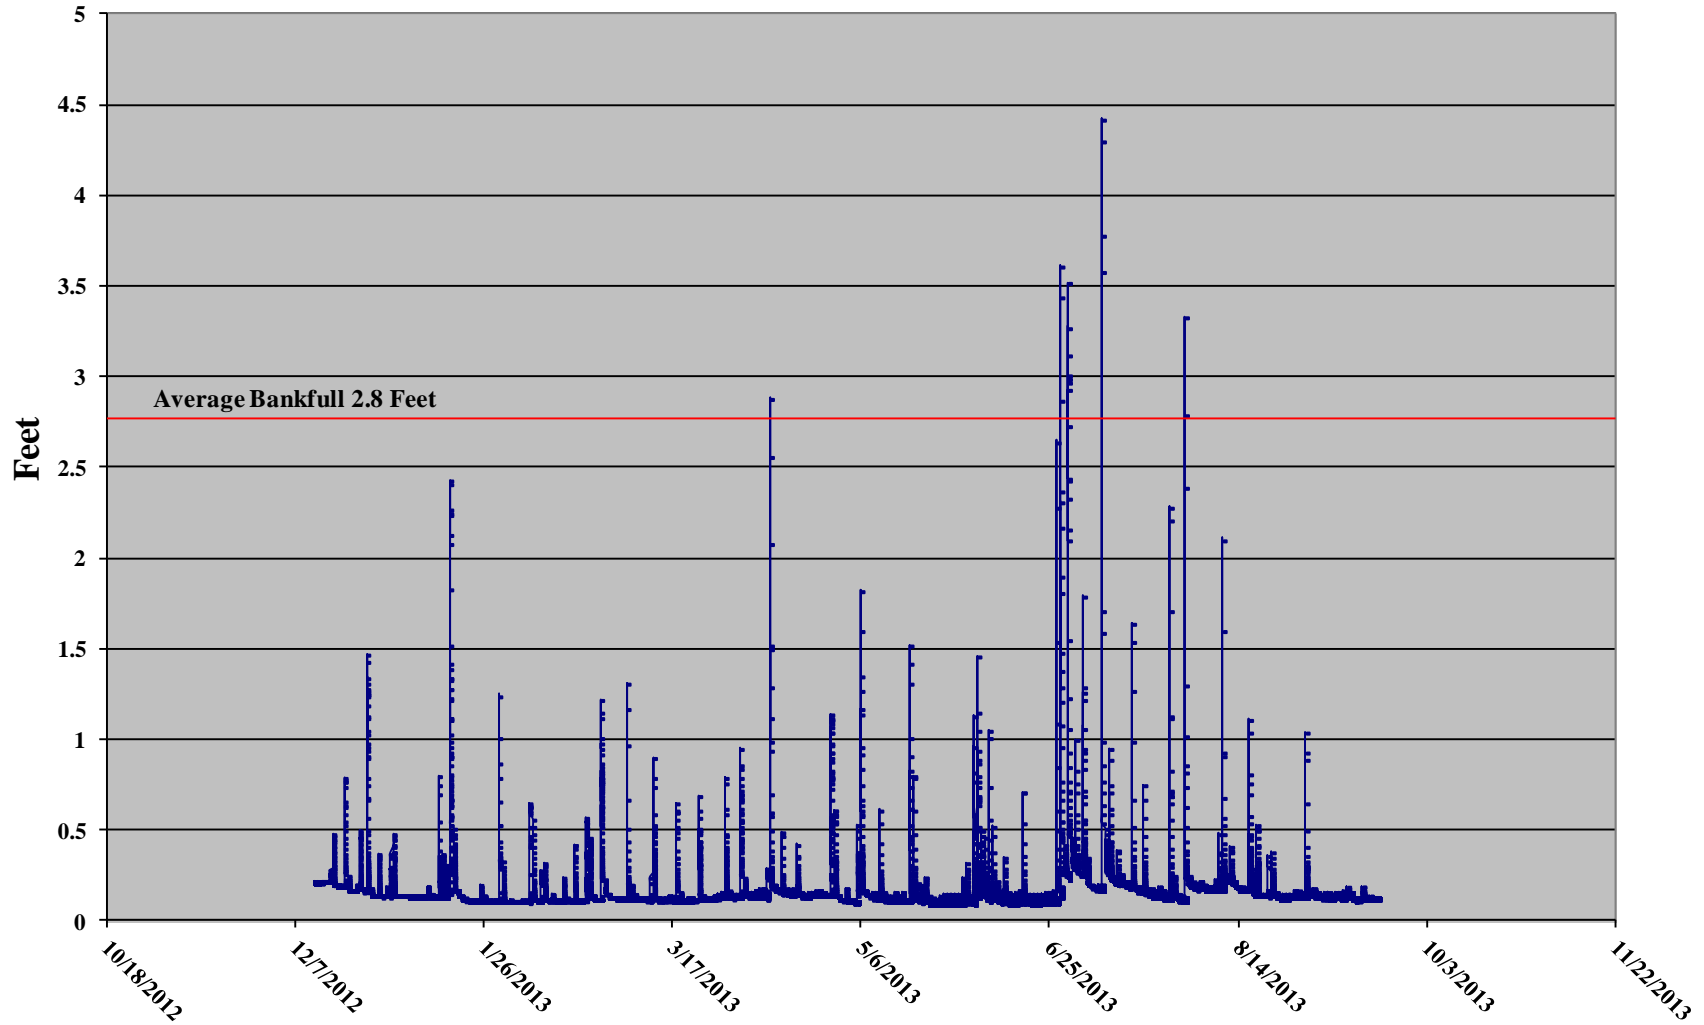
Figure 3. Dye Branch Water Level Logger Chart

<b>Table 12. Verification of Bankfull Events Dye Branch II / Project No. 92255</b>		
<b>Date of Occurrence</b>	<b>Method</b>	<b>Feet Above Average Bankfull Elevation</b>
7/8/2011	Water level logger	1.07
9/21/2011	Water level logger	1.14
9/24/2011	Water level logger	0.52
5/16/2012	Water level logger	1.63
7/11/2012	Water level logger	0.21
9/29/2012	Water level logger	0.22
4/12/2013	Water level logger	0.08
6/28/2013	Water level logger	0.81
6/30/2013	Water level logger	0.72
7/9/2013	Water level logger	1.62
7/31/2013	Water level logger	0.53
