**Dye Branch II
Stream Restoration
MY8 Monitoring Report (2019)
NCDMS Project Number: 92255**

**Submitted to
North Carolina Division of Mitigation Services
North Carolina Department of Environmental Quality
March 2020**

Dye Branch II Stream Restoration 2019 MY8 Monitoring Report

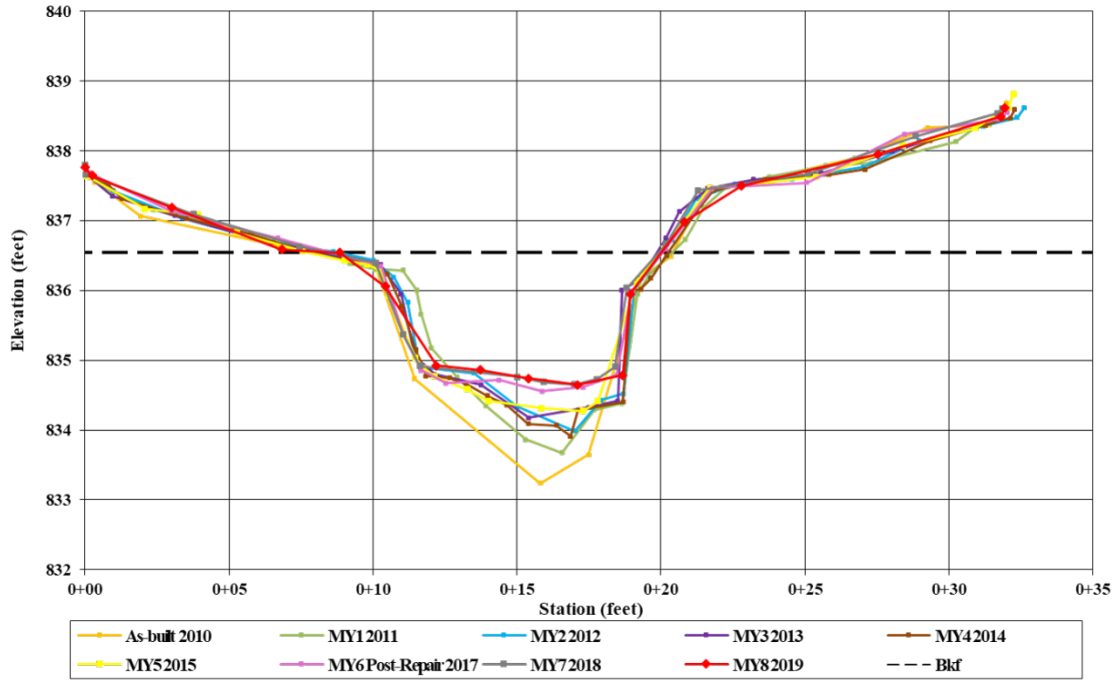
Cemetery Branch
Cross-Section 1 - Pool
Station 1 + 04.27

MY8 morphologic monitoring of the Dye Branch Site included ten (10) cross-sections. Cross-sectional overlays are located in Appendix D and a summary of the data is located in Table 11a and 11b. Cross-sections remained relatively stable between the Post-Construction data and MY8 monitoring. Cross-section 5 continues to undergo change, as it has taken on a riffle-like geometry. Cross-sections 7 and 8, which were noted as aggrading in the MY7 report, appear to be trending back to their as-built geometry. Riffle dimensions for the three different reaches also remained relatively stable during MY8. Dimensional changes for Cemetery Branch were a decrease in the bankfull width by 0.3 foot and lowering of the width/ depth ratio by 0.3. Dye Branch Upstream exhibits little dimensional change from MY7, Dye Branch Downstream underwent an increase in bankfull width of 0.3 feet and the width/ depth ratio also increased by 0.3.
