# **MONITORING YEAR 2 ANNUAL REPORT FINAL**

## **DYNAMITE CREEK MITIGATION SITE**

Rockingham County, NC  
Roanoke River Basin  
HUC 03010103

**DYNAMITE CREEK MITIGATION SITE**  
Monitoring Year 2 Annual Report

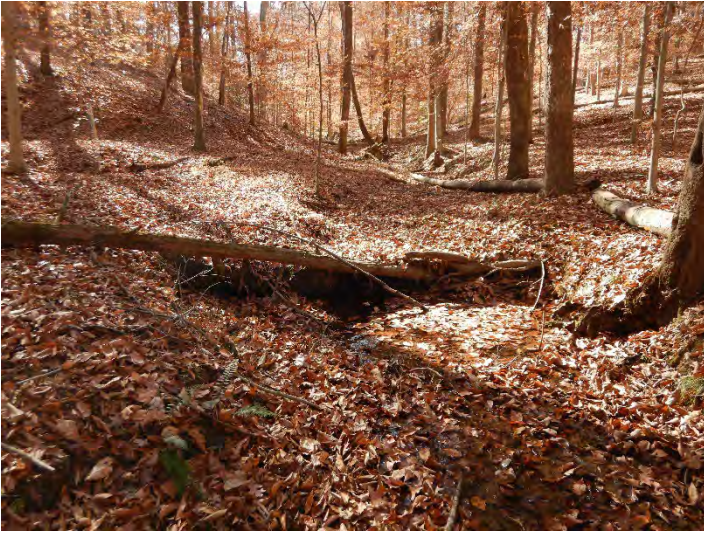
**PHOTO POINT 16\* Dynamite Creek Confluence with UT1 –  
upstream (11/16/2023)**

Additionally at the confluence of UT1 and Dynamite Creek, the stream was observed flowing through a hole on the downstream right side of the channel, behind an old fallen tree that had been acting as grade control. The IRT requested an additional photo point be added to monitor the area and confirm stream stability. The photo point (PP16) was installed, and photos were taken on November 16, 2023. Please see Stream Photographs in Appendix A and Figure 1a for the location.
