East Buffalo Creek Mitigation Project

Year 1 Monitoring Report - Final Graham County, North Carolina

Monitoring Firm: Michael Baker
Engineering, Inc. (Baker)

Prepared for: North Carolina Ecosystem
Enhancement Program (NCEEP)

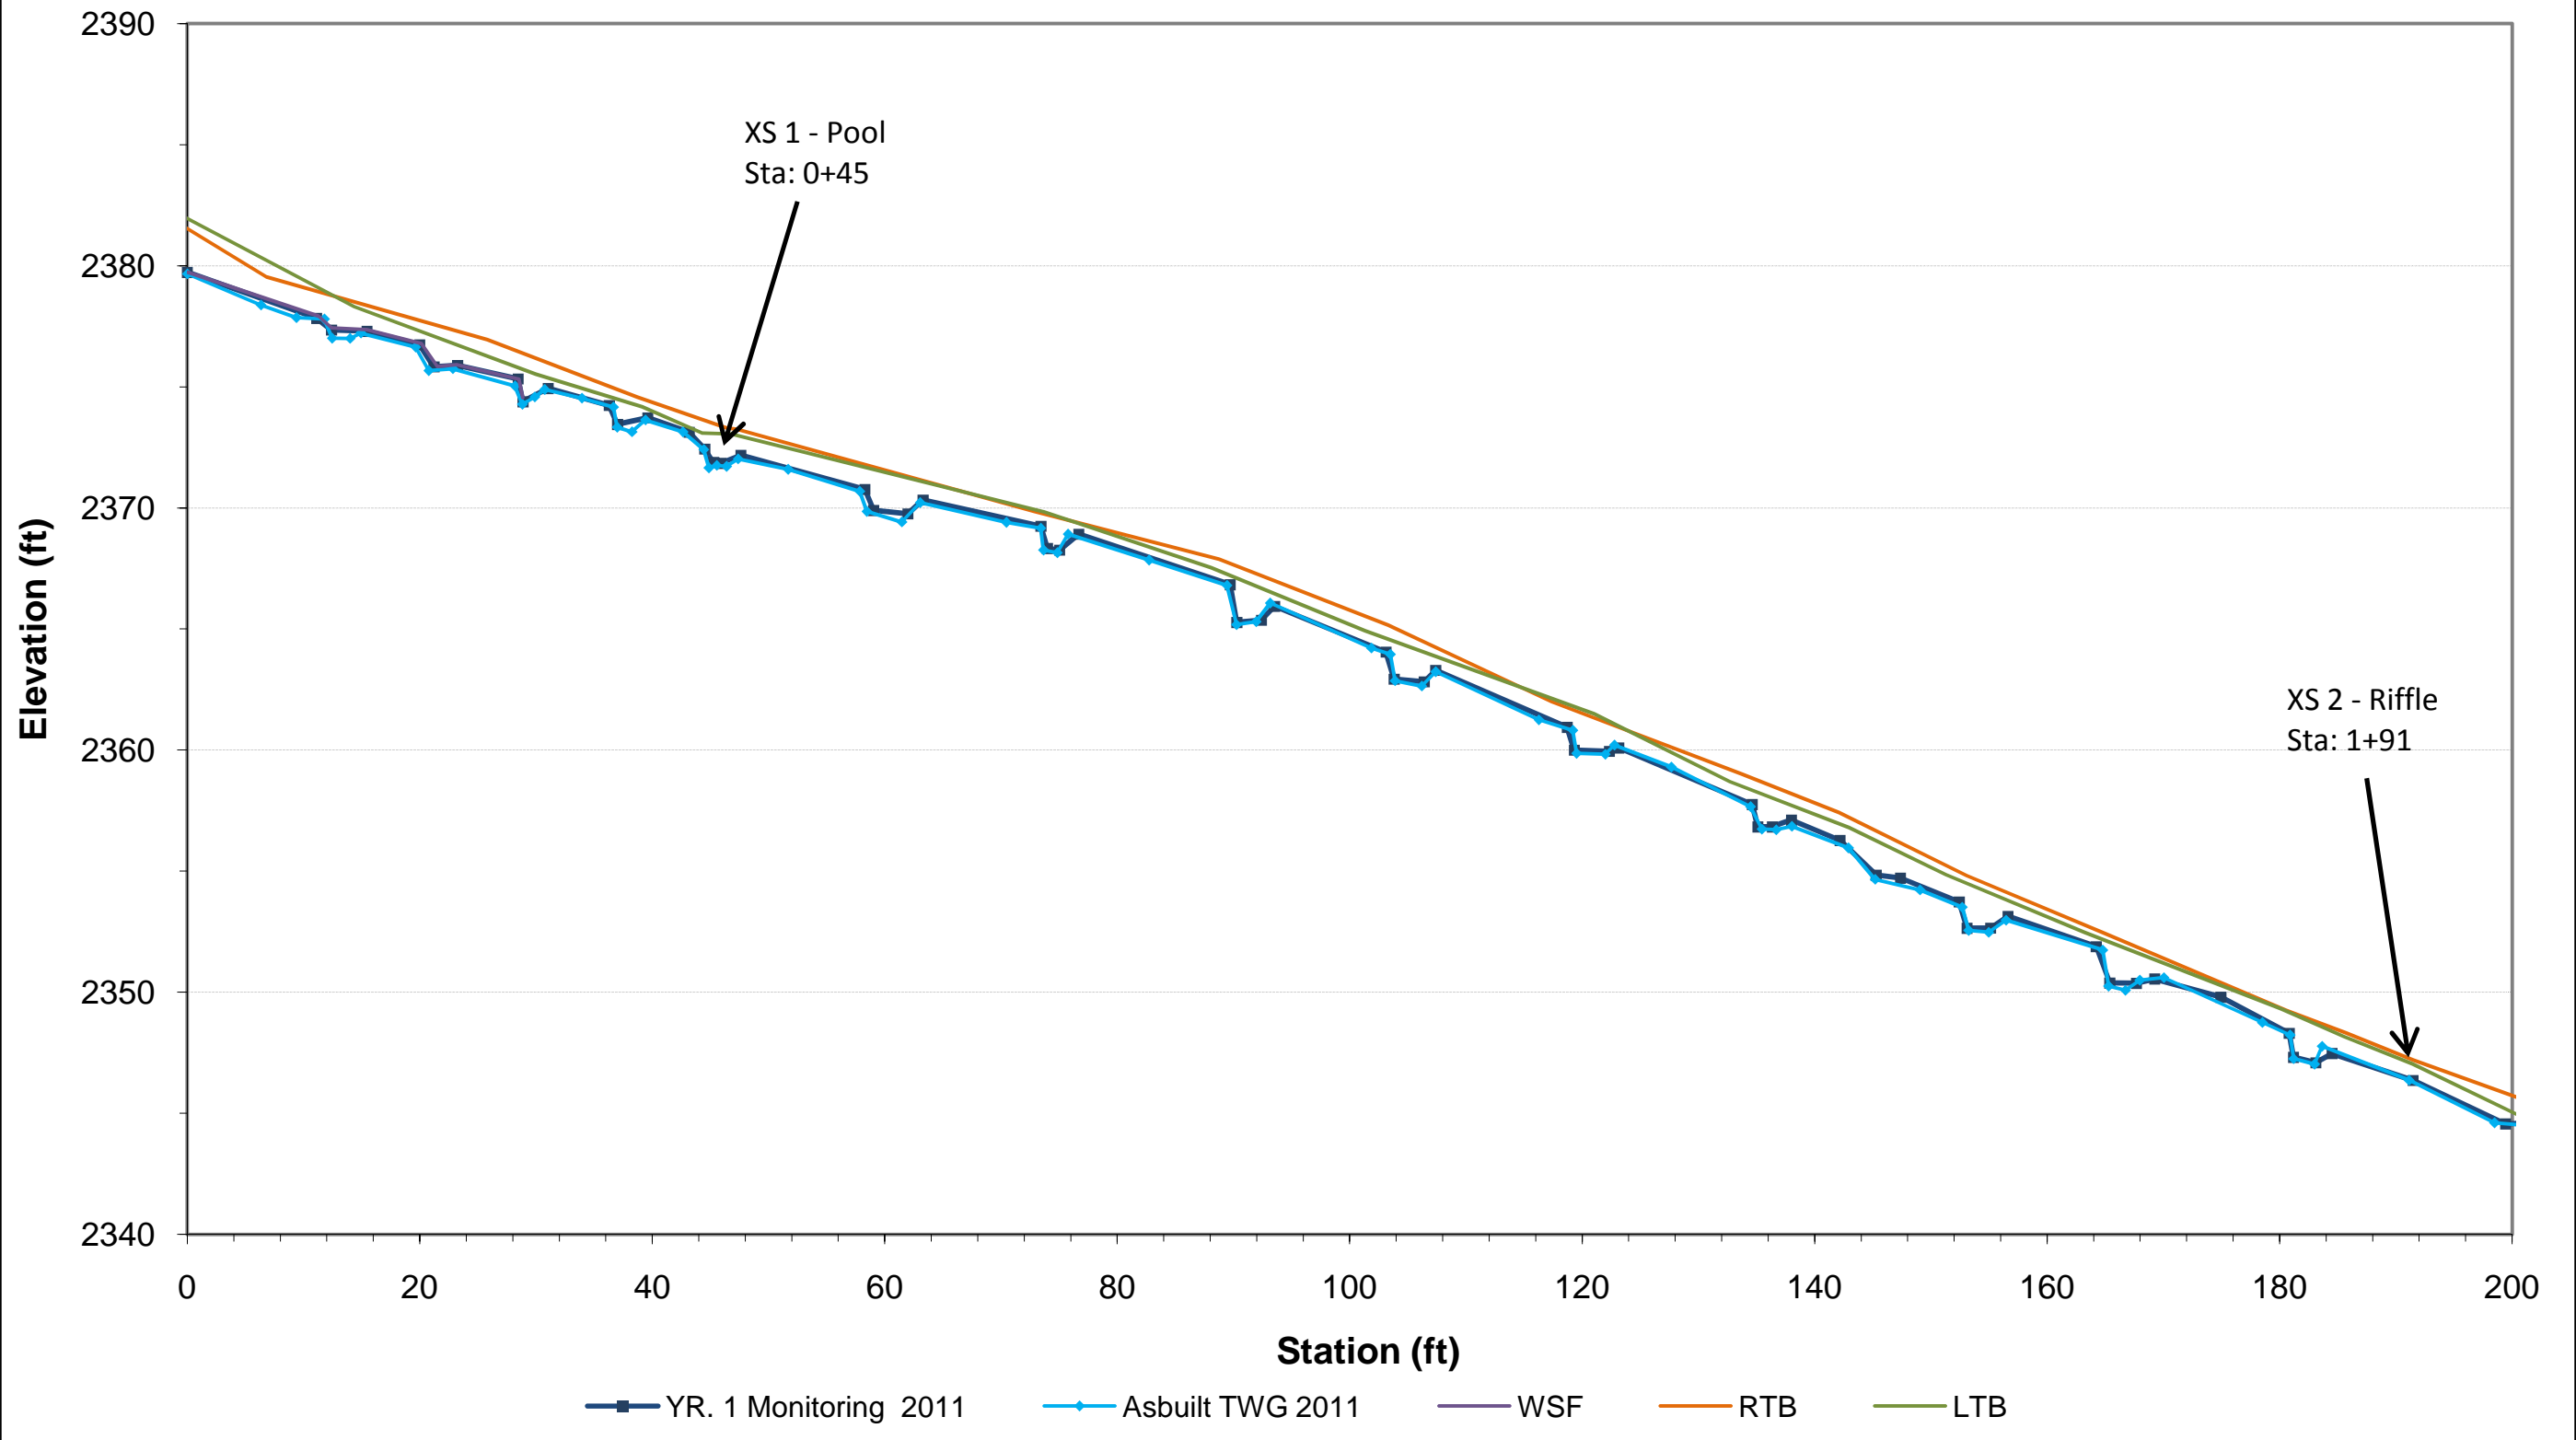
Longitudinal Profile - UT2 (Station 0+00 to 2+00)

Feature Issue	Station No.	Suspected Cause	Photo Number
Other	0+39 to 5+72 and 5+87 to 6+34 (downstream limits of project reach)	Channel is dry from flow going subsurface in two areas probably due to lack of seal behind upstream drop structure.	UT2 Photo Points 2 - 5 in Appendix B

At this time, the only item that is being monitored beyond the success criteria noted in this report is the dry segment of UT2. As noted in Section 2.1.1.2 of the Baseline Monitoring Report, we believe that the surface flow is presently flowing beneath and through the channel bed material. The flow should surface as organic material and fine particles reduce interstitial spaces in the constructed channel. If necessary, modifications will be made to establish surface flow throughout the project reach if flow does not return by the Spring of 2012.
