East Buffalo Creek Mitigation Project

Year 2 Monitoring Report - Final Graham County, North Carolina

Monitoring Firm: Michael Baker
Engineering, Inc. (Baker)

Prepared for: North Carolina Ecosystem
Enhancement Program (NCEEP)

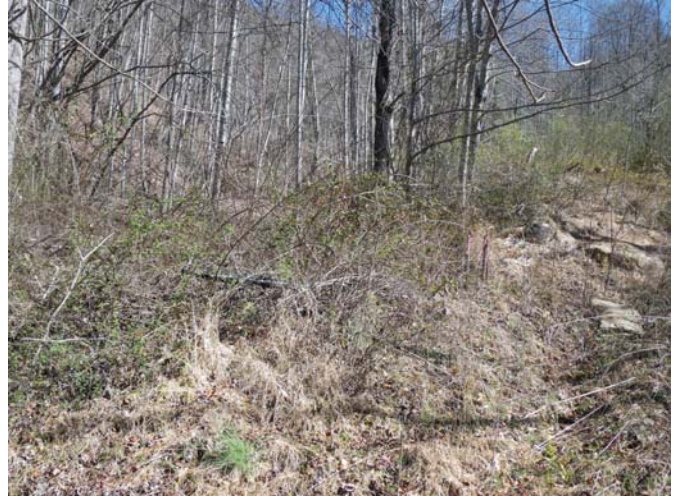
UT6 Reach 2 (565 LF)			
Feature Issue	Station No.	Suspected Cause	Photo Number
Invasive/Exotic Populations	See Plan View	<i>Rosa multiflora</i> , and <i>Ligustrum sinense</i> : persisting after treatment	VPA1
East Buffalo Reach 2 (932 LF)			
Feature Issue	Station No.	Suspected Cause	Photo Number
Invasive/Exotic Populations	See Plan View	<i>Rosa multiflora</i> , and <i>Ligustrum sinense</i> : persisting after treatment	VPA2
UT5 Reach 2 (607 LF)			
Feature Issue	Station No.	Suspected Cause	Photo Number
Invasive/Exotic Populations	See Plan View	<i>Rosa multiflora</i> , and <i>Ligustrum sinense</i> : persisting after treatment	VPA3

VPA1 – Multiflora Rose and Chinese Privet persisting after treatment along the upstream portion of UT6 Reach 2 (looking upstream from the left bank)

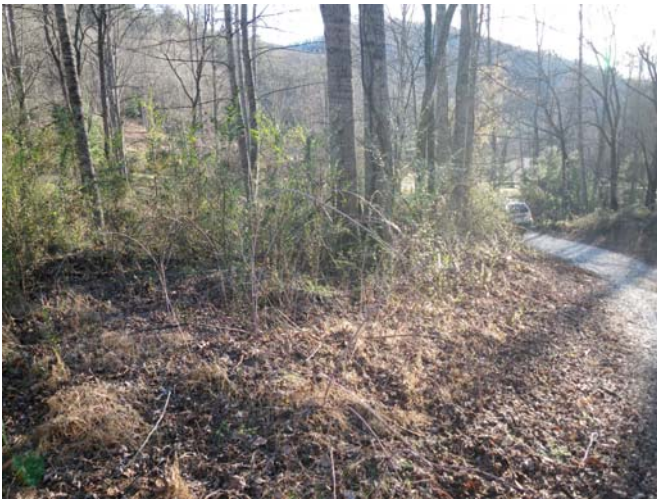
VPA2 – Multiflora Rose and Chinese Privet persisting after treatment on the downstream portion of E. Buffalo Reach 2 (looking downstream from the right bank)

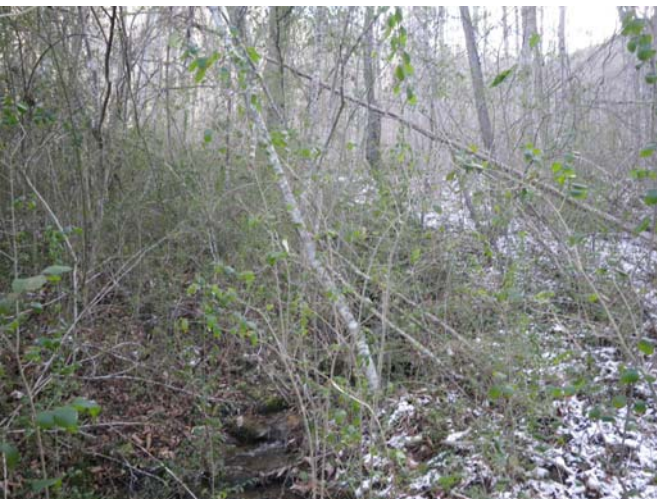
VPA3 – Multiflora Rose and Chinese Privet persisting after treatment on the downstream portion of UT5 Reach 2 (looking upstream)

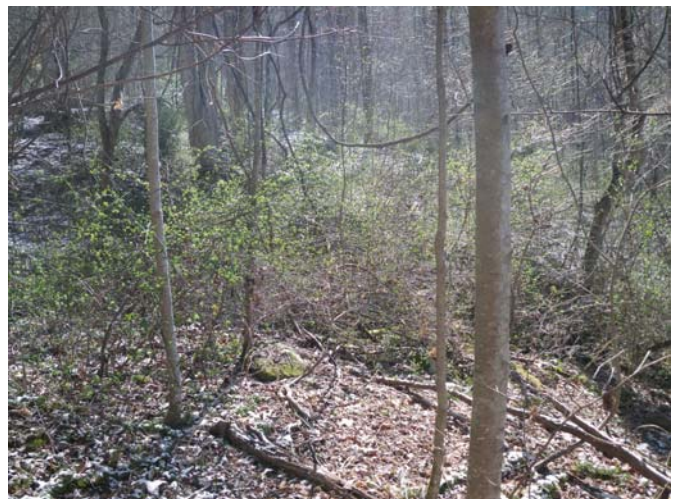
VPA3 – Multiflora Rose and Chinese Privet persisting after treatment on the upstream portion of UT5 Reach 2 (looking across channel from the right floodplain)
