East Buffalo Creek Mitigation Project

Year 4 Monitoring Report - Final Graham County, North Carolina

Monitoring Firm: Michael Baker
Engineering, Inc. (Baker)
Monitoring Firm POC: Micky Clemmons

Prepared for: NCDENR – Division of
Mitigation Services
DMS Project Manager: Paul Wiesner

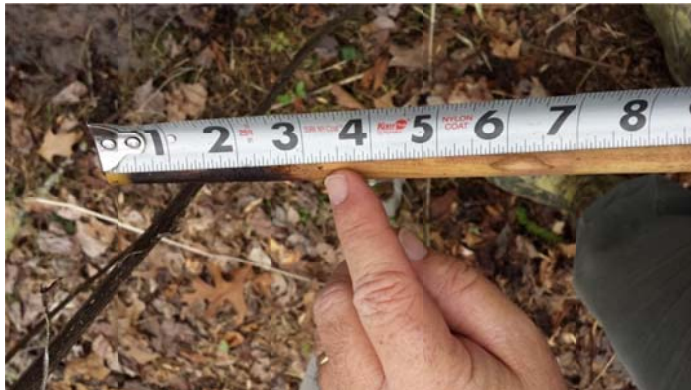
Photo of staff and cork at 3.25 in above bankfull, from UT2 crest gauge.

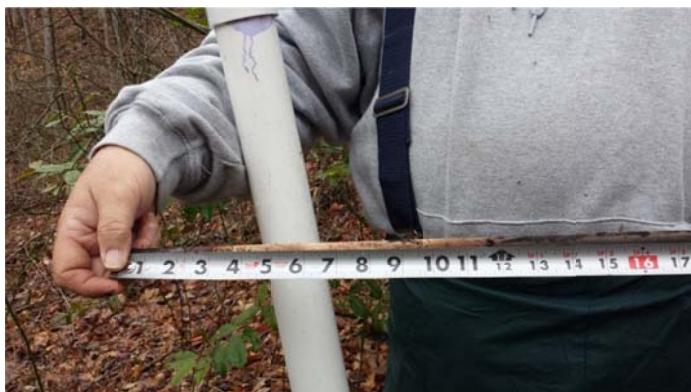
Photo of staff and cork at 4 in above bankfull, from UT6 crest gauge.
