# East Buffalo Creek Mitigation Project

## Year 5 Monitoring Report Graham County, North Carolina

Monitoring Firm: Michael Baker  
Engineering, Inc. (Baker)

Report Submitted: March 2016

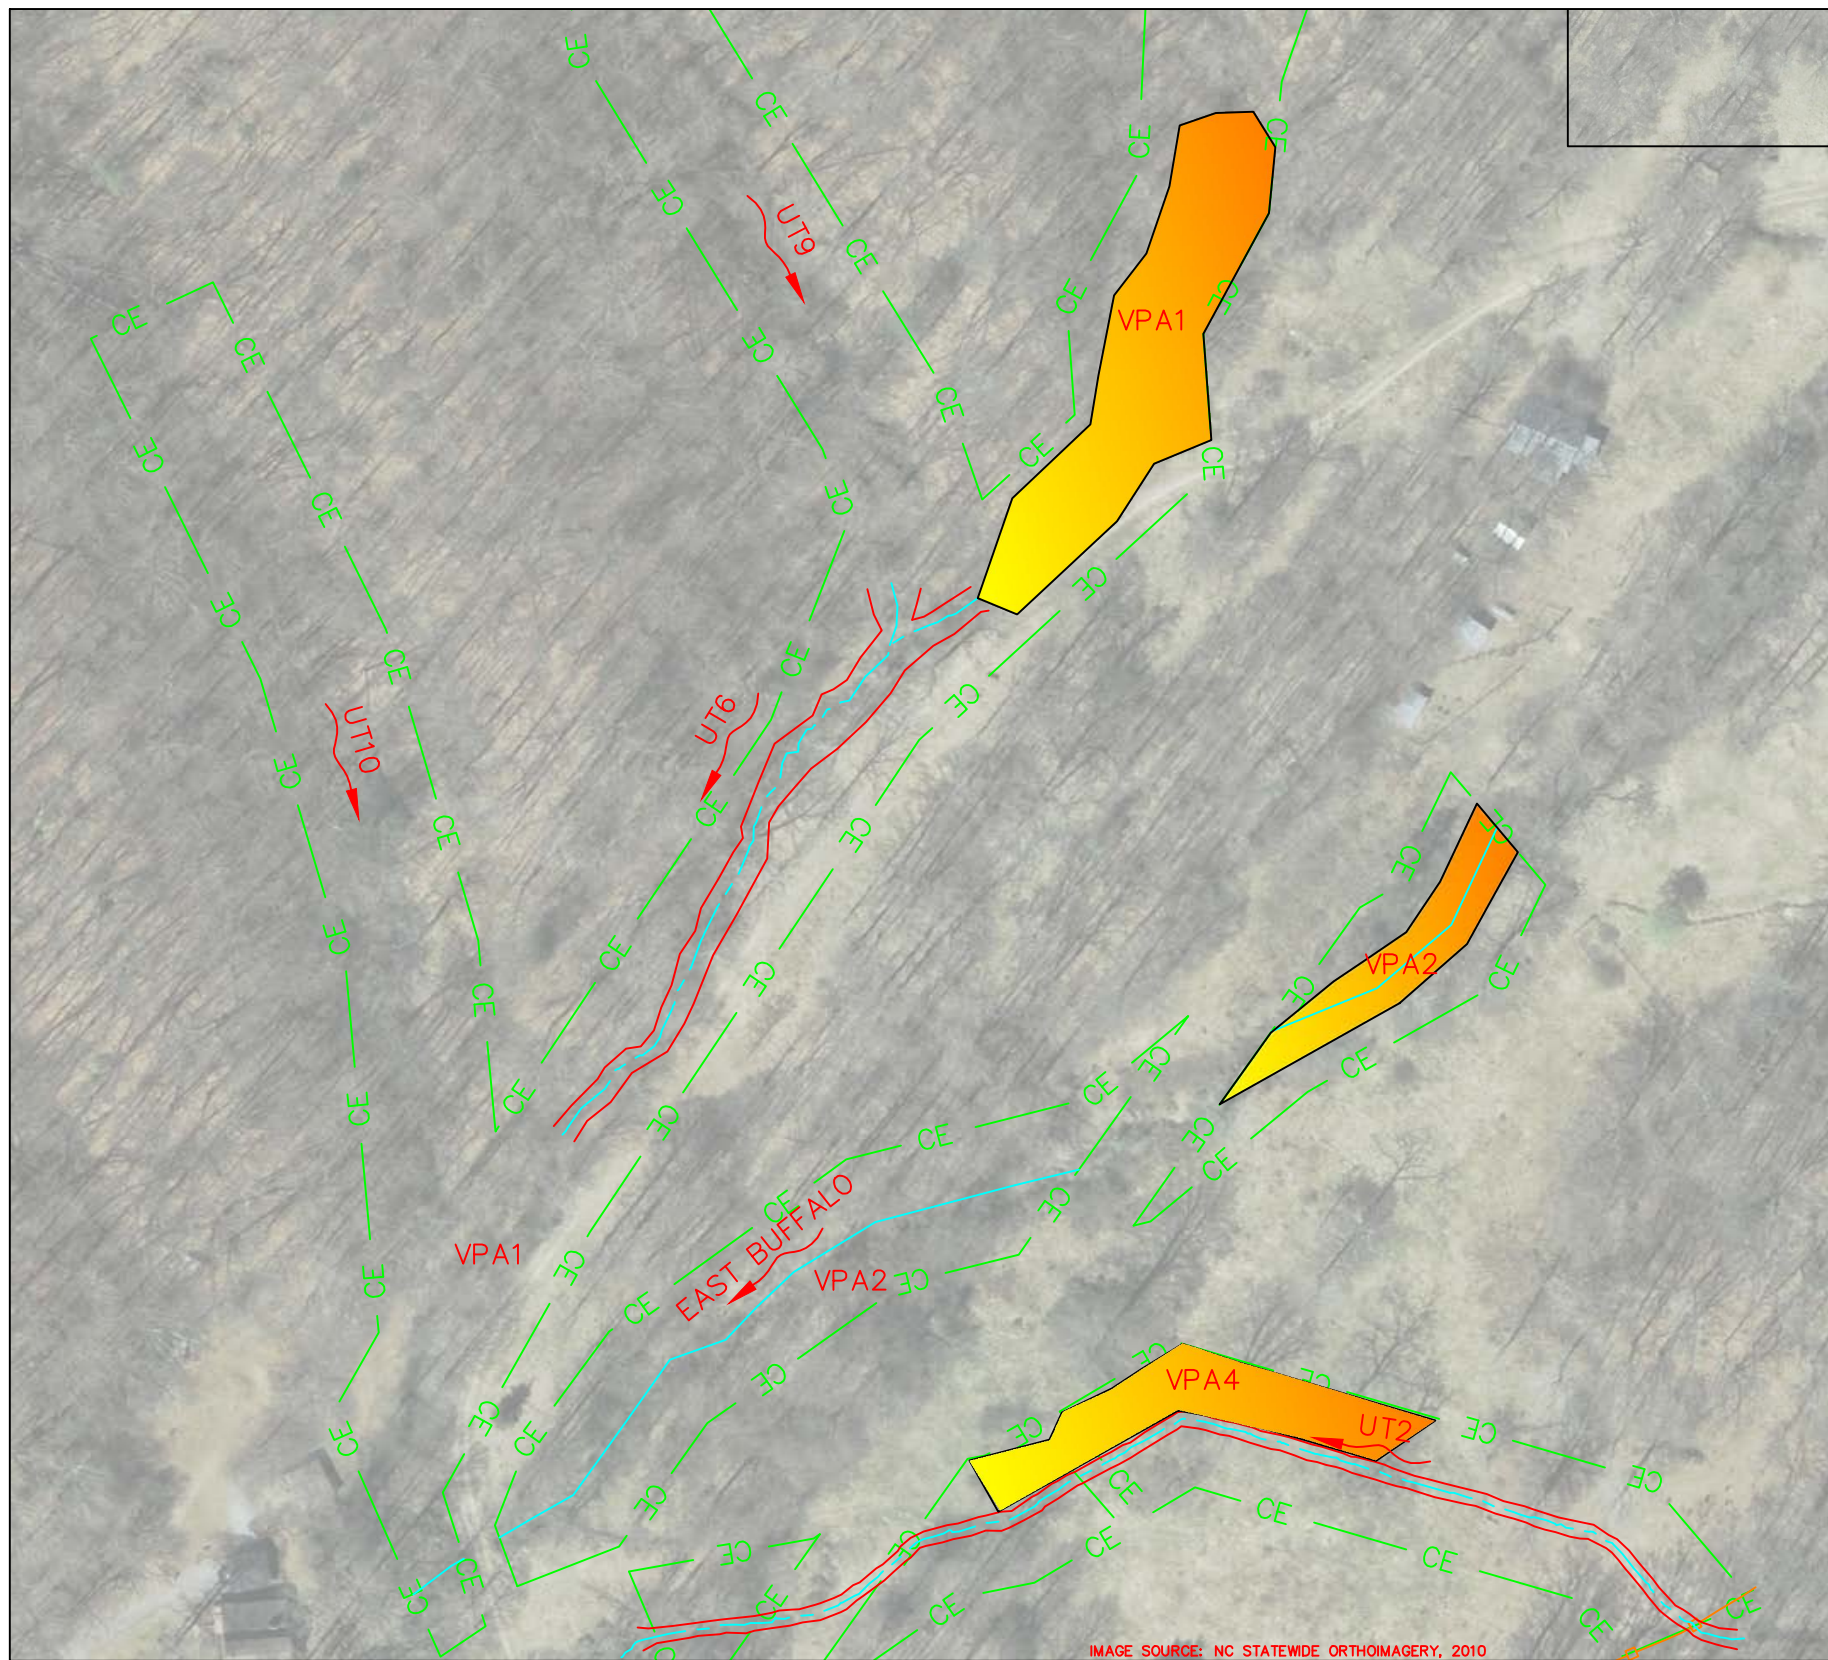
EAST BUFFALO  
CURRENT CONDITION  
PLAN VIEW  
YEAR 5 MONITORING

There were four vegetation problem areas identified during Year 5 monitoring that related to the presence of invasive vegetation along Reaches 2 of UT5, UT6, UT2 and East Buffalo Creek. The VPA 4 was added this year as a thick stand of Multiflora rose has developed along the lower right bank of UT2. Multiflora rose and Chinese Privet found along portions of these reaches appear to be primarily a result of invasives that have persisted after prior treatment. We have retained the same areas of concern that were reported in previous years in this year's report; however, a significant reduction in the density of invasives has been made in these areas as evidenced by the photo that is presented (Appendix F). The large area of withered and dead multiflora rose and Chinese Privet observed along these reaches, especially along UT5 Reach 2, is indicative of the success of prior herbicide treatment. However, the current extent of persistent invasives (CCPV in Appendix F) warrants follow-up treatment to limit continued growth and treatment will be scheduled in the spring of 2016.
