**East Tarboro Canal Stream Restoration Project  
Edgecombe County  
North Carolina**

**CU: 03020103  
SCO# 030603101  
EEP Project No. 123**

**Year 1 Monitoring Report  
January 22, 2009**

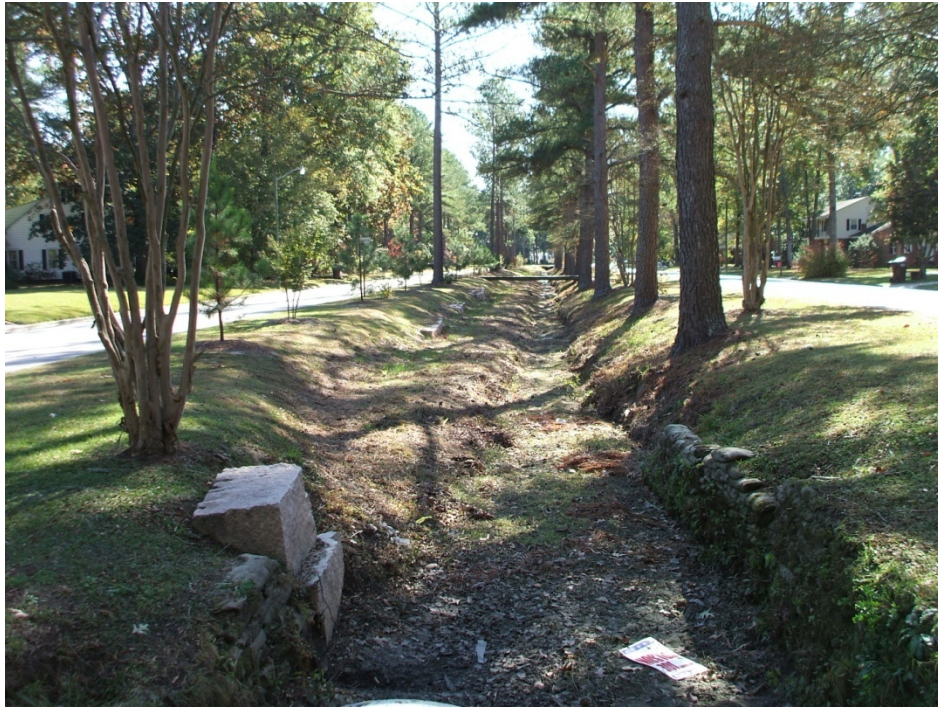
Photo Station 1. Beginning of Reach 1

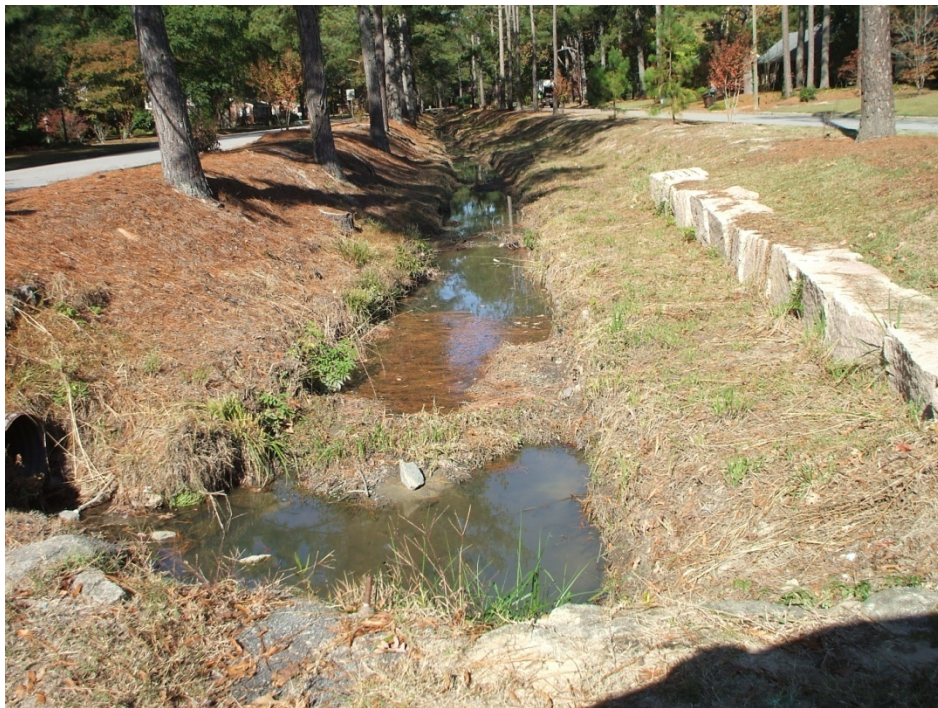
Photo Station 2. Reach 1 Culvert upstream

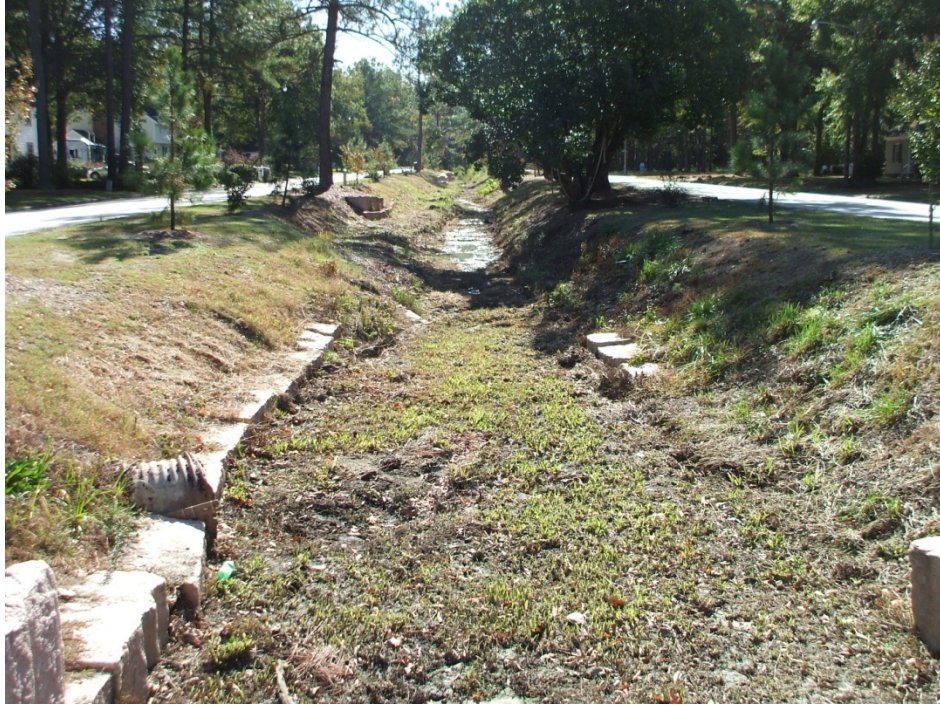
Photo Station 3. Reach 1 Culvert Downstream

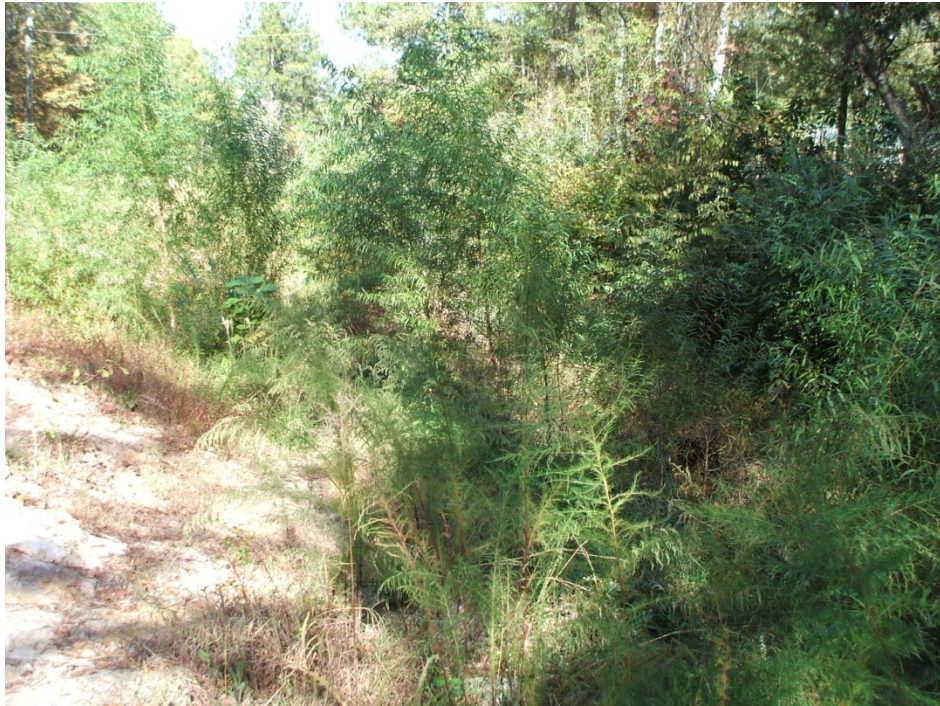
Photo Station 4. End of Reach 1 Upstream

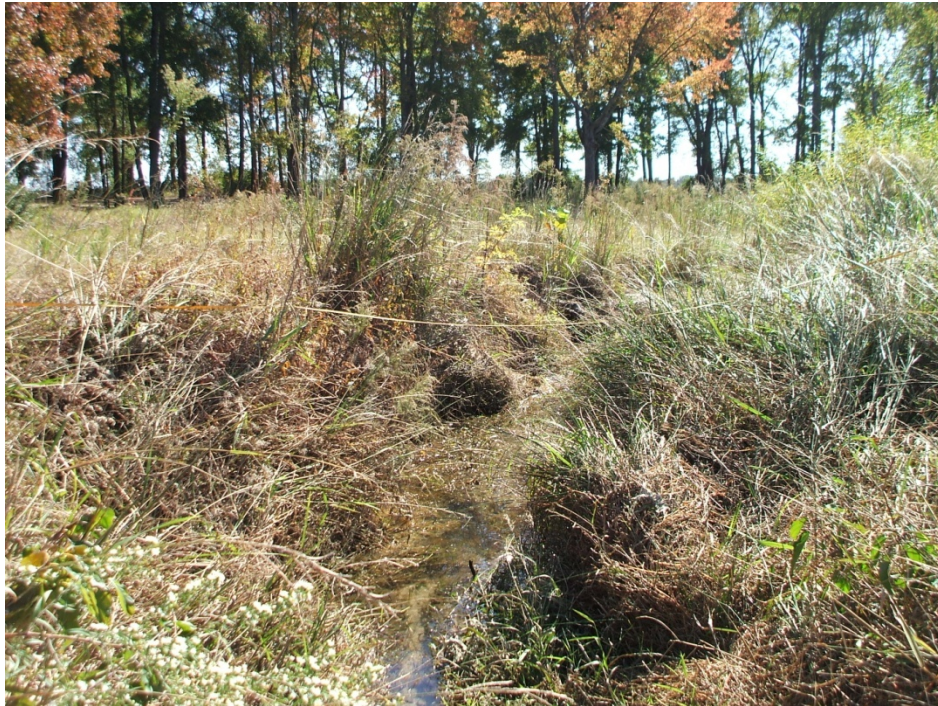
Photo Station 8. Wilson Street Crossing – Downstream

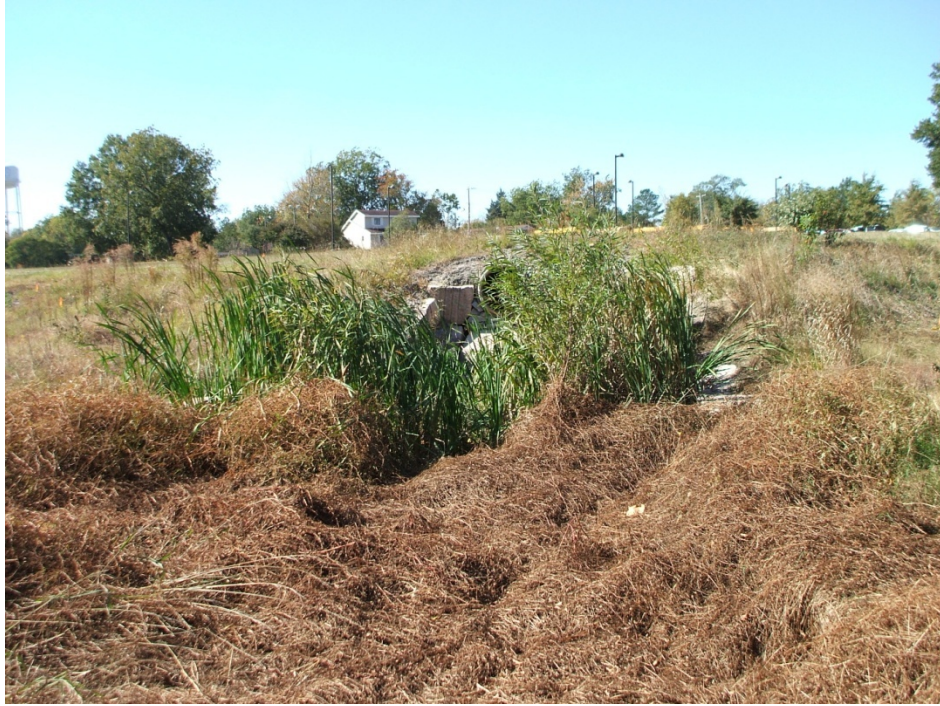
Photo Station 9. Culvert Upstream

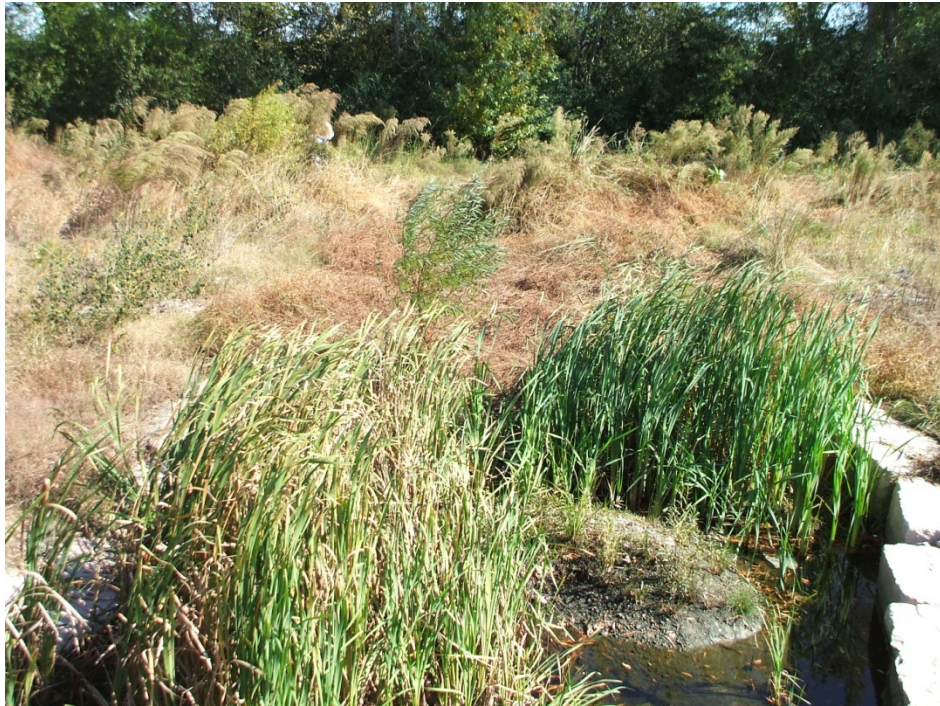
Photo Station 10. Pool Culvert Downstream

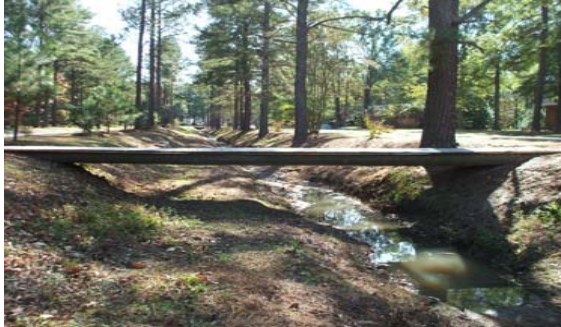
Photo of Cross-Section #1 - Looking Downstream
