Monitoring Report – Year 4  
FINAL VERSION  
Edwards-Johnson Mitigation Project  
Calendar Year of Data Collection: 2021

NCDEQ DMS Project Identification # 97080  
NCDEQ DMS Contract # 6825  
Neuse River Basin (Cataloging Unit 03020201)  
USACE Action ID Number: SAW-2016-00883  
NCDEQ DWR Project # 2016-0404 V2  
Johnston County, NC  
Contracted Under RFP # 16-006477  
Data Collection Period: September 2021  
Submission Date: October 20<sup>th</sup>, 2021

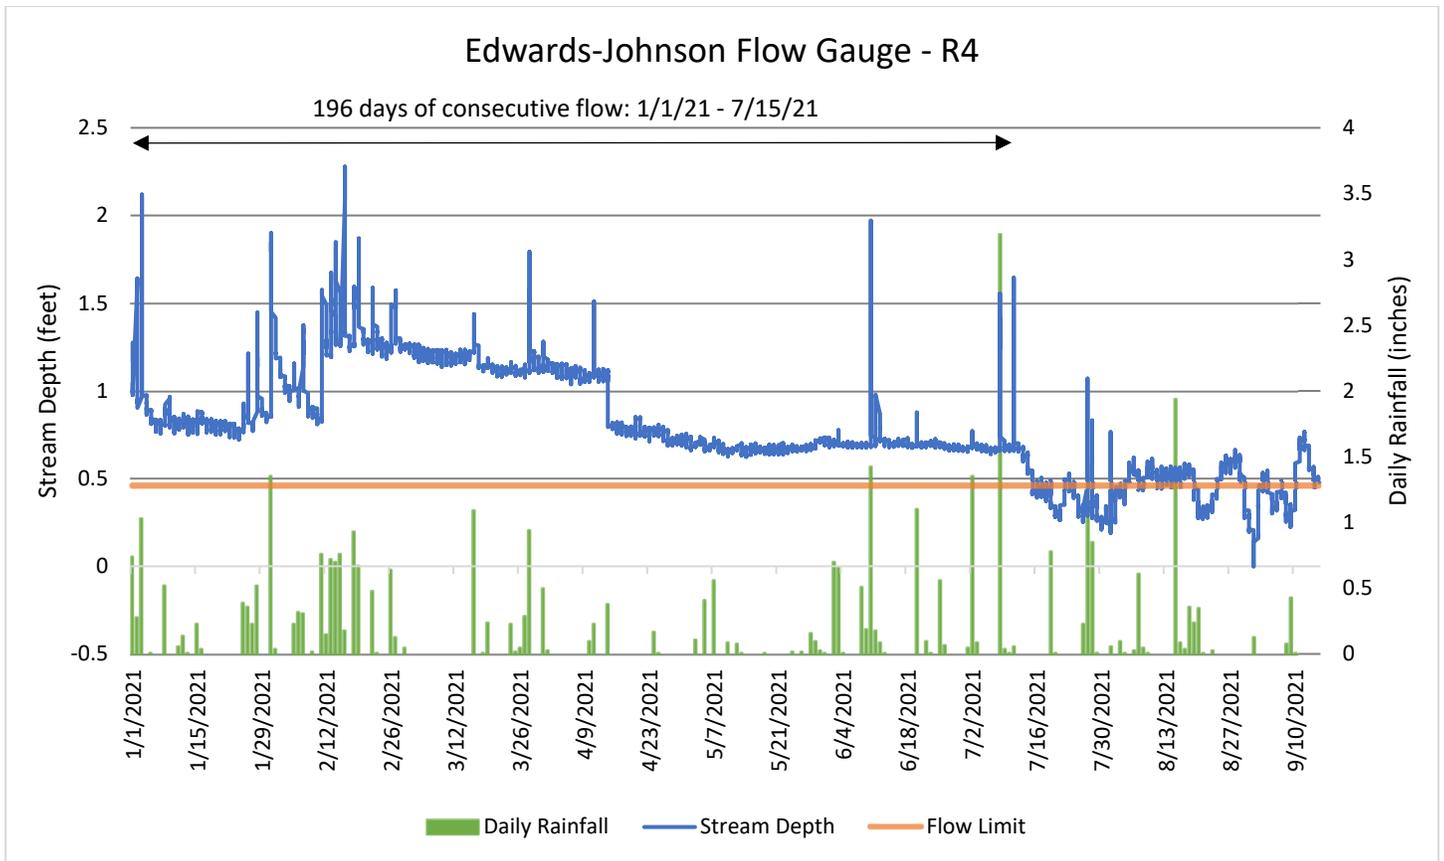
Figure 4a:

Longest consecutive days of flow: 196 days, January 1, 2021 - July 15, 2021.

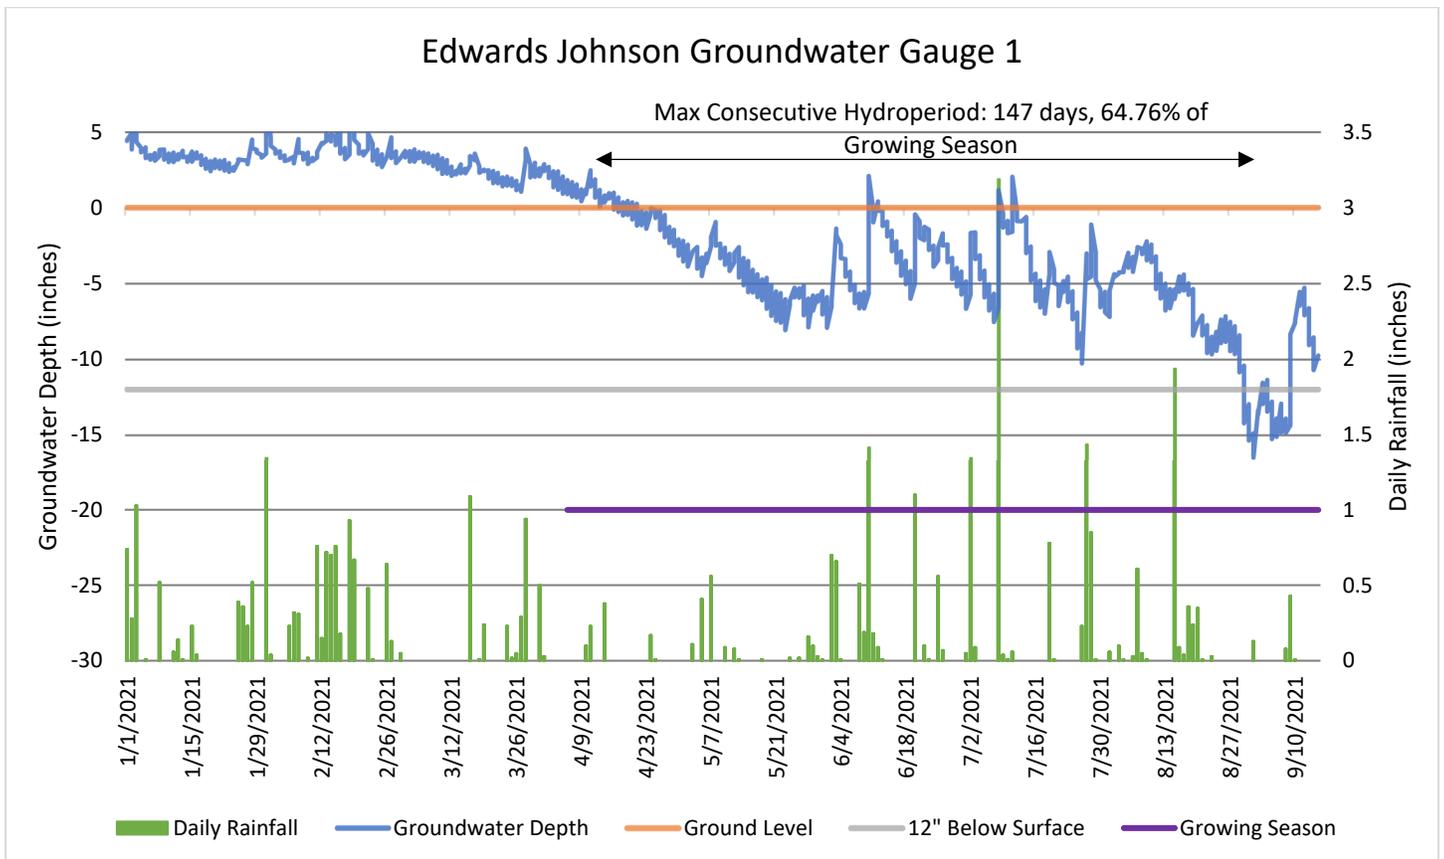
Max Consecutive Hydroperiod: 147 days, April 6, 2021 - August 30, 2021, 64.76 % of Growing Season

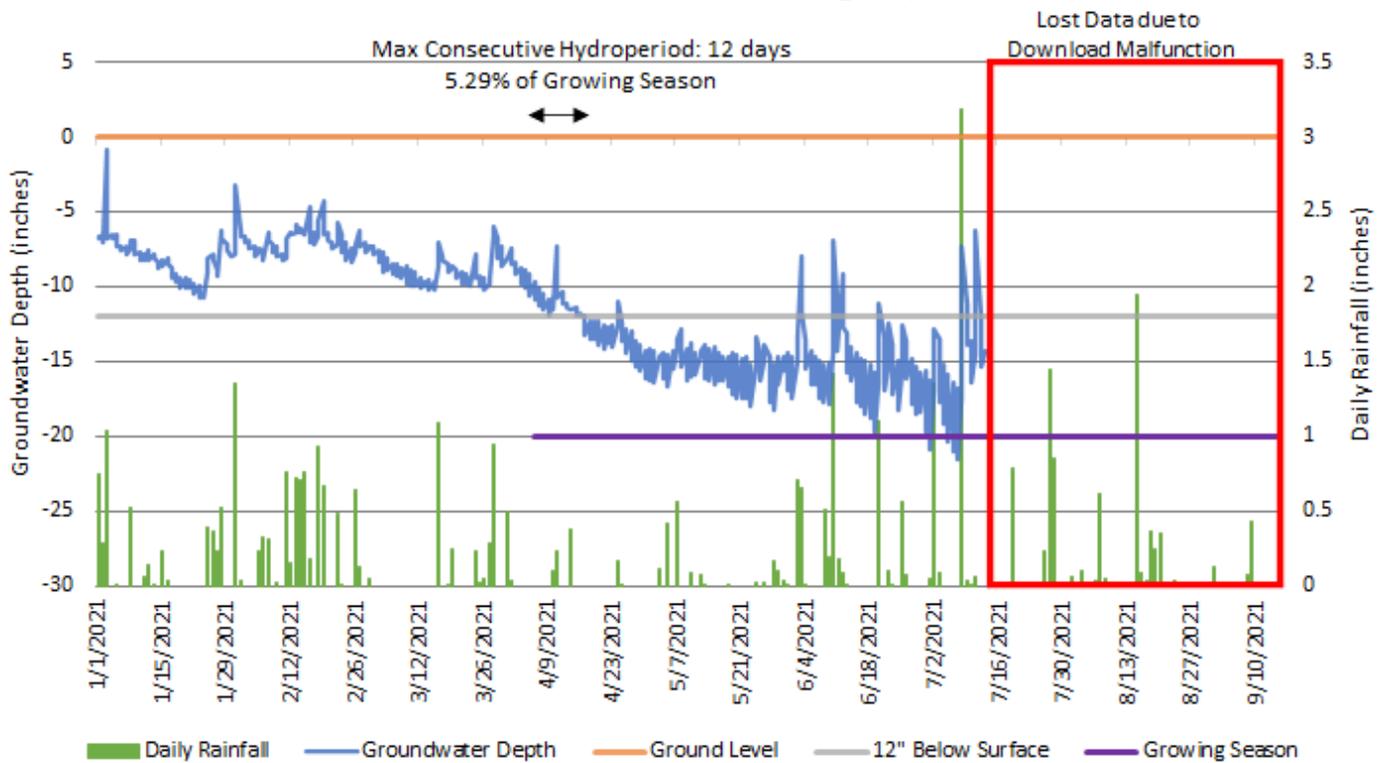
### Edwards Johnson Groundwater Gauge 2 (Reference)

Max Consecutive Hydroperiod: 12 days, April 6, 2021 - April 17, 2021, 5.29 % of Growing Season

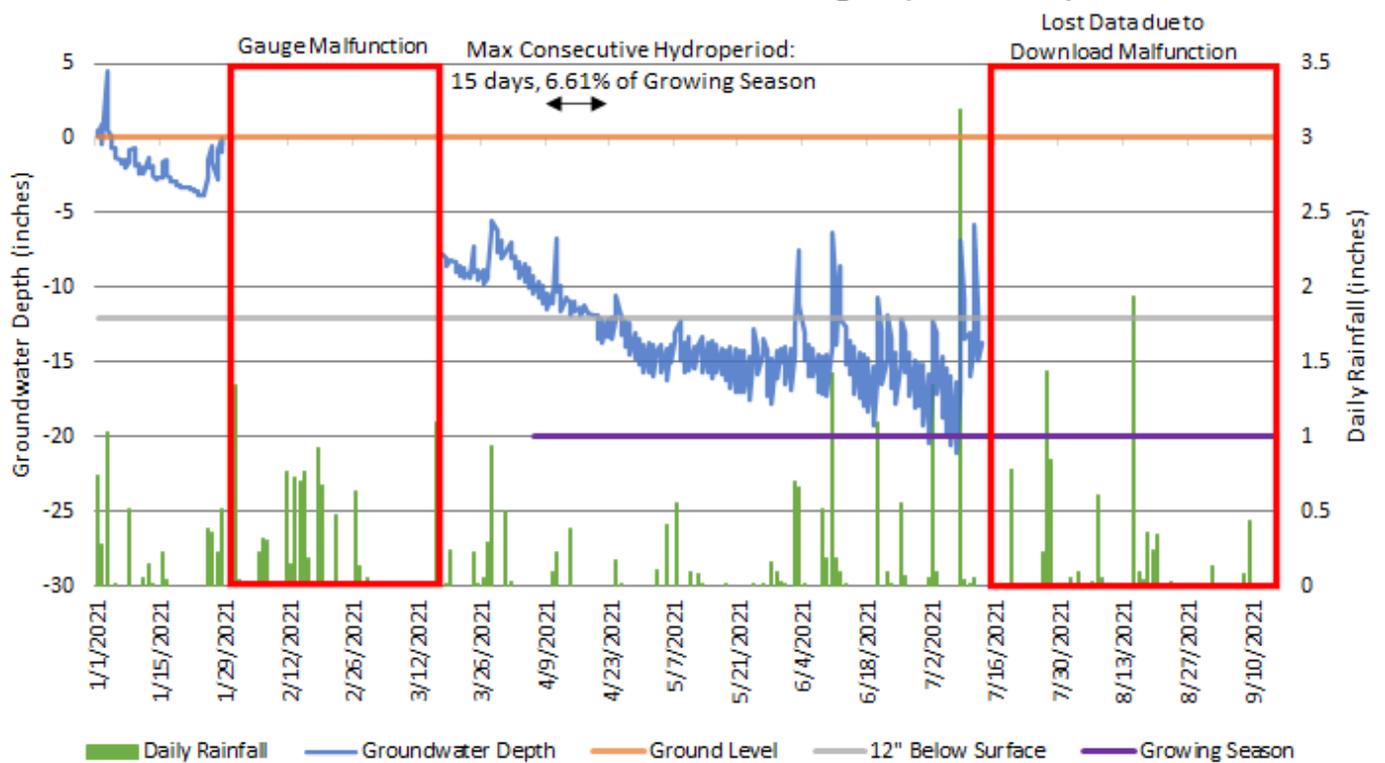
### Edwards Johnson Groundwater Gauge 3 (Reference)

Max Consecutive Hydroperiod: 15 days, April 6, 2021 - April 20, 2021, 6.61 % of Growing Season

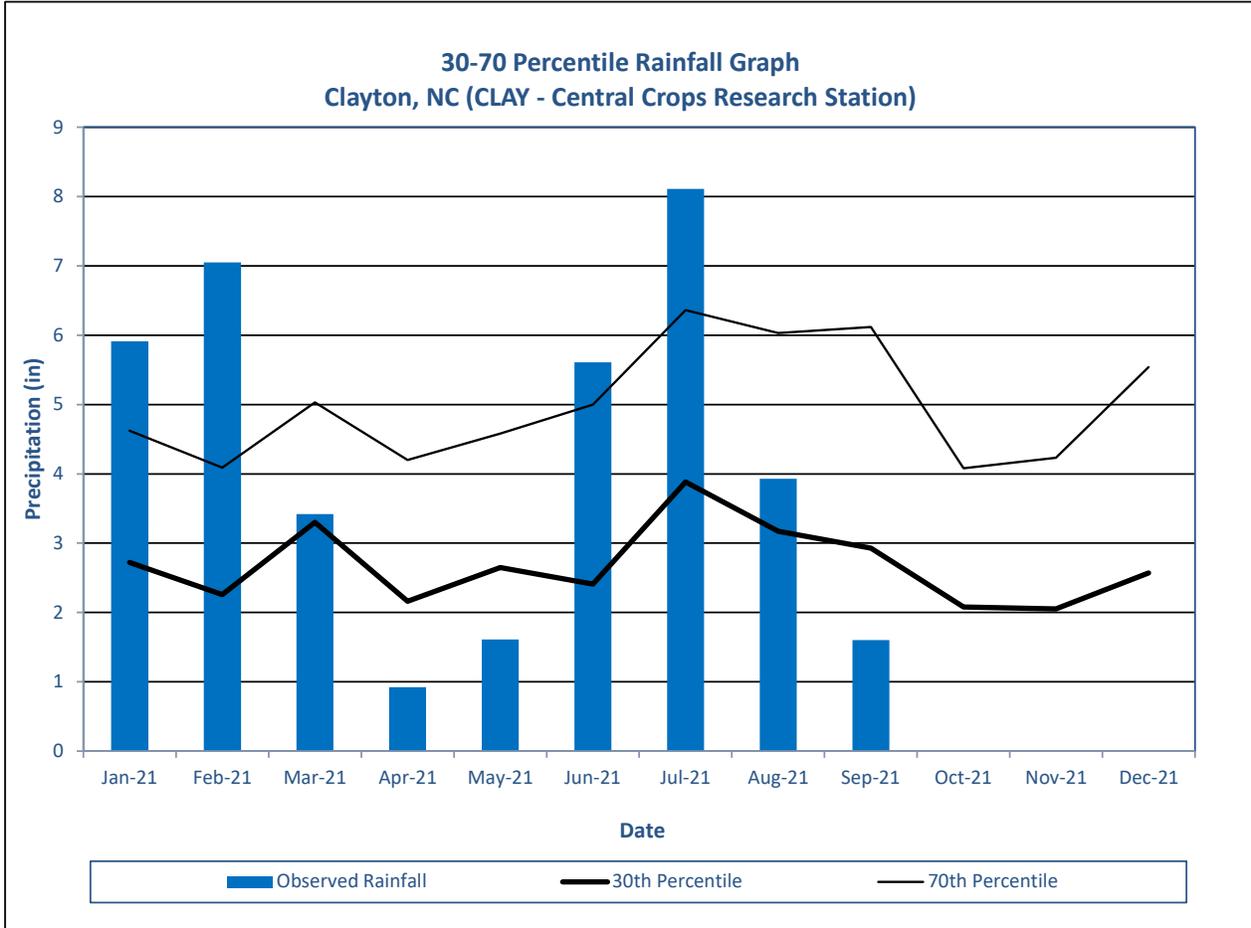
**Figure 5: Monthly Rainfall Data**  
**Edwards-Johnson Mitigation Project (NCDEQ DMS Project ID# 97080)**  
**MY4 2021**

- 5. DMS Comment: Update rain report for additional months if possible.** WLS Response: September rain data has been added to Figure 5.
