Monitoring Report – Year 5
FINAL VERSION
Edwards-Johnson Mitigation Project
Calendar Year of Data Collection: 2022

NCDEQ DMS Project Identification # 97080
NCDEQ DMS Contract # 6825
Neuse River Basin (Cataloging Unit 03020201)
USACE Action ID Number: SAW-2016-00883
NCDEQ DWR Project # 2016-0404 V2
Johnston County, NC
Contracted Under RFP # 16-006477
Data Collection Period: September 2022
Submission Date: November 30th, 2022

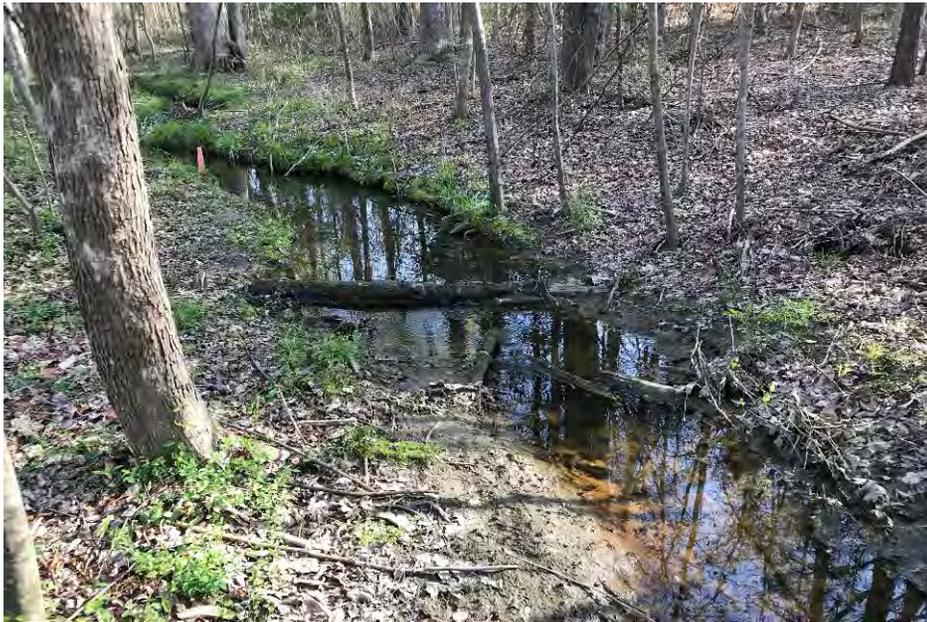
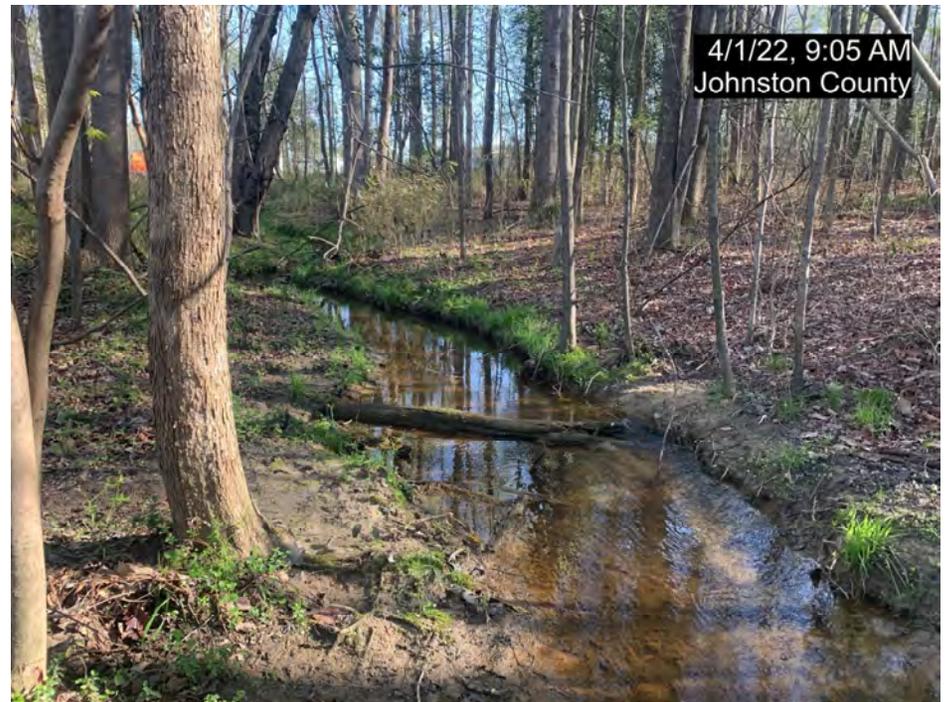
PS-1, Reach R1, facing upstream, April 12, 2018 (MY-00)

PS-1, Reach R1, facing upstream, April 1, 2022 (MY-05)

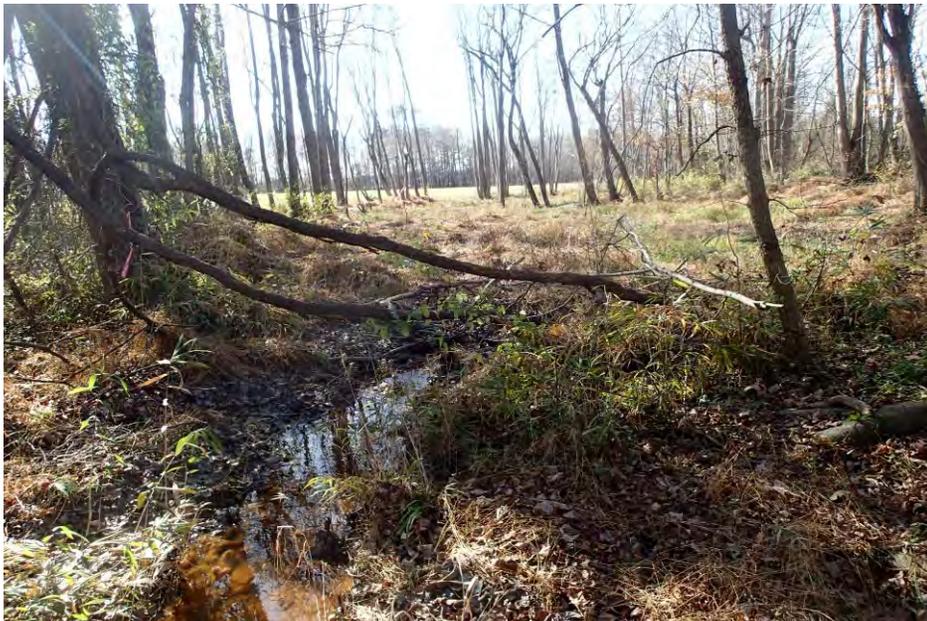
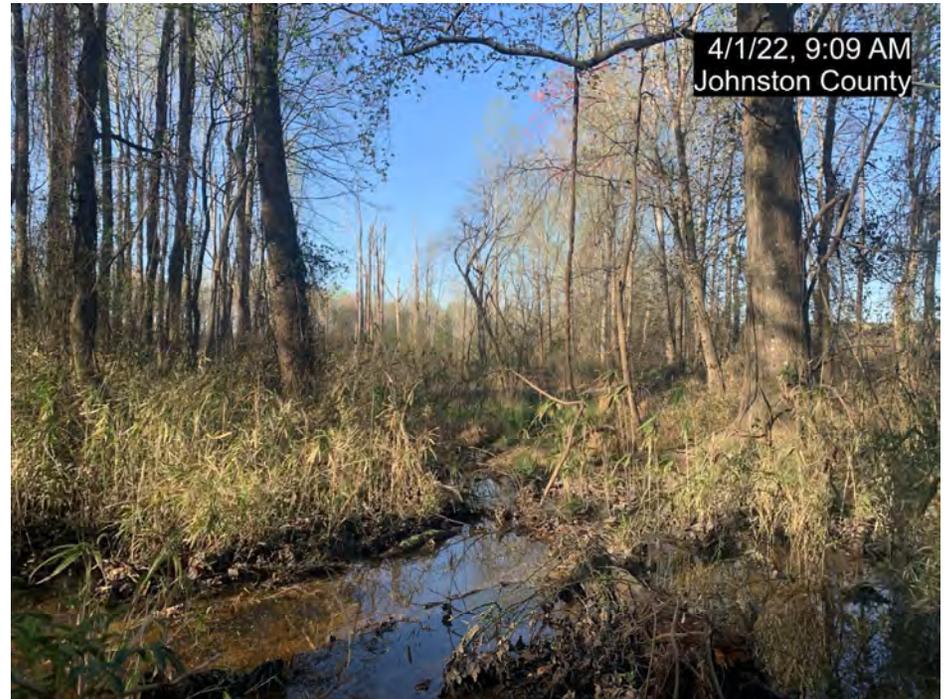
PS-2, Reach R1, facing downstream, Dec 6, 2018 (MY-01)

PS-2, Reach R1, facing downstream, April 1, 2022 (MY-05)

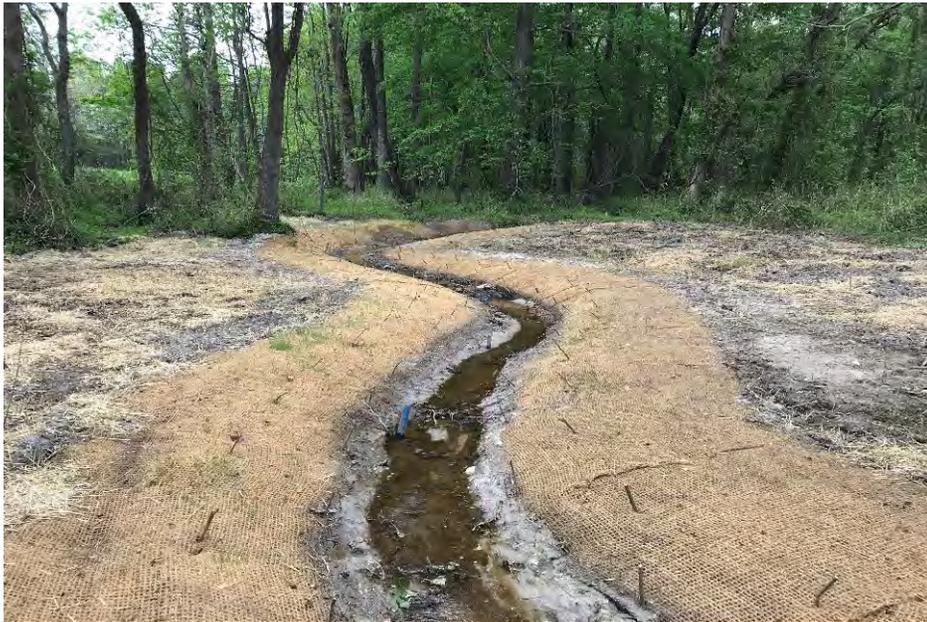
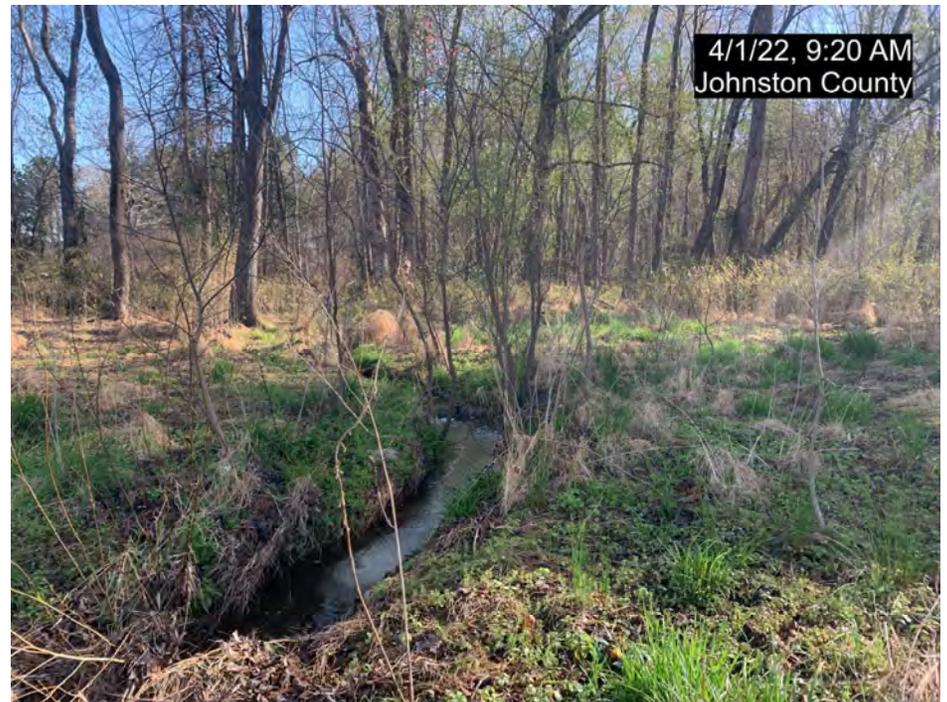
PS-3, Reach R2, facing upstream, Sta 17+00, April 23, 2018 (MY-00)

PS-3, Reach R2, facing upstream, Sta 17+00, April 1, 2022 (MY-05)

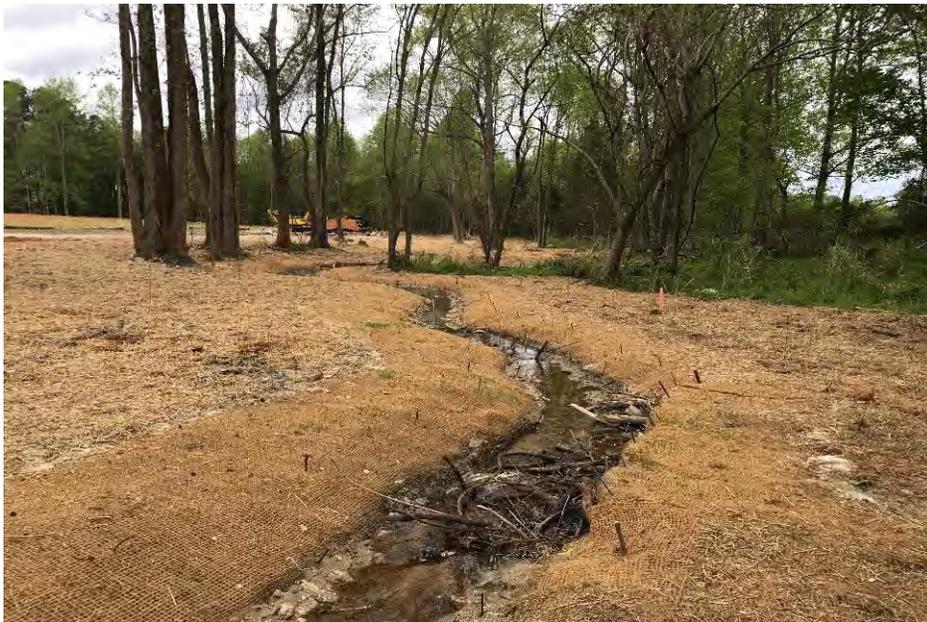
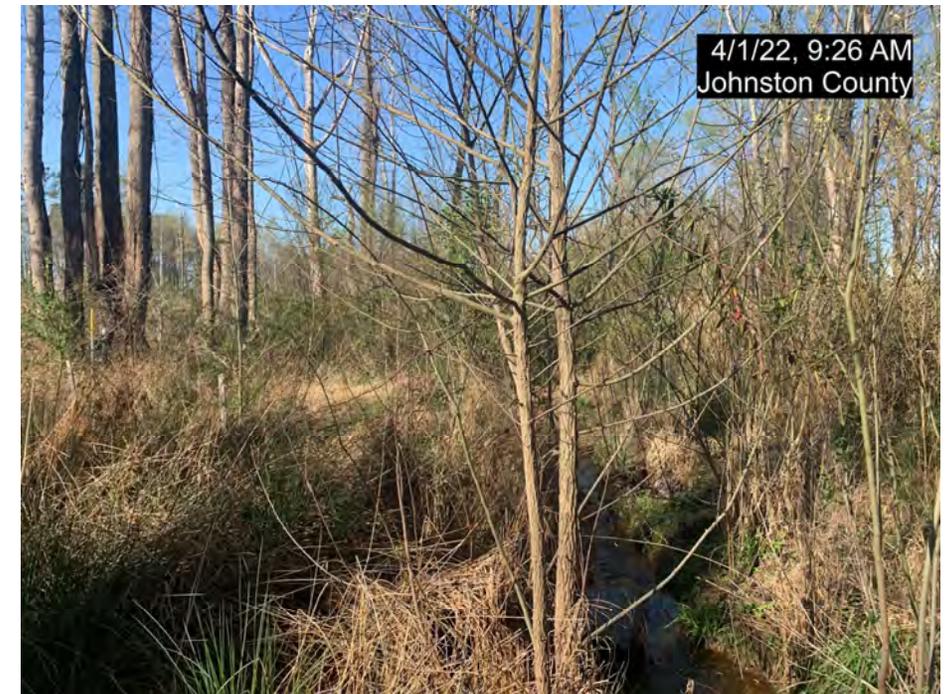
PS-4, Reach R2, facing downstream, Sta 18+00, April 23, 2018 (MY-00)

PS-4, Reach R2, facing downstream, Sta 18+00, April 1, 2022 (MY-05)

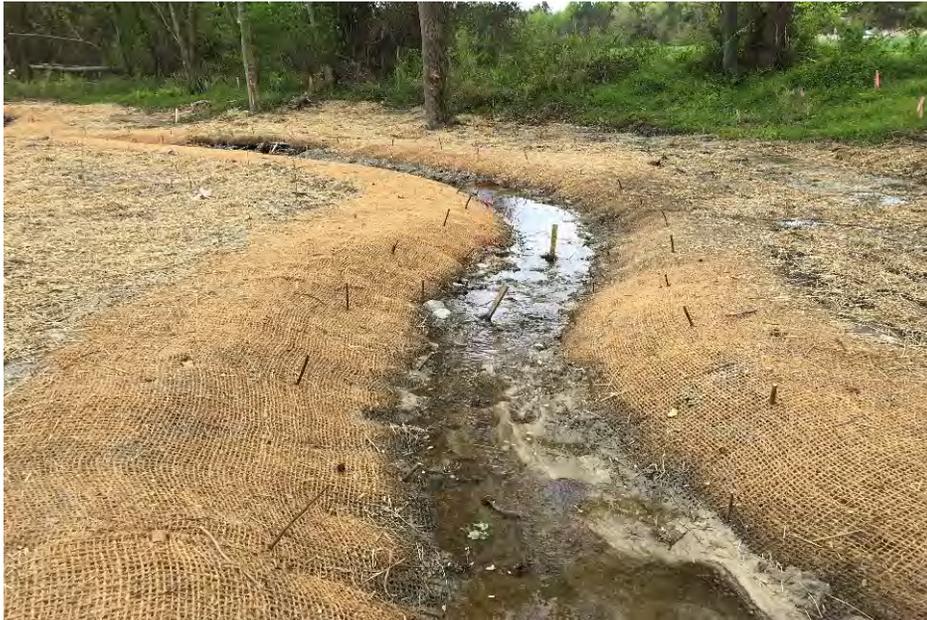
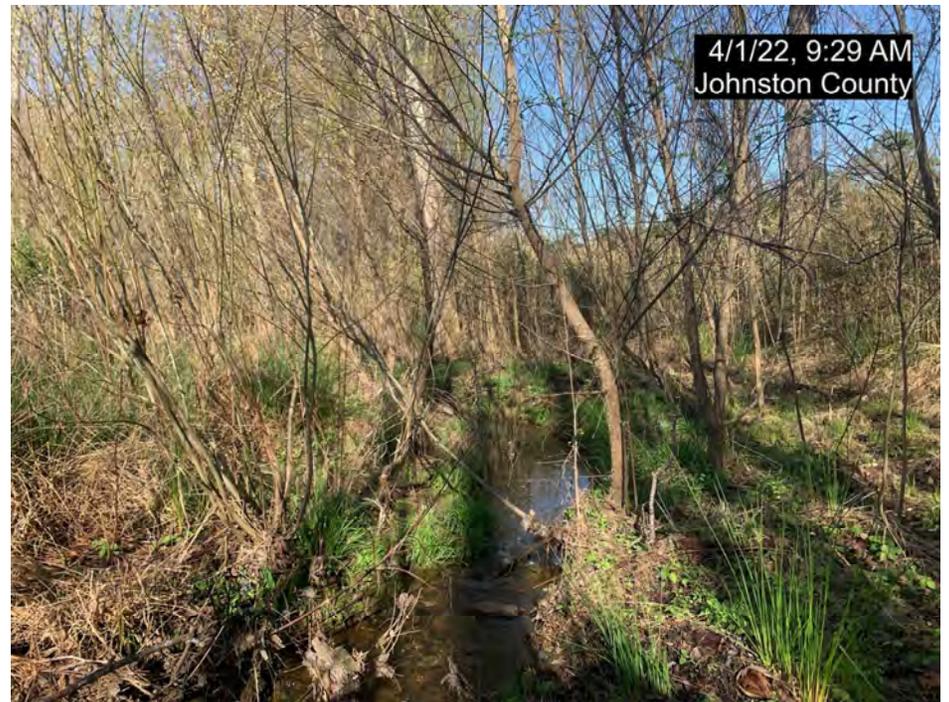
PS-5, Reach R2, facing downstream, Sta 19+50, Sept 17, 2018 (MY-00)

PS-5, Reach R2, facing downstream, Sta 19+50, April 1, 2022 (MY-05)

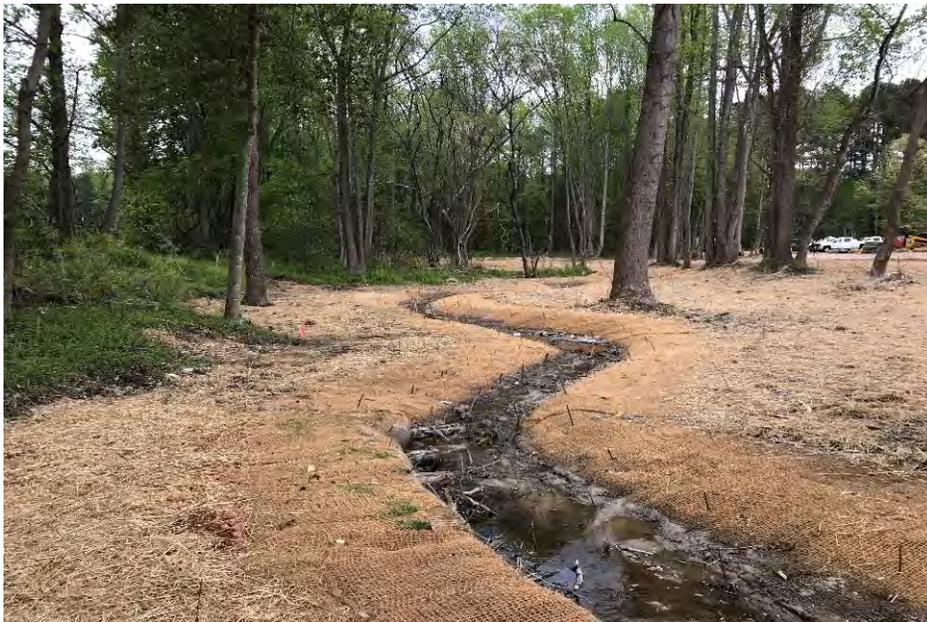
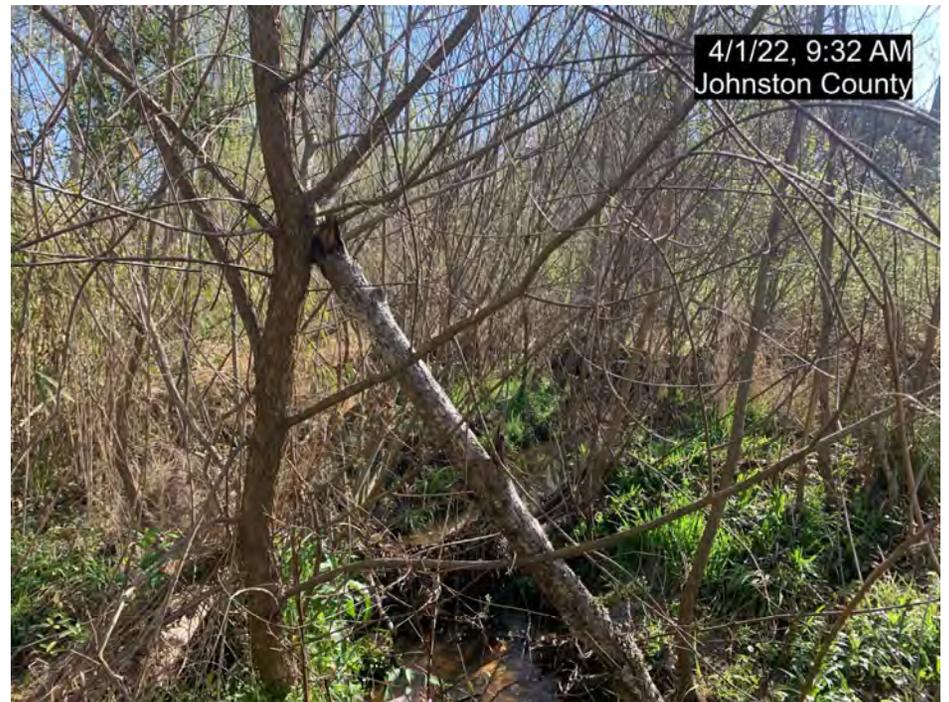
PS-6, Reach R2, facing upstream, Sta 20+75, April 23, 2018 (MY-00)

PS-6, Reach R2, facing upstream, Sta 20+75, April 1, 2022 (MY-05)

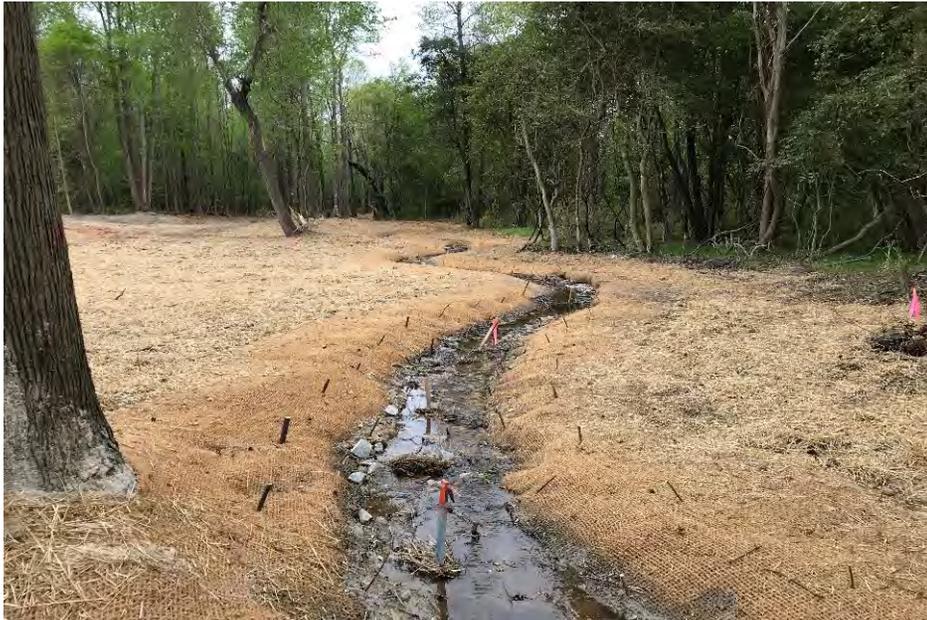
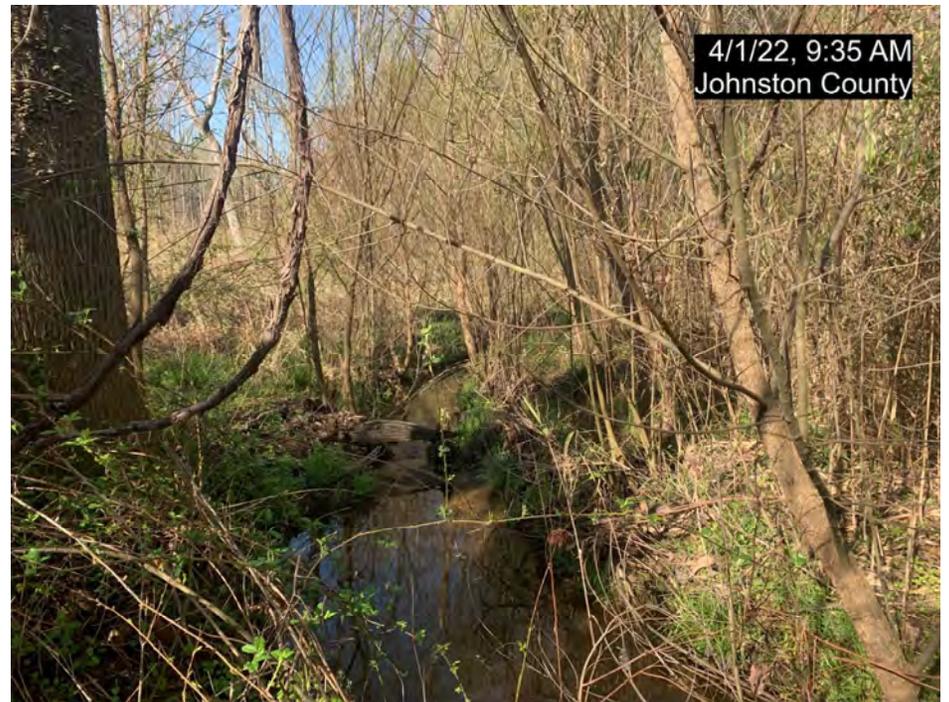
PS-7, Reach R2, facing downstream, Sta 21+00, April 23, 2018 (MY-00)

PS-7, Reach R2, facing downstream, Sta 21+00, March 10, 2021 (MY-05)

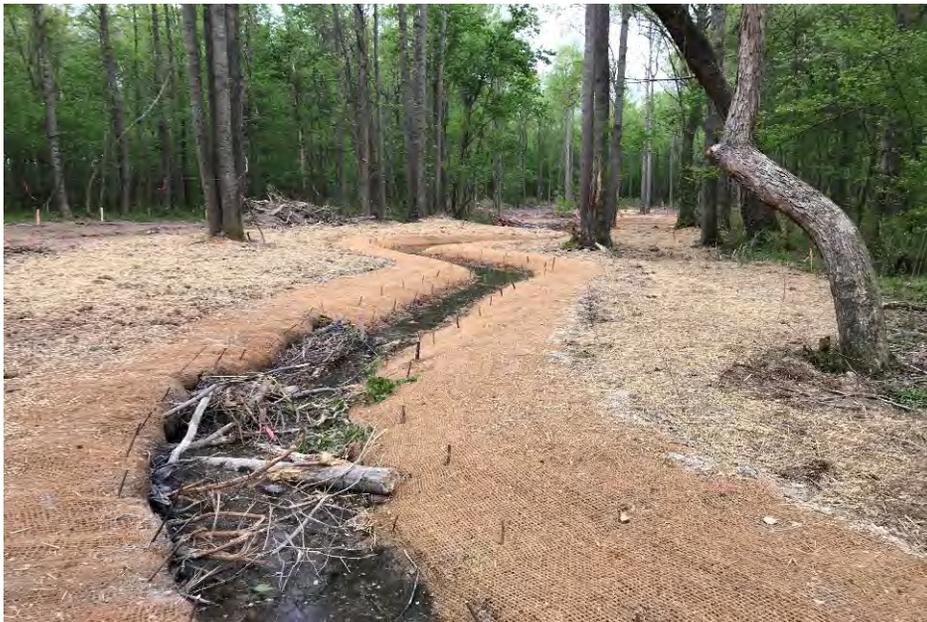
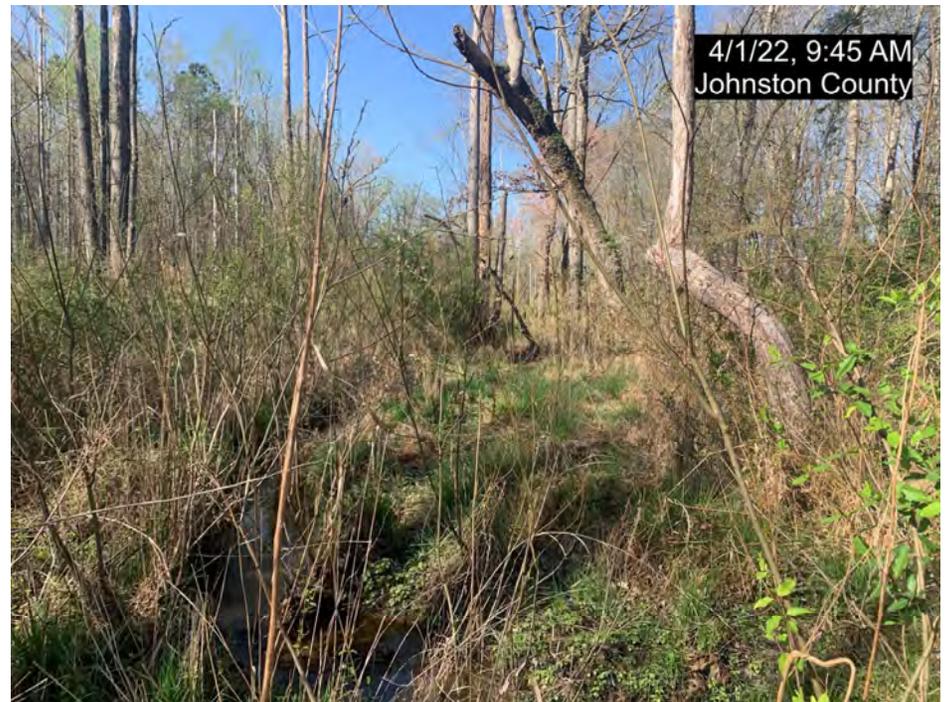
PS-8, Reach R2, facing downstream, Sta 24+50, April 23, 2018 (MY-00)

PS-8, Reach R2, facing downstream, Sta 24+50, April 1, 2022 (MY-05)

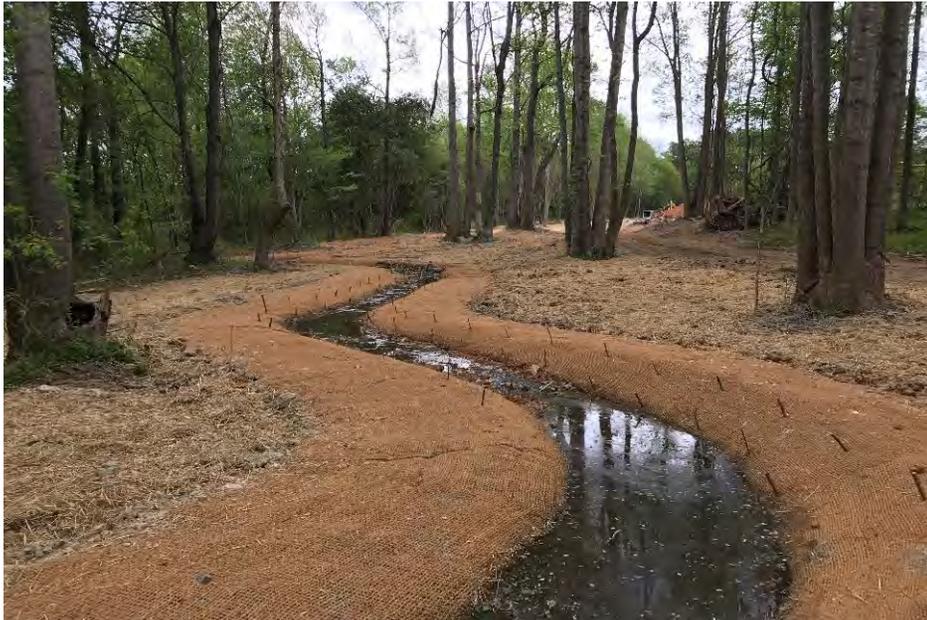
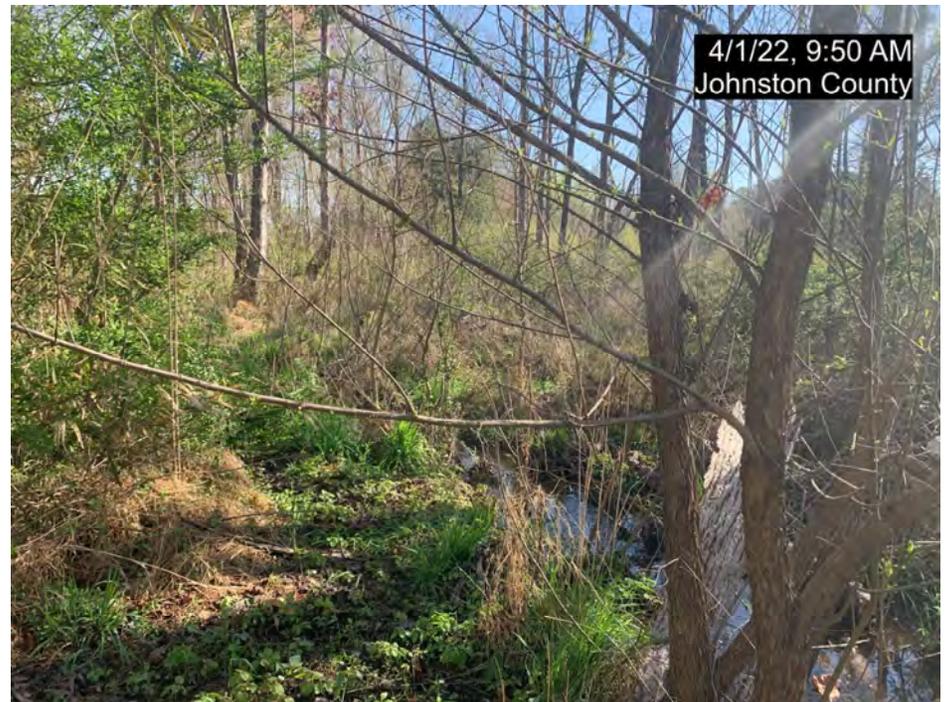
PS-9, Reach R2, facing upstream, Sta 25+75, April 23, 2018 (MY-00)

PS-9, Reach R2, facing upstream, Sta 25+75, April 1, 2022 (MY-05)

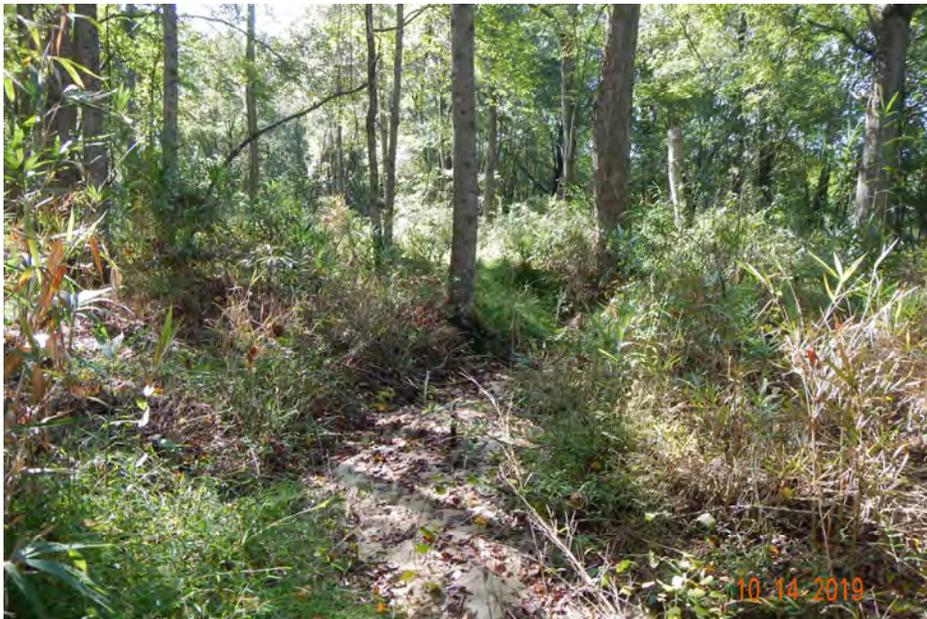
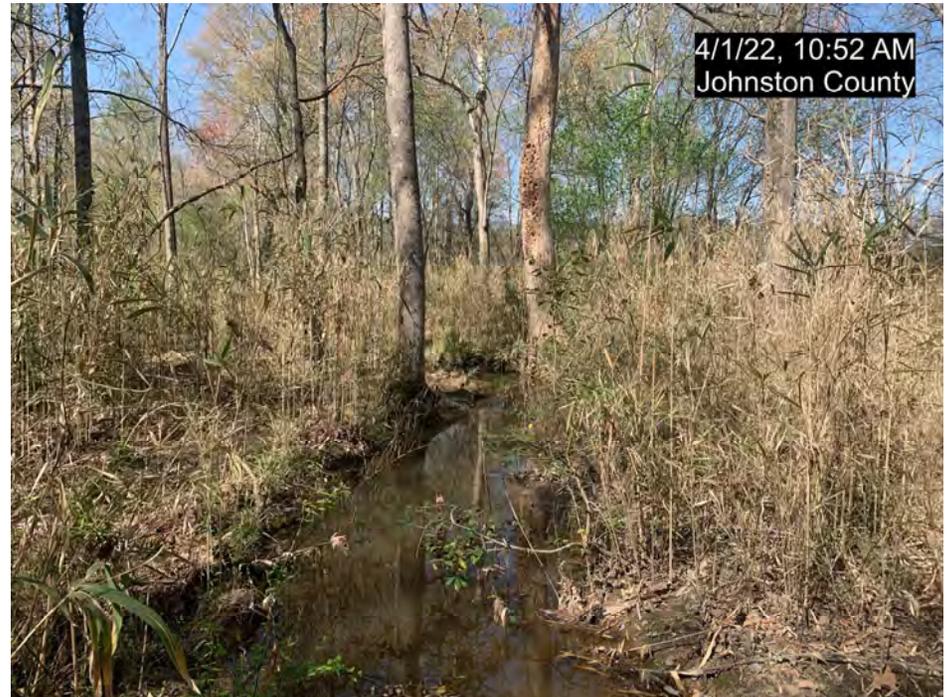
PS-10, Reach R3, facing downstream, Sta 32+00, October 14, 2019 (MY-02)

PS-10, Reach R3, facing downstream, Sta 32+00, April 1, 2022 (MY-05)

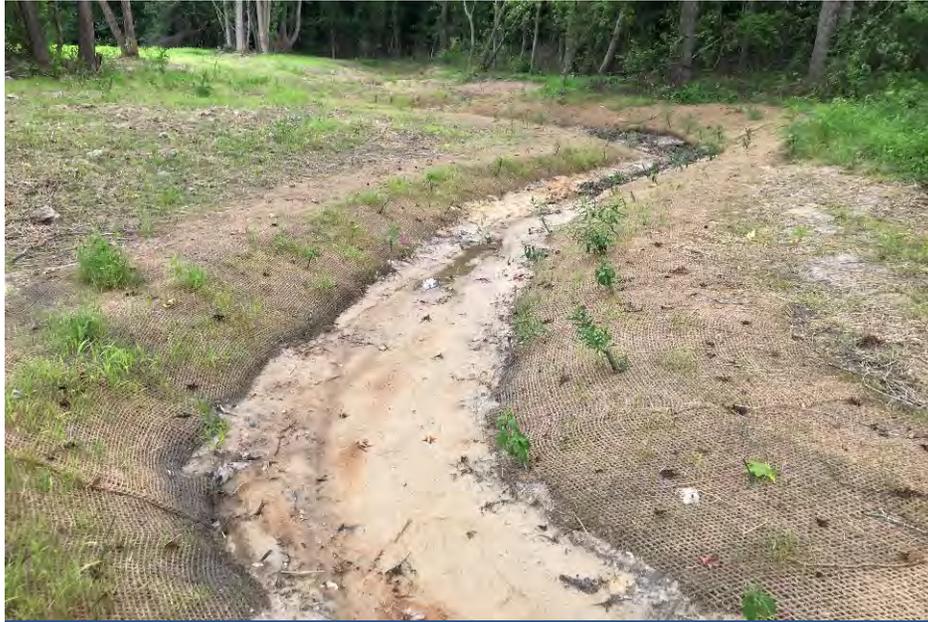
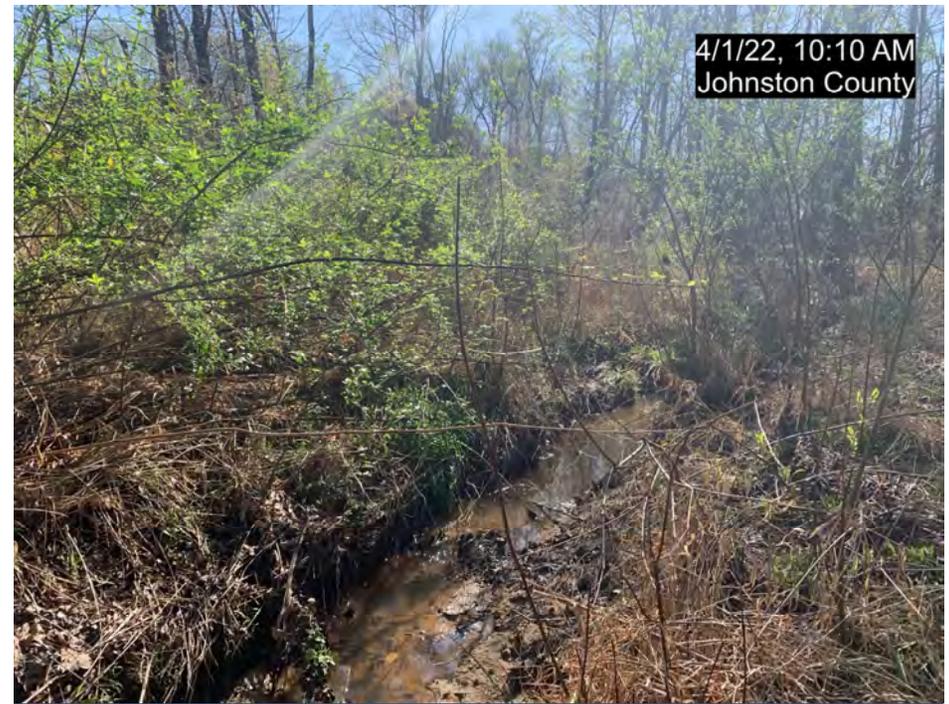
PS-11, Reach R4, facing upstream, Sta 13+00, June 11, 2018 (MY-00)

PS-11, Reach R4, facing upstream, Sta 13+00, April 1, 2022 (MY-05)

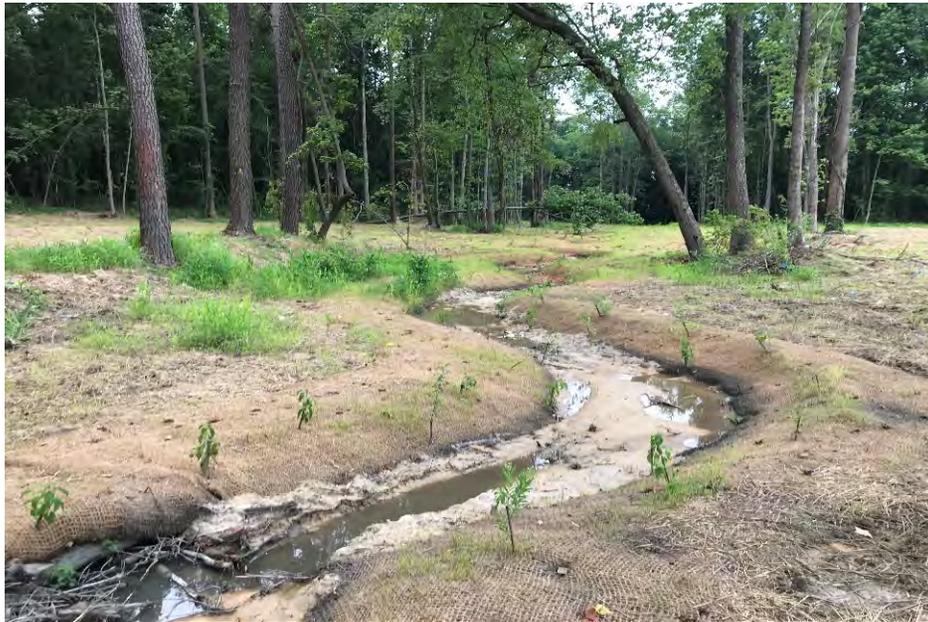
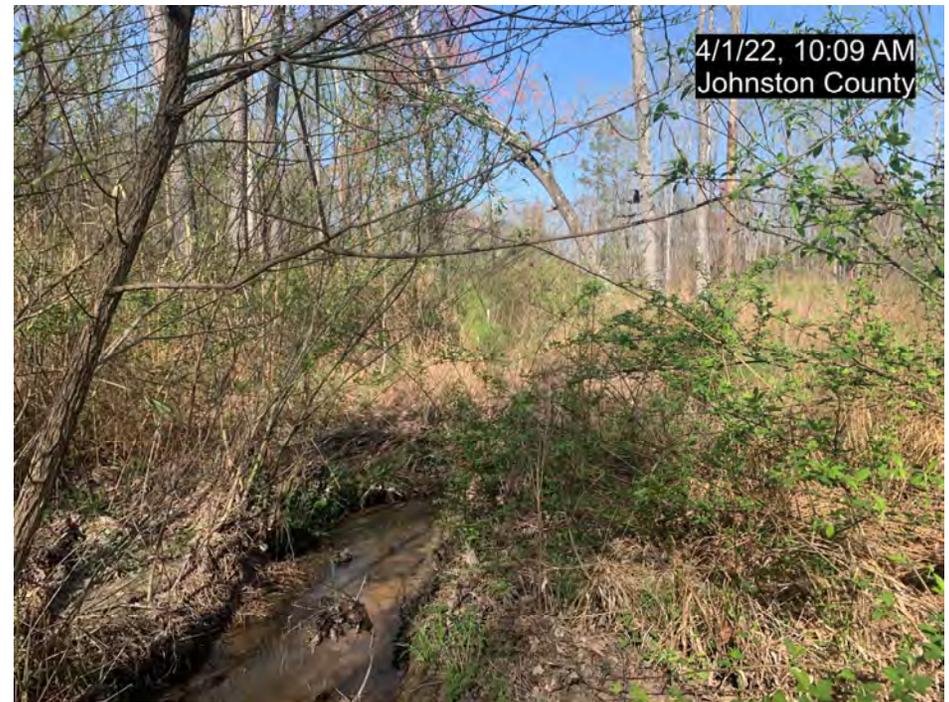
PS-11, Reach R4, facing downstream, Sta 13+00, June 11, 2018 (MY-00)

PS-11, Reach R4, facing downstream, Sta 13+00, April 1, 2022 (MY-05)

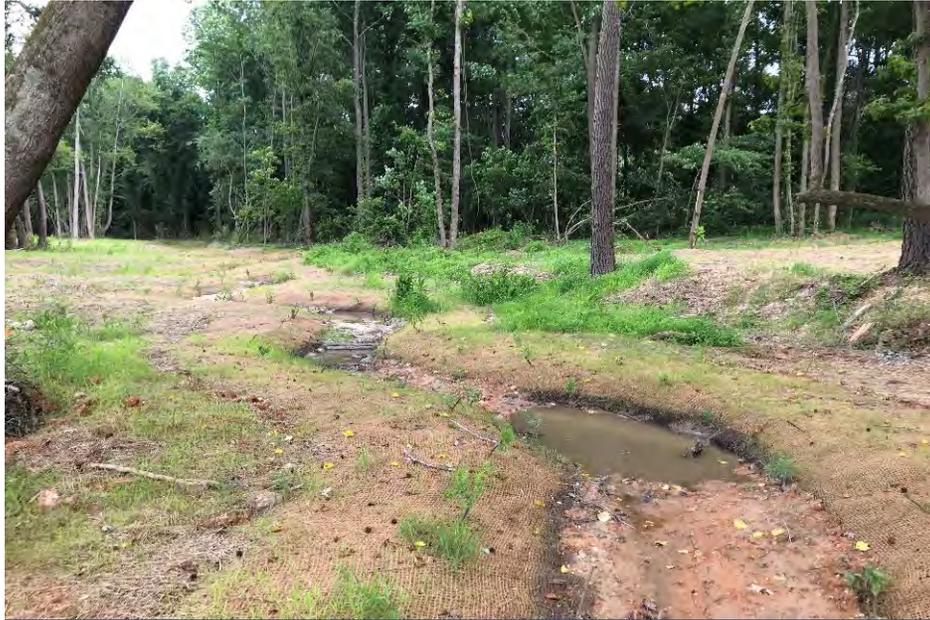
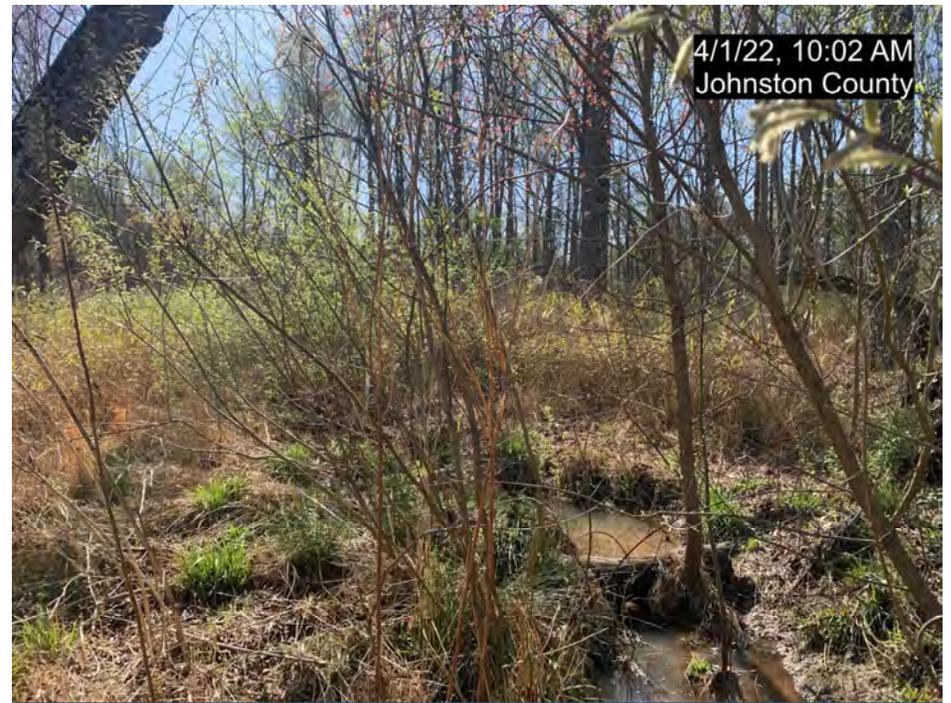
PS-12, Reach R4, facing upstream, Sta 14+00, June 11, 2018 (MY-00)

PS-12, Reach R4, facing upstream, Sta 14+00, April 1, 2022 (MY-05)

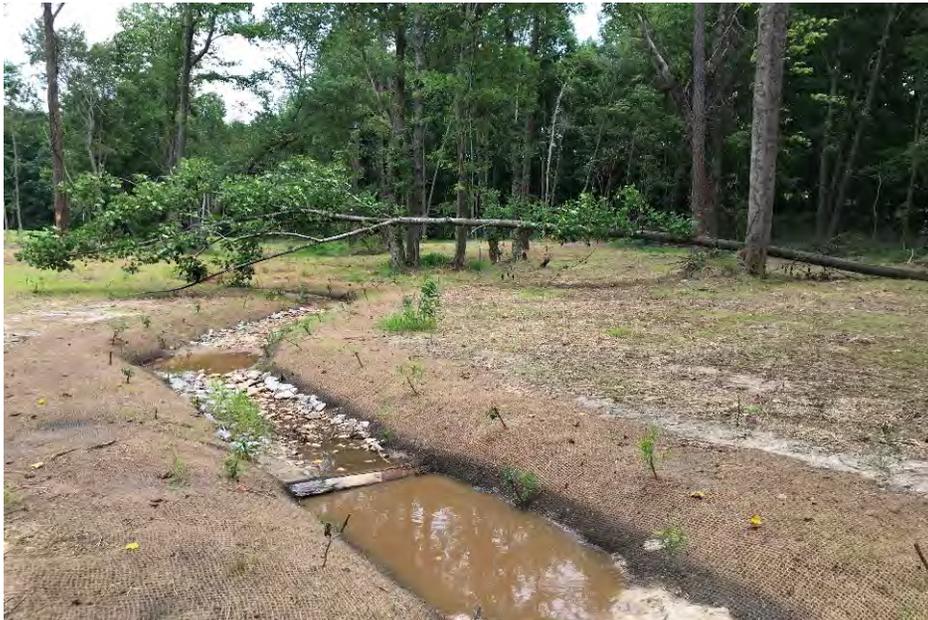
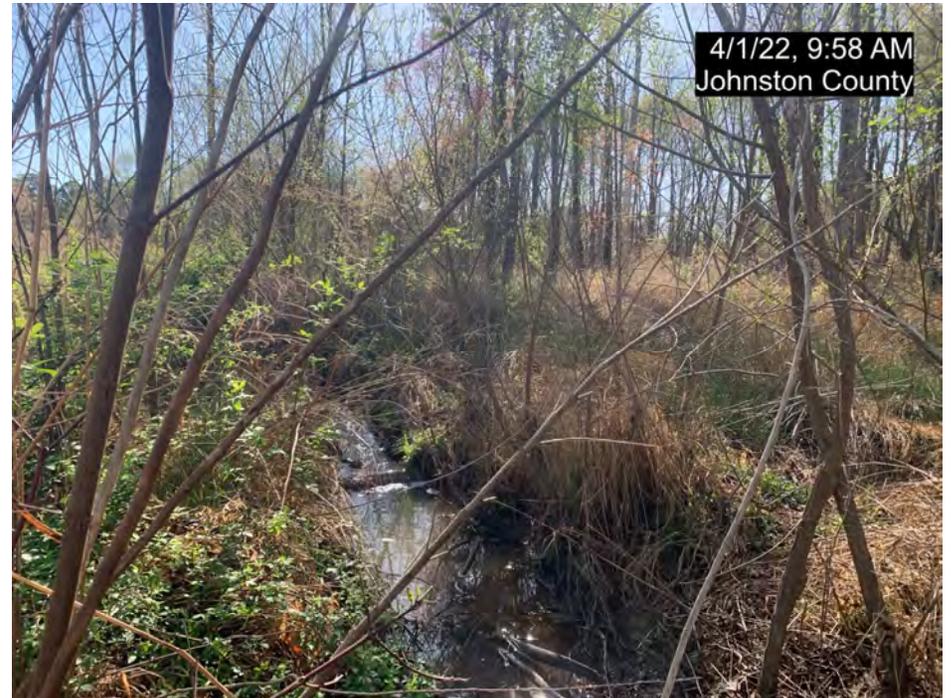
PS-13, Reach R4, facing upstream, Sta 17+00, June 11, 2018 (MY-00)

PS-13, Reach R4, facing upstream, Sta 17+00, April 1, 2022 (MY-05)

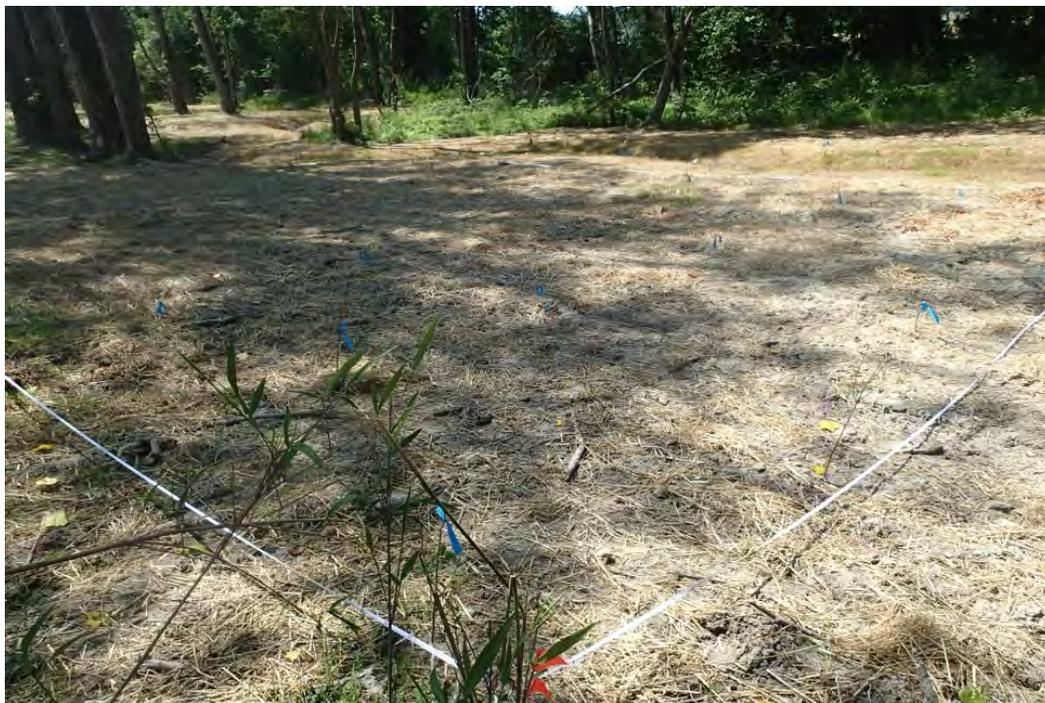
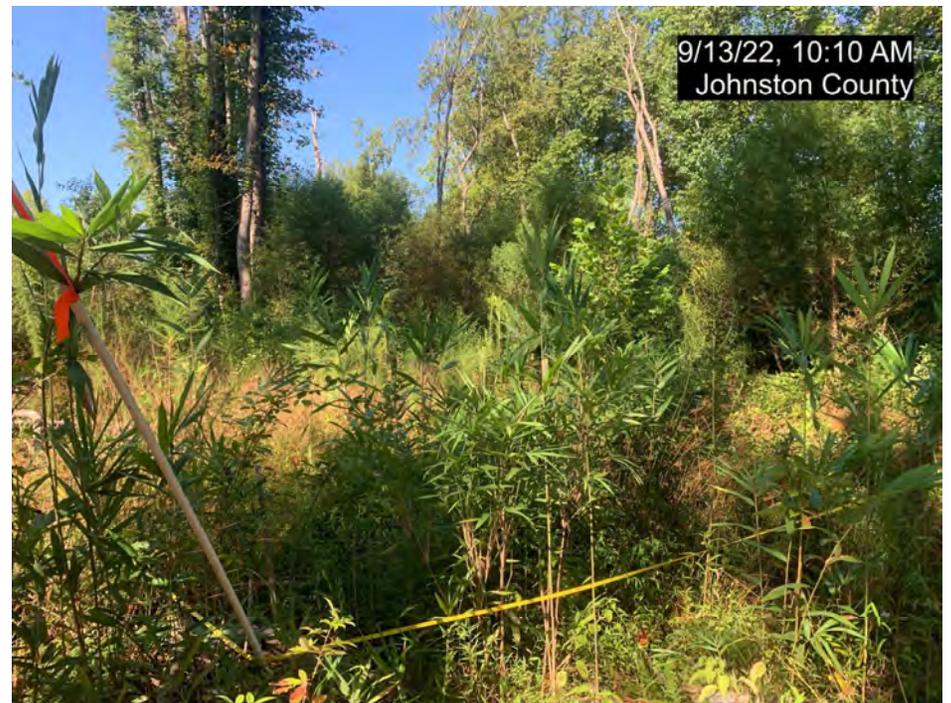
Veg Plot 1, May 14, 2018 (MY-00)

Veg Plot 1, September 13, 2022 (MY-05)

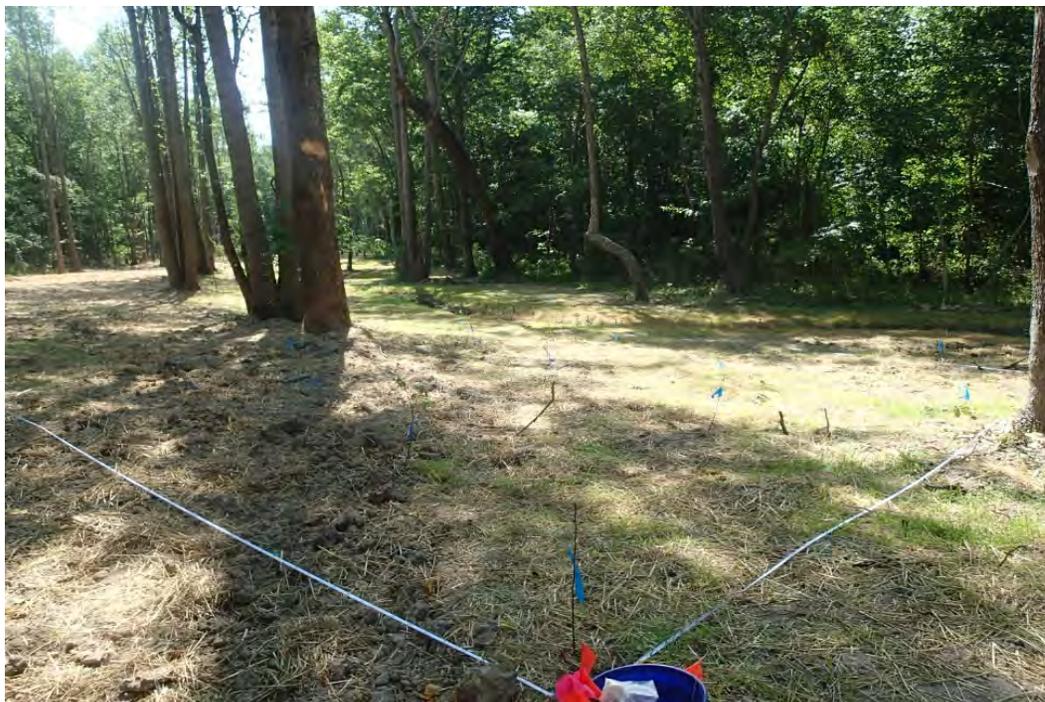
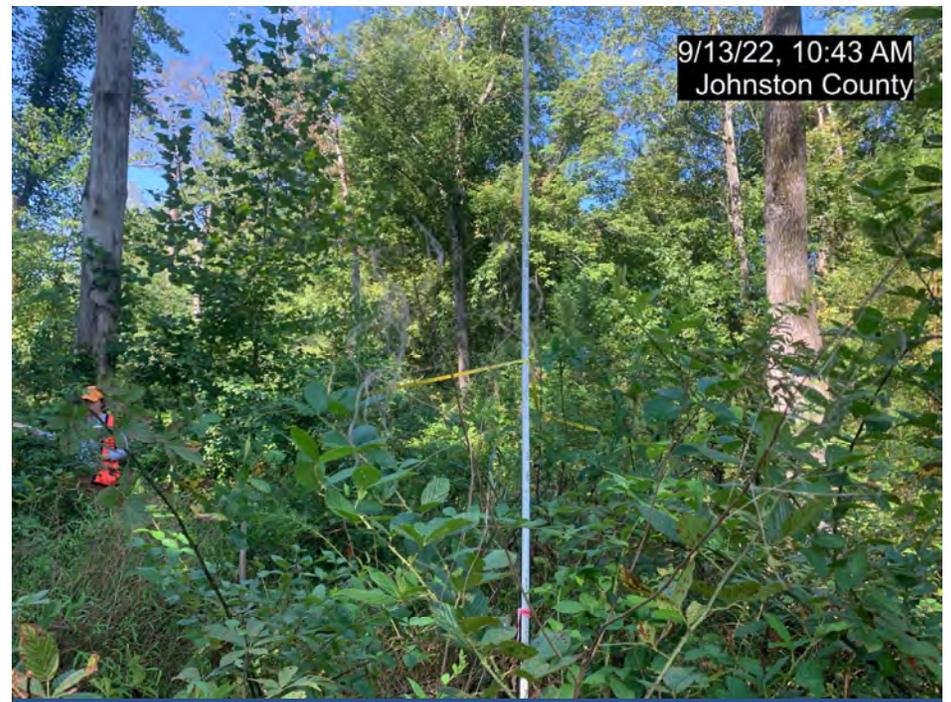
Veg Plot 2, May 14, 2018 (MY-00)

Veg Plot 2, September 13, 2022 (MY-05)

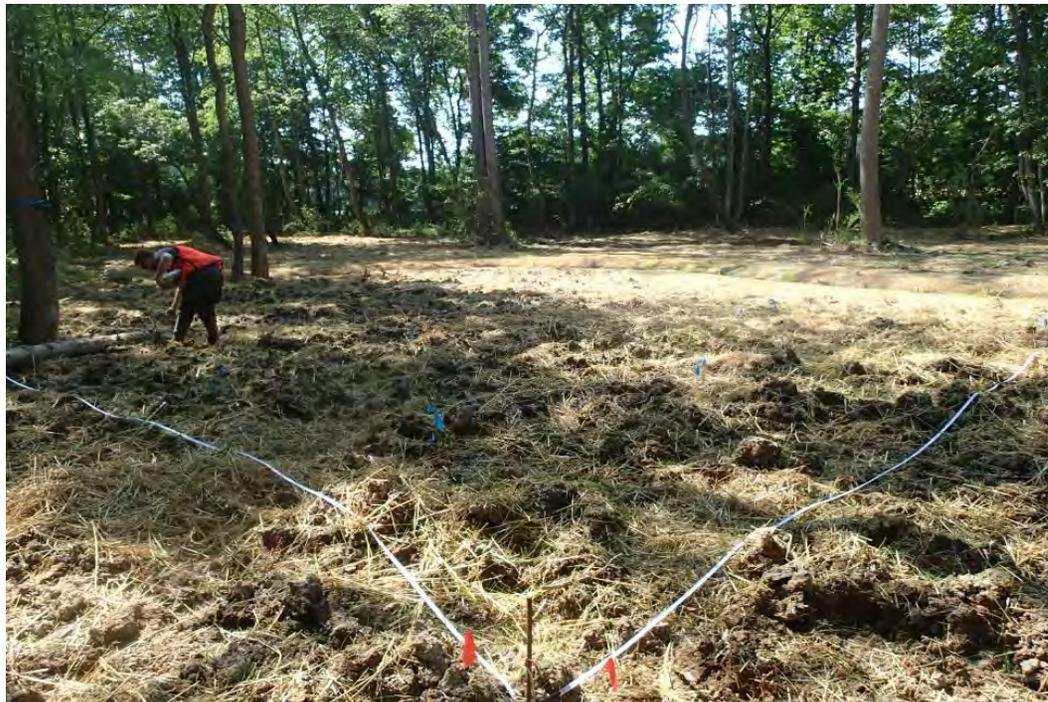
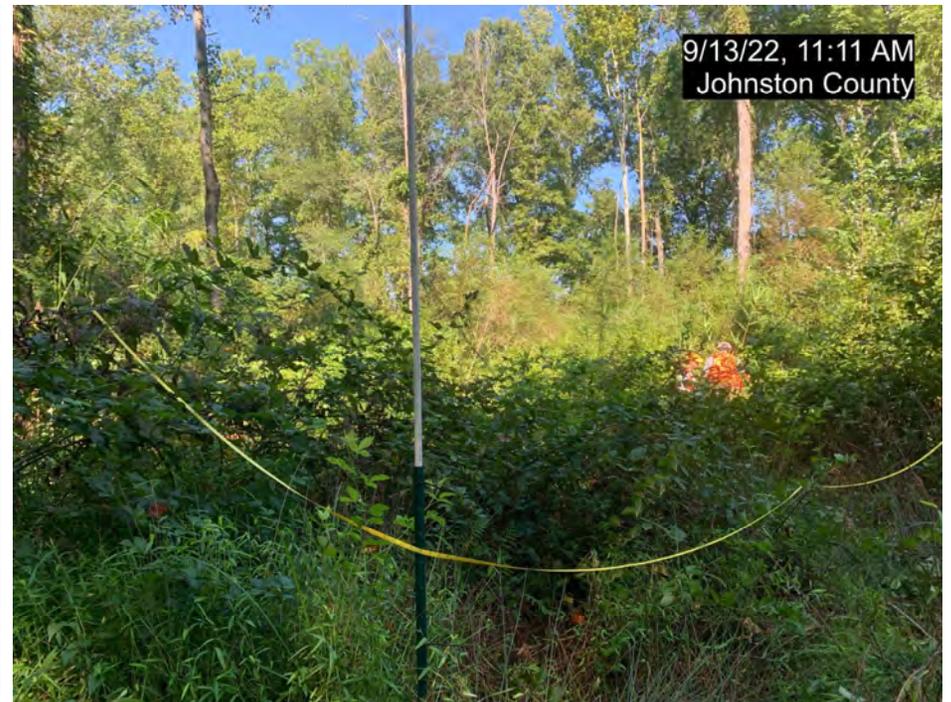
Veg Plot 3, May 14, 2018 (MY-00)

Veg Plot 3, September 13, 2022 (MY-05)
