Monitoring Report – Year 5
FINAL VERSION
Edwards-Johnson Mitigation Project
Calendar Year of Data Collection: 2022

NCDEQ DMS Project Identification # 97080
NCDEQ DMS Contract # 6825
Neuse River Basin (Cataloging Unit 03020201)
USACE Action ID Number: SAW-2016-00883
NCDEQ DWR Project # 2016-0404 V2
Johnston County, NC
Contracted Under RFP # 16-006477
Data Collection Period: September 2022
Submission Date: November 30th, 2022

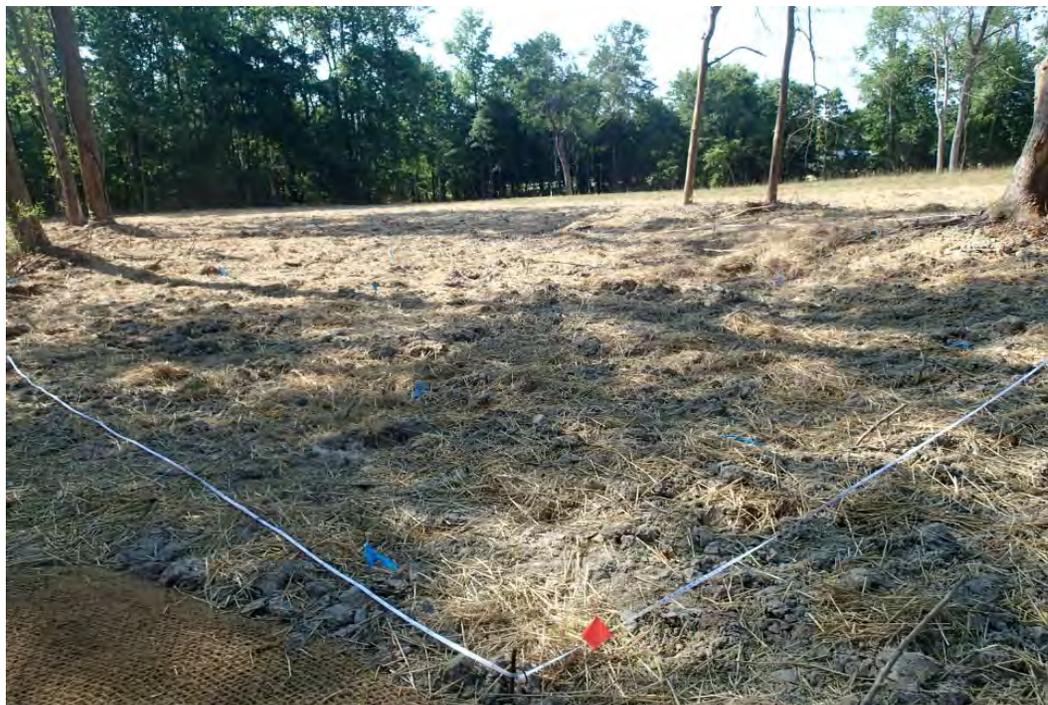
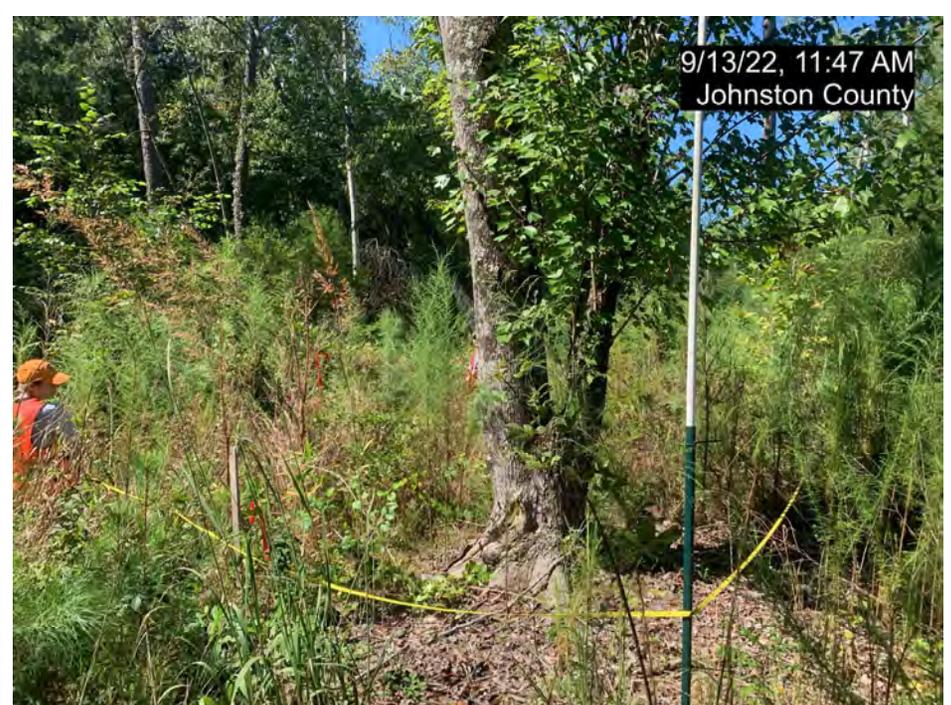
Veg Plot 4, May 14, 2018 (MY-00)
*plot origin at corner to the right

Veg Plot 4, September 13, 2022 (MY-05)

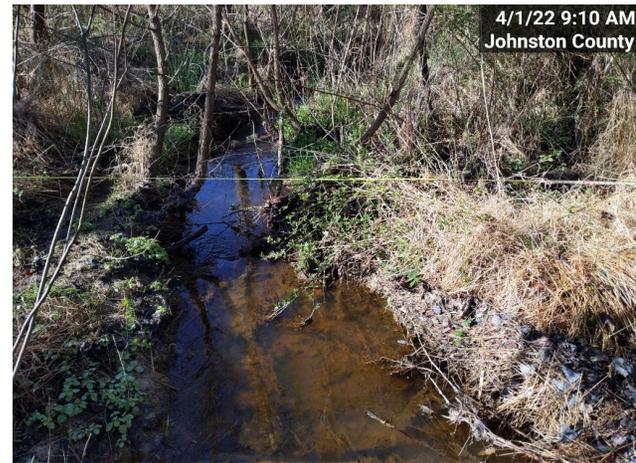
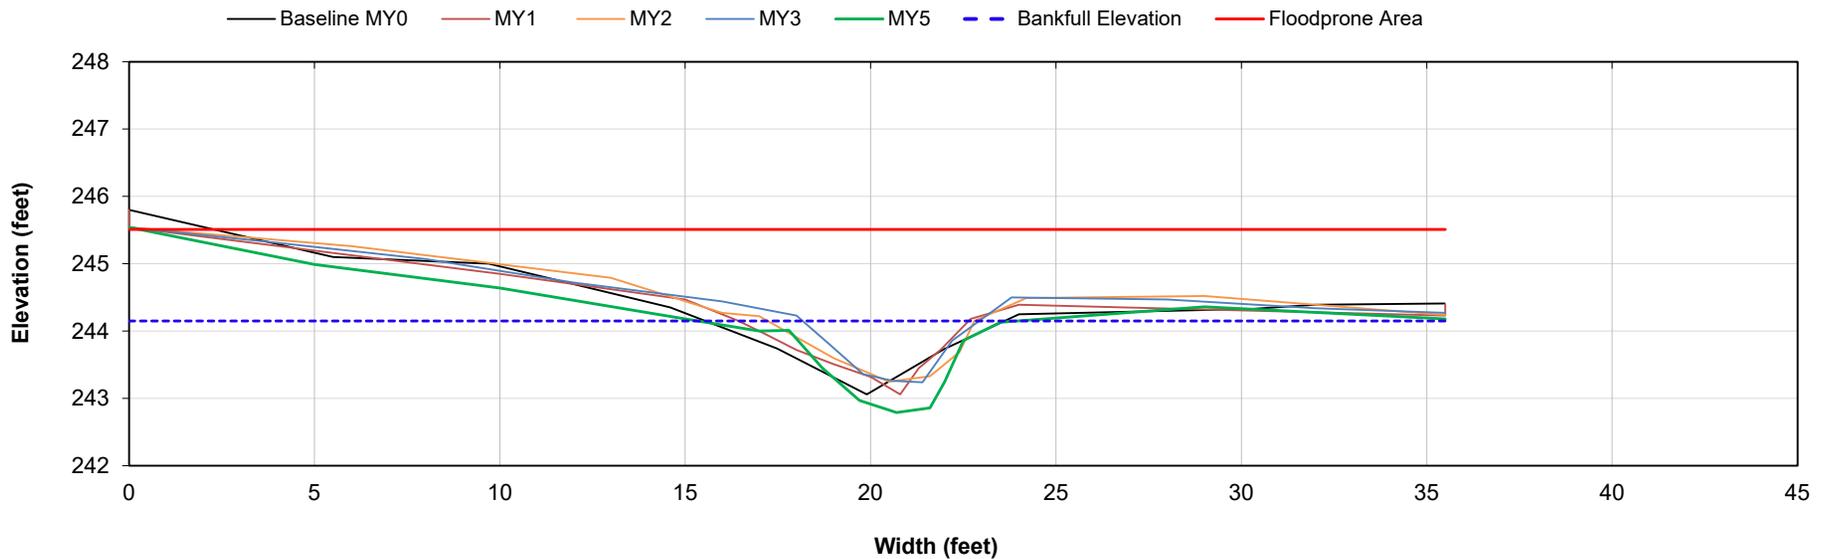
XS-1 Riffle, STA 18+77

Dimension Data Summary: MY5 2022	
Bankfull Elevation (ft)	244.2
Low Bank Height Elevation (ft)	244.0
Bankfull Max Depth (ft)	1.4
Low Bank Height (ft)	1.2
Bank Height Ratio	0.90
Bankfull X-section Area (ft ²)	4.9
% Change Bank Height Ratio	10.0%

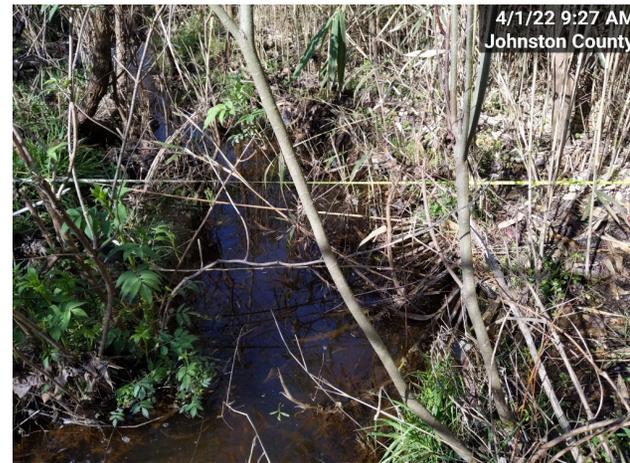
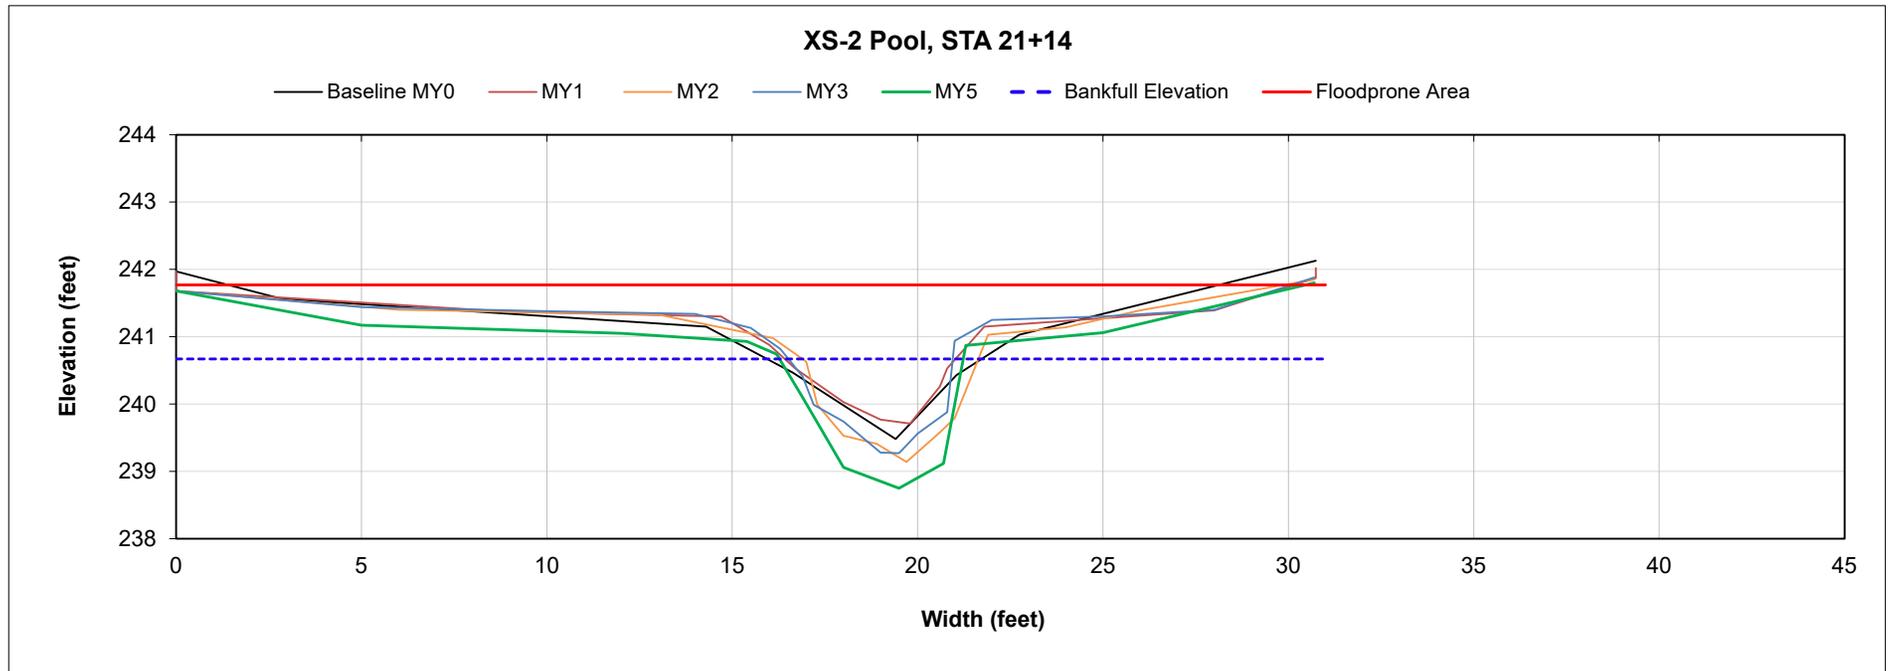
Project Name	Edwards-Johnson Mitigation Project
Project ID	97080
Reach ID	R2
Cross Section ID	XS-2
Field Crew	K. Obermiller, C. Durham

Dimension Data Summary: MY5 2022	
Bankfull Elevation (ft)	240.7
Low Bank Height Elevation (ft)	240.7
Bankfull Max Depth (ft)	1.9
Low Bank Height (ft)	2.0
Bank Height Ratio	N/A
Bankfull X-section Area (ft ²)	6.5
% Change Bank Height Ratio	N/A

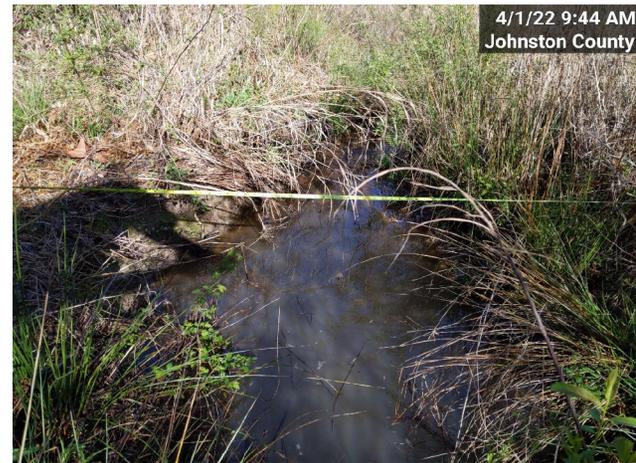
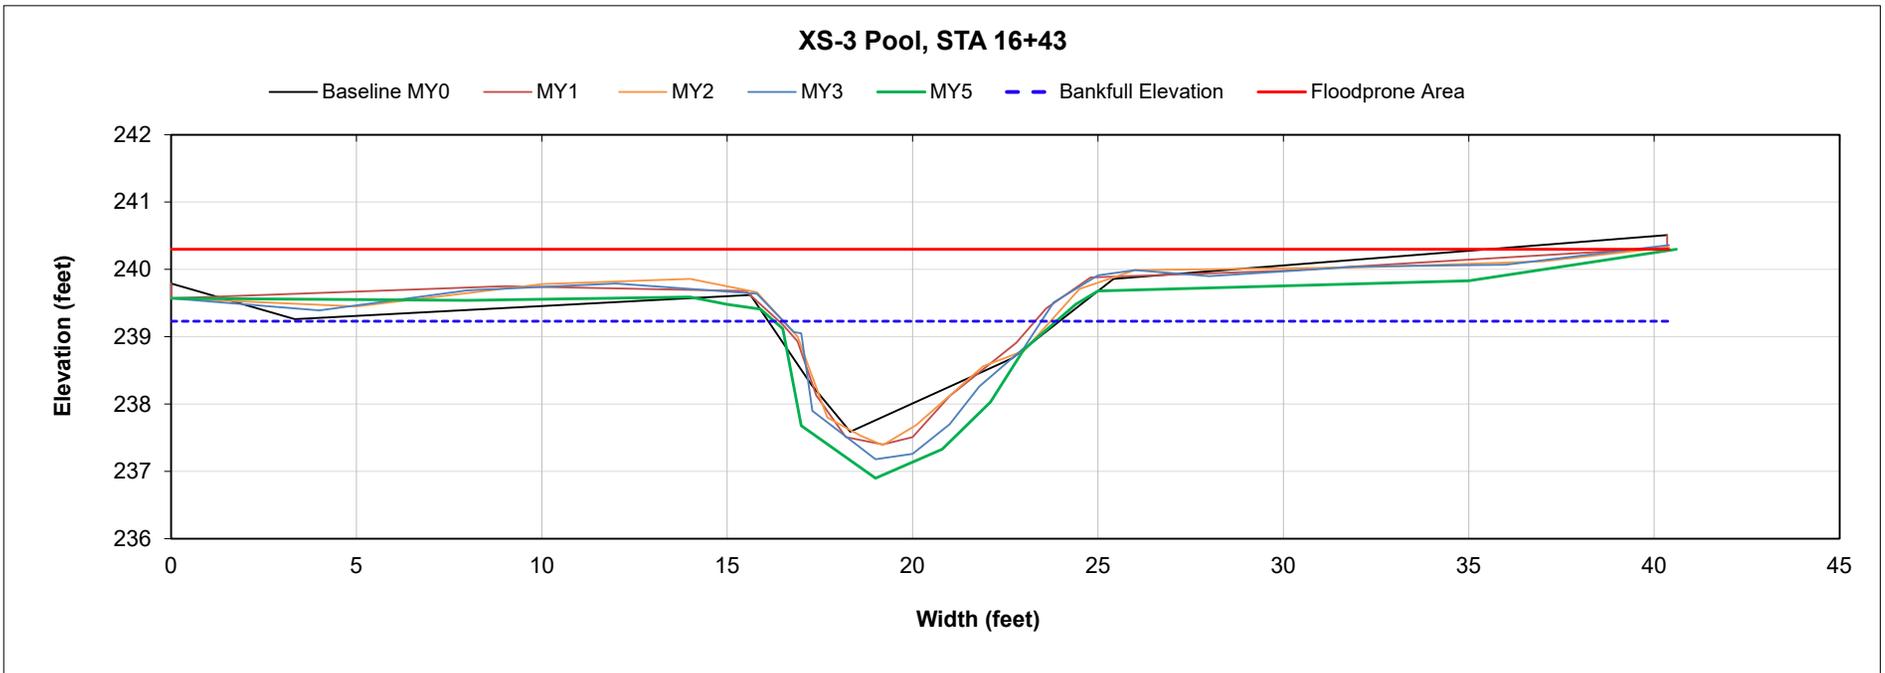
Project Name	Edwards-Johnson Mitigation Project
Project ID	97080
Reach ID	R4
Cross Section ID	XS-3
Field Crew	K. Obermiller, C. Durham

Dimension Data Summary: MY5 2022	
Bankfull Elevation (ft)	239.2
Low Bank Height Elevation (ft)	239.4
Bankfull Max Depth (ft)	2.3
Low Bank Height (ft)	2.5
Bank Height Ratio	N/A
Bankfull X-section Area (ft²)	11.0
% Change Bank Height Ratio	N/A

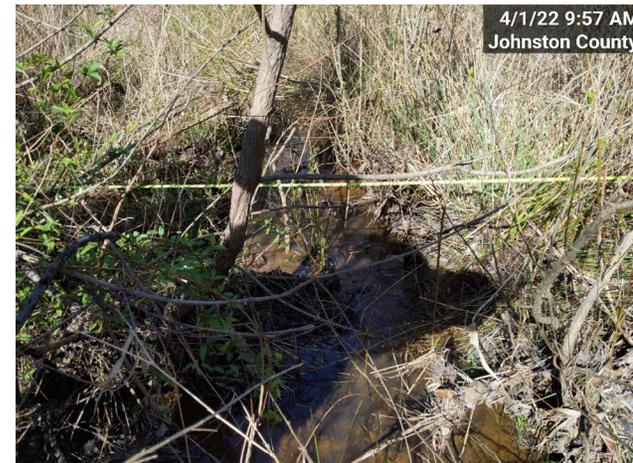
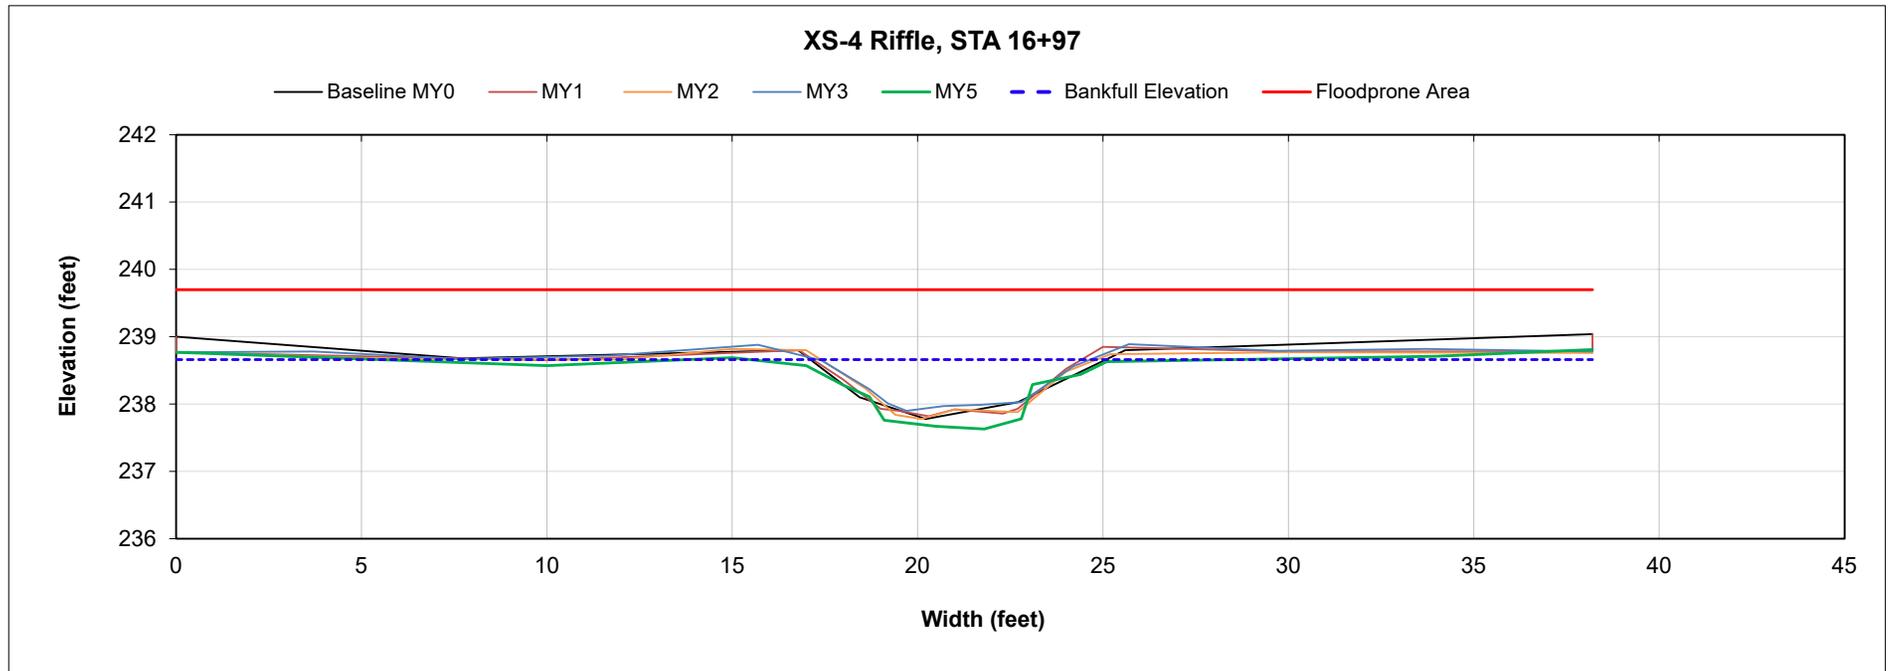
Project Name	Edwards-Johnson Mitigation Project
Project ID	97080
Reach ID	R4
Cross Section ID	XS-4
Field Crew	K. Obermiller, C. Durham

Dimension Data Summary: MY5 2022	
Bankfull Elevation (ft)	238.6
Low Bank Height Elevation (ft)	238.6
Bankfull Max Depth (ft)	1.0
Low Bank Height (ft)	1.0
Bank Height Ratio	0.97
Bankfull X-section Area (ft ²)	5.2
% Change Bank Height Ratio	3.0%

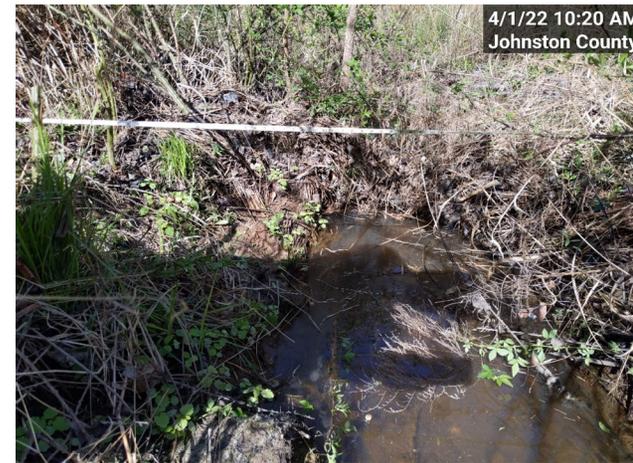
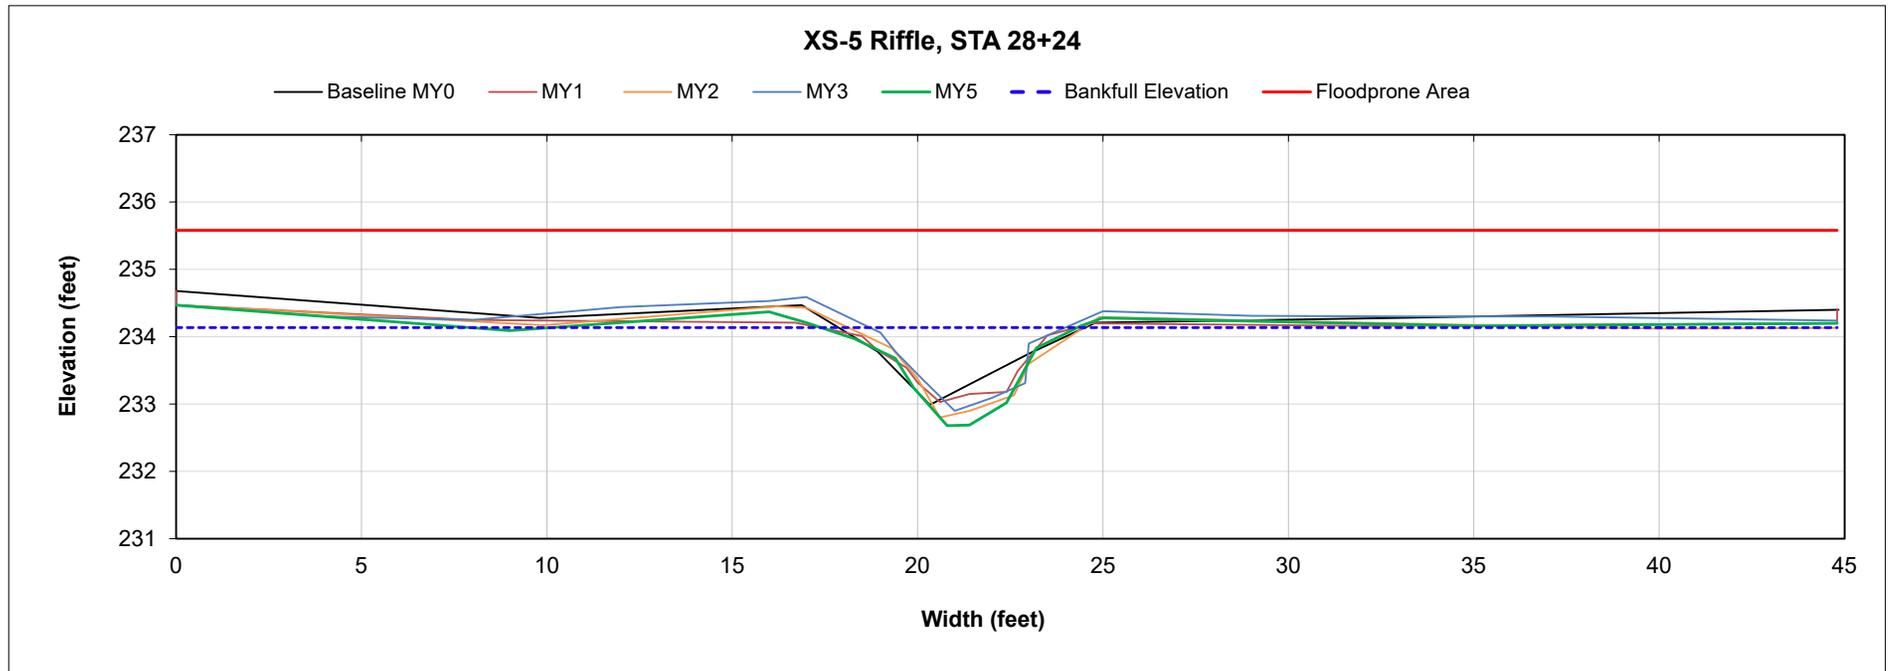
Project Name	Edwards-Johnson Mitigation Project
Project ID	97080
Reach ID	R3
Cross Section ID	XS-5
Field Crew	K. Obermiller, C. Durham

Dimension Data Summary: MY5 2022	
Bankfull Elevation (ft)	234.1
Low Bank Height Elevation (ft)	234.2
Bankfull Max Depth (ft)	1.5
Low Bank Height (ft)	1.5
Bank Height Ratio	1.02
Bankfull X-section Area (ft ²)	4.7
% Change Bank Height Ratio	2.0%

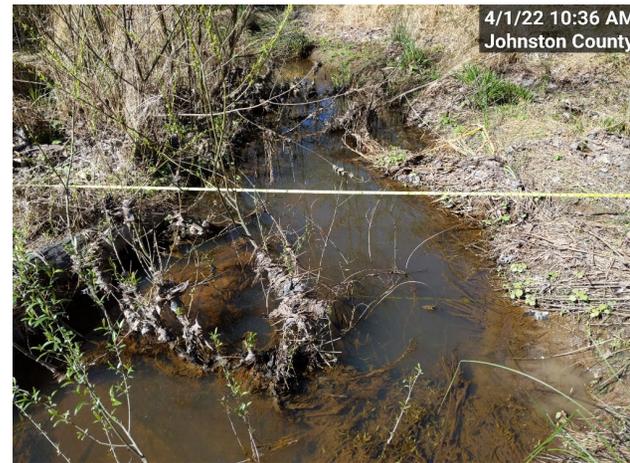
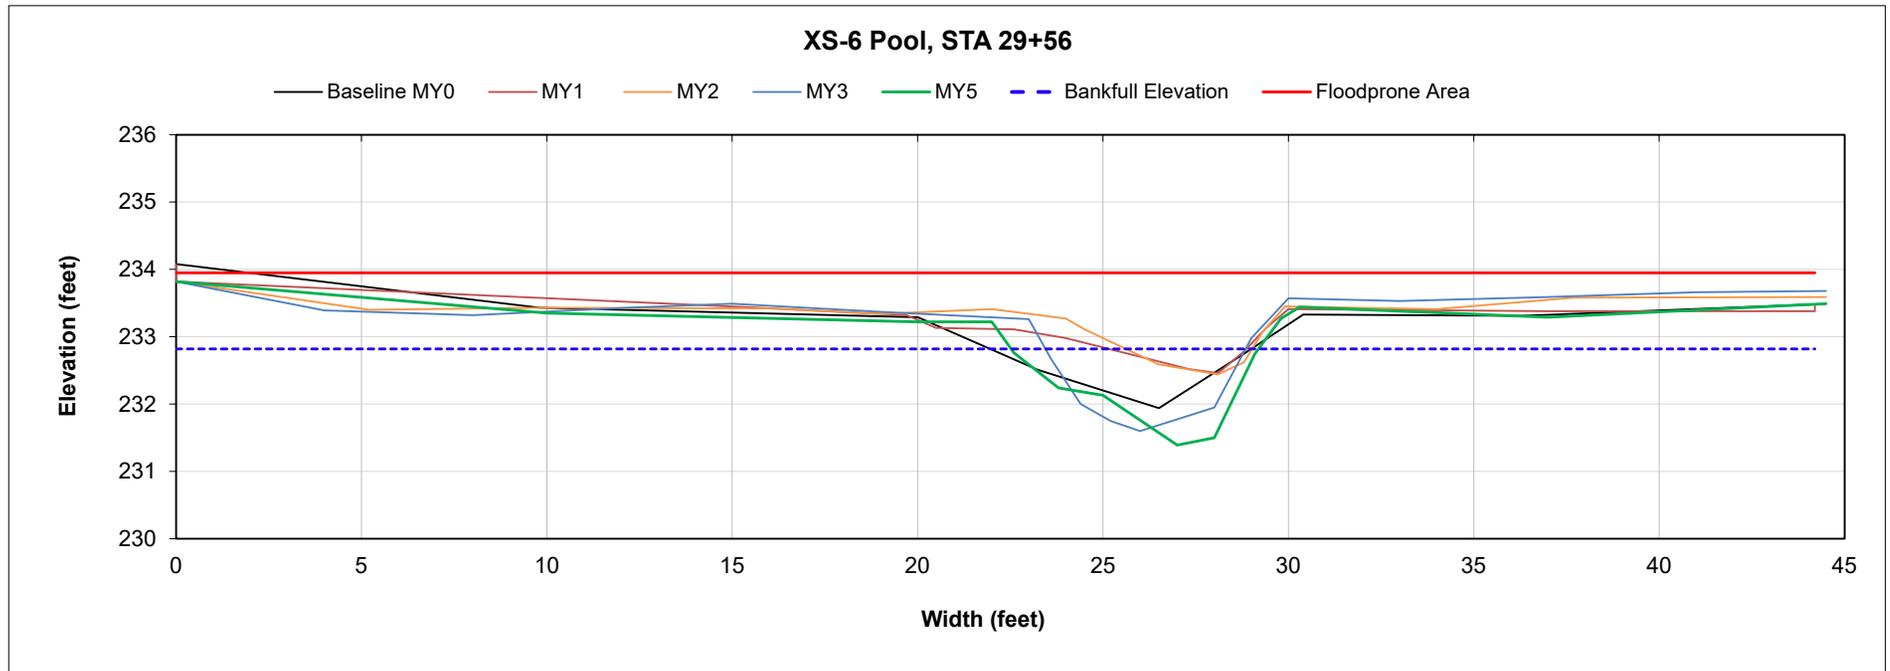
Project Name	Edwards-Johnson Mitigation Project
Project ID	97080
Reach ID	R3
Cross Section ID	XS-6
Field Crew	K. Obermiller, C. Durham

Dimension Data Summary: MY5 2022	
Bankfull Elevation (ft)	232.9
Low Bank Height Elevation (ft)	233.2
Bankfull Max Depth (ft)	1.5
Low Bank Height (ft)	1.8
Bank Height Ratio	N/A
Bankfull X-section Area (ft²)	5.6
% Change Bank Height Ratio	N/A

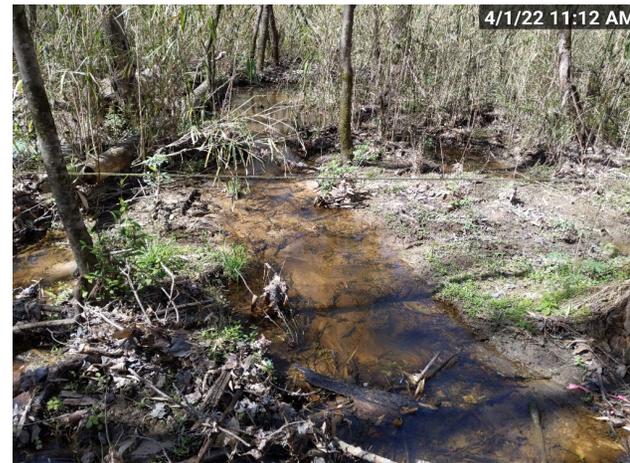
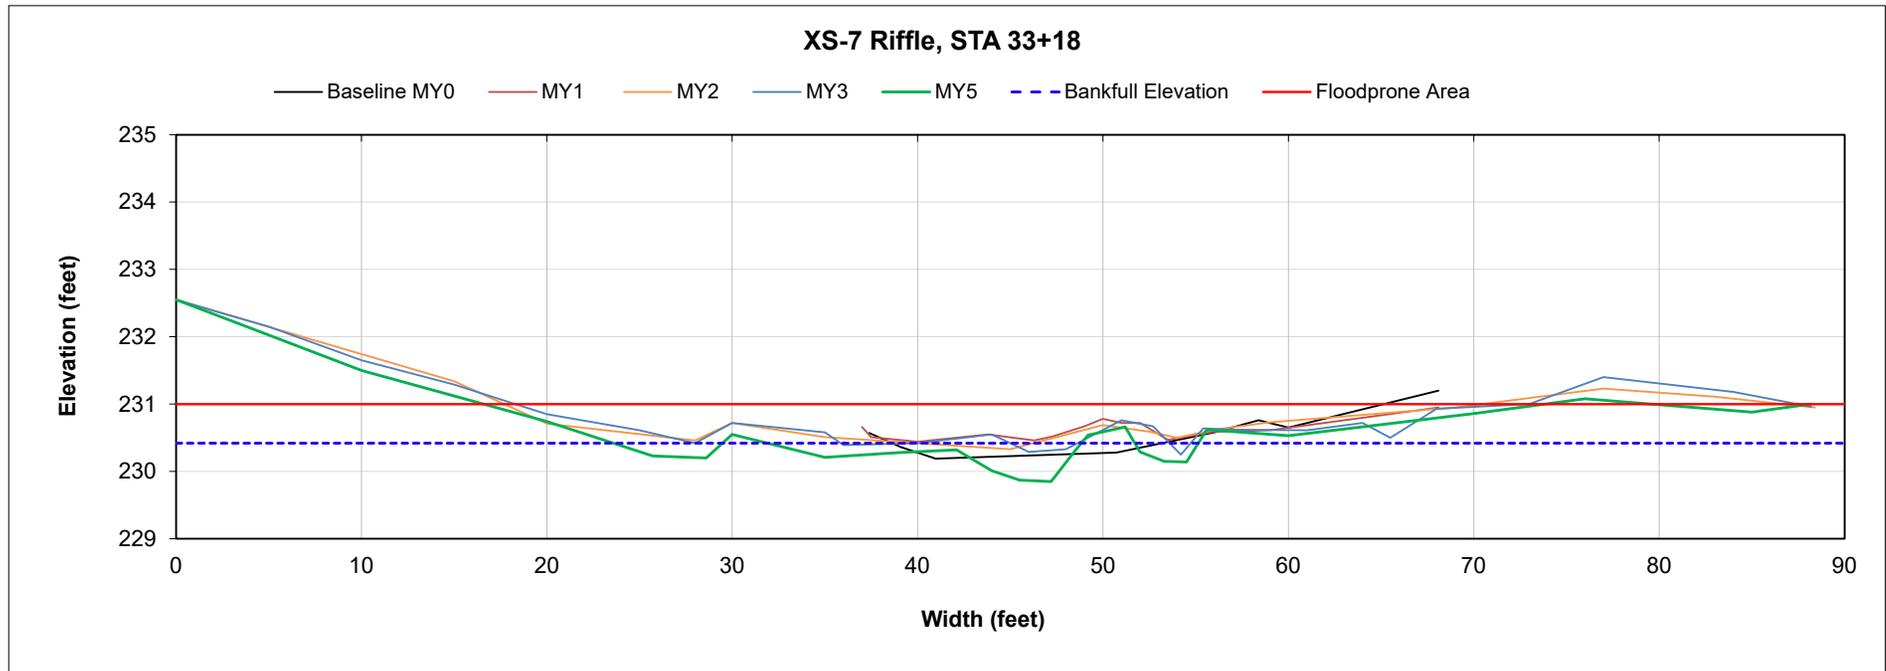
Project Name	Edwards-Johnson Mitigation Project
Project ID	97080
Reach ID	R3 (Multi-Thread Channel)
Cross Section ID	XS-7
Field Crew	K. Obermiller, C. Durham

Dimension Data Summary: MY5 2022	
Bankfull Elevation (ft)	230.4
Low Bank Height Elevation (ft)	230.3
Bankfull Max Depth (ft)	0.6
Low Bank Height (ft)	0.5
Bank Height Ratio	0.82
Bankfull X-section Area (ft ²)	4.7
% Change Bank Height Ratio	18.0%

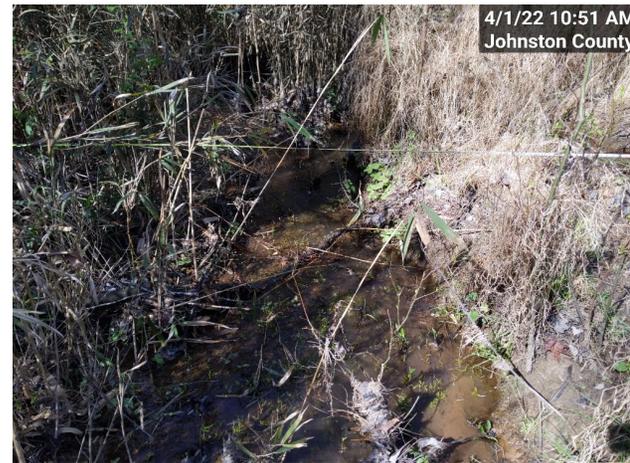
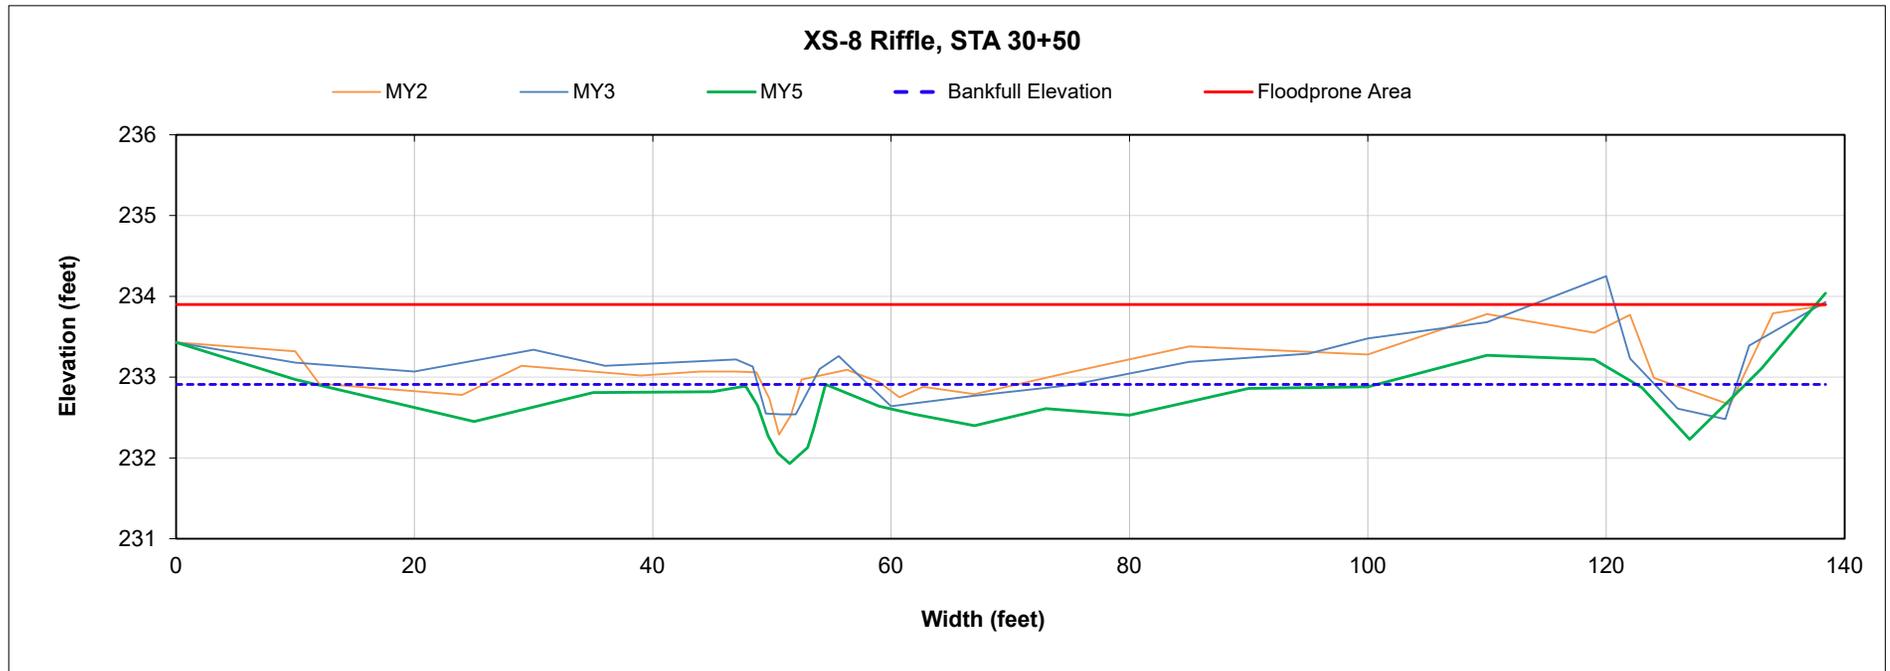
Project Name	Edwards-Johnson Mitigation Project
Project ID	97080
Reach ID	R3 (Multi-Thread Channel)
Cross Section ID	XS-8
Field Crew	K. Obermiller, C. Durham

Dimension Data Summary: MY5 2022	
Bankfull Elevation (ft)	233.2
Low Bank Height Elevation (ft)	233.2
Bankfull Max Depth (ft)	0.7
Low Bank Height (ft)	0.7
Bank Height Ratio	1.0
Bankfull X-section Area (ft ²)	4.7
% Change Bank Height Ratio	0.0%

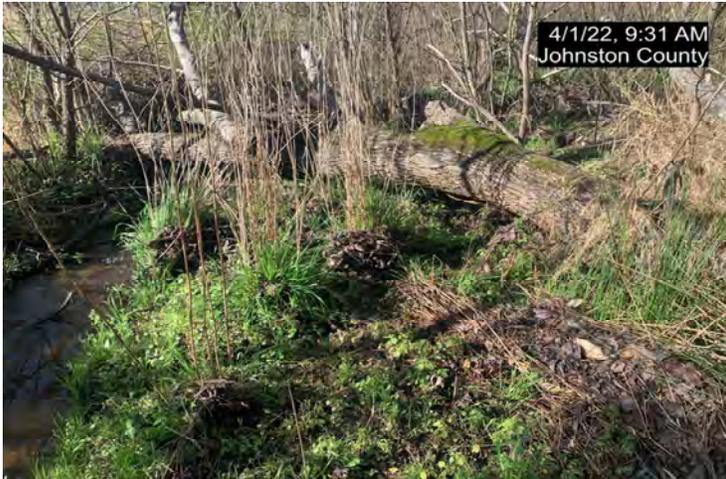
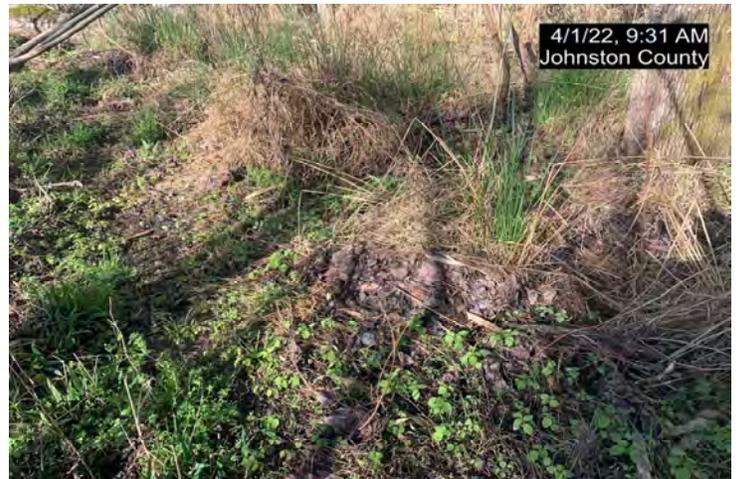
Monitoring Year	Date of Data Collection	Date of Occurrence	Method	Greater than Bankfull (Bkf) or Qgs (Q2*0.66 = 50.66 CFS) Stage?	Photo/ Notes	Measurement
MY1	9/17/2018	9/16-9/17/2018	Observed indicators of bankfull stage (wrack lines) after storm event	Bkf	Photo	
MY2	7/26/2019	7/24/2019	Crest Gauge	Bkf	Photo	.25 ft
	8/20/2019	unknown	Crest Gauge	Bkf	Photo	.28 ft
	9/6/2019	9/5/2019	Crest Gauge	Bkf	Photo	.25 ft
	9/6/2019	9/5/2019	Observed indicators of bankfull stage (wrack lines) after storm event	Bkf	Photo	NA
MY3	2/7/2020	2/6/2020	Crest Gauge	Bkf & Qgs	Photo	.85 ft
	8/4/2020	8/4/2020	Crest Gauge	Bkf & Qgs	Photo	0.5 ft
MY4	1/13/2021	unknown	Crest Gauge	Bkf	Photo	0.95 ft
	7/13/2021	unknown	Crest Gauge	Bkf	Photo	0.7 ft
MY5	4/1/2022	unknown	Observed indicators of bankfull stage (wrack lines) after storm event	Bkf	Photo	N/A

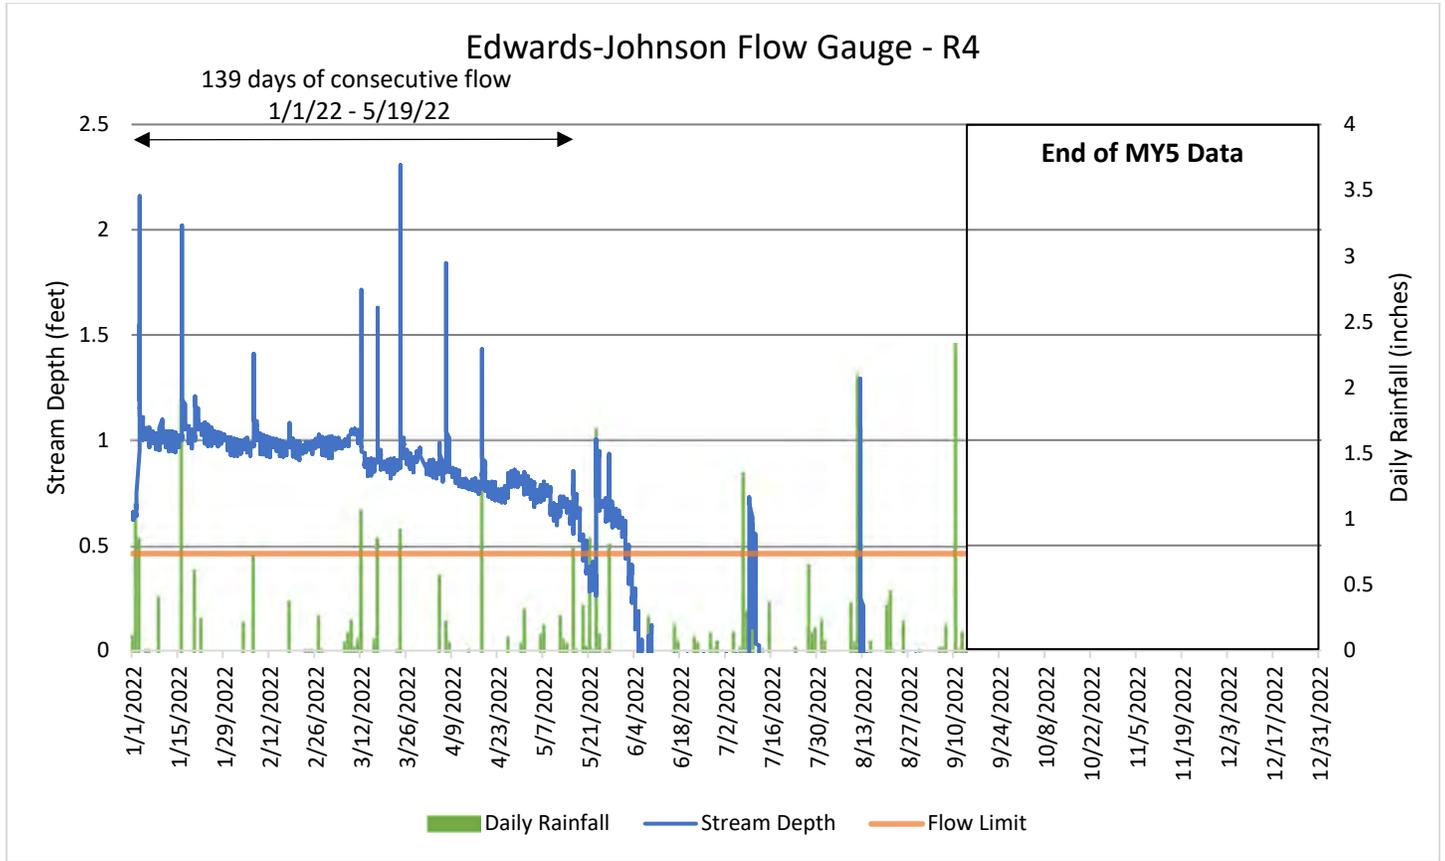
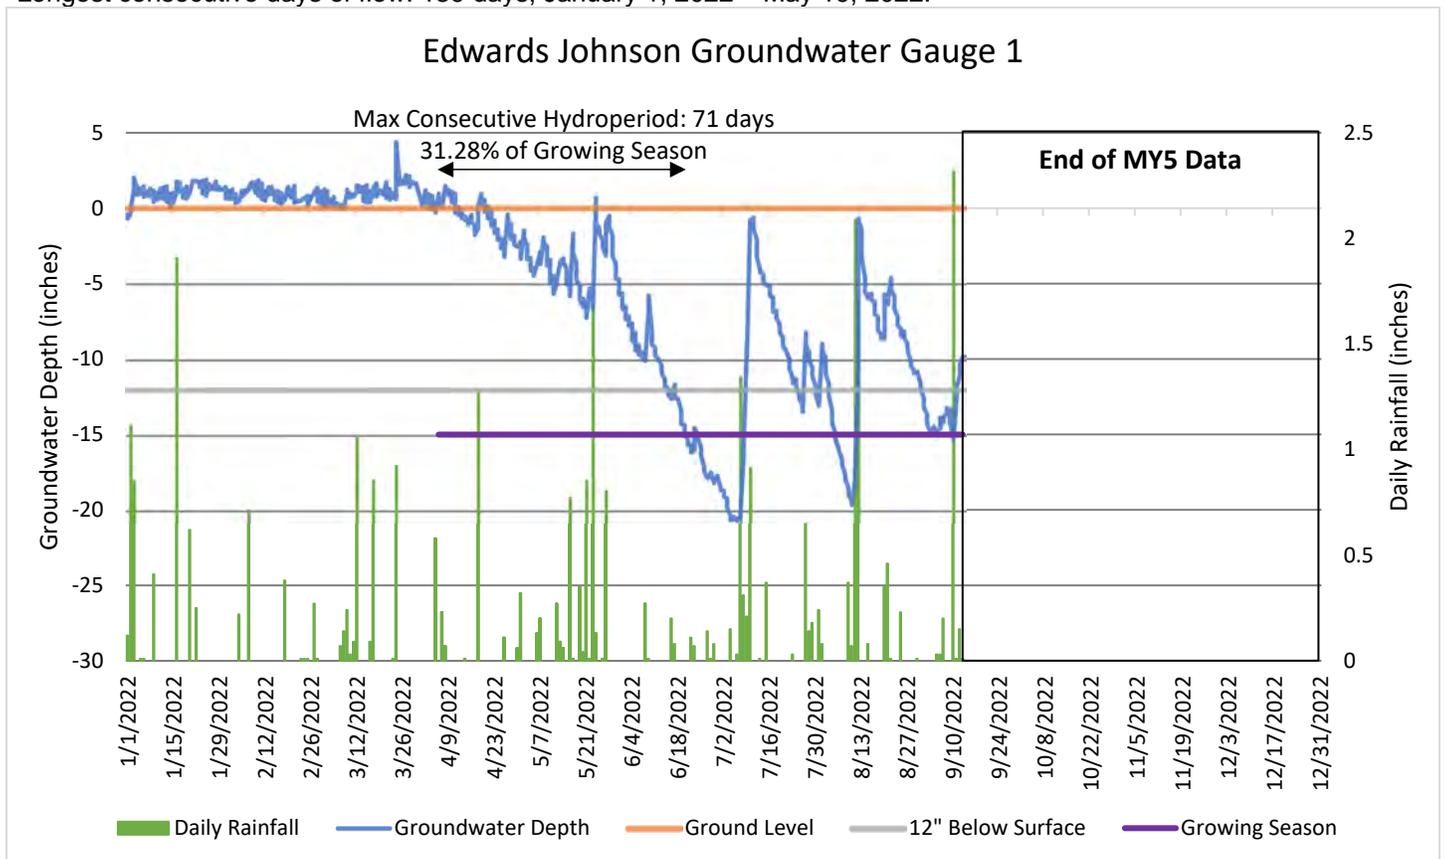
Figure 3a:

Jurisdictional stream flow documentation and monitoring of restored intermittent reaches is achieved using a flow gauge (continuous-read pressure transducers) within the thalweg of the channel towards the middle portion of the Reach R4 (Figure 1). Additionally, to determine if rainfall amounts are normal for the given year, precipitation data was obtained from CLAY Central Crops Research Station in Johnston County, approximately nine miles southwest of the site. The flow gauge documented that the stream exhibited surface flow for 139 consecutive days from January 1st through May 19th, 2022, during a year with normal rainfall conditions (Figure 3).

*Longest consecutive days of flow: 139 days, January 1, 2022 – May 19, 2022.

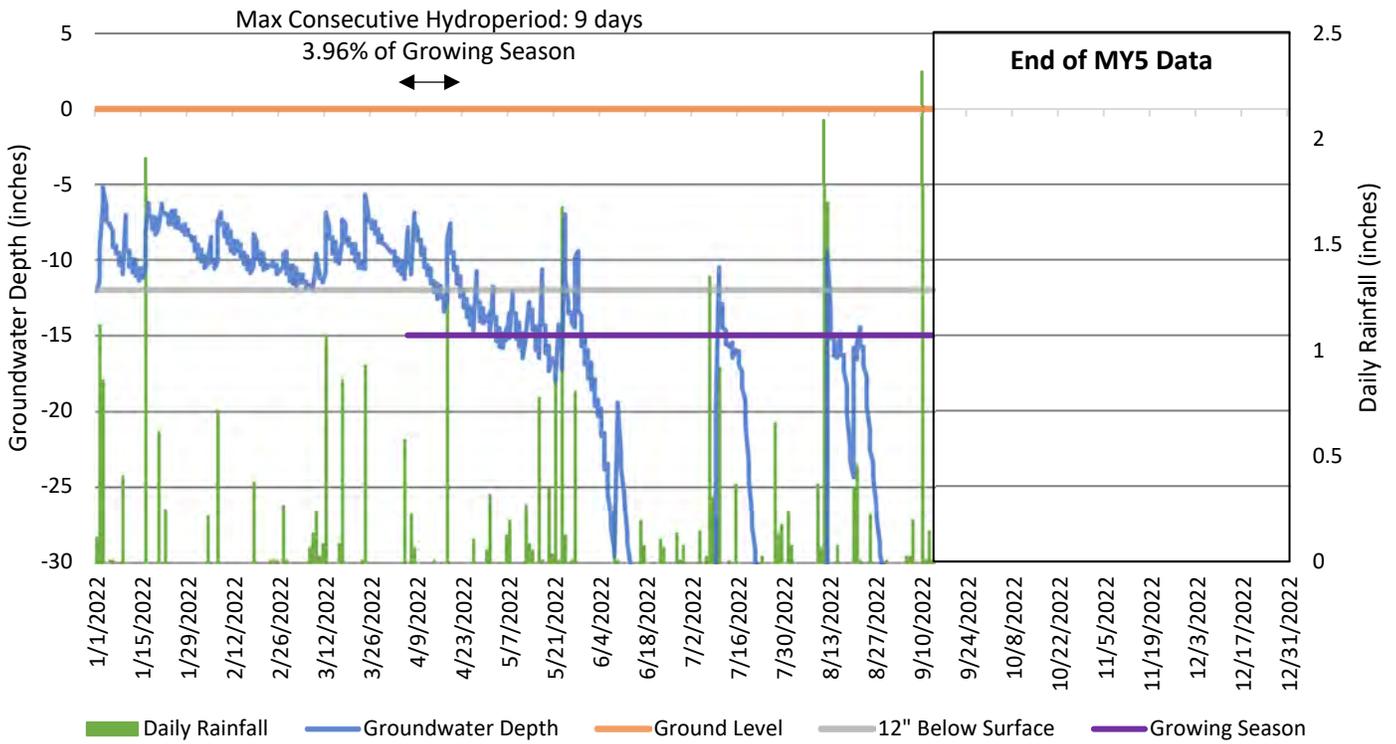
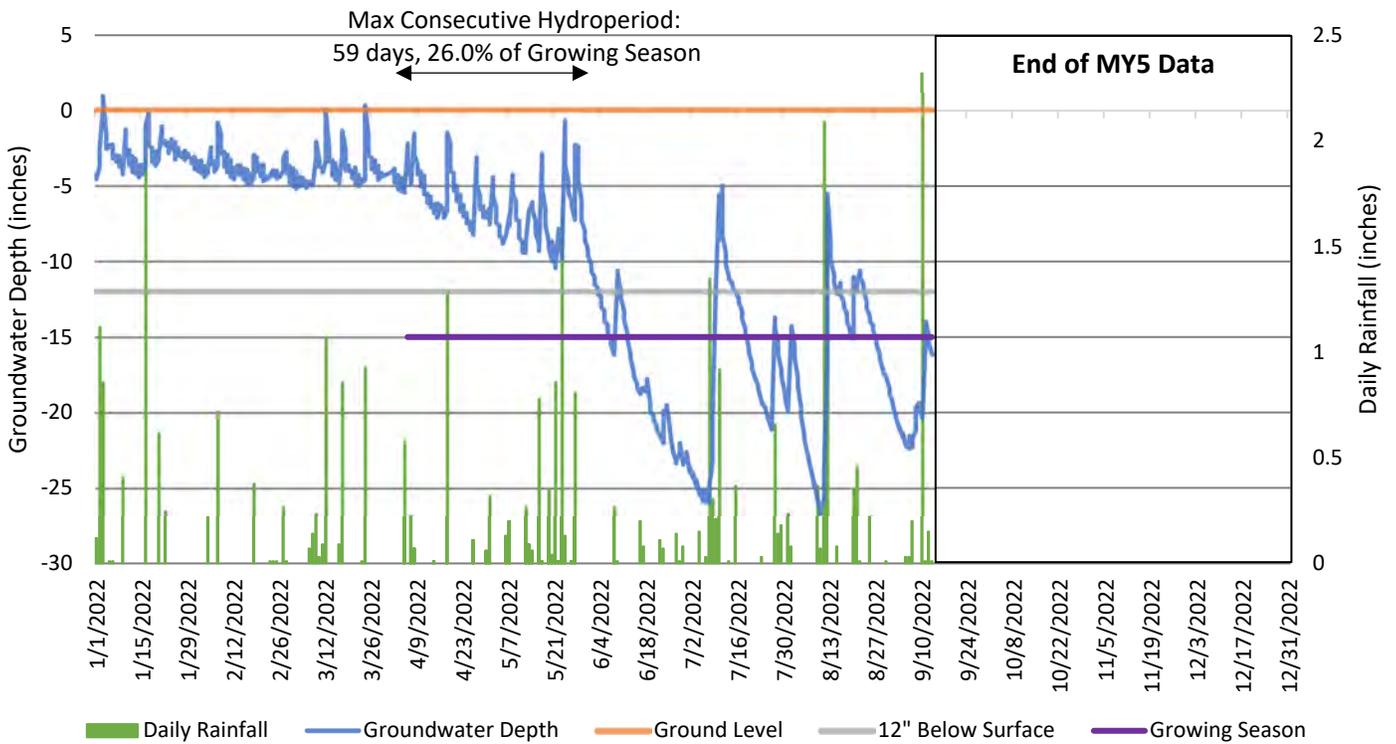
Figure 3b - Groundwater Gauge Data
 Edwards-Johnson Mitigation Project (NCDEQ DMS Project ID# 97080)
 MY5 2022

Wetland mitigation credits are not contracted or proposed for this project. One groundwater monitoring well was installed during the baseline monitoring along Reach R3. Two additional groundwater monitoring wells are installed along Reach R3 near station 33 + 75 and 37 + 00 (Figure 3). These wells were installed to document groundwater levels within the restoration area for reference and comparison to the preservation areas, at the request of the NCIRT (DWR). No performance standards for wetland hydrology success were proposed in the Mitigation Plan and therefore wetland mitigation monitoring is not included for this project. The well data are presented in the appendices. Groundwater gauge 1 exhibited a max consecutive hydroperiod of 71 days during the growing season or 31.28 percent. Groundwater gauge 2 exhibited a max consecutive hydroperiod of 9 days during the growing season or 3.96 percent.

Monitoring Gauge Name	Max Consecutive Hydroperiod: Saturation within 12 Inches of Soil Surface (Percent of Growing Season) WETS Station: 317994 - Smithfield Growing Season: 4/6-11/4 (227 days)							
	2018	2019	2020	2021	2022	2023	2024	Mean
Edwards-Johnson Wetland Gauge 1	M	6.17%	6.61%	64.76%	31.28%			
Edwards-Johnson Reference Wetland Gauge 2	M	39.21%	84.14%	5.29%	3.96%			
Edwards-Johnson Reference Wetland Gauge 3	N/A	N/A	37.00%	6.61%	26.00%
