Monitoring Report – Year 6
FINAL VERSION
Edwards-Johnson Mitigation Project
Calendar Year of Data Collection: 2023

NCDEQ DMS Project Identification # 97080
NCDEQ DMS Contract # 6825
Neuse River Basin (Cataloging Unit 03020201)
USACE Action ID Number: SAW-2016-00883
NCDEQ DWR Project # 2016-0404 V2
Johnston County, NC
Contracted Under RFP # 16-006477
Data Collection Period: March and October
2023 Submission Date: December 29, 2023

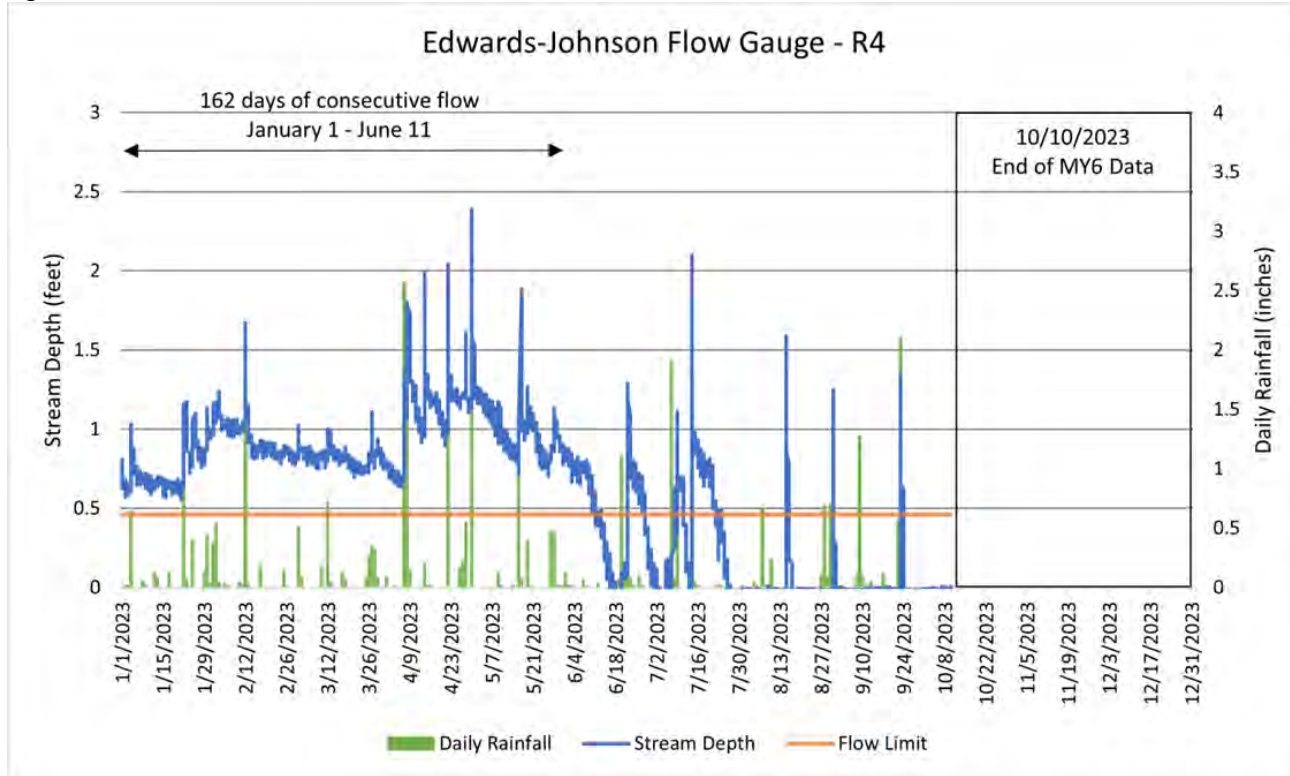
Figure 3a:

Jurisdictional stream flow documentation and monitoring of restored intermittent reaches is achieved using a flow gauge (continuous-read pressure transducer) within the thalweg of the channel towards the middle portion of Reach R4 (Figure 1). Additionally, to determine if rainfall amounts are normal for the given year, precipitation data was obtained from CLAY Central Crops Research Station in Johnston County, approximately nine miles southwest of the site. The flow gauge documented that the stream exhibited surface flow for 162 consecutive days from January 1st through June 11th, 2023, during a year with normal rainfall conditions (Figure 3).

Longest consecutive days of flow: 162 days, January 1, 2023 - June 11, 2023.

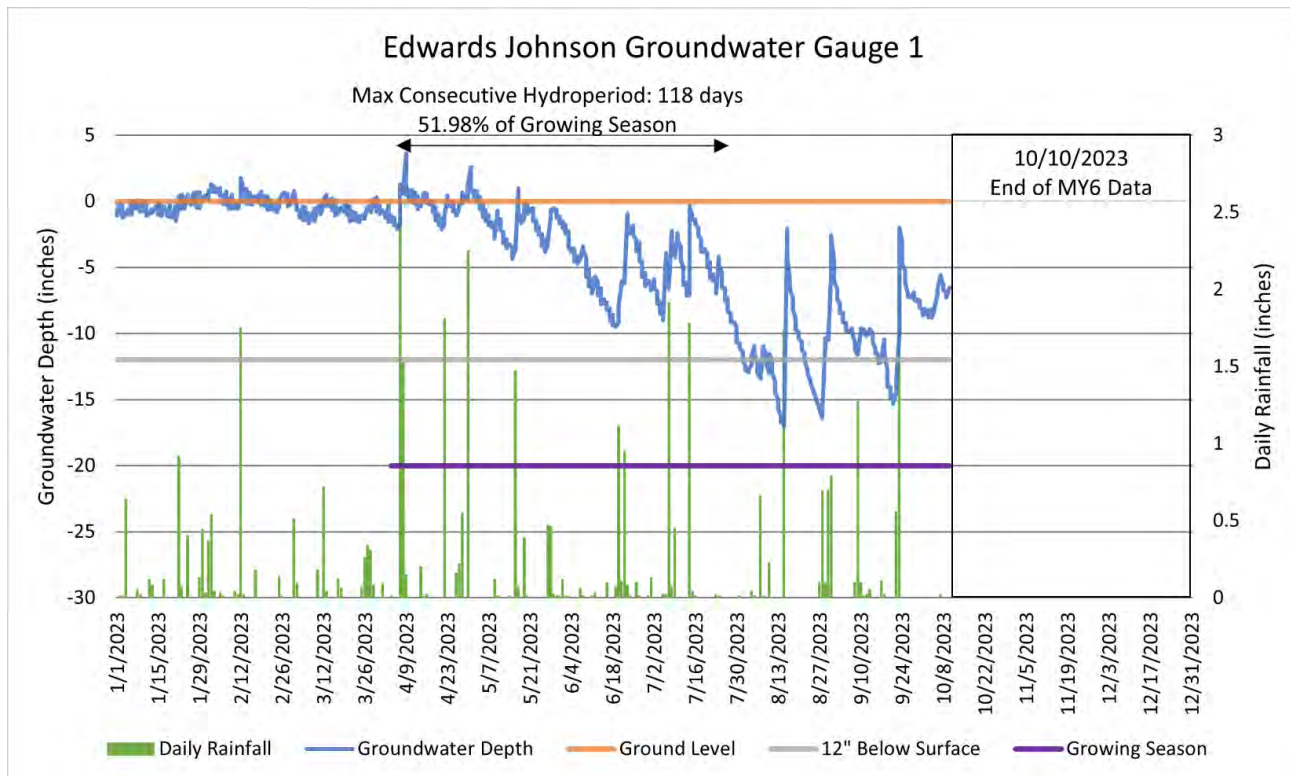
Max Consecutive Hydroperiod: 118 days, April 6, 2023 - August 1, 2023, 51.98 % of Growing Season

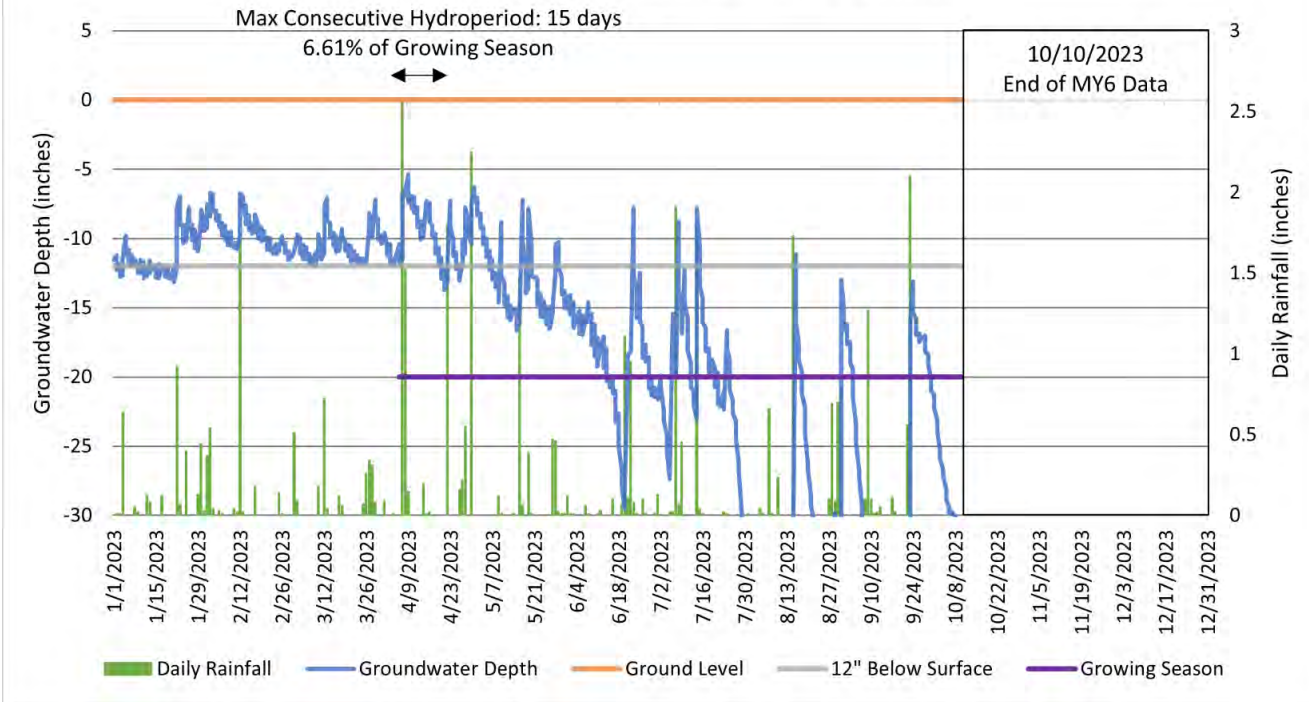
Edwards Johnson Groundwater Gauge 2 (Reference)

Max Consecutive Hydroperiod: 15 days, April 6, 2023 - April 20, 2023, 6.61 % of Growing Season

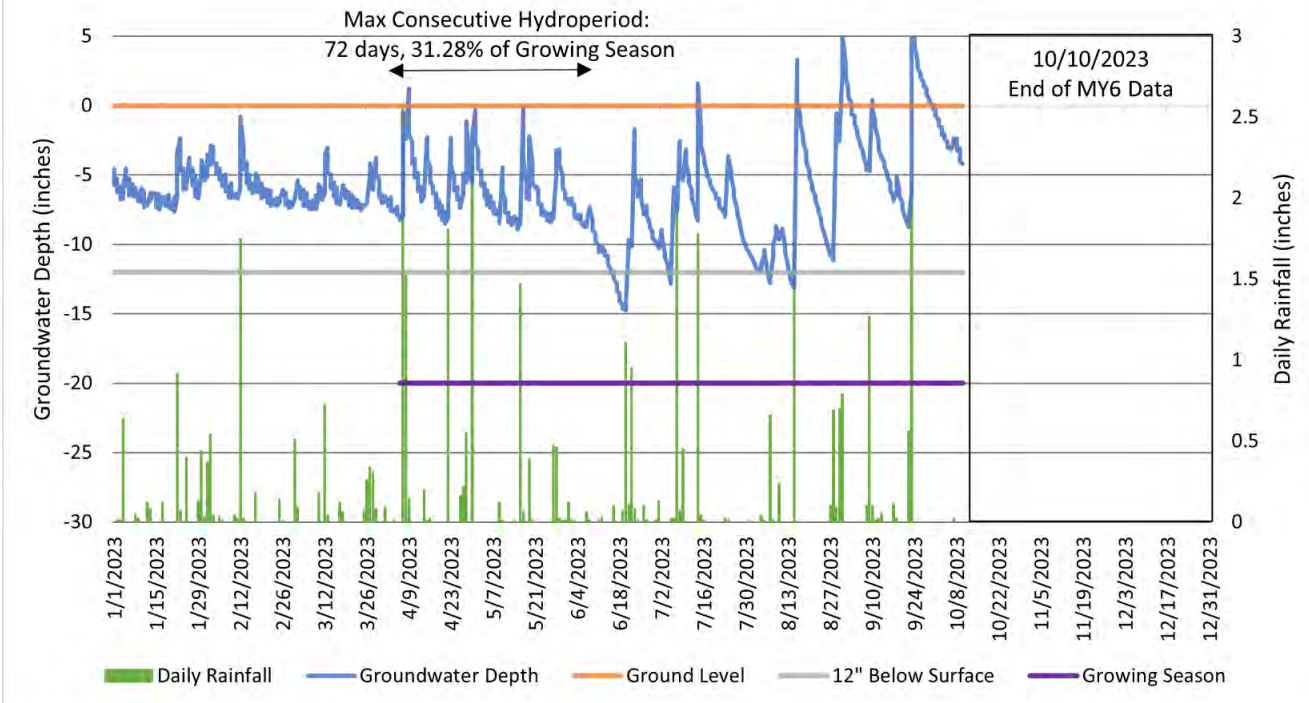
Edwards Johnson Groundwater Gauge 3 (Reference)

Wetland mitigation credits are not contracted or proposed for this project. One groundwater monitoring well was installed during baseline monitoring along Reach R3. Two additional groundwater monitoring wells are installed along Reach R3 near station 33 + 75 and 37 + 00 (Figure 3). These wells were installed to document groundwater levels within the restoration area for reference and comparison to the preservation areas, at the request of the NCIRT (DWR). No performance standards for wetland hydrology success were proposed in the Mitigation Plan, and therefore, wetland mitigation monitoring is not included for this project. The well data is presented in the appendices. Groundwater gauge 1 exhibited a max consecutive hydroperiod of 118 days during the growing season or 51.98 percent. Groundwater gauge 2 exhibited a max consecutive hydroperiod of 15 days during the growing season or 6.61 percent. Groundwater gauge 3 exhibited a max consecutive hydroperiod of 72 days during the growing season or 31.28 percent.

Max Consecutive Hydroperiod: 72 days, April 6, 2023 - June 15, 2023, 31.28 % of Growing Season

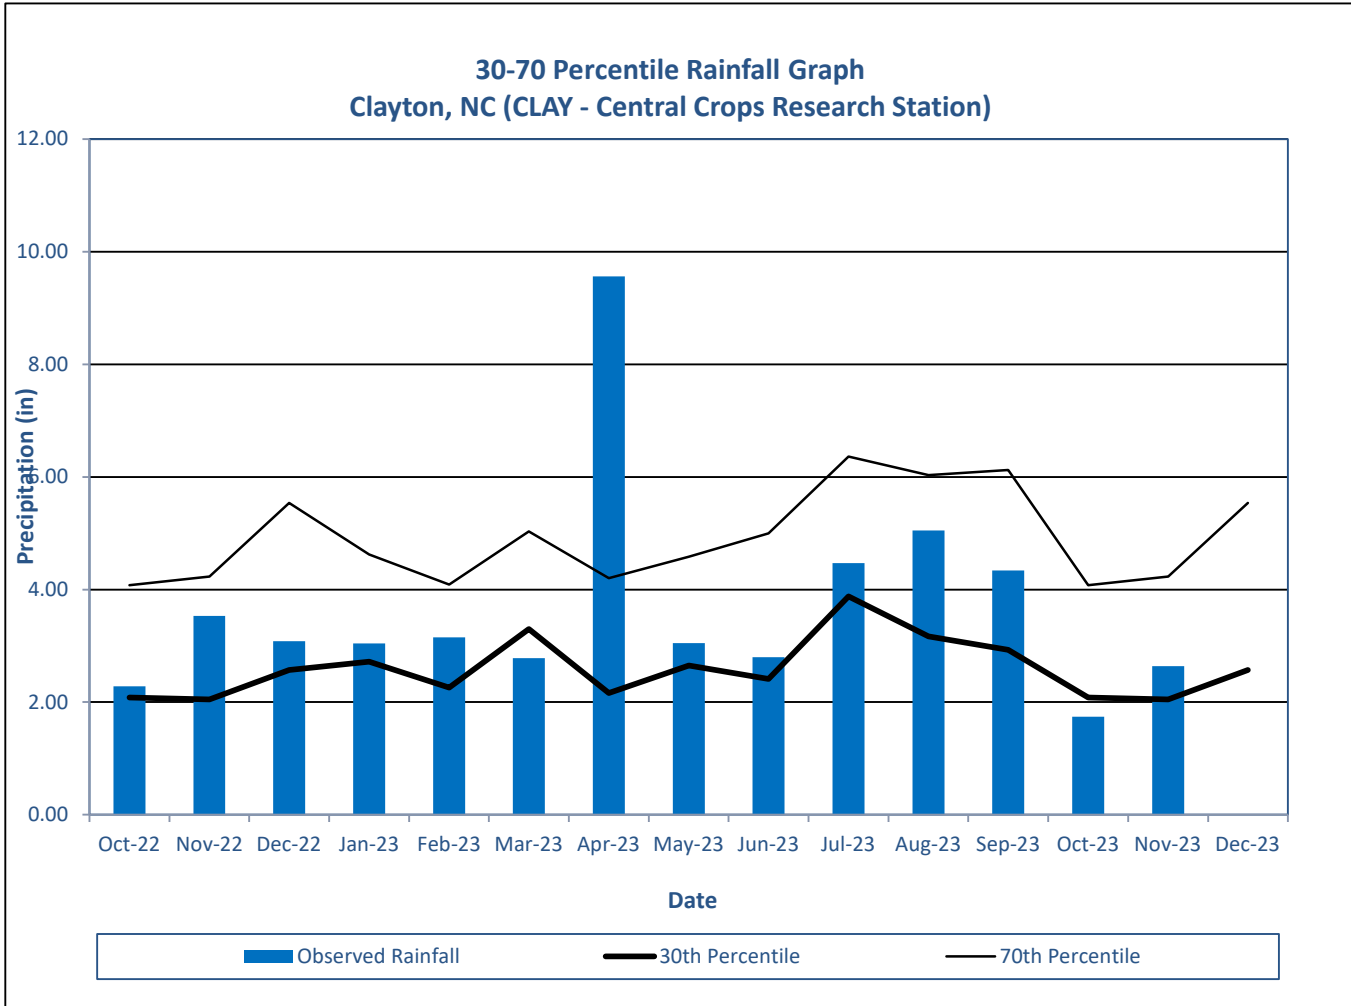
Figure 4: Monthly Rainfall Data
Edwards-Johnson Mitigation Project (NCDEQ DMS Project ID# 97080)
MY6 2023

Annual Precip Total	NA
WETS 30th Percentile	42.7
WETS 70th Percentile	51.8
Normal	Y
