Monitoring Report – Year 2
FINAL VERSION
Edwards-Johnson Mitigation Project
Calendar Year of Data Collection: 2019

NCDEQ DMS Project Identification # 97080
NCDEQ DMS Contract # 6825
Neuse River Basin (Cataloging Unit 03020201)
USACE Action ID Number: SAW-2016-00883
NCDEQ DWR Project # 2016-0404
Johnston County, NC
Contracted Under RFP # 16-006477
Data Collection Period: June-October 2019, Submission Date: December 2019

Mitigation Project Name Edwards-Johnson
DMS ID 97080
River Basin Neuse
Cataloging Unit 03020201

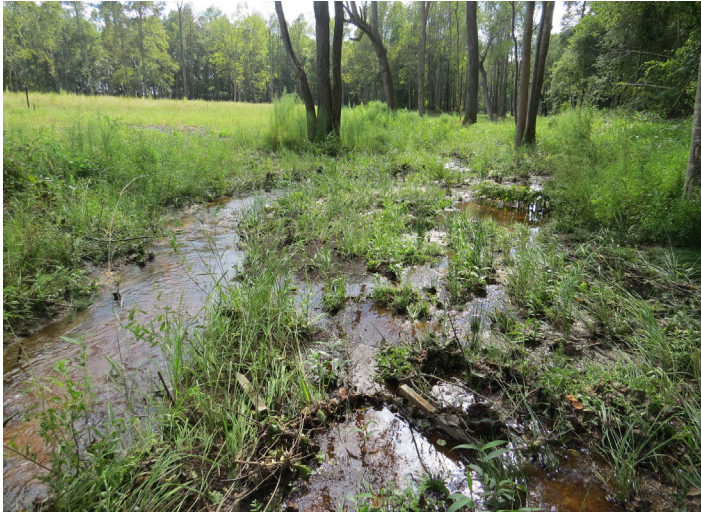
Table 8. Verification of Flow Events					
Edwards-Johnson Mitigation Project (NCDEQ DMS Project ID# 97080)					
Date of Data Collection	Date of Occurrence	Method	Greater than Bankfull (Bkf) or Qgs (Q2*0.66) Stage?	Photo/ Notes	Measurement
9/17/2018	9/16-9/17/2018	Observed indicators of bankfull stage (wrack lines) after storm event	Bkf	Photo	
7/26/2019	7/24/2019	Crest Gage	Bkf	Photo	2.5 inches
8/20/2019	unknown	Crest Gage	Bkf	Photo	2.8 inches
9/6/2019	9/5/2019	Crest Gage	Bkf	Photo	2.5 inches
9/6/2019	9/5/2019	Observed indicators of bankfull stage (wrack lines) after storm event	Bkf	Photo	NA
