Monitoring Report – Year 3
FINAL VERSION
Edwards-Johnson Mitigation Project
Calendar Year of Data Collection: 2020

NCDEQ DMS Project Identification # 97080
NCDEQ DMS Contract # 6825
Neuse River Basin (Cataloging Unit 03020201)
USACE Action ID Number: SAW-2016-00883
NCDEQ DWR Project # 2016-0404
Johnston County, NC
Contracted Under RFP # 16-006477
Data Collection Period: September – October 2020
Submission Date: December 11, 2020

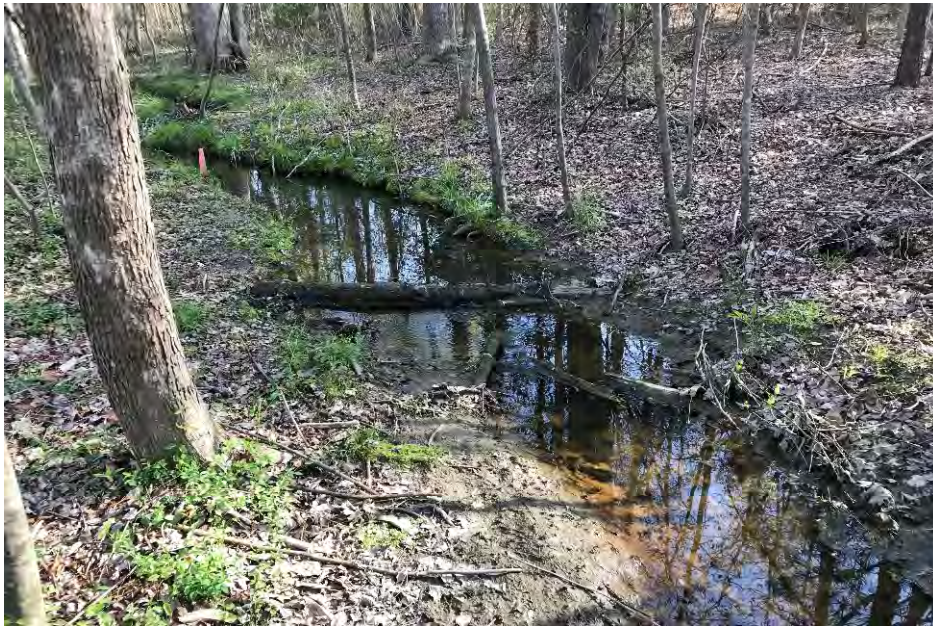
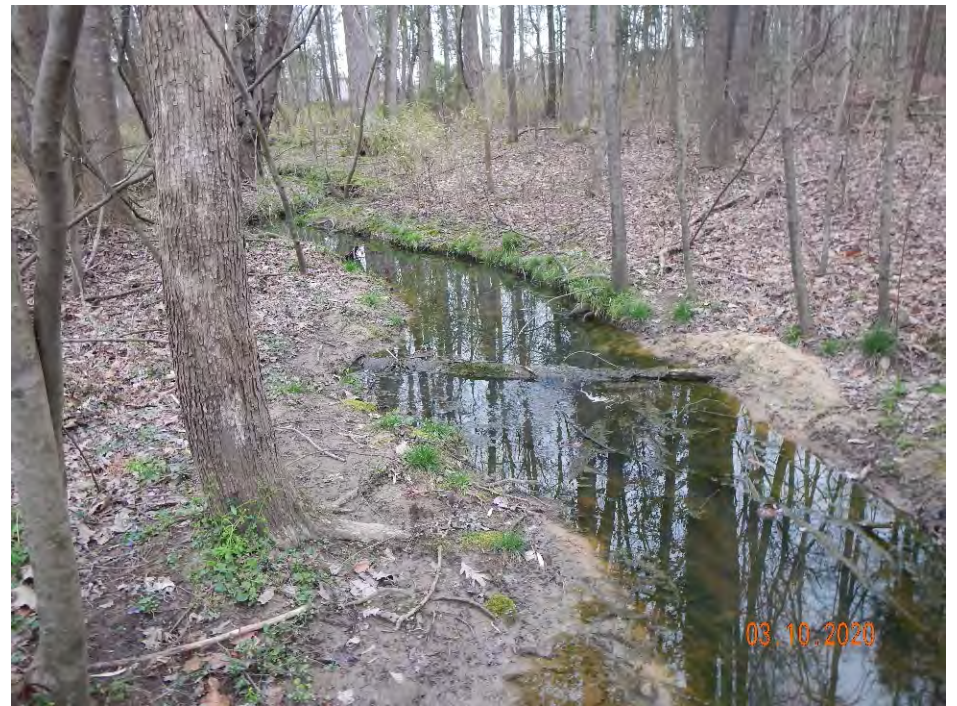
PS-1, Reach R1, facing upstream, April 12, 2018 (MY-00)

PS-1, Reach R1, facing upstream, March 10, 2020 (MY-03)

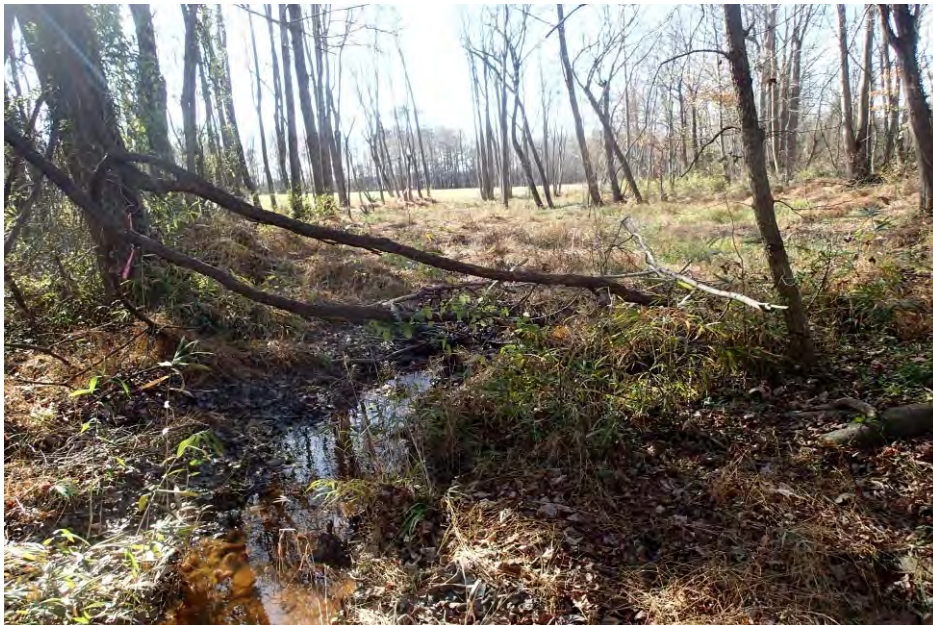
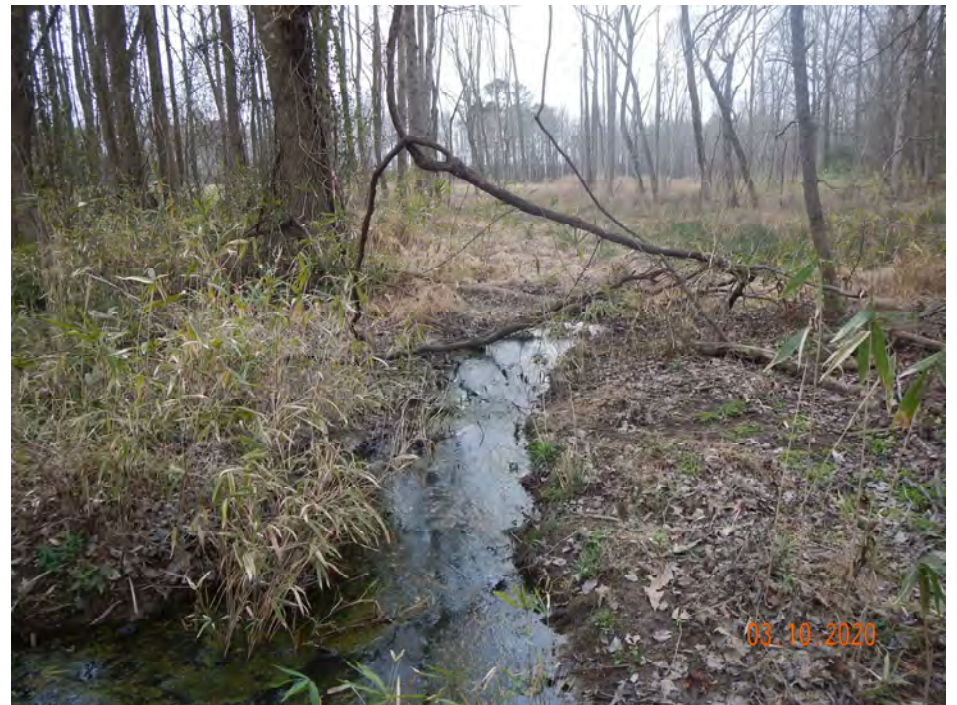
PS-2, Reach R1, facing downstream, Dec 6, 2018 (MY-01)

PS-2, Reach R1, facing downstream, March 10, 2020 (MY-03)

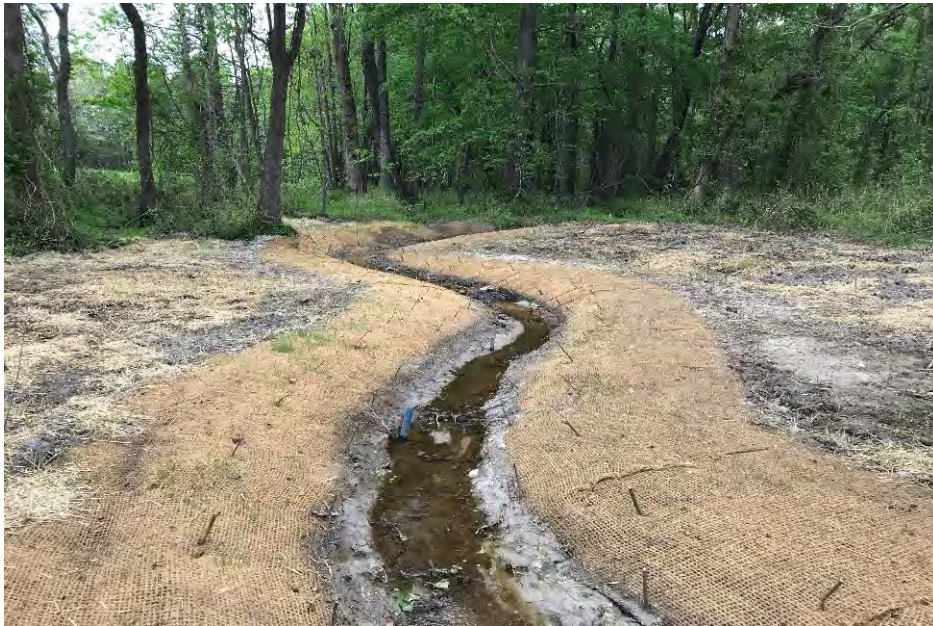
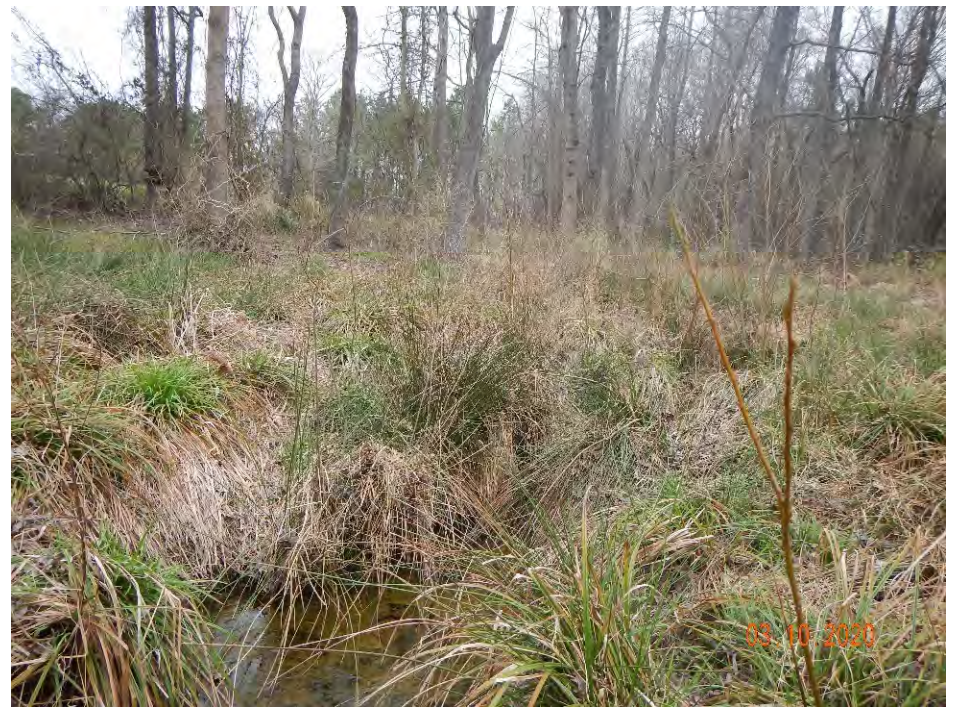
PS-3, Reach R2, facing upstream, Sta 17+00, April 23, 2018 (MY-00)

PS-3, Reach R2, facing upstream, Sta 17+00, March 10, 2020 (MY-03)

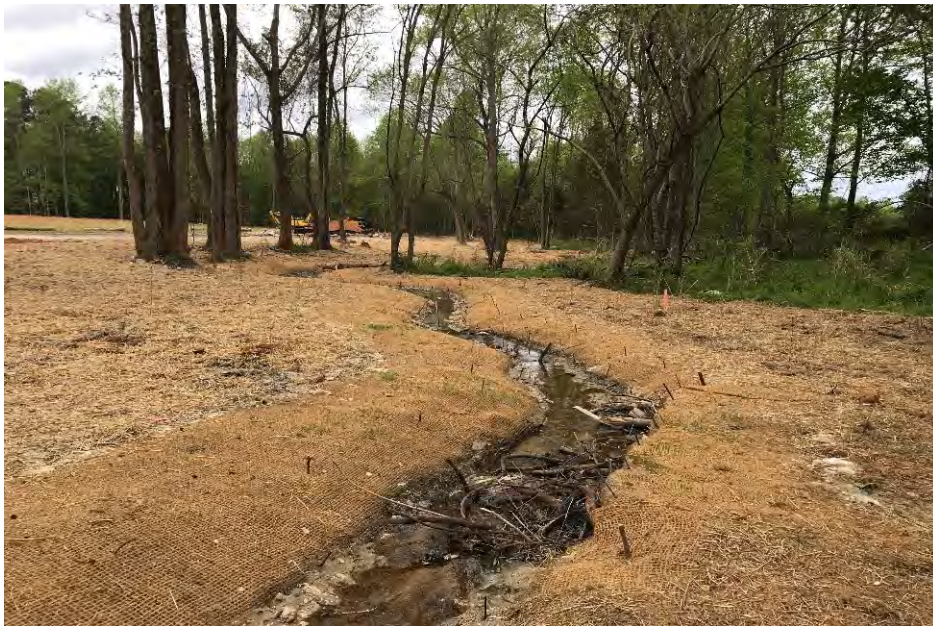
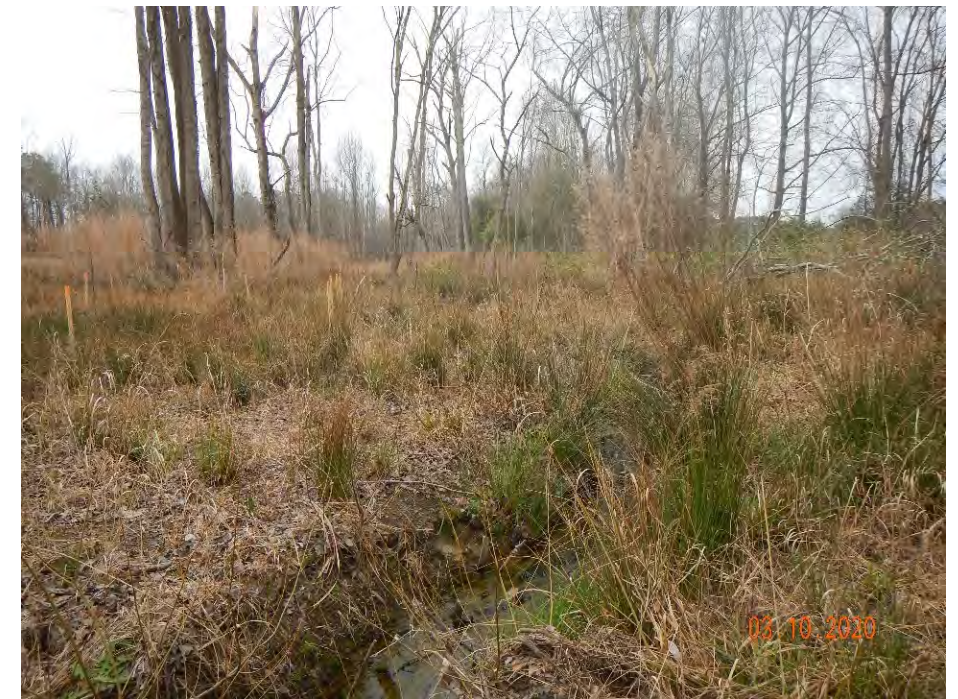
PS-4, Reach R2, facing downstream, Sta 18+00, April 23, 2018 (MY-00)

PS-4, Reach R2, facing downstream, Sta 18+00, March 10, 2020 (MY-03)

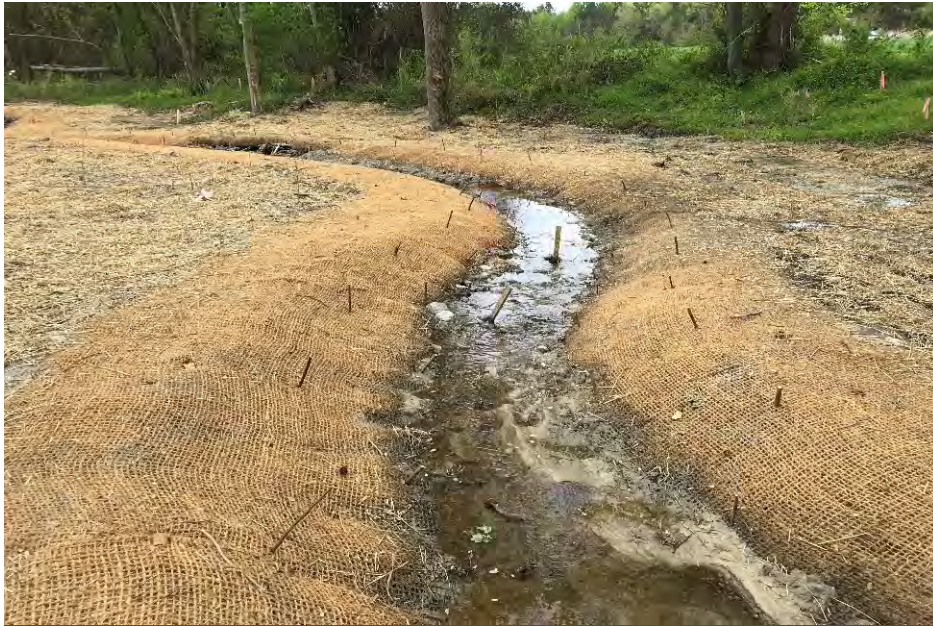
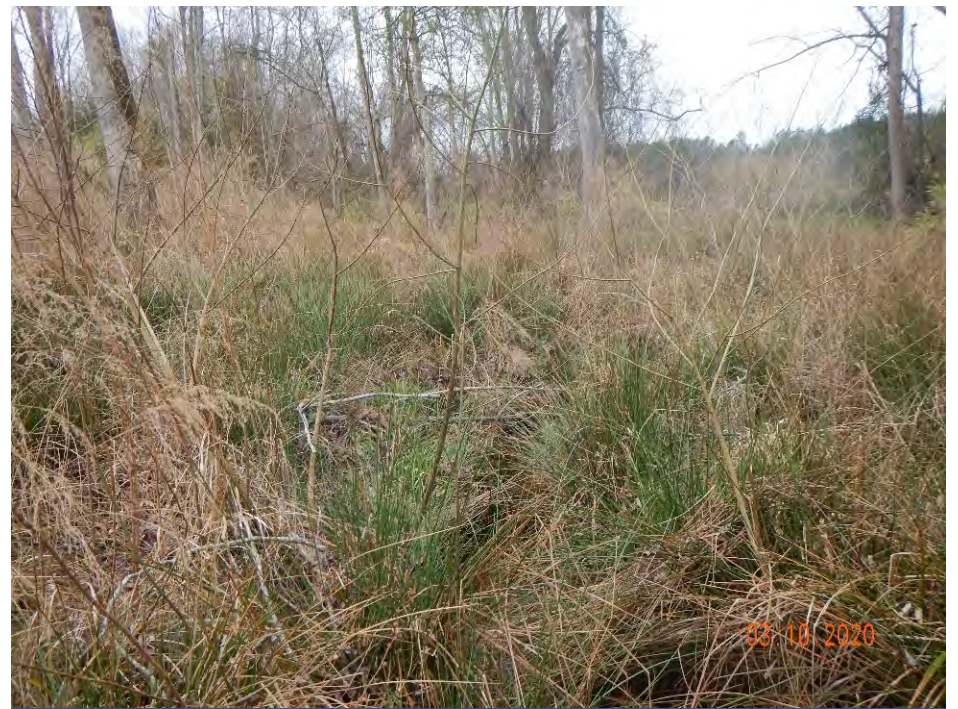
PS-5, Reach R2, facing downstream, Sta 19+50, Sept 17, 2018 (MY-00)

PS-5, Reach R2, facing downstream, Sta 19+50, March 10, 2020 (MY-03)

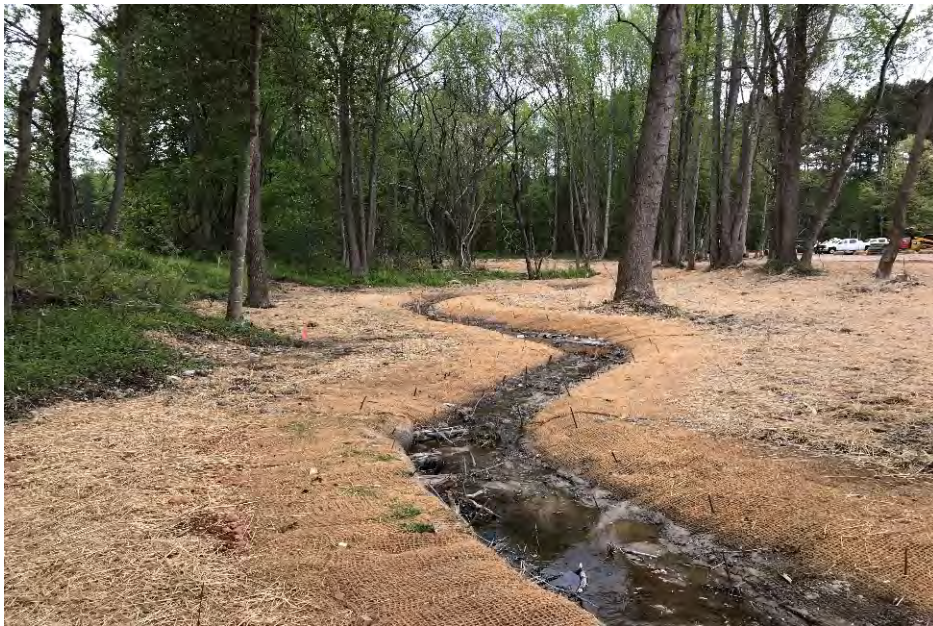
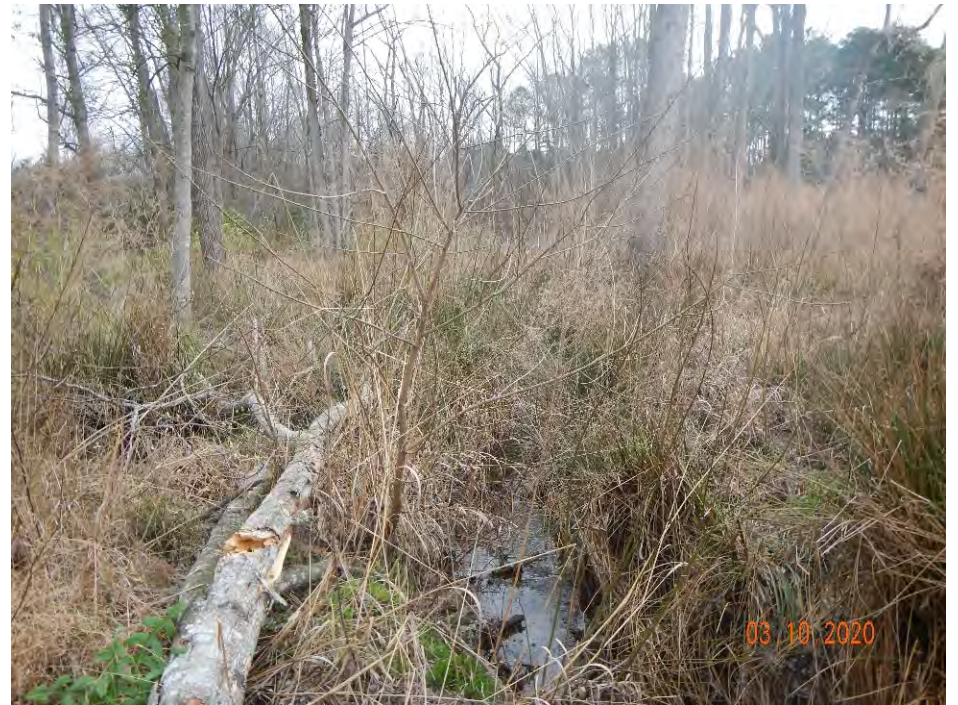
PS-6, Reach R2, facing upstream, Sta 20+75, April 23, 2018 (MY-00)

PS-6, Reach R2, facing upstream, Sta 20+75, March 10, 2020 (MY-03)

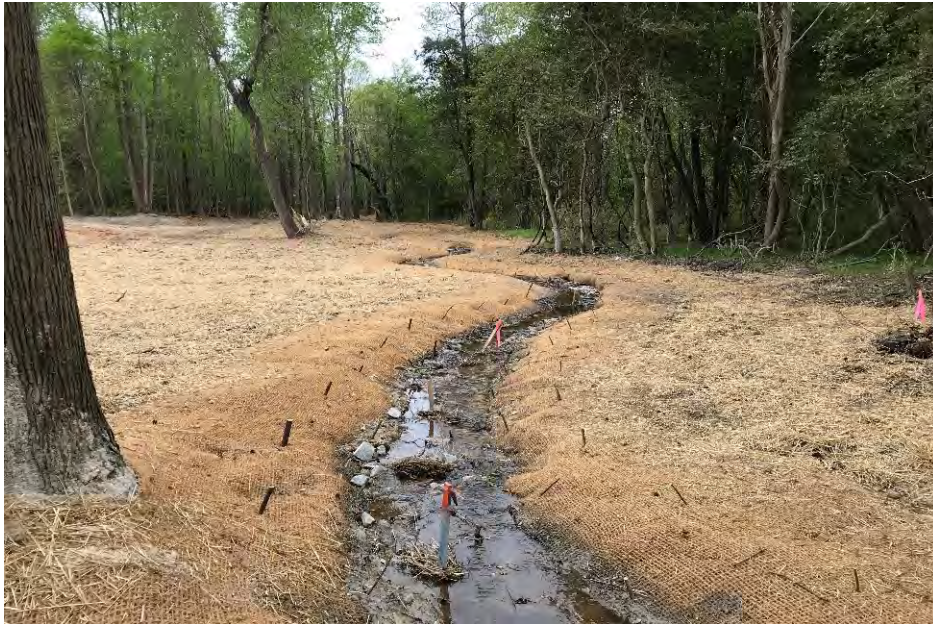
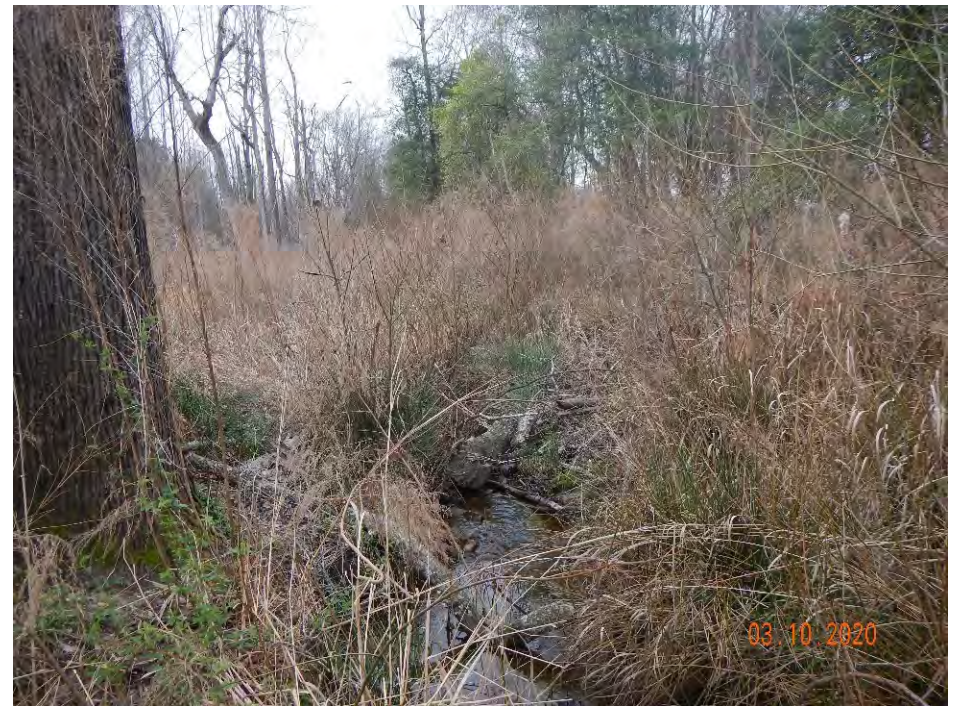
PS-7, Reach R2, facing downstream, Sta 21+00, April 23, 2018 (MY-00)

PS-7, Reach R2, facing downstream, Sta 21+00, March 10, 2020 (MY-03)

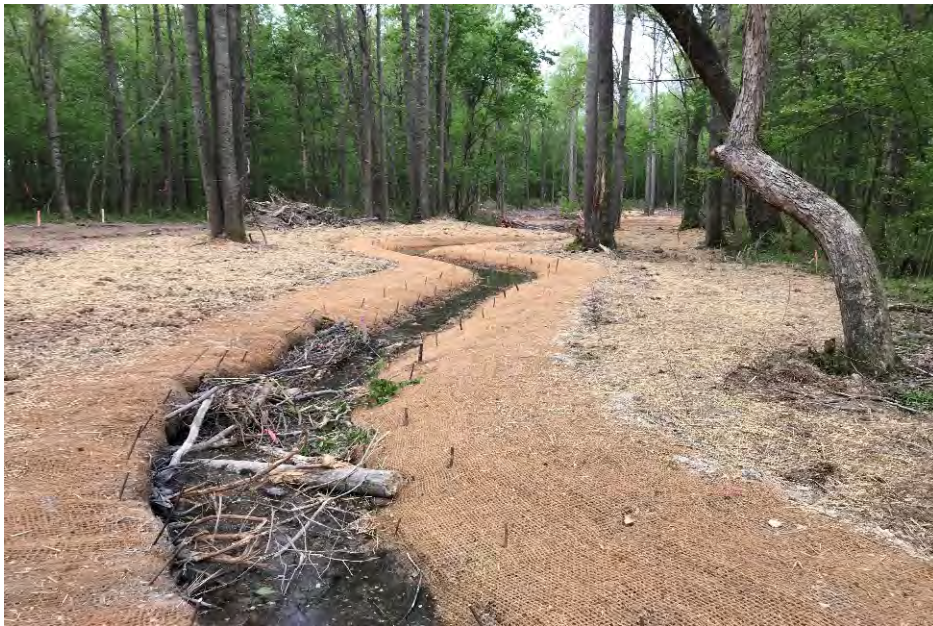
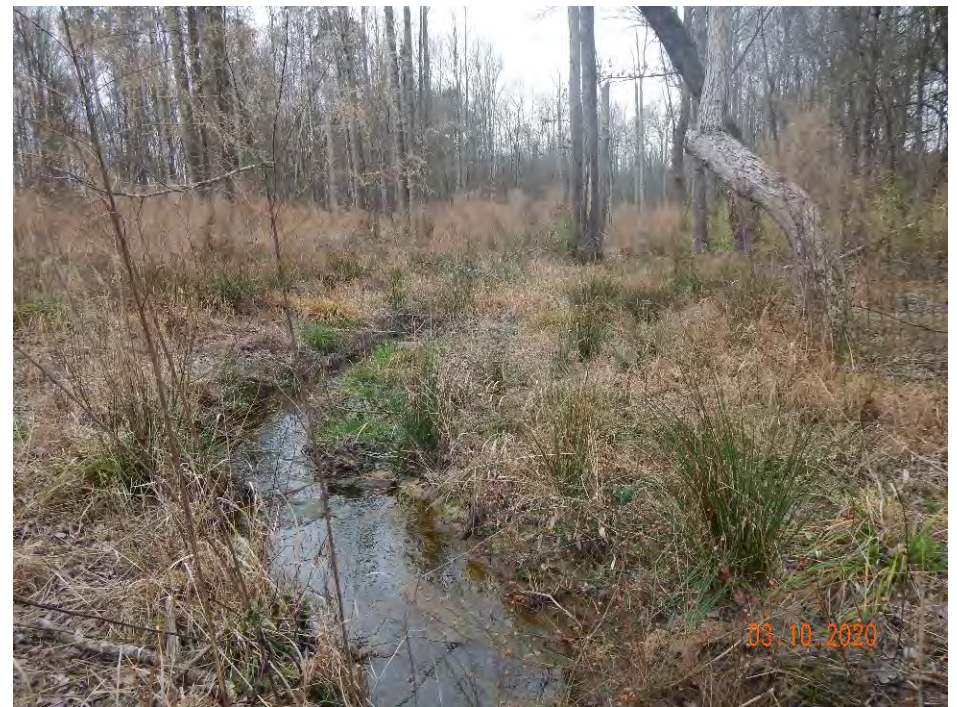
PS-8, Reach R2, facing downstream, Sta 24+50, April 23, 2018 (MY-00)

PS-8, Reach R2, facing downstream, Sta 24+50, March 10, 2020 (MY-03)

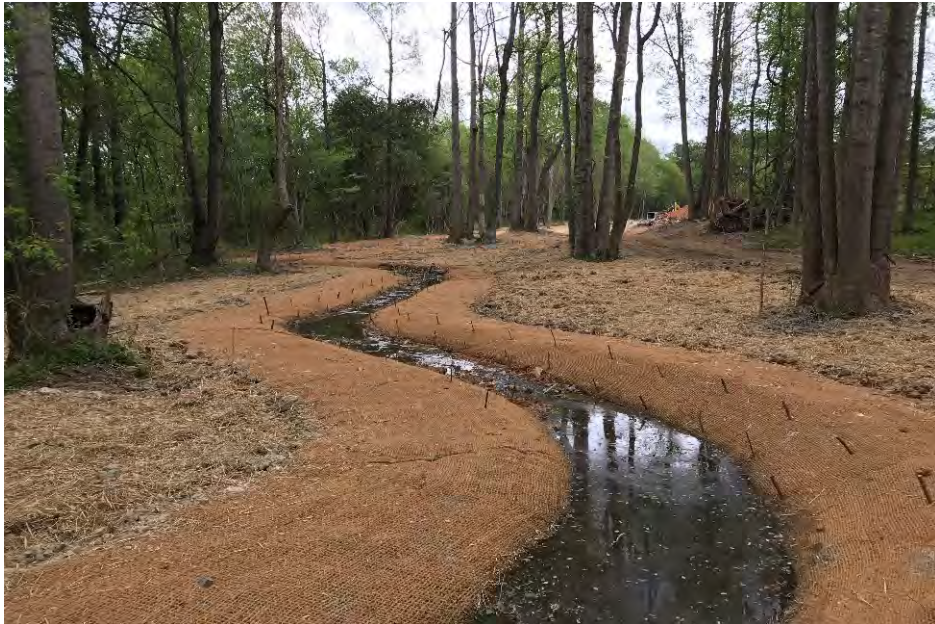
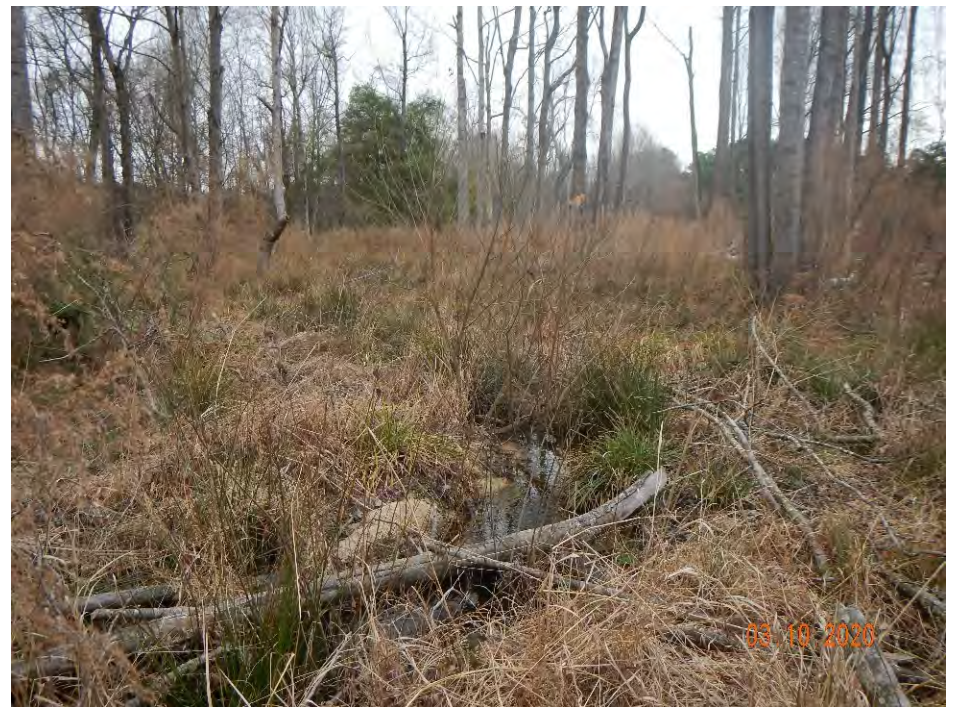
PS-9, Reach R2, facing upstream, Sta 25+75, April 23, 2018 (MY-00)

PS-9, Reach R2, facing upstream, Sta 25+75, March 10, 2020 (MY-03)

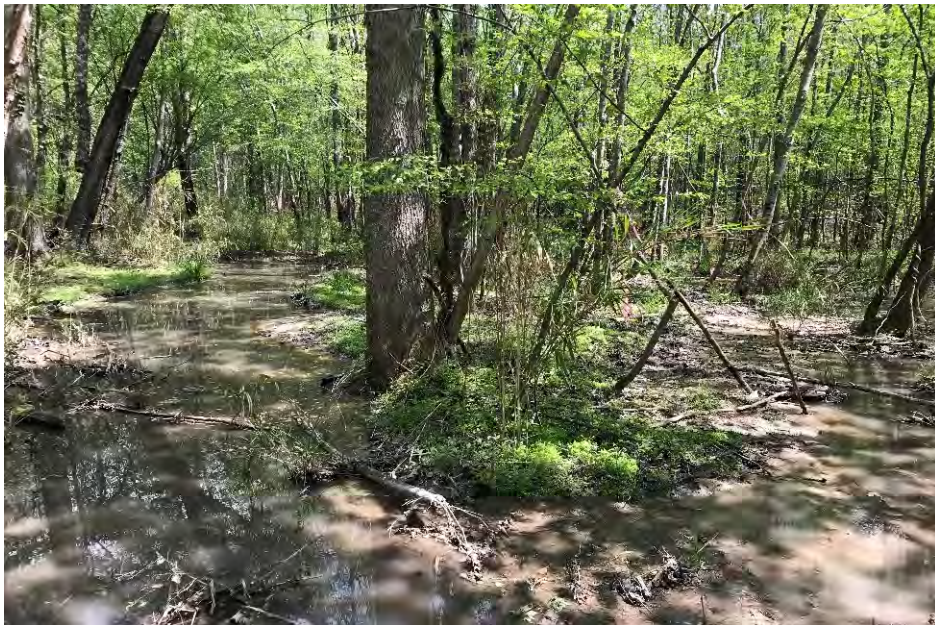
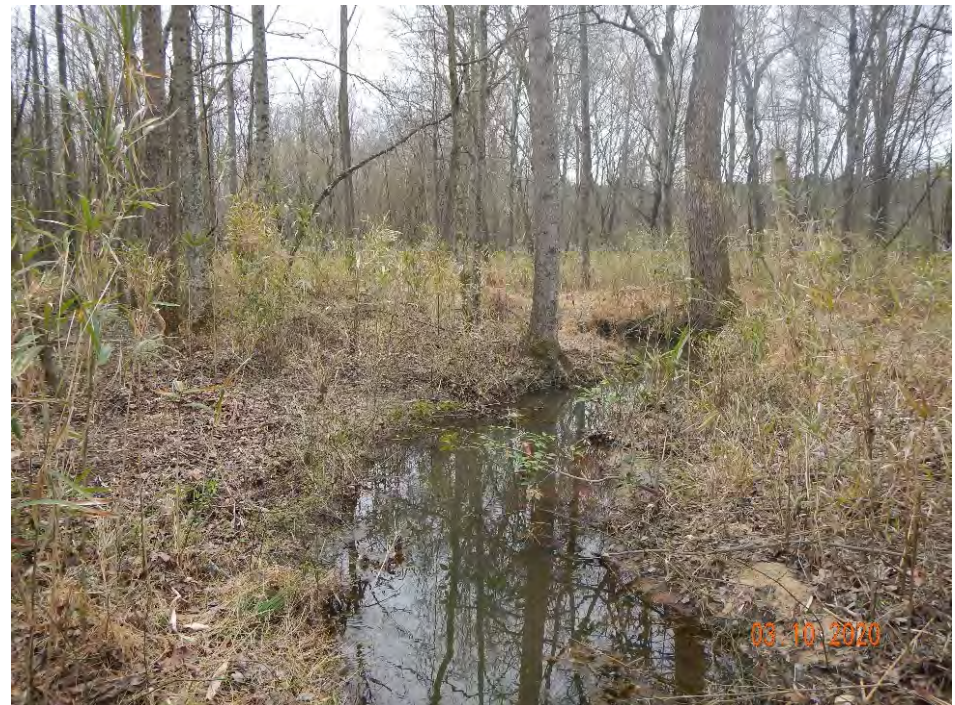
PS-10, Reach R3, facing downstream, Sta 32+00, April 19, 2018 (MY-00)

PS-10, Reach R3, facing downstream, Sta 32+00, March 10, 2020 (MY-03)

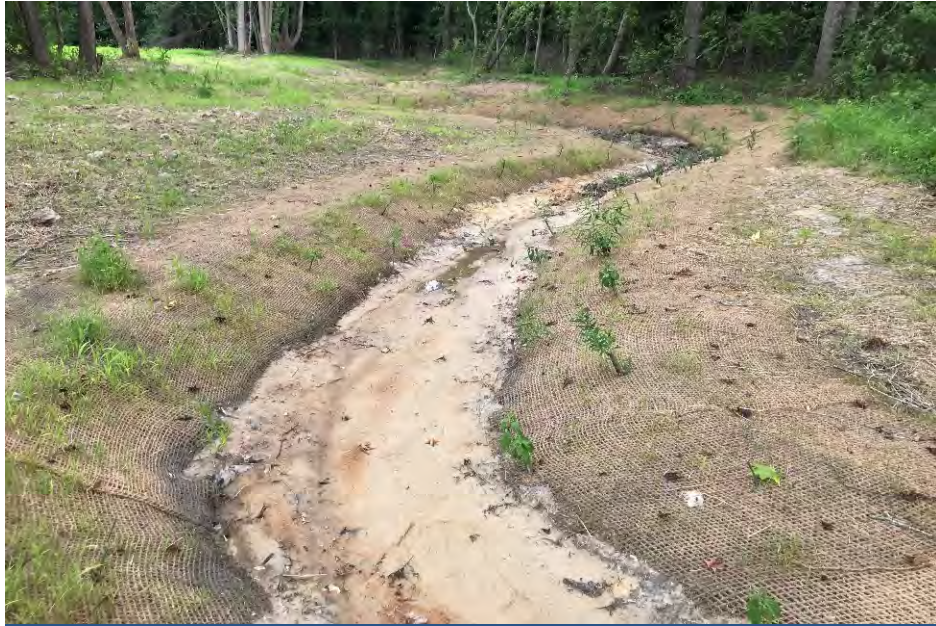
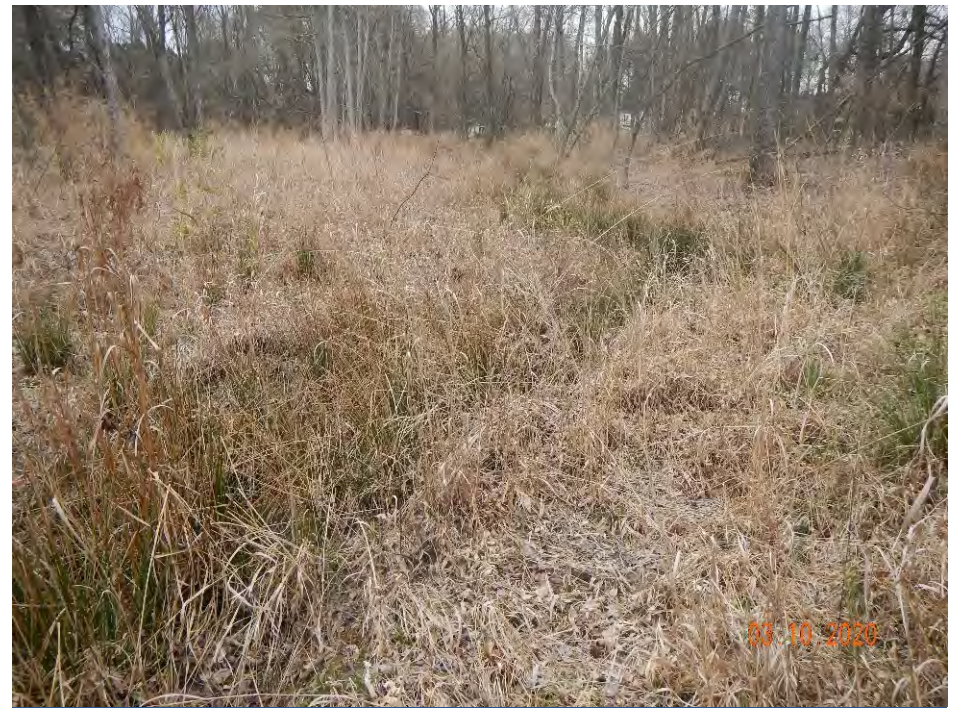
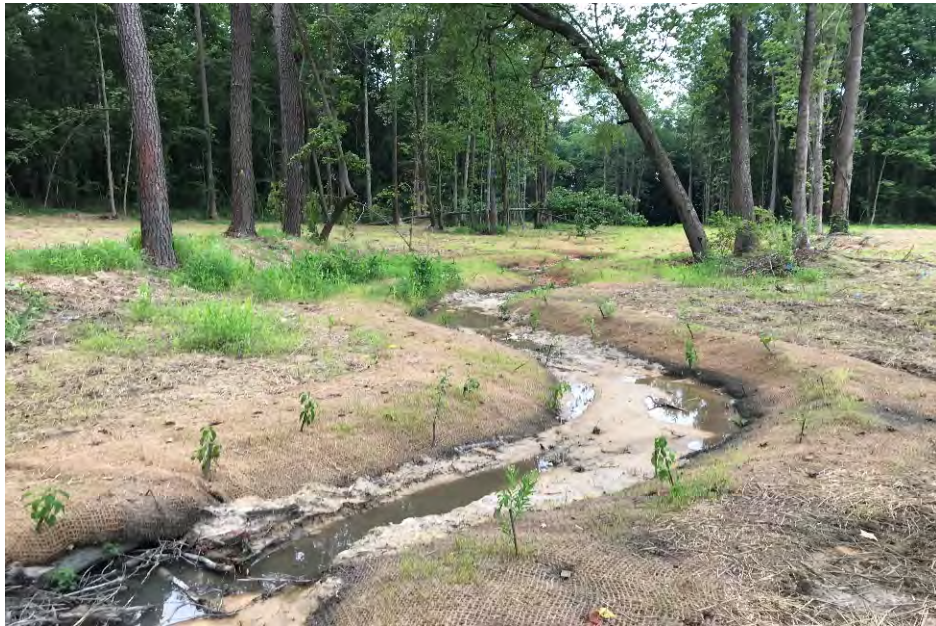
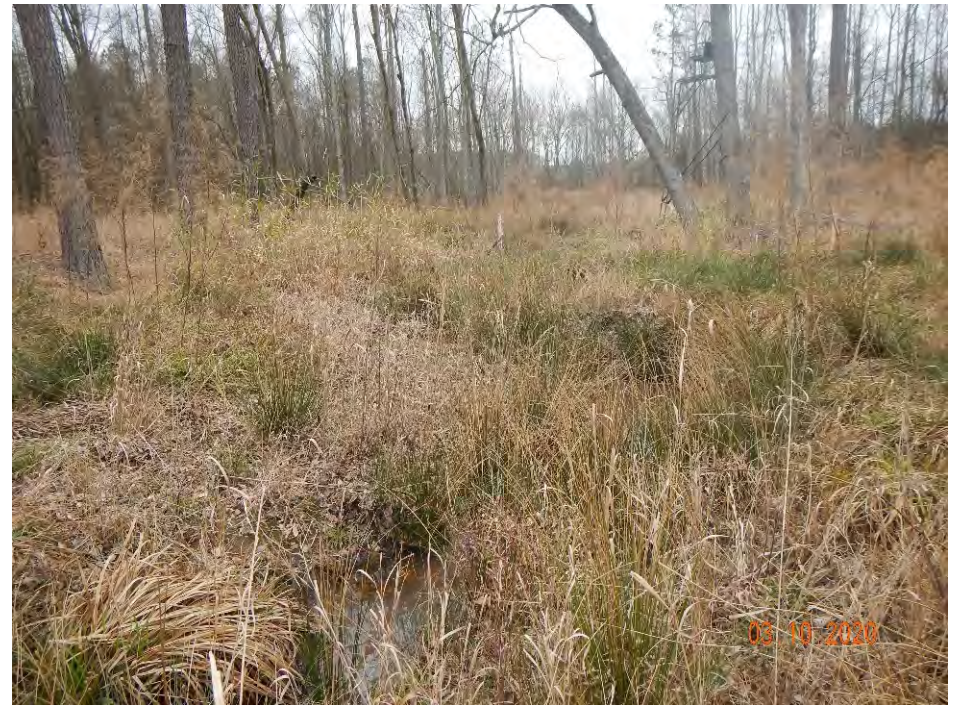
PS-11, Reach R4, facing upstream, Sta 13+00, June 11, 2018 (MY-00)

PS-11, Reach R4, facing upstream, Sta 13+00, March 10, 2020(MY-03)

PS-11, Reach R4, facing downstream, Sta 13+00, June 11, 2018 (MY-00)

PS-11, Reach R4, facing downstream, Sta 13+00, March 10, 2020 (MY-03)

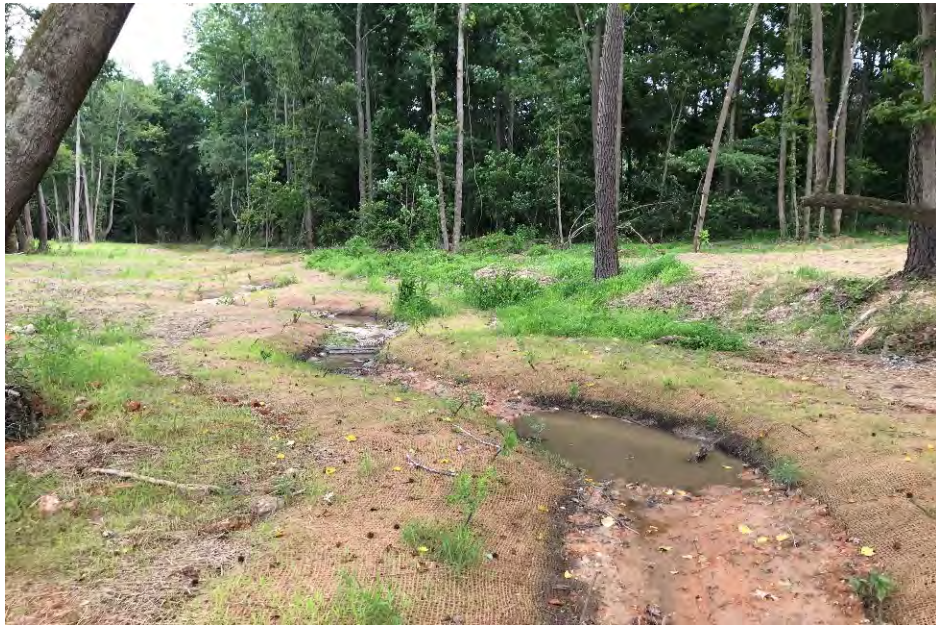
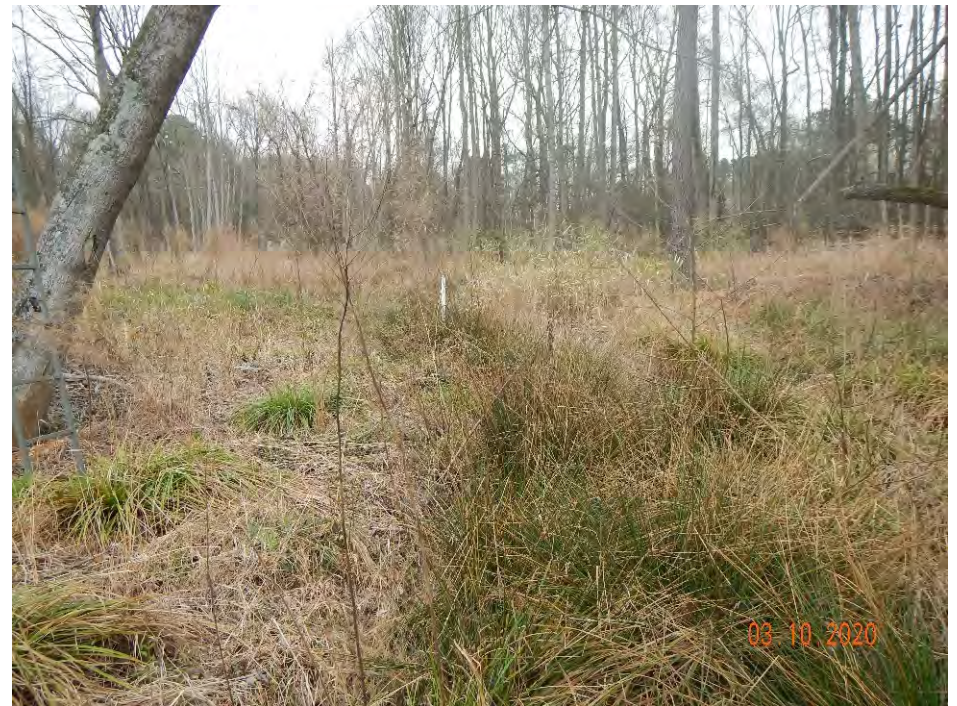
PS-12, Reach R4, facing upstream, Sta 14+00, June 11, 2018 (MY-00)

PS-12, Reach R4, facing upstream, Sta 14+00, March 10, 2020 (MY-03)

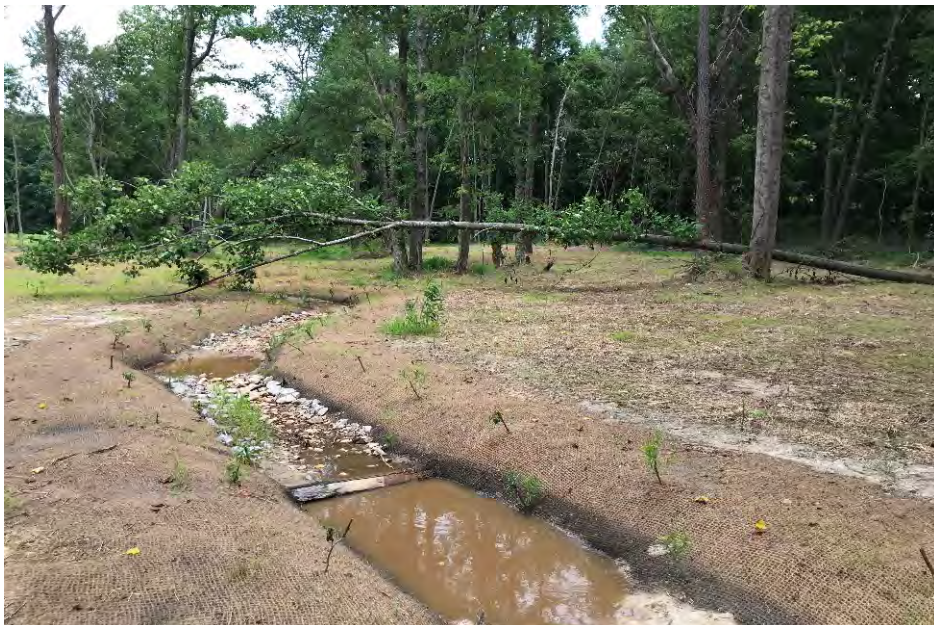
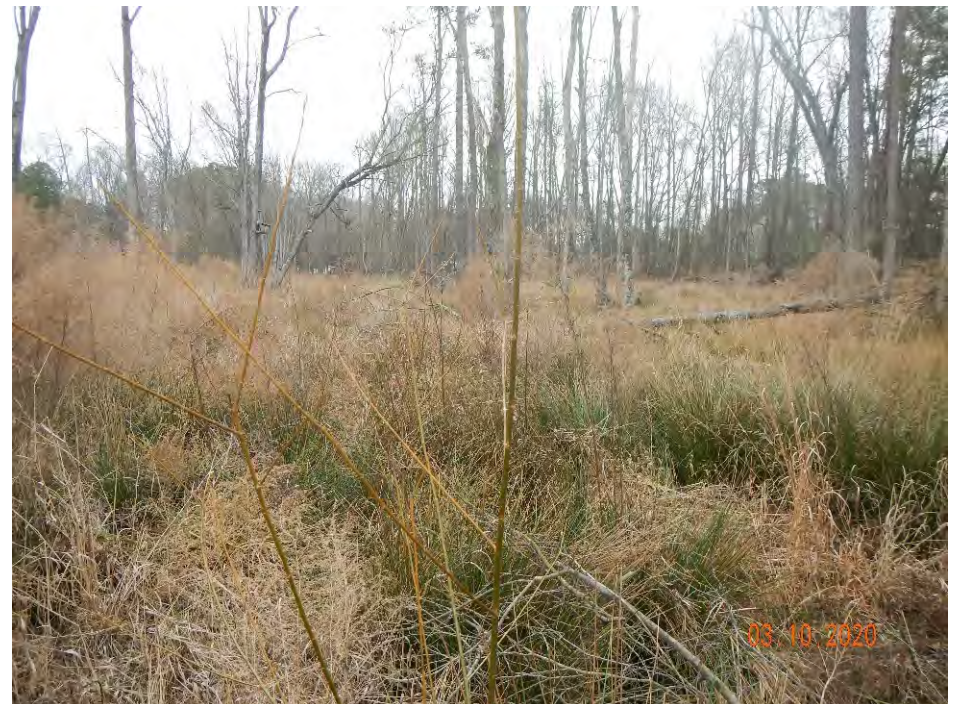
One area of erosion found during the visual assessments of MY2 totaling approximately 15 linear feet and located in a pool at a meander bend of R4 at approximately STA 18+00 has stabilized and no remedial action is needed. This area will continue to be monitored in MY4. An additional area on the right bank of R2 located at the transition of R1 to R2 at station 16+13 has approximately 10 linear feet of undercut bank and was noted during the spring 2020 visual assessment. This area is where the transition from preservation to restoration occurred. This area stabilized throughout MY3 and will continue to be monitored in MY4. Photographs of the two areas can be found in Appendix B. Overall, only minor (non-systemic) channel adjustments in riffle slopes, pool depths and pattern were observed and therefore did not present a stability concern or indicate a need for immediate remedial action.

PS-13, Reach R4, facing upstream, Sta 17+00, June 11, 2018 (MY-00)

PS-13, Reach R4, facing upstream, Sta 17+00, March 10, 2020 (MY-03)

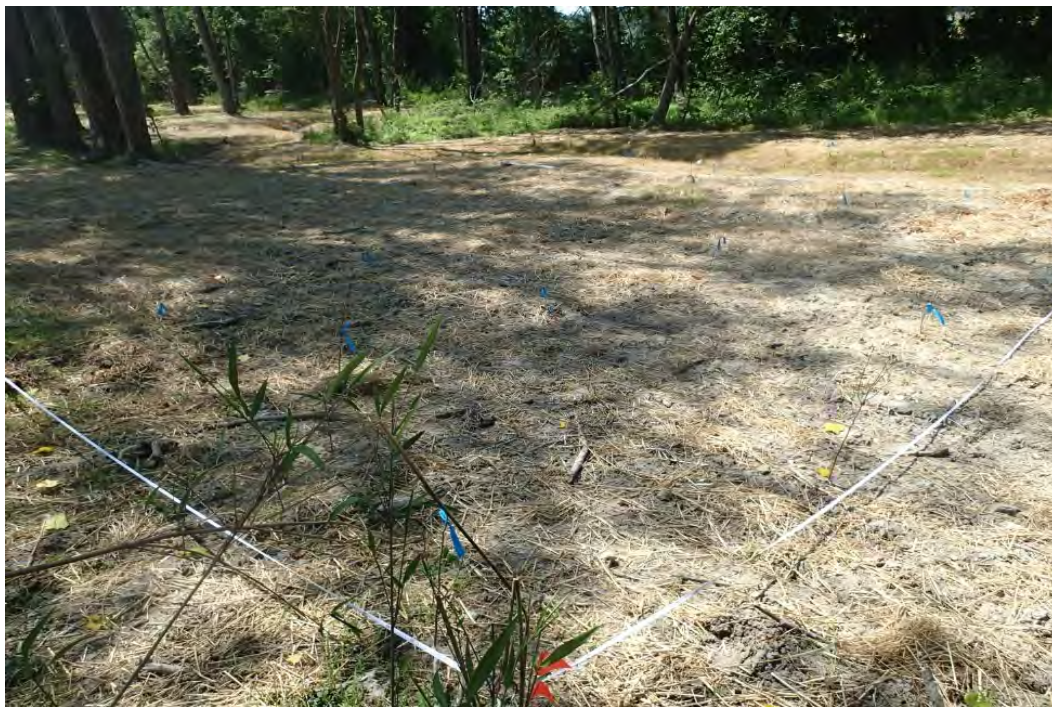
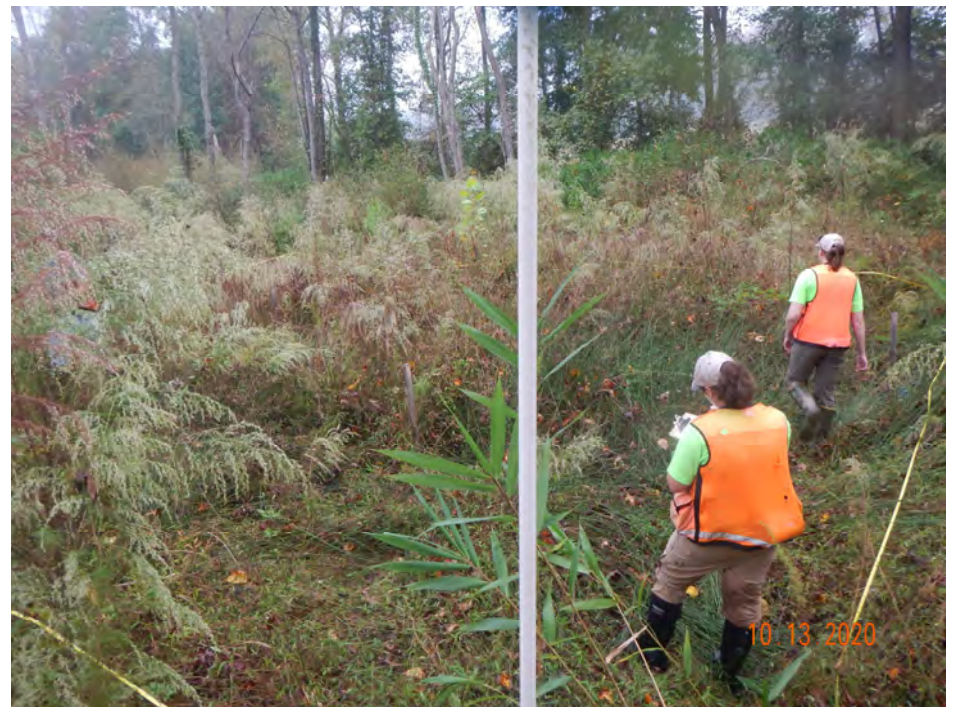
Veg Plot 1, May 14, 2018 (MY-00)

Veg Plot 1, October 13, 2020 (MY-03)

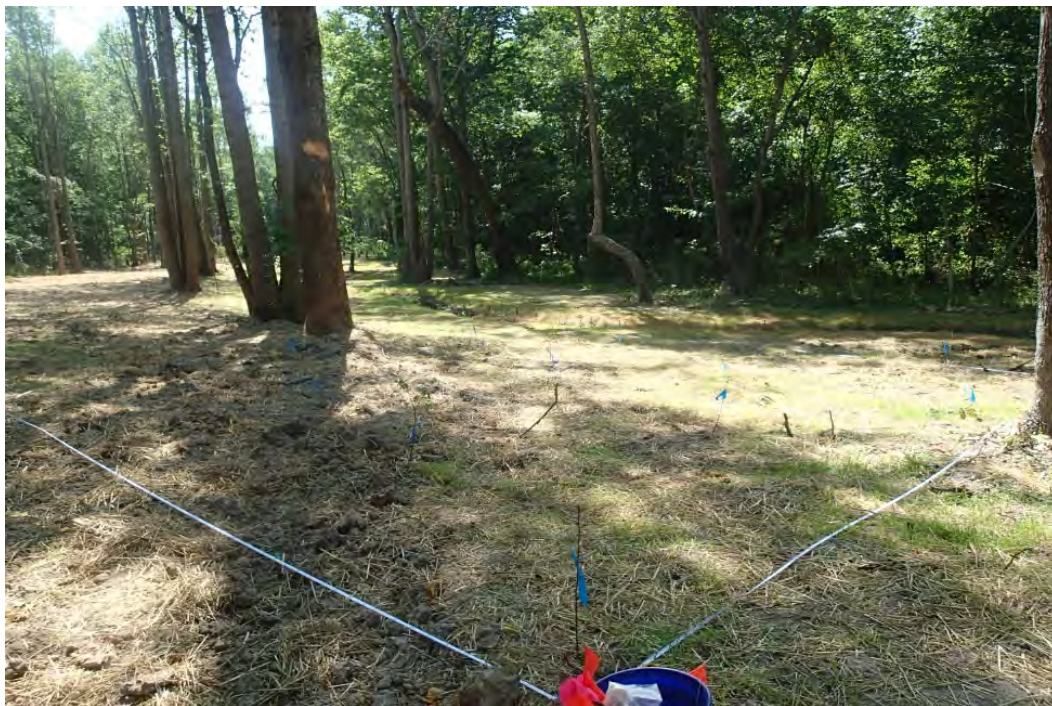
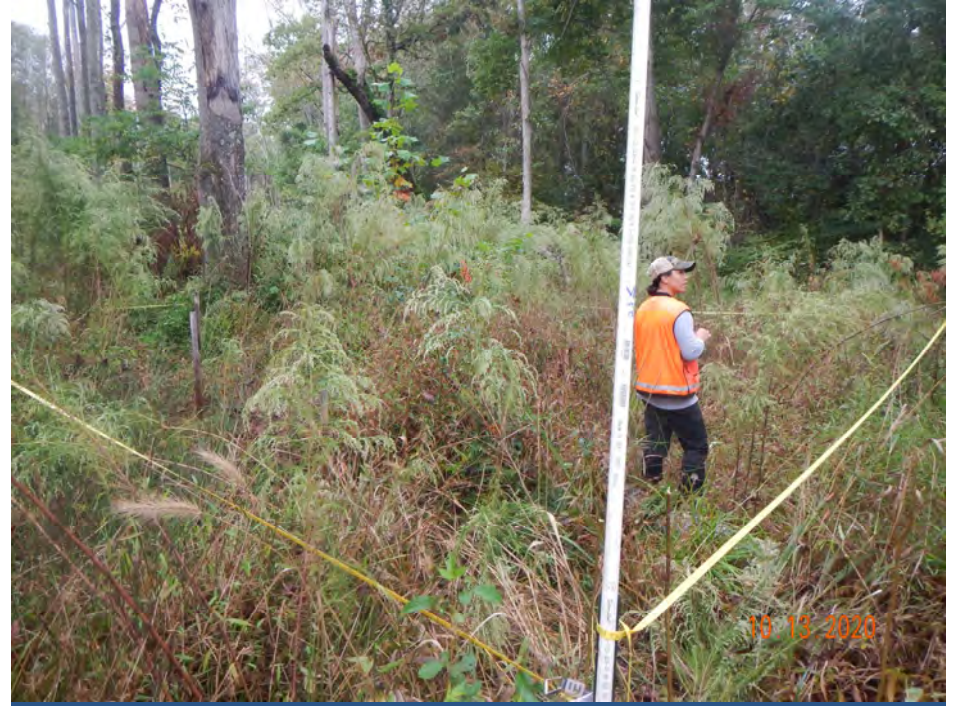
Veg Plot 2, May 14, 2018 (MY-00)

Veg Plot 2, October 13, 2020 (MY-03)

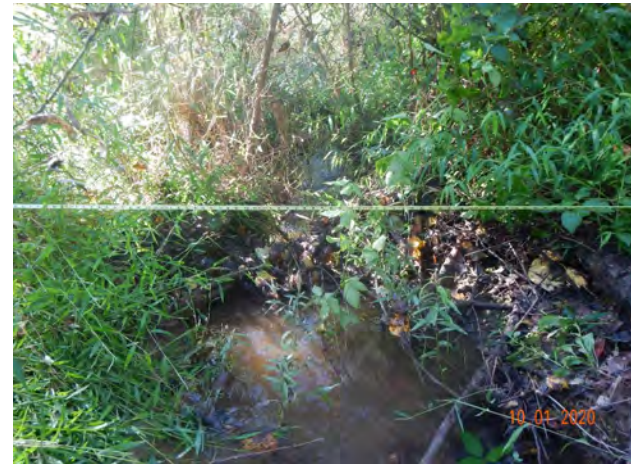
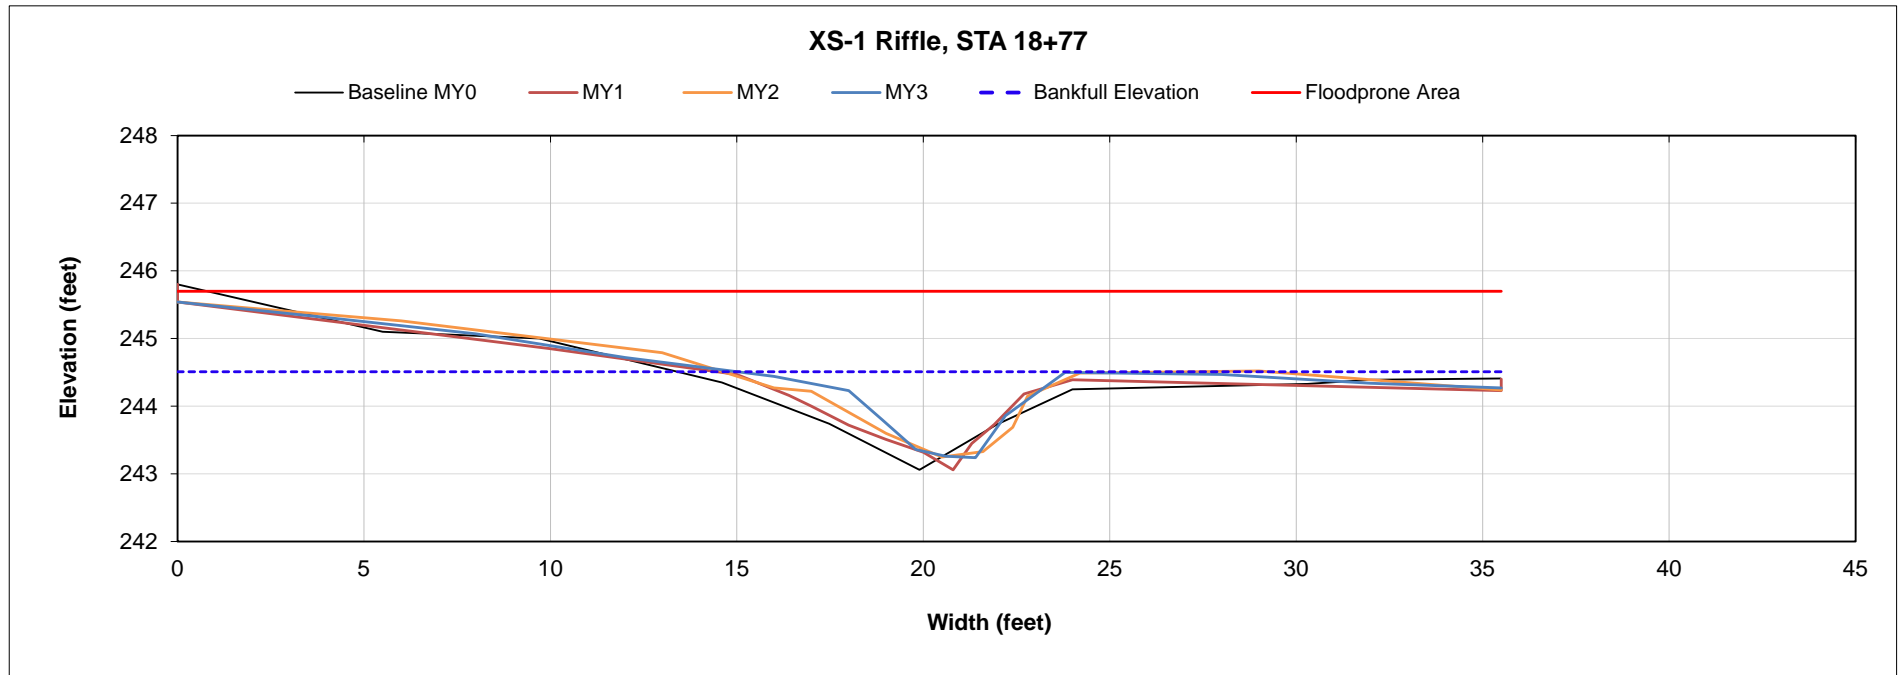
Project Name	Edwards-Johnson Mitigation Project
Project ID	97080
Reach ID	R2
Cross Section ID	XS-1
Field Crew	E. Dunnigan, N. Childs

Dimension Data Summary: MY3 2020	
Bankfull Elevation (ft)	244.5
Low Bank Height Elevation (ft)	244.4
Bankfull Max Depth (ft)	1.3
Low Bank Height (ft)	1.2
Bank Height Ratio	0.9
Bankfull X-section Area (ft ²)	4.9
% Change Bank Height Ratio	10.0%
