Monitoring Report – Year 3
FINAL VERSION
Edwards-Johnson Mitigation Project
Calendar Year of Data Collection: 2020

NCDEQ DMS Project Identification # 97080
NCDEQ DMS Contract # 6825
Neuse River Basin (Cataloging Unit 03020201)
USACE Action ID Number: SAW-2016-00883
NCDEQ DWR Project # 2016-0404
Johnston County, NC
Contracted Under RFP # 16-006477
Data Collection Period: September – October 2020
Submission Date: December 11, 2020

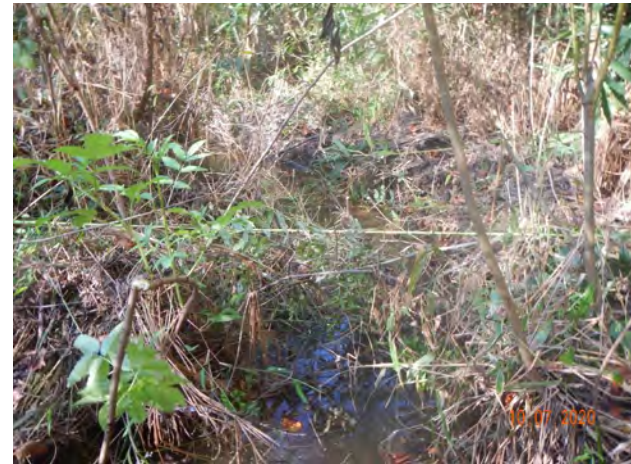
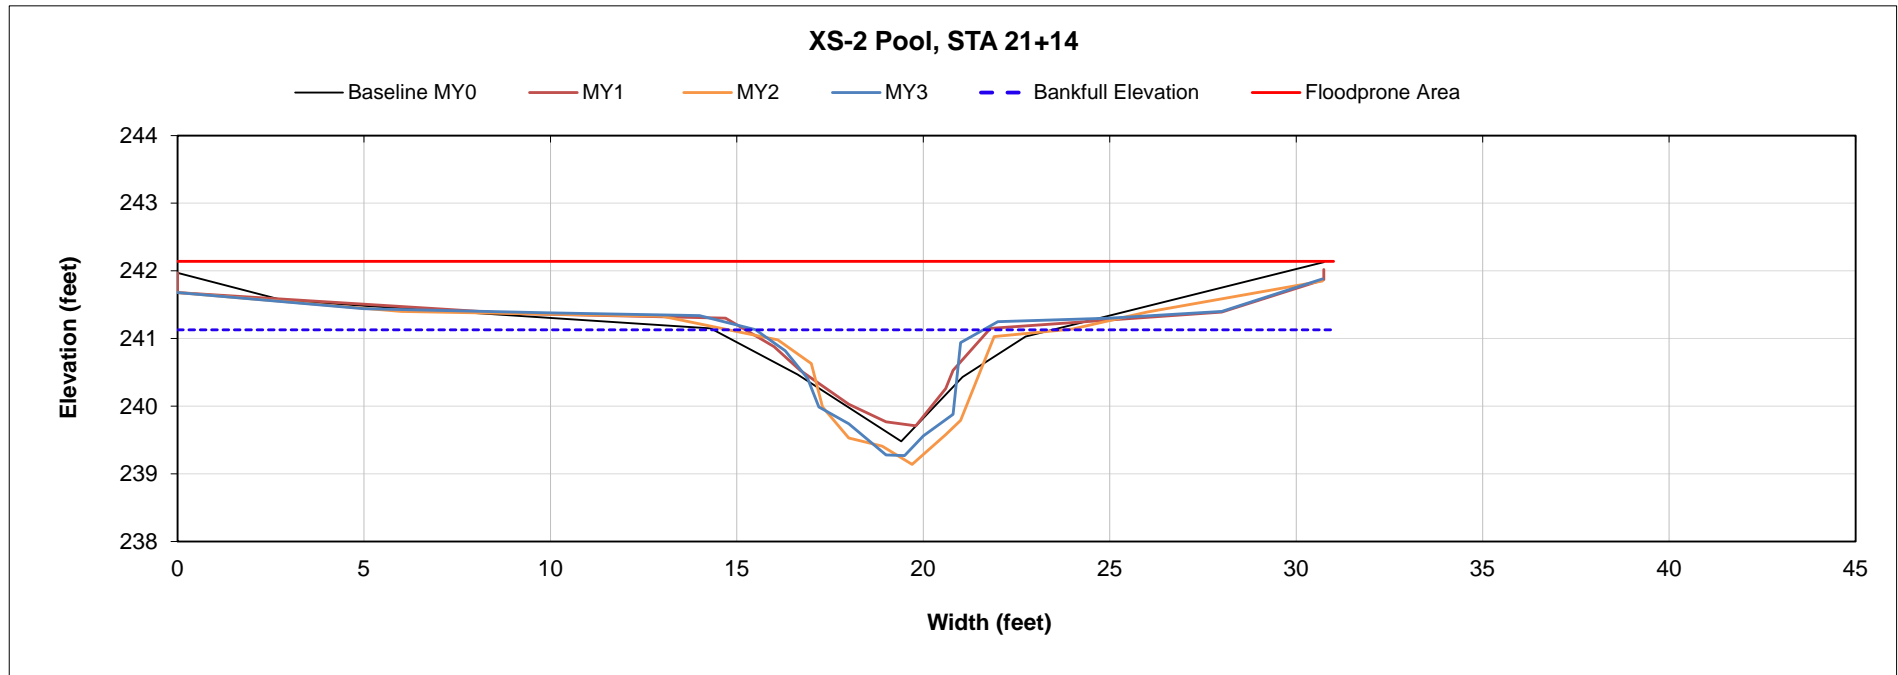
Project Name	Edwards-Johnson Mitigation Project
Project ID	97080
Reach ID	R2
Cross Section ID	XS-2
Field Crew	K. Obermiller, E. Dunnigan

Dimension Data Summary: MY3 2020	
Bankfull Elevation (ft)	241.1
Low Bank Height Elevation (ft)	241.1
Bankfull Max Depth (ft)	1.9
Low Bank Height (ft)	1.9
Bank Height Ratio	1.0
Bankfull X-section Area (ft ²)	6.5
% Change Bank Height Ratio	0.0%

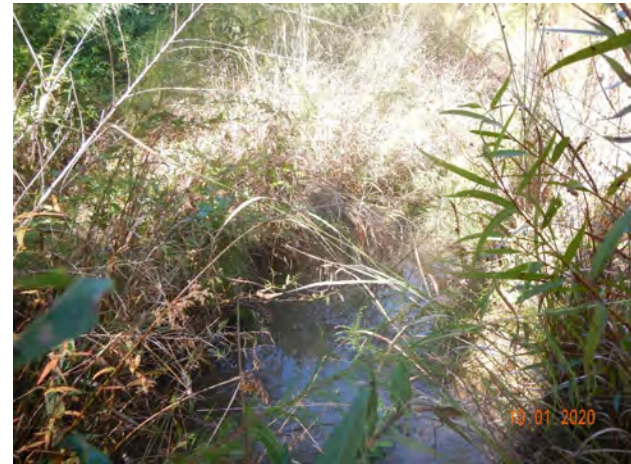
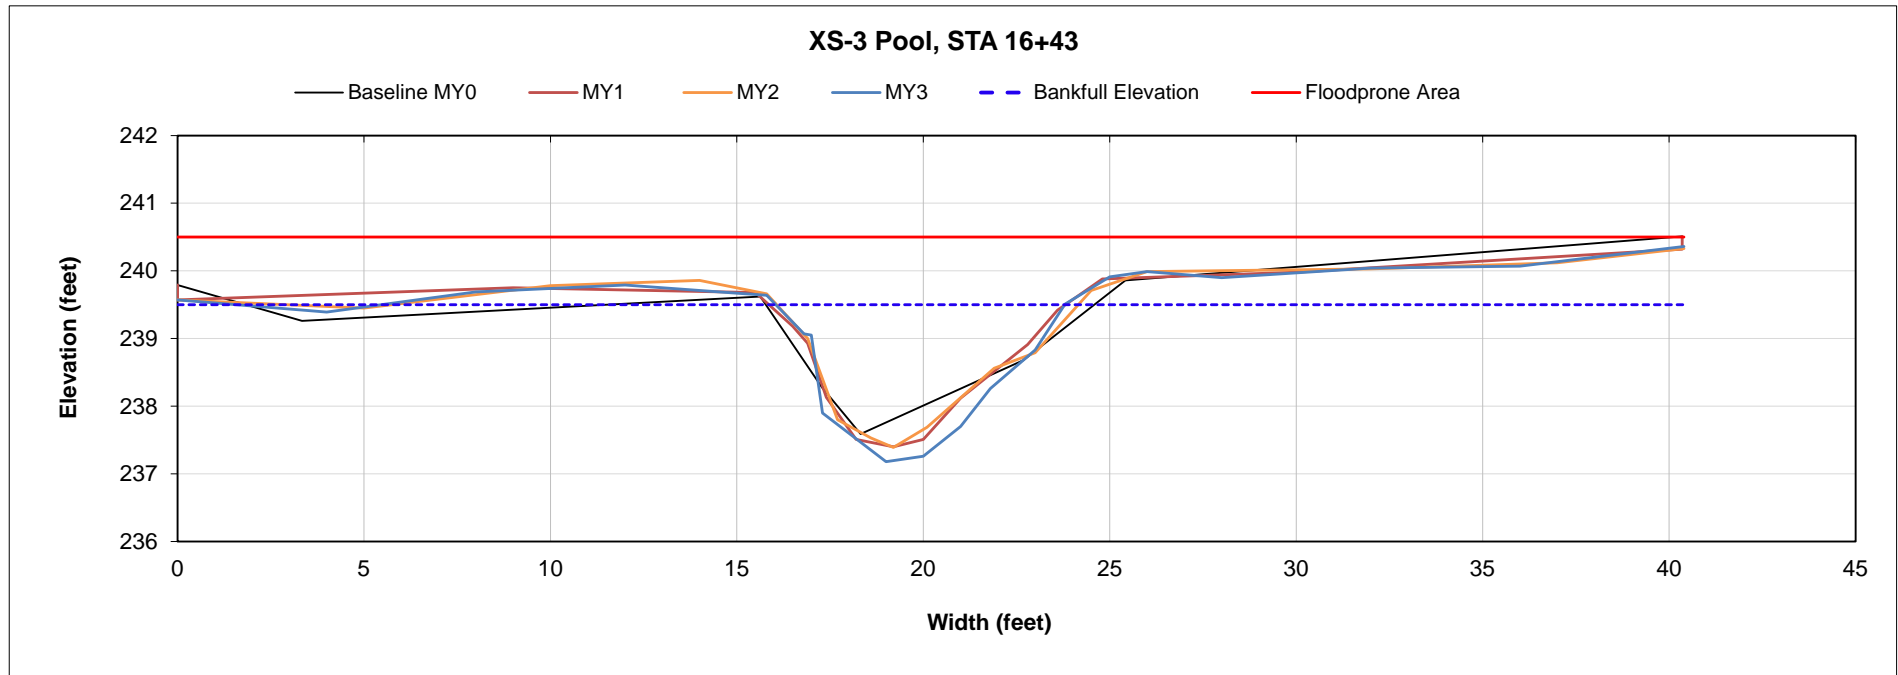
Project Name	Edwards-Johnson Mitigation Project
Project ID	97080
Reach ID	R4
Cross Section ID	XS-3
Field Crew	E. Dunnigan, N. Childs

Dimension Data Summary: MY3 2020	
Bankfull Elevation (ft)	239.5
Low Bank Height Elevation (ft)	239.5
Bankfull Max Depth (ft)	2.3
Low Bank Height (ft)	2.3
Bank Height Ratio	1.0
Bankfull X-section Area (ft ²)	11.0
% Change Bank Height Ratio	0.0%

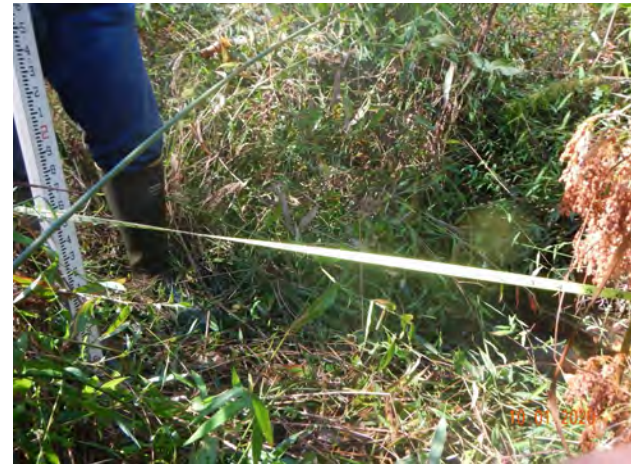
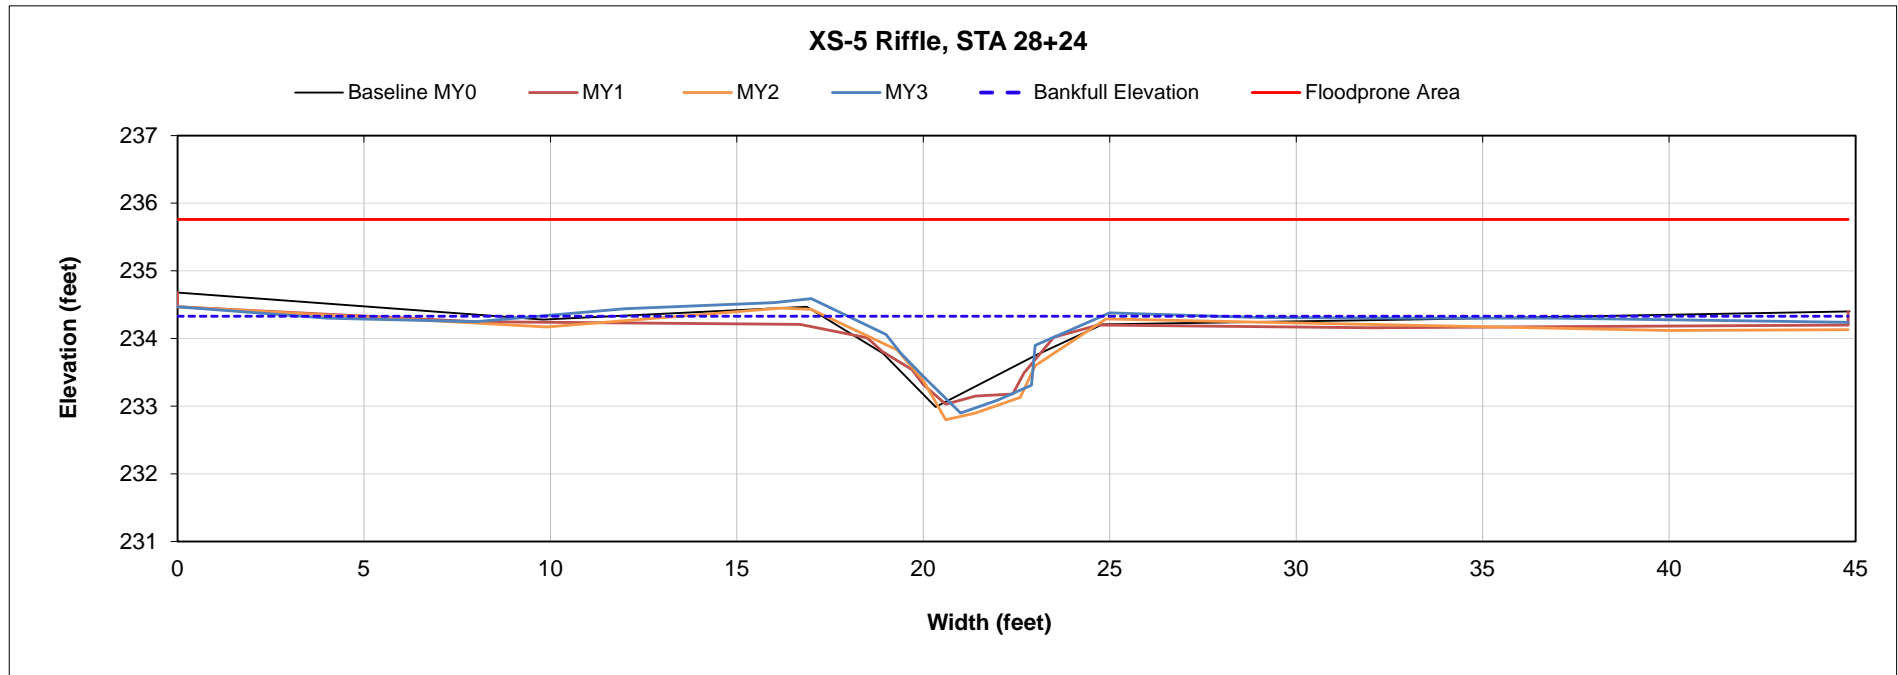
Project Name	Edwards-Johnson Mitigation Project
Project ID	97080
Reach ID	R3
Cross Section ID	XS-5
Field Crew	E. Dunnigan, N. Childs

Dimension Data Summary: MY3 2020	
Bankfull Elevation (ft)	234.3
Low Bank Height Elevation (ft)	234.4
Bankfull Max Depth (ft)	1.4
Low Bank Height (ft)	1.5
Bank Height Ratio	1.0
Bankfull X-section Area (ft ²)	4.7
% Change Bank Height Ratio	0.0%

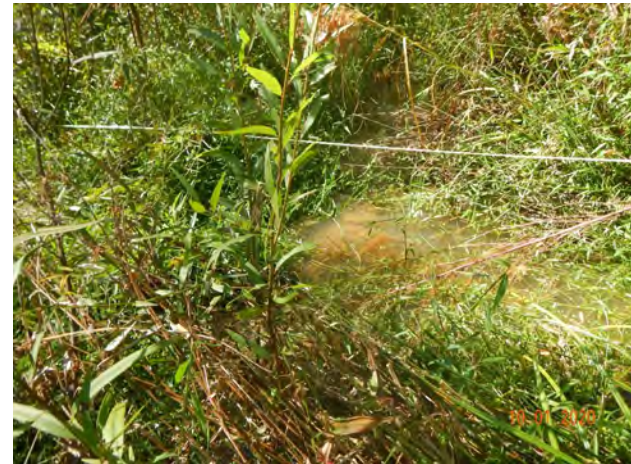
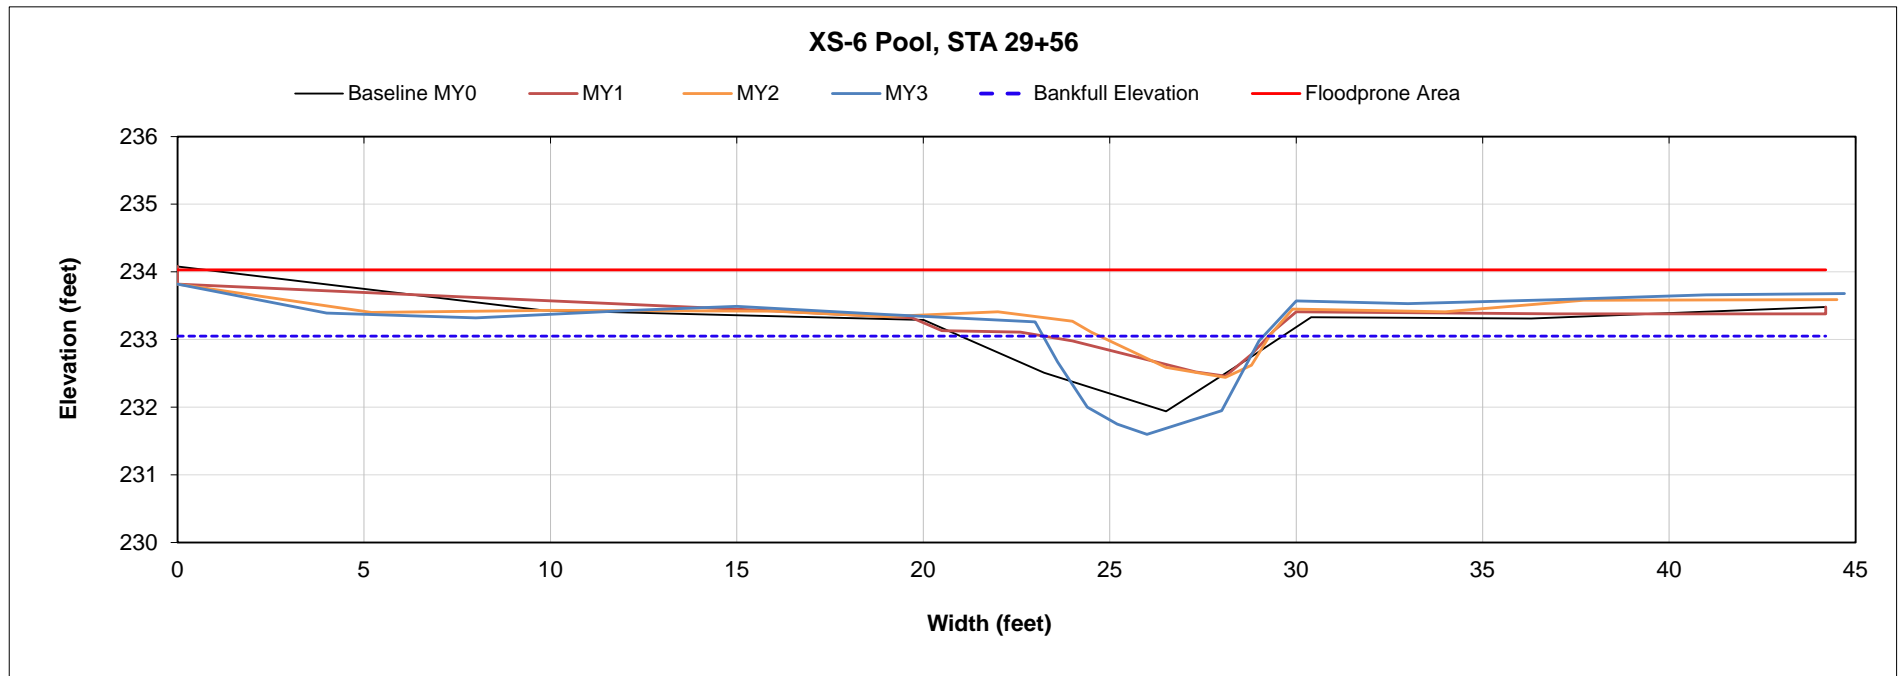
Project Name	Edwards-Johnson Mitigation Project
Project ID	97080
Reach ID	R3
Cross Section ID	XS-6
Field Crew	E. Dunnigan, N. Childs

Dimension Data Summary: MY3 2020	
Bankfull Elevation (ft)	233.0
Low Bank Height Elevation (ft)	233.3
Bankfull Max Depth (ft)	1.4
Low Bank Height (ft)	1.7
Bank Height Ratio	1.2
Bankfull X-section Area (ft ²)	5.6
% Change Bank Height Ratio	20.0%

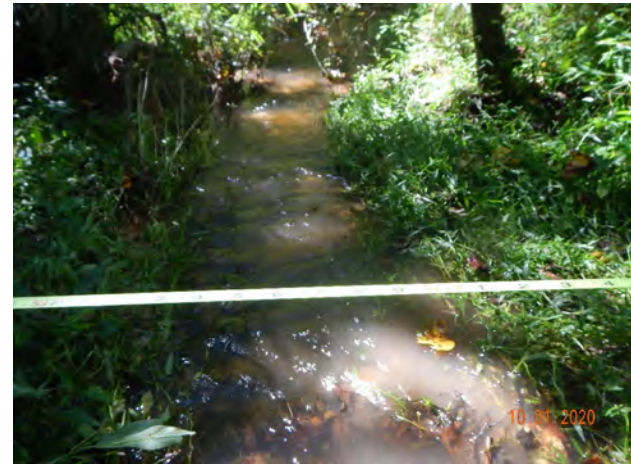
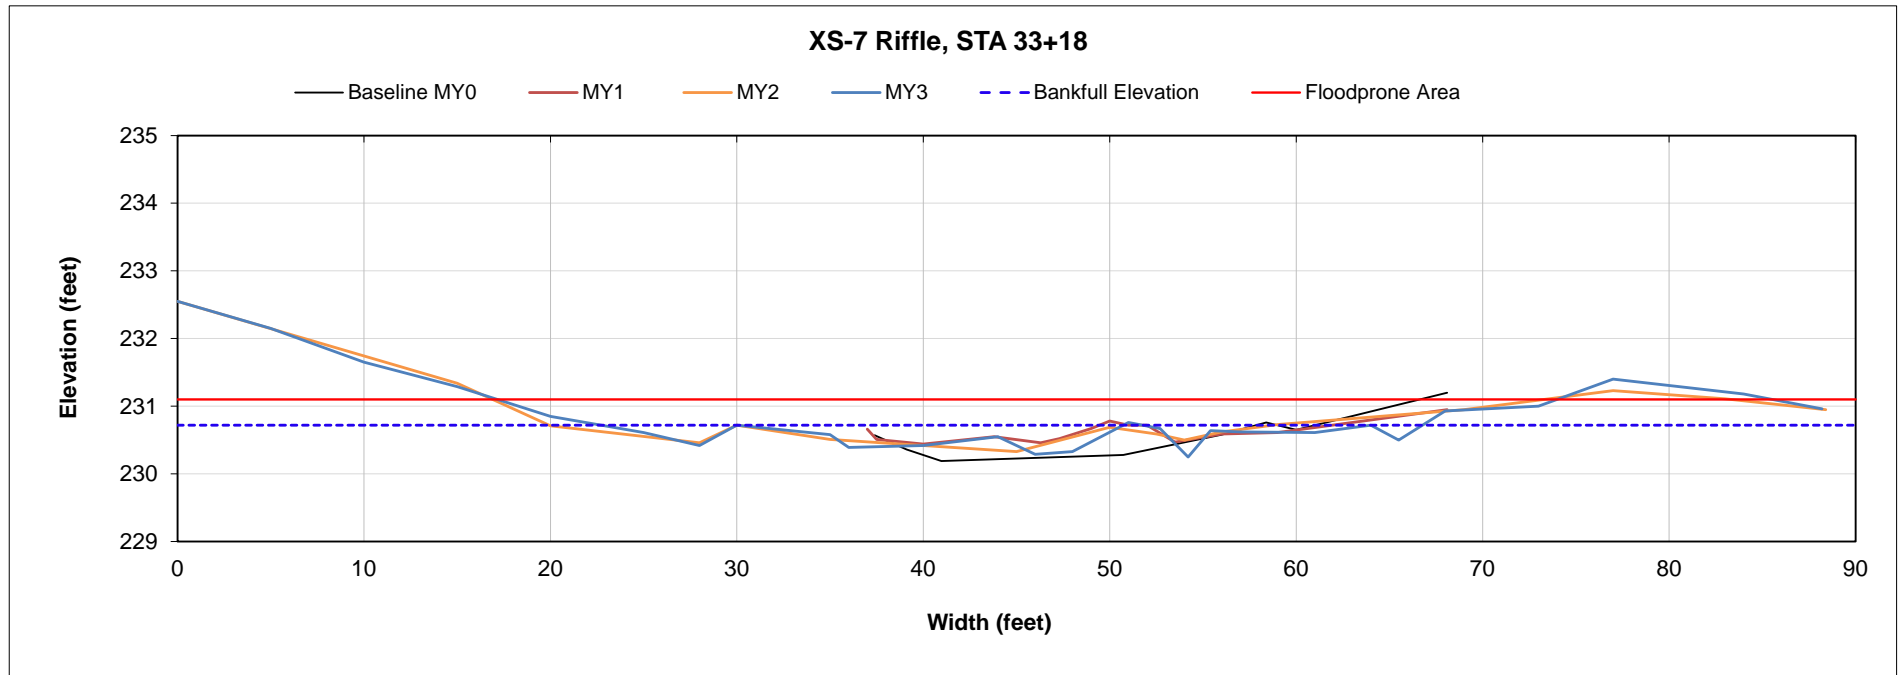
Project Name	Edwards-Johnson Mitigation Project
Project ID	97080
Reach ID	R3 (Multi-Thread Channel)
Cross Section ID	XS-7
Field Crew	E. Dunnigan, N. Childs

Dimension Data Summary: MY3 2020	
Bankfull Elevation (ft)	230.7
Low Bank Height Elevation (ft)	230.6
Bankfull Max Depth (ft)	0.4
Low Bank Height (ft)	0.4
Bank Height Ratio	0.9
Bankfull X-section Area (ft ²)	4.7
% Change Bank Height Ratio	10.0%

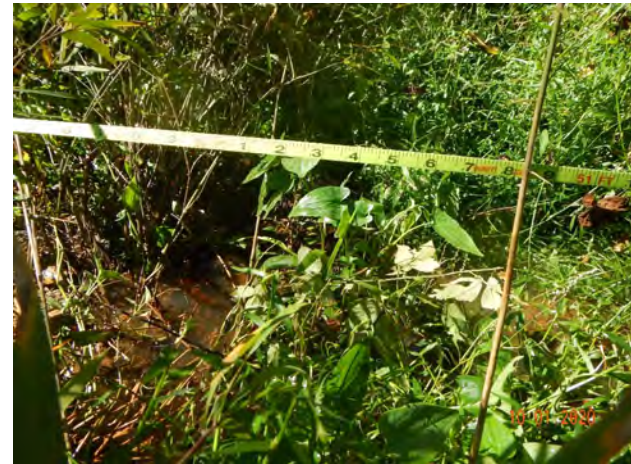
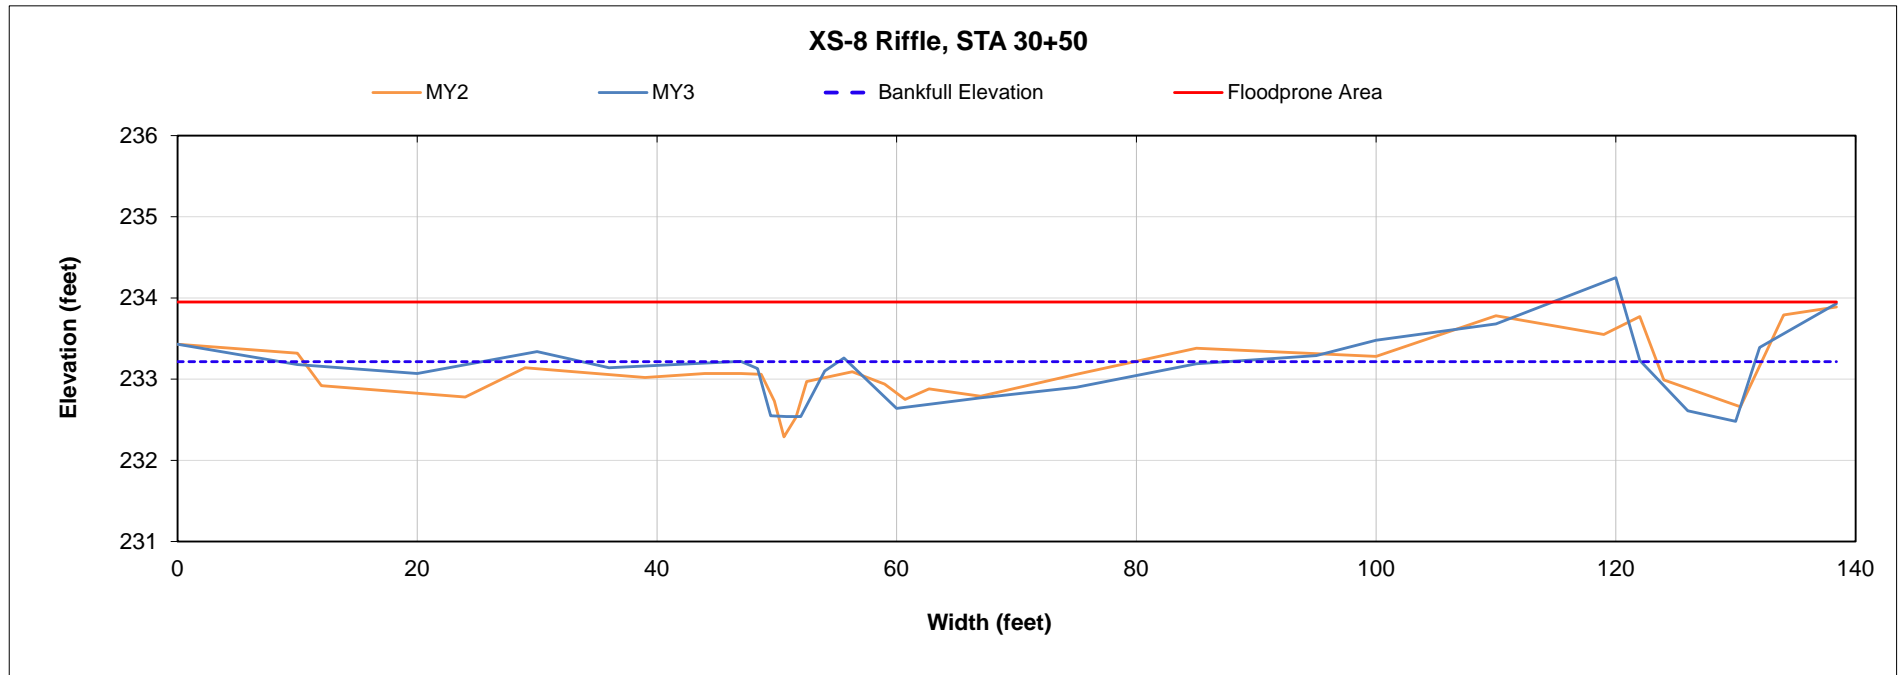
Project Name	Edwards-Johnson Mitigation Project
Project ID	97080
Reach ID	R3 (Multi-Thread Channel)
Cross Section ID	XS-8
Field Crew	E. Dunnigan, N. Childs

Dimension Data Summary: MY3 2020	
Bankfull Elevation (ft)	233.2
Low Bank Height Elevation (ft)	233.2
Bankfull Max Depth (ft)	0.7
Low Bank Height (ft)	0.7
Bank Height Ratio	1.0
Bankfull X-section Area (ft ²)	4.7
% Change Bank Height Ratio	0.0%
