Elk Branch Restoration Project

Year 3 Monitoring Report

Mitchell County, North Carolina

Monitoring Firm: Michael Baker Engineering, Inc. (Baker)

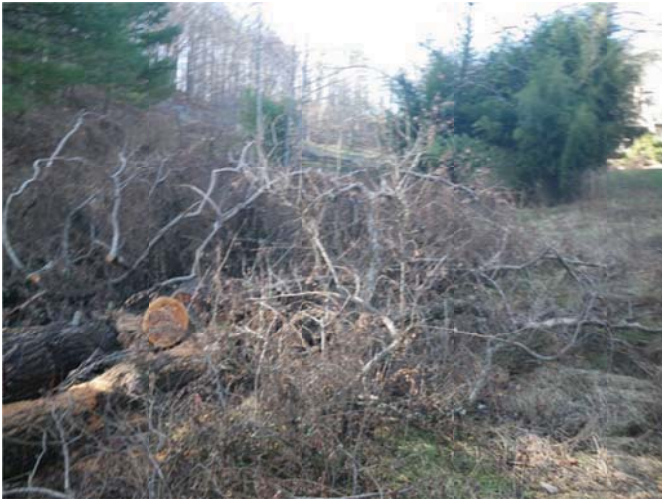
Photo Point 1: looking upstream, willow tree blown down in wind storm blocking normal photo point.
