ELK SHOALS STREAM RESTORATION SITE

ANNUAL MONITORING REPORT FOR 2008 (YEAR 4)

CONTRACT NUMBER AW.03003-B

November 2008

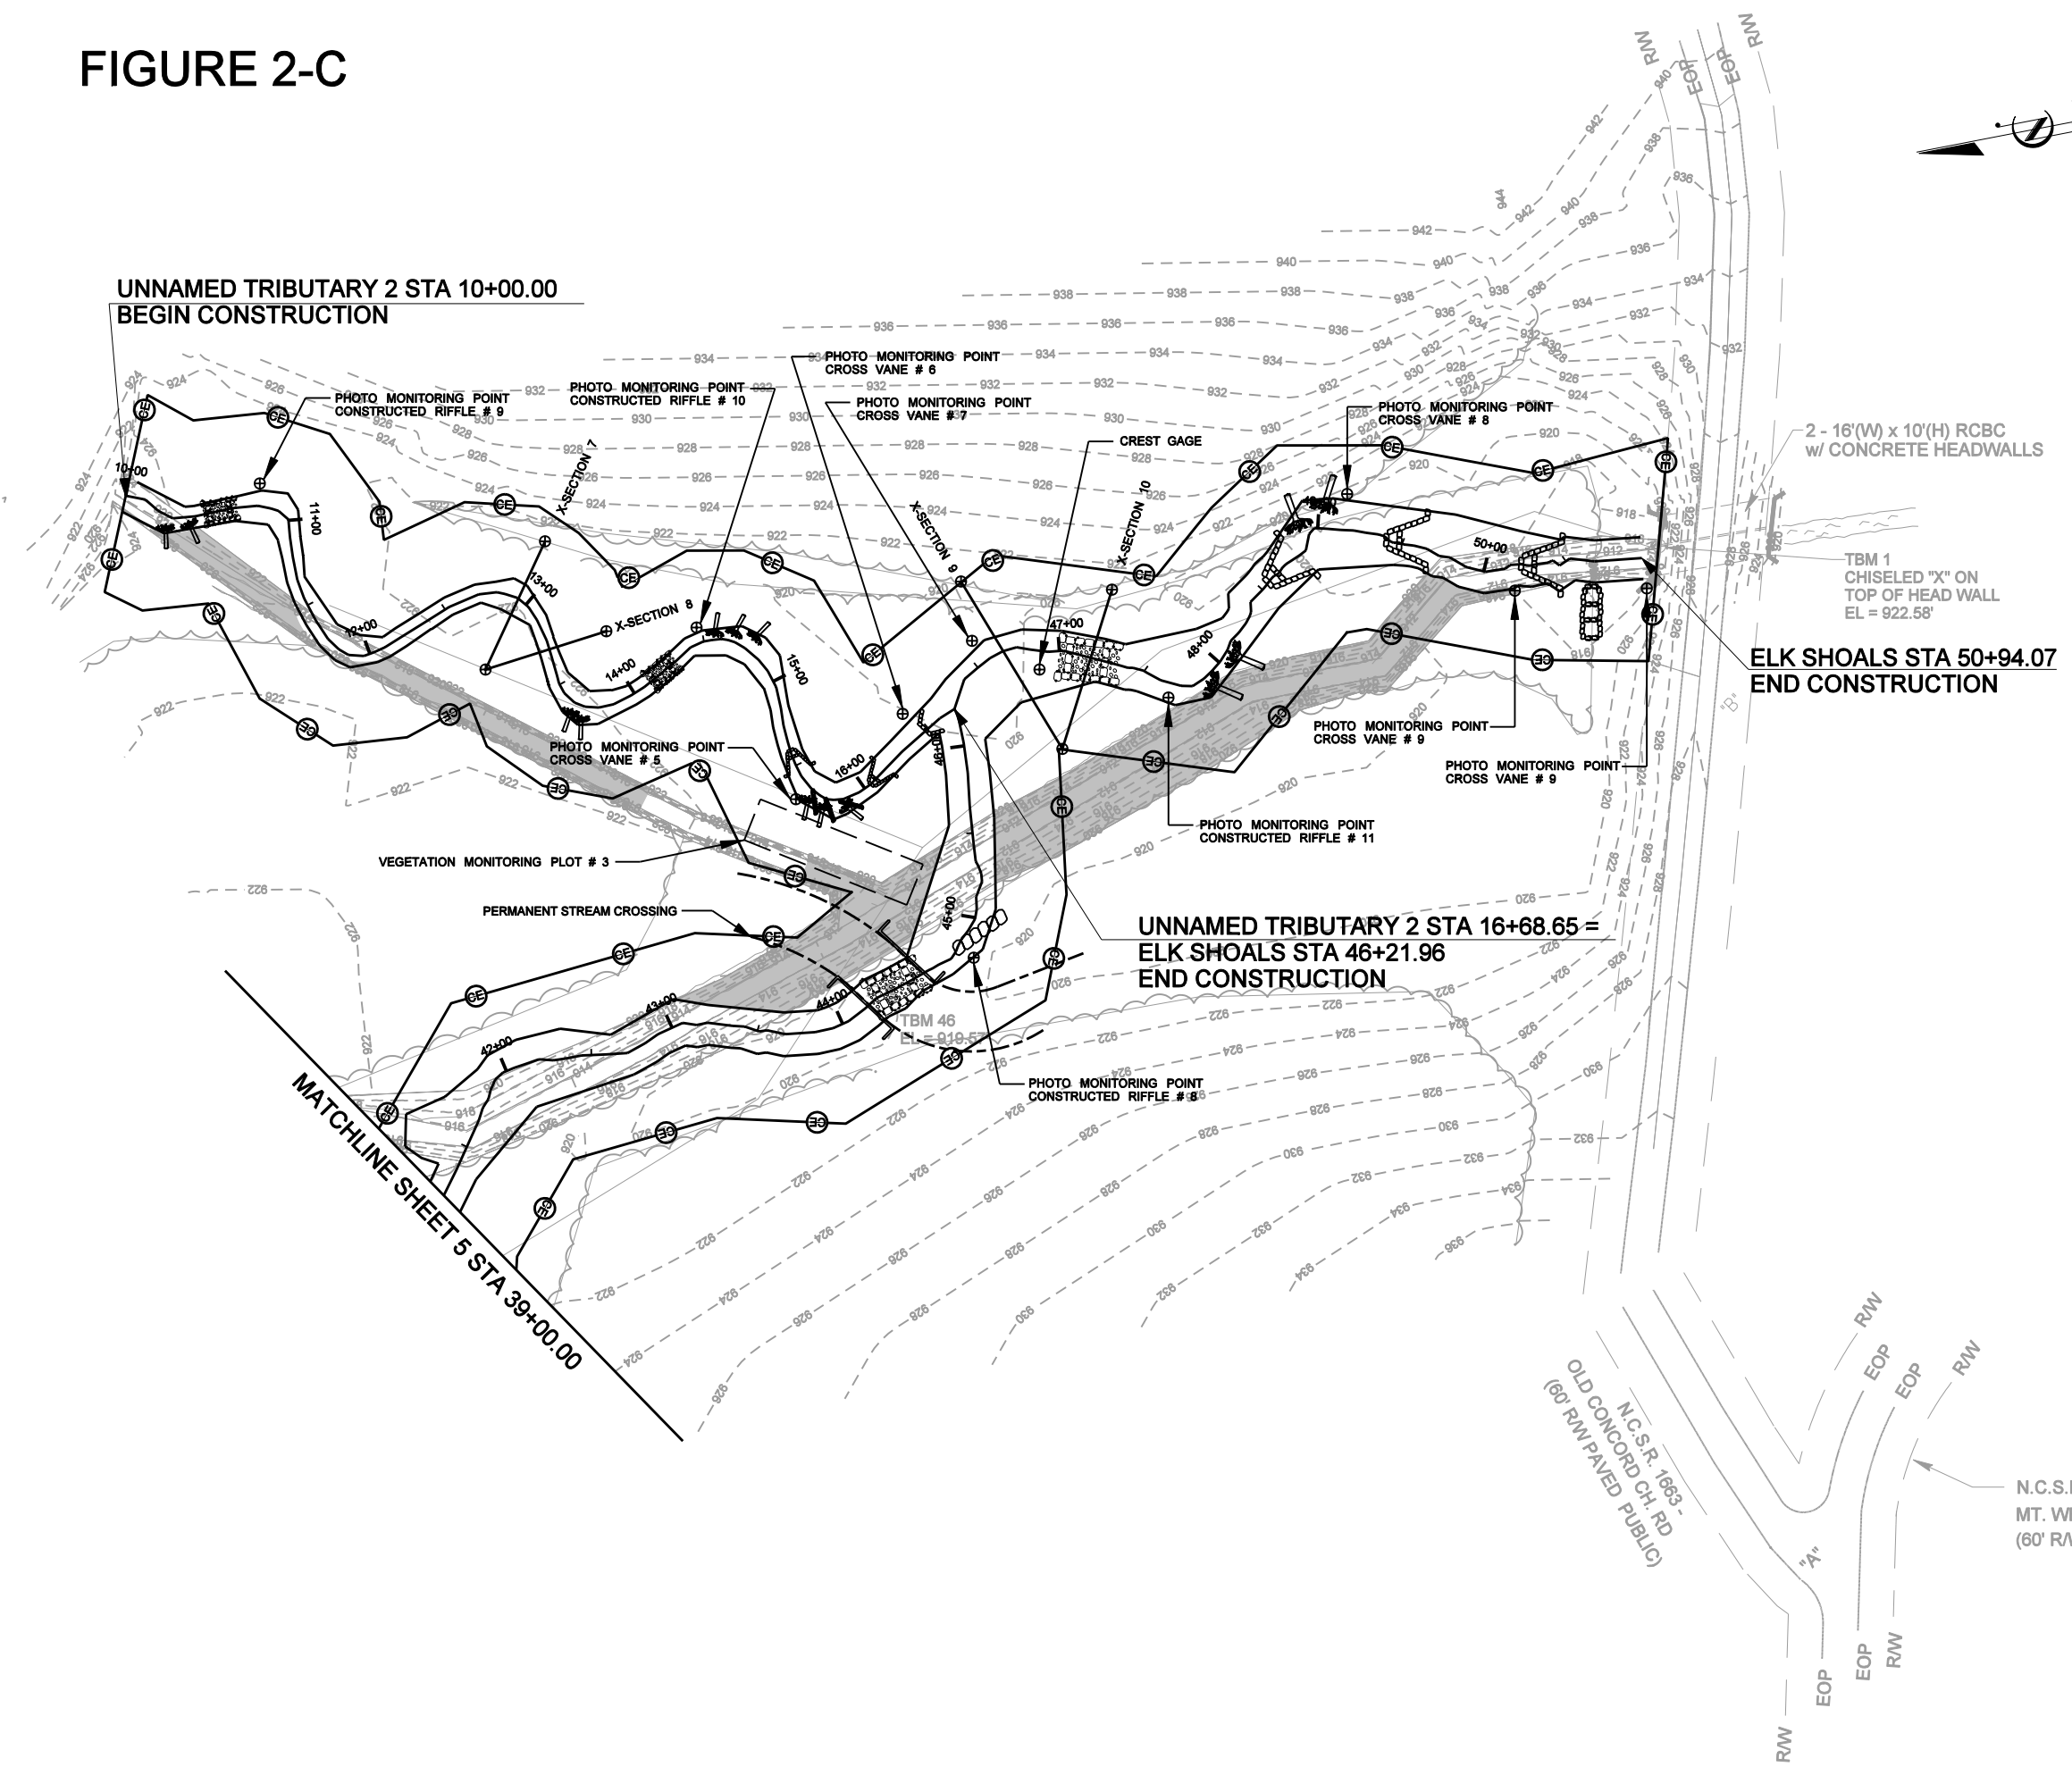
FIGURE 2-C

Bankfull Events: A crest gauge was installed on the Site to document bankfull events. The gauge is checked during yearly site visits, and records the highest out-of-bank flow event that occurs during the year. The gauge is located at stream station 47+00, near permanent cross-section 10 (see Figure 2-C).

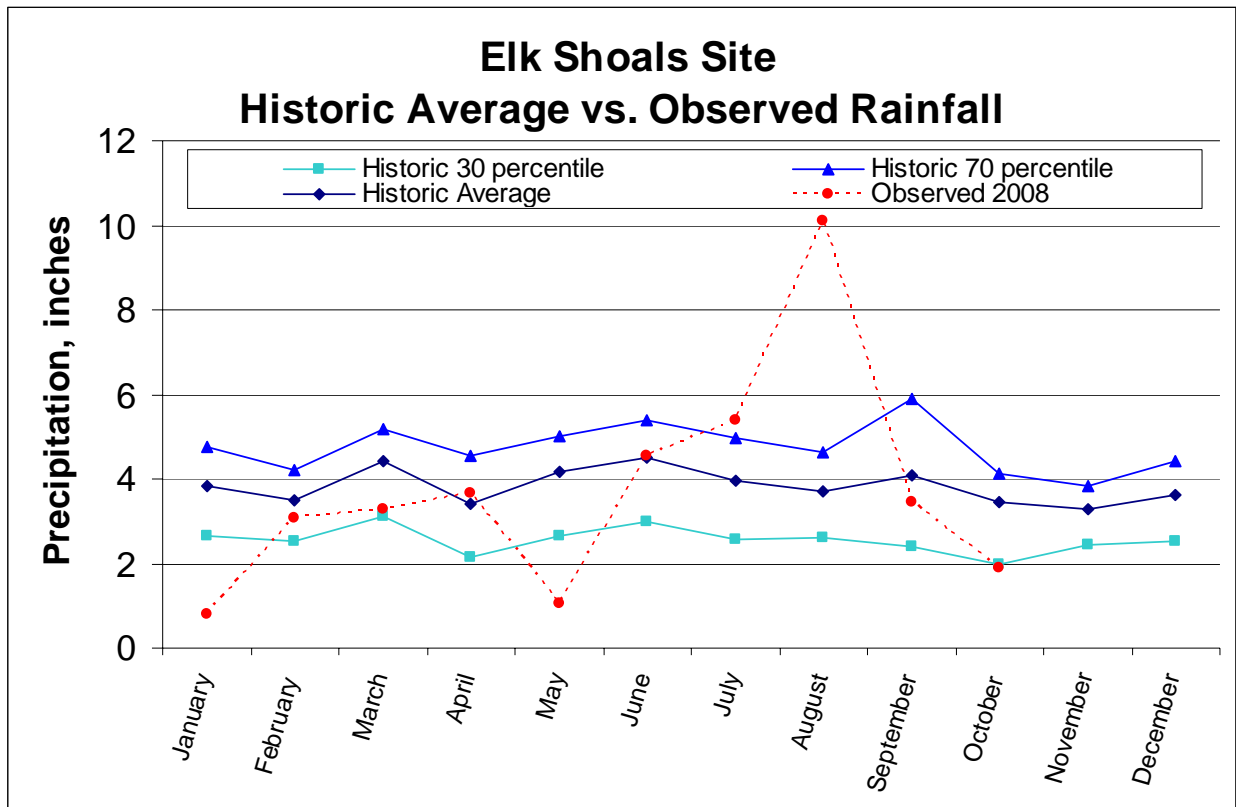
Figure 3. Comparison of Historic Average Rainfall to 2008 Observed Rainfall

Table 5 and Figure 3 show a comparison of the 2008 monthly rainfall to historical precipitation (WETS table for Iredell County, collected between 1971 and 2000) for the project area. Historic climate information for Alexander County was not readily available; therefore, data from Iredell County were used due to its proximity to the Site. Weather data from the Statesville Weather Station (UCAN: 14362, COOP: 318292) were used to document precipitation for the monitoring year. Historical average rainfall totals were compared to the 2008 observed rainfall totals. For 2008, total rainfall observed at the weather station between the months of April and September was 28.19 inches, compared to the long-term average of 23.80 inches for the same period. Monthly precipitation values for 2008 were mostly average to below average, with the exceptions of July and August that experienced higher than normal rainfall due to tropical systems. This demonstrates that the climatic conditions observed during the 2008 growing season were substantially wetter than the long-term average.
