ELK SHOALS STREAM RESTORATION SITE
ANNUAL MONITORING REPORT FOR 2009 (YEAR 5)
CONTRACT NUMBER AW03003-B

ANNUAL REPORT FOR 2009 (YEAR 5)

Elk Shoals Stream Restoration Site

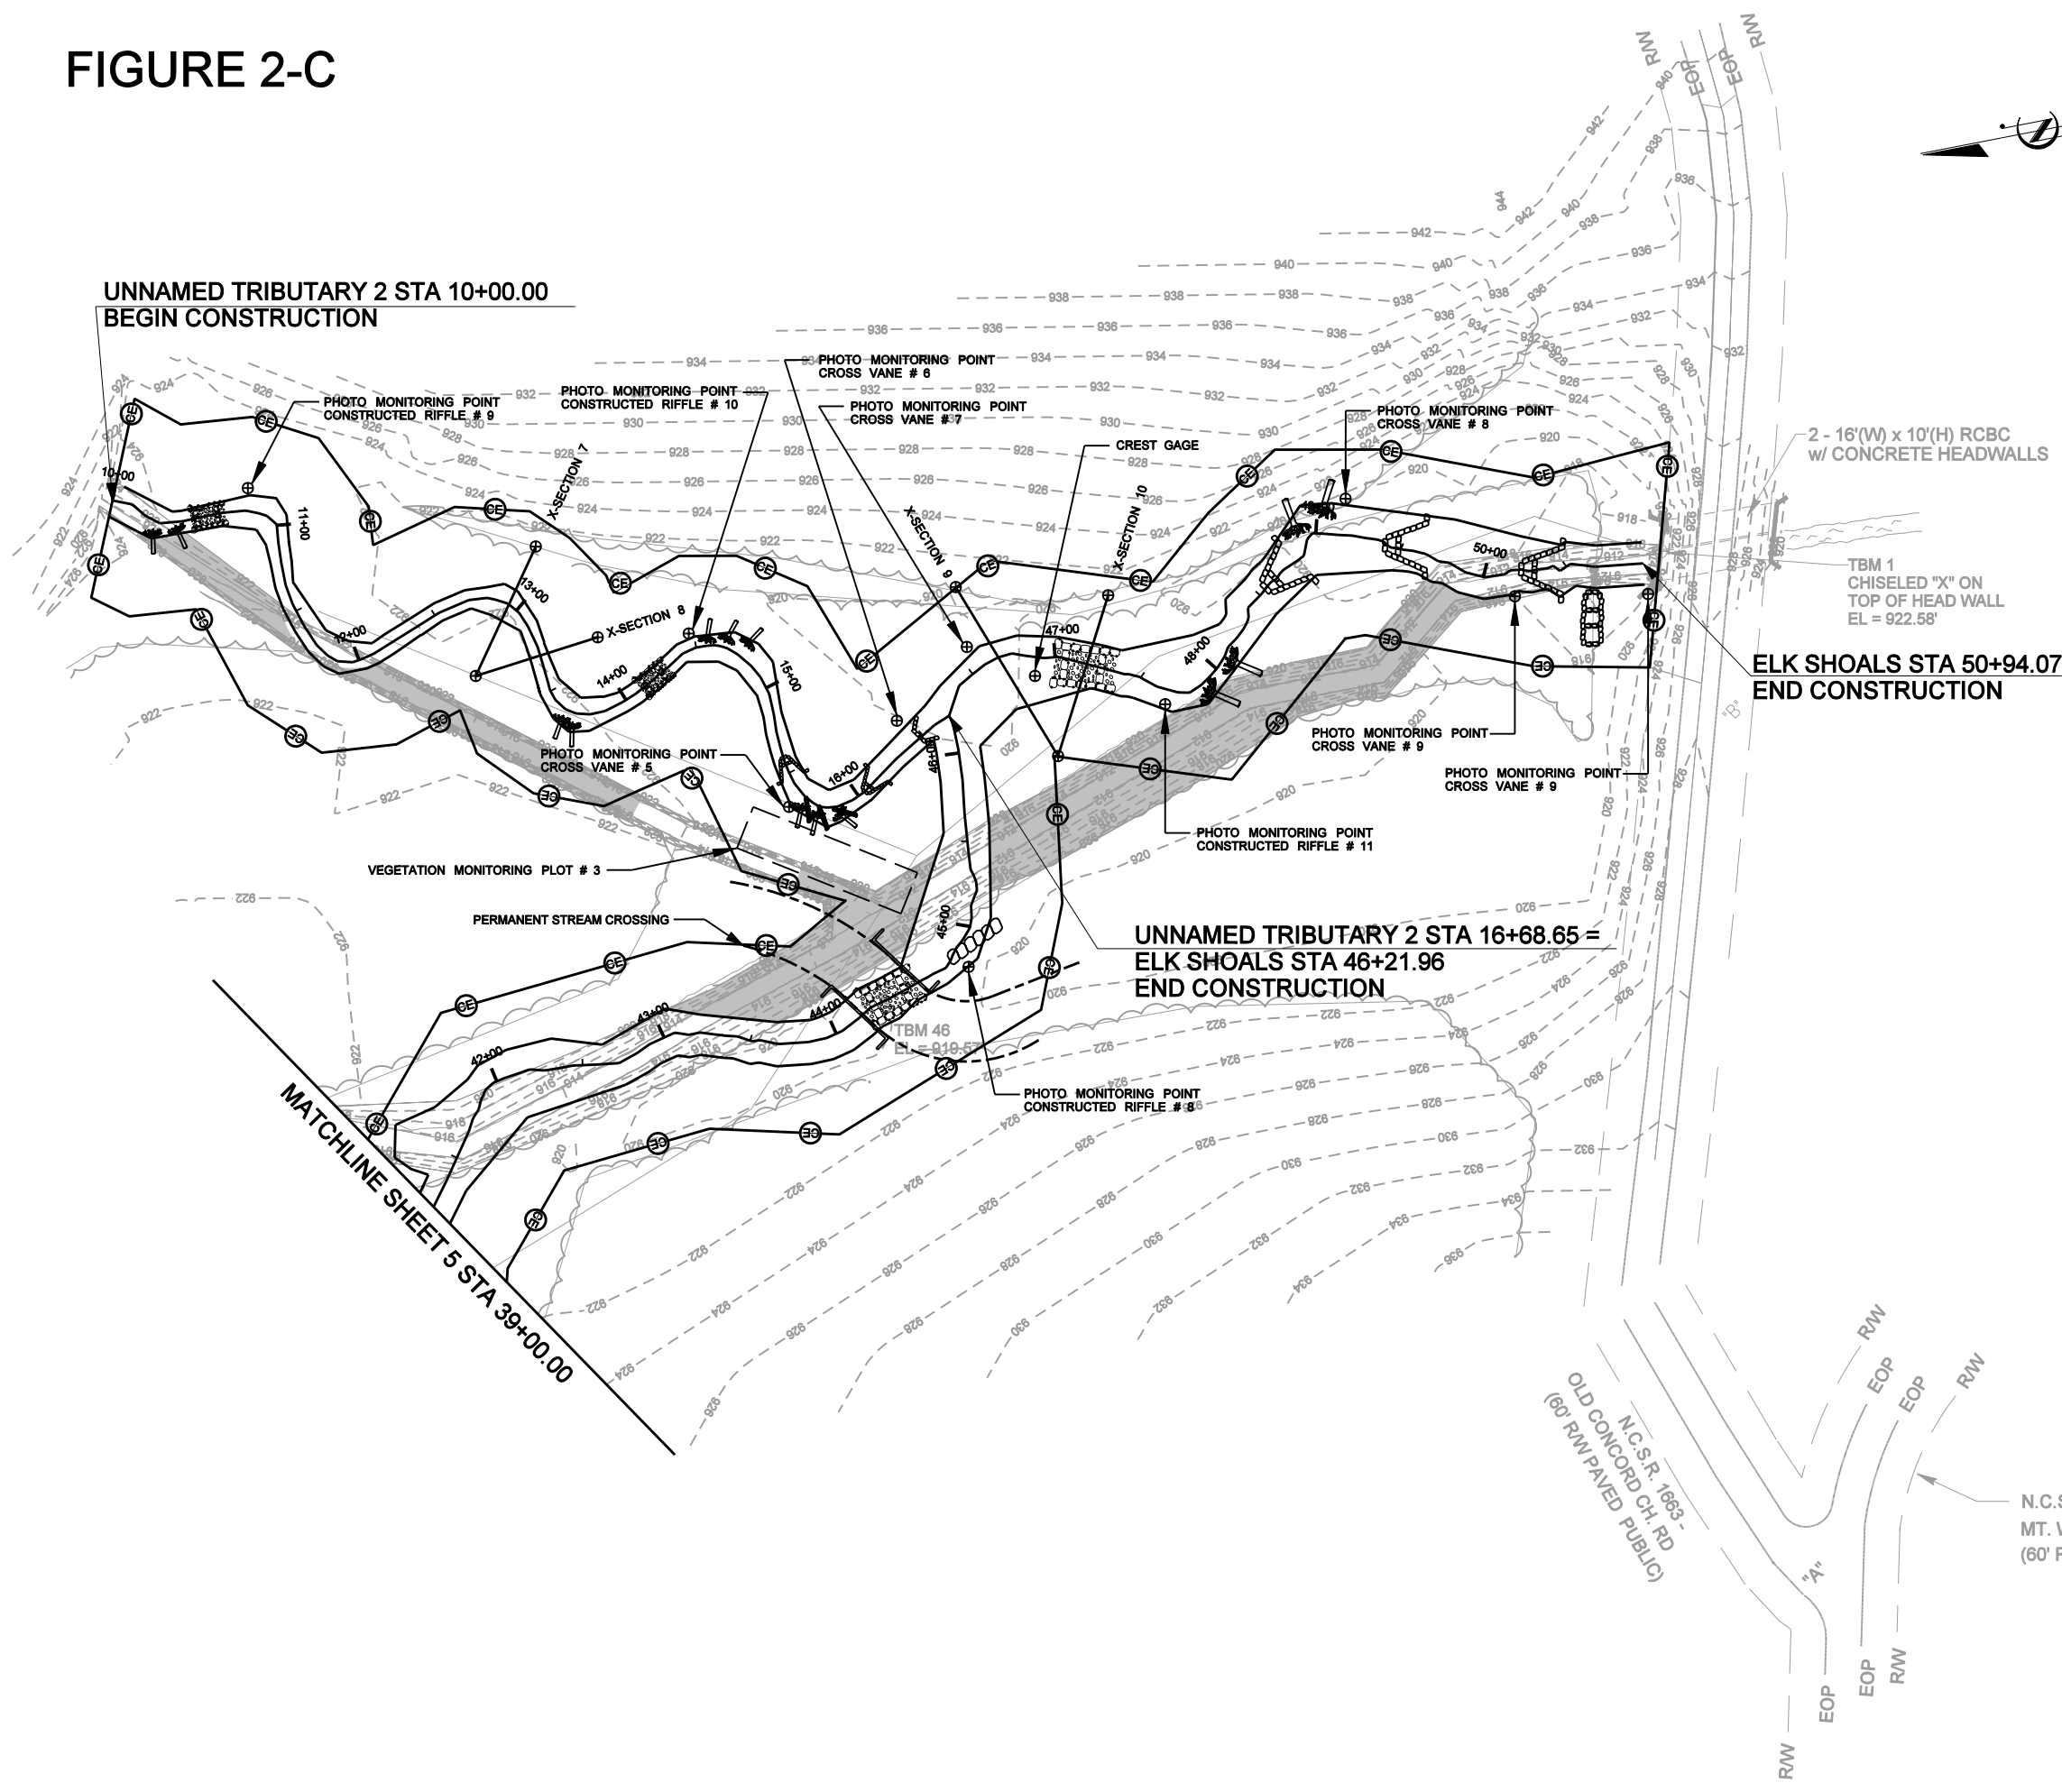
FIGURE 2-C

Bankfull Events: A crest gauge was installed on the Site to document bankfull events. The gauge is checked during yearly site visits, and records the highest out-of-bank flow event that occurs during the year. The gauge is located at stream station 47+00, near permanent cross-section 10 (see Figure 2-C).

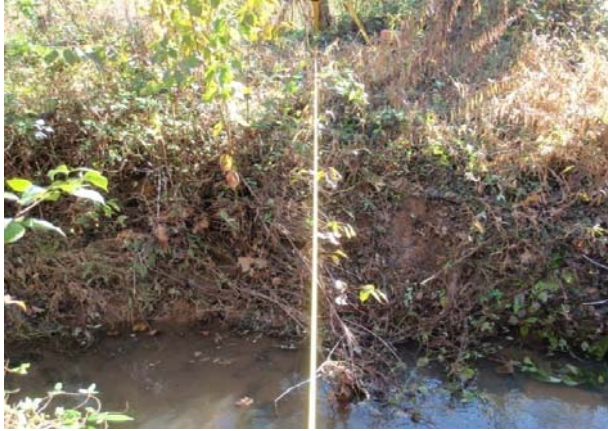
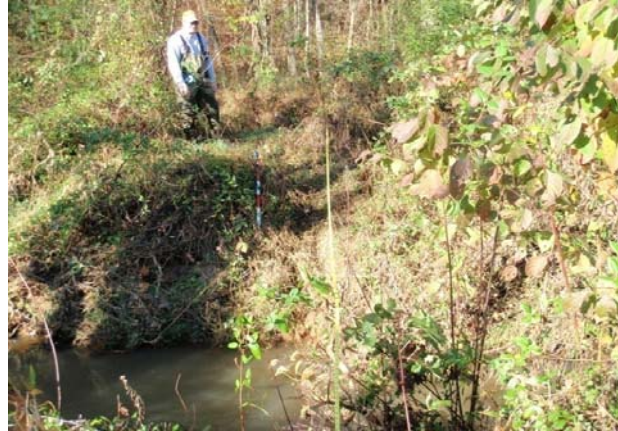
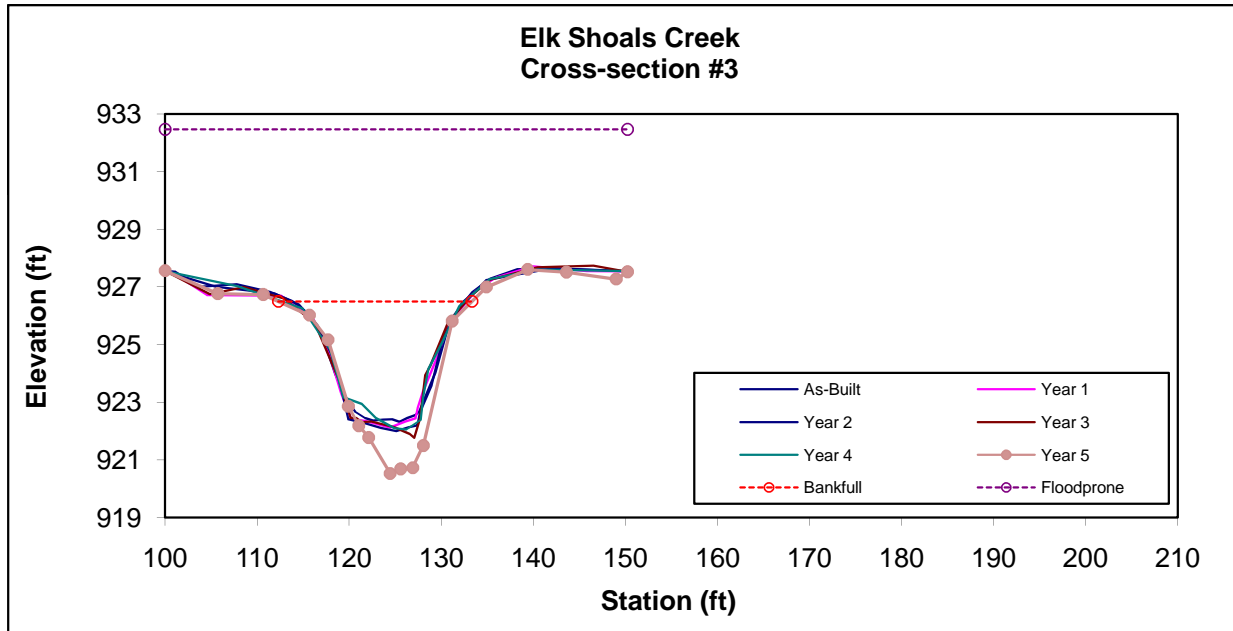
Permanent Cross-section #3
 (Year 5 Data - Collected November 2009)

Feature	Stream Type	BKF Area	BKF Width	BKF Depth	Max BKF Depth	W/D	BH Ratio	ER	BKF Elev	TOB Elev
Riffle	E	60.1	21.01	2.86	5.97	7.35	1	2.4	926.5	926.74

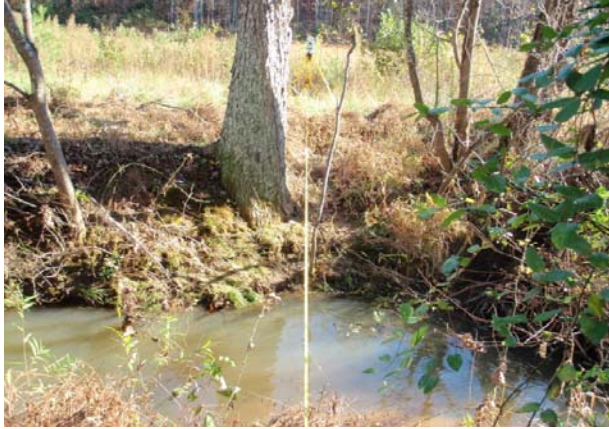
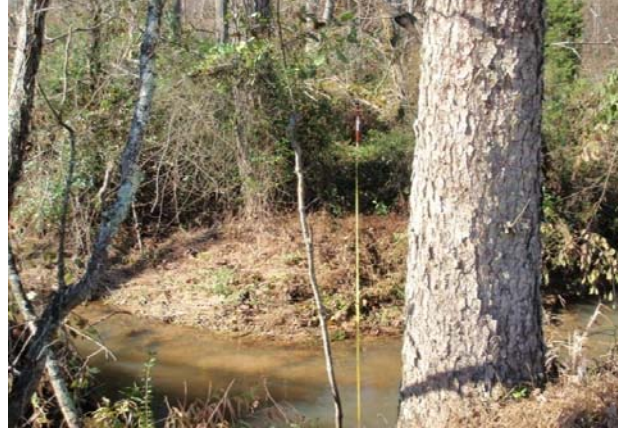
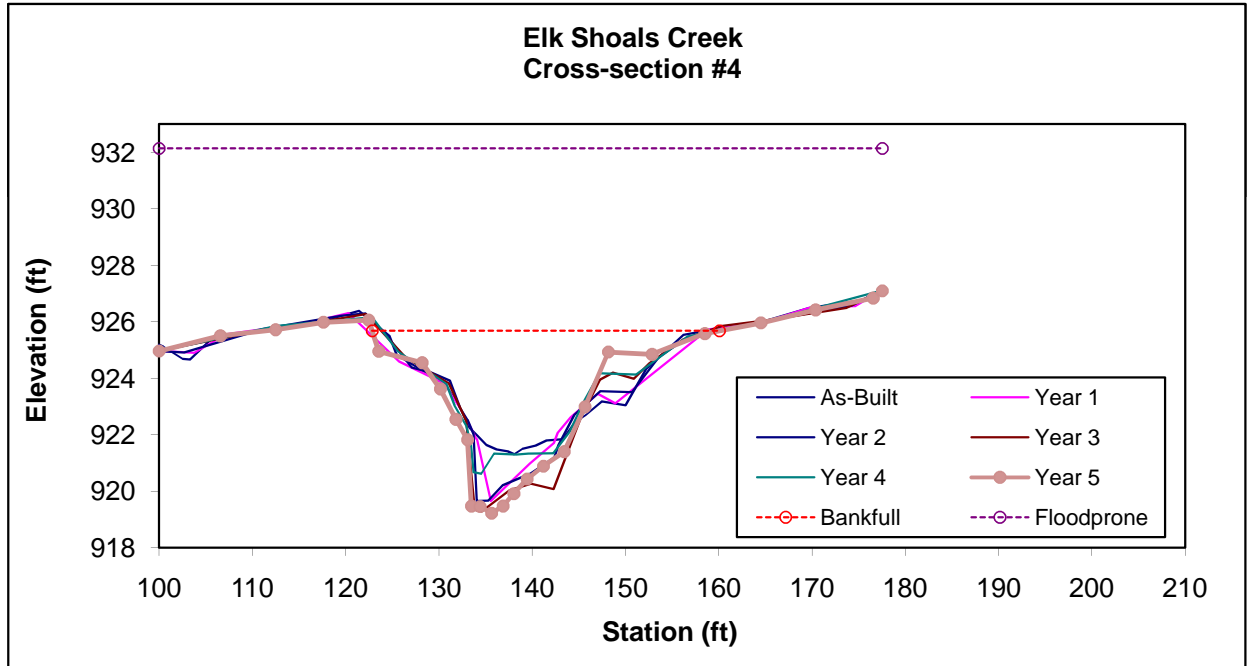
Permanent Cross-section #4
 (Year 5 Data - Collected November 2009)

Feature	Stream Type	BKF Area	BKF Width	BKF Depth	Max BKF Depth	W/D	BH Ratio	ER	BKF Elev	TOB Elev
Pool		92	37.23	2.47	6.46	15.06	1	2.1	925.68	925.58
