**ELLERBE CREEK STREAM RESTORATION – Project #127
Second Annual Monitoring Report - February 2007 - Final**

Designed by:
Stantec Consulting Services, Inc.
Suite 300, 801 Jones Franklin Road
Raleigh, North Carolina 27606

North Carolina Department of Environment and
Natural Resources
Ecosystem Enhancement Program
1652 Mail Service Center
Raleigh, NC 27699-1652

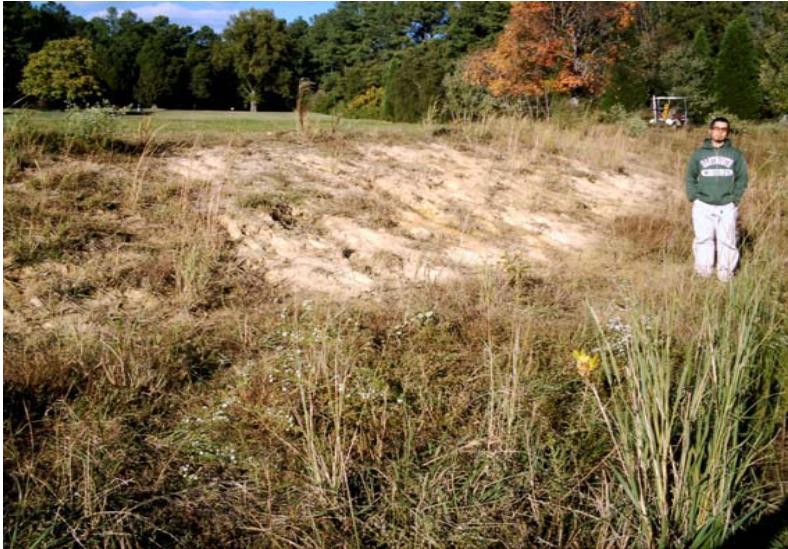
Feature/Issue	Station/Range	Probable Cause	Photo #
Bare soil/eroded slopes	1110-1260	Compated soil/high runoff from golf course	VP1, VP2
Bare soil/eroded slopes	1800-1975	Compated soil/high runoff from golf course	VP1, VP2
Bare soil/eroded slopes	1850-2020	Compated soil/high runoff from golf course	VP1, VP2
Beaver browsing	2880-2910	Beaver dams in area	VP3
Bare soil/eroded slopes	3490-3560	Compated soil/high runoff from golf course	VP1, VP2
Bare soil/eroded slopes	6235-6470	Compated soil/high runoff from golf course	VP1, VP2
Beaver browsing	6355-6490	Beaver dams in area	VP3

Three vegetation problem areas were observed in the Hillsborough reach during the second growing season. Two of them are on the slopes between the terrace and the golf course. They are likely to have resulted from rill and gully erosion in compacted subsoil. The third, and largest, vegetation problem area is the result of beaver damage to planted woody stems in the floodplain and lower terrace, immediately adjacent to the beaver ponds.

VP1. Bare / eroded soil

Replanting, mulching, and installation of erosion control devices (e.g. coir matting) in the rill and gully areas is recommended. During the June qualitative evaluation, a beaver dam was observed. Several more dams were observed during the September evaluation and vegetation monitoring and planted woody stems appeared have been harvested. The beaver on the site was reported to have been killed by an automobile during late November 2006 (Roy Clark, Greenskeeper, Hillandale Golf Course, personal communication). The dams were subsequently removed by an EEP subcontractor. Because the impacted planted woody stems adjacent to the ponds were unlikely to have been killed and may recover during the 2007 growing season, no remedial action is recommended at this time. In addition to beaver harvest in this floodplain area, planted woody stem vigor in this floodplain area was relatively low. Because of the low slope in this floodplain area, the cause appears to be lack of and adequate growth medium (i.e. too compact/not enough organic material/nutrients).

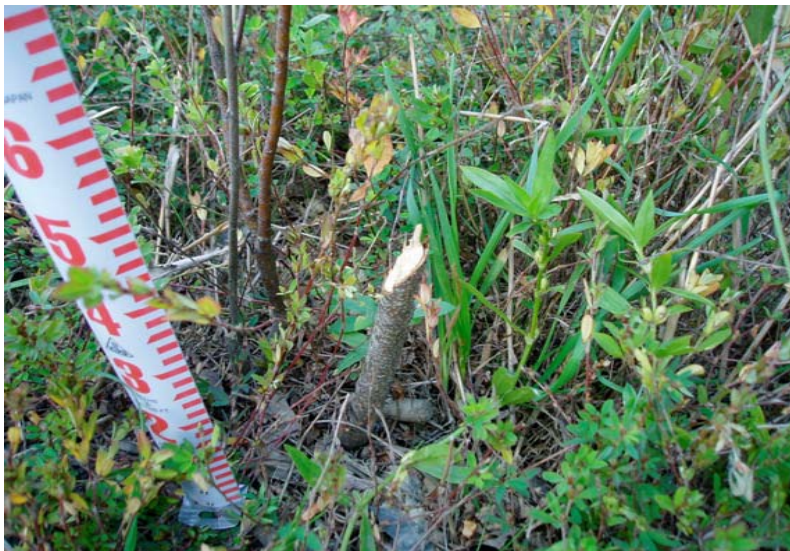
Two small, relative narrow, beaver harvest areas were observed along both banks, immediately downstream of the Croasdaile Bridge. Like the areas described above, the impacted planted woody stems are unlikely to have been killed and, because of the beaver's death and removal of the dams, they are likely to re-sprout during the 2007 growing season.

VP3. Beaver harvest

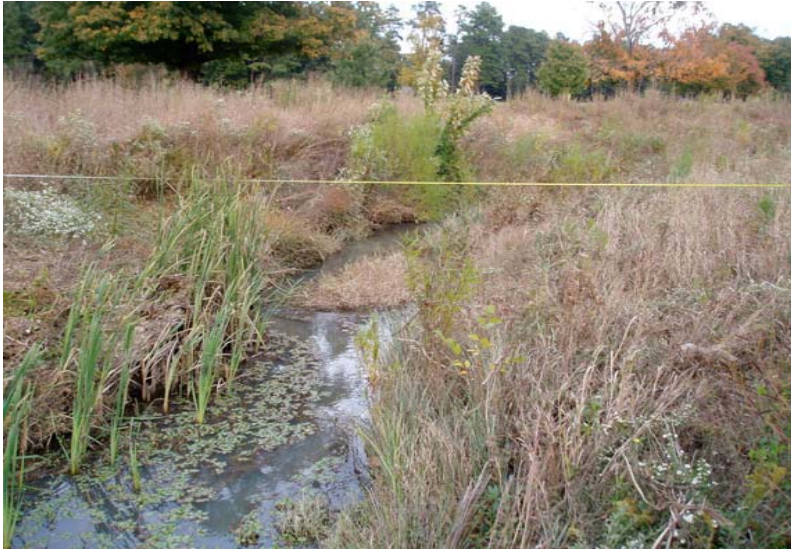
Exhibit Table X. Stream Problem Areas – Ellerbe Stream Restoration – Project #127			
Feature/Issue	Station	Probable Cause	Photo #
Bank undercut	1010.5	Rootwad needed	SP6
Aggradation (bar)	1234	Unknown	SP1
Rill and gully	1291	Insufficient growth medium	SP5
Aggradation (pool)	1369.2	Beaverdam	SP2
Rill and gully	1496.2	Insufficient growth medium	SP5
Rill and gully	1596	Insufficient growth medium	SP5
Beaver dam	1682	Colonization from downstream	SP3,4
Rill and gully	1767	Insufficient growth medium	SP3,4
Aggradation (pool)	1791	Beaverdam	SP2
Rootwad undercut	1824	Unknown	SP7
Beaverdam	1985	Colonization from downstream	SP4

SP1. Aggradation (bar)

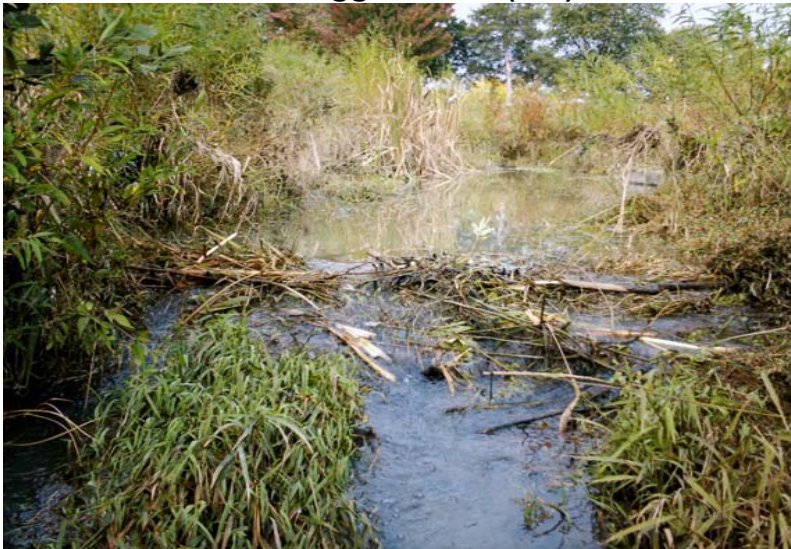
Most structural problems observed were caused by the occupation of the site by one or more beavers. The constructed dams caused flooding throughout the restoration site. This eliminated a normal sediment transport regime and caused impacts to vegetation through flooded conditions and beaver harvest of planted woody stems. Other instream problems observed were flooding/burying of cross-vanes, which was presumably worsened by the presence of beaver dams causing excessive sediment collection in some areas and low flows and minimal deposition in others. In one area where the dam had failed, the stream was developing a new pattern by downcutting through the deposited sediment.

SP3. Beaverdam

As noted above, the beaver and its dams have since been removed from the restoration site and therefore, immediate remedial action is not recommended.
