**ELLERBE CREEK STREAM RESTORATION – Project #127
Third Annual Monitoring Report - February 2008 - FINAL**

Designed by:
Stantec Consulting Services, Inc.
Suite 300, 801 Jones Franklin Road
Raleigh, North Carolina 27606

North Carolina Department of Environment and
Natural Resources
Ecosystem Enhancement Program
1652 Mail Service Center
Raleigh, NC 27699-1652

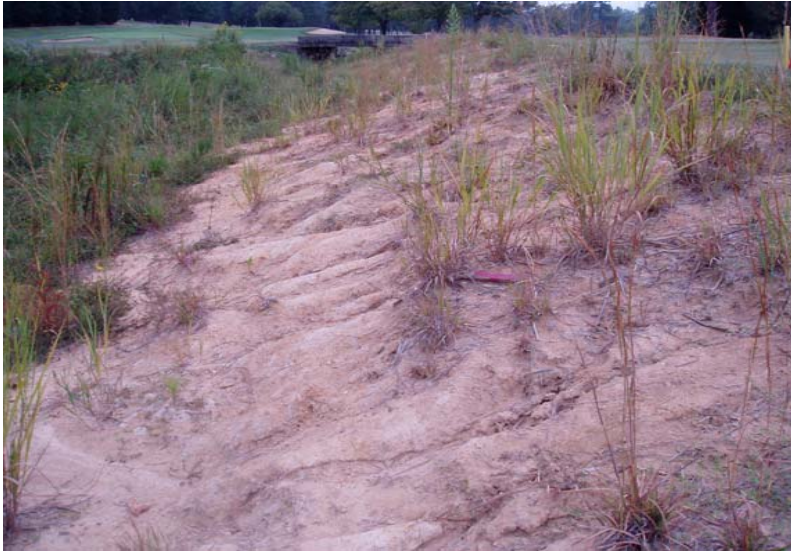
Exhibit Table 6. Vegetation Problem Areas – Ellerbe Creek Stream Restoration – Project #127			
Feature/Issue	Station/Range	Probable Cause	Photo #
Bare soil/eroded slopes	1140-1280	Compated soil/high runoff from golf course	VP1
Bare soil/eroded slopes	1840-2025	Compated soil/high runoff from golf course	VP1
Bare soil/eroded slopes, including floodplain	1890-2070	Compated soil/high runoff from golf course	VP1, VP2
Bare soil/eroded slopes	3540-3630	Compated soil/high runoff from golf course	VP1
Bare soil/eroded slopes, including floodplain	5555-5840	Compated soil/high runoff from golf course	VP1, VP2
Bare soil/eroded slopes, including floodplain	6315-6570	Compated soil/high runoff from golf course	VP1, VP2

VP1. Bare soil/eroded slopes

Replanting, mulching, and installation of erosion control devices (e.g. coir matting) in the rill and gully areas is recommended. Although poor soil/conditions in the larger vegetation problem area has resulted in bare soil and sparse herbaceous cover, the vegetation monitoring plot (HB-V3) located adjacent to the area contains 22 live, planted stems (or 890 stems per acre). Because the area is far exceeding the goal of 320 stems per acre, no remedial work appears to be necessary at this time. These areas should continue to be closely monitored.

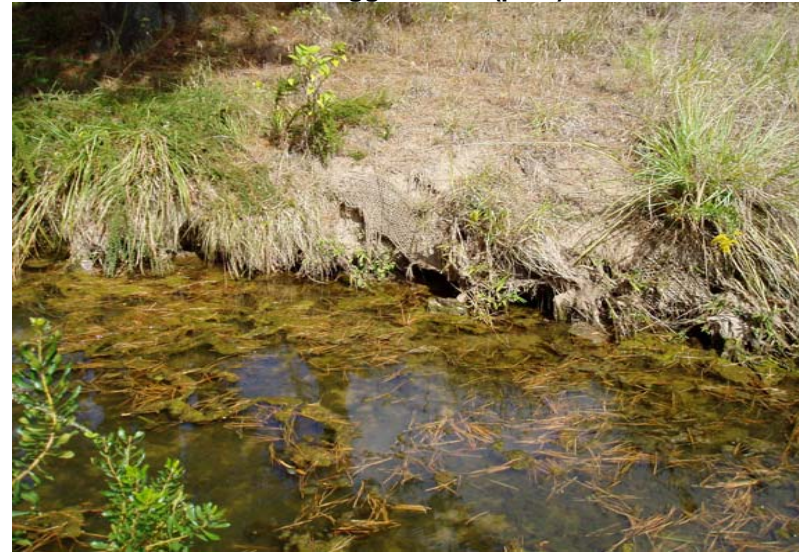
SP4. Bank undercut/scour
