**ELLERBE CREEK STREAM RESTORATION – Project #127
Fourth Annual Monitoring Report - 2008 - FINAL**

Submitted on January 30, 2009 to:

North Carolina Department of
Environment and Natural Resources
Ecosystem Enhancement Program
1652 Mail Service Center
Raleigh, NC 27699-1652

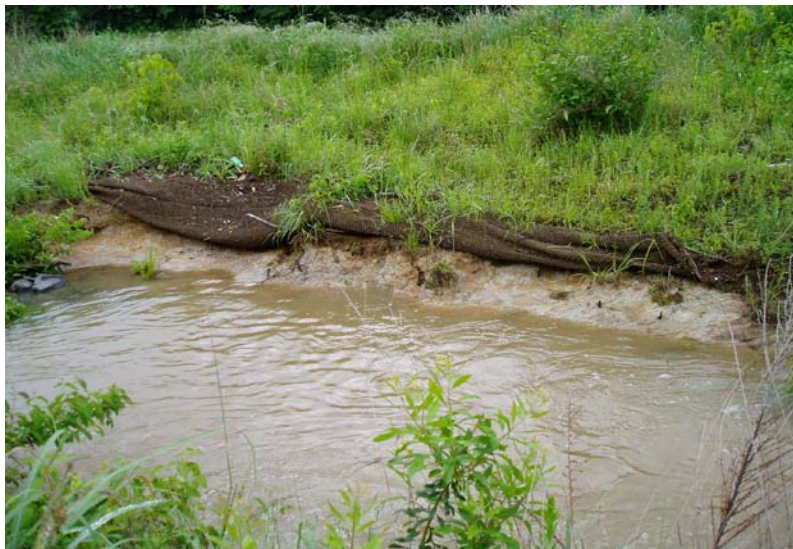
Feature/Issue	Station #s	Photo	Suspected Cause
Bank undercut/scour	1130-1145	SP1	Matting unattached
Bank undercut/scour	1290-1320	SP1	Scour beneath matting
Aggradation (pool)	1345-1360	SP2	Sediment from upstream/scour areas
Bank undercut/scour	1385-1403	SP6	Insufficient armoring
Aggradation (bar)	1407	SP7	Sediment from upstream/scour areas
Aggradation (bar)	1535	SP7	Sediment from upstream/scour areas
Rootwad under/backcut	1625	SP6	Rootwad placed too high in bank
Bank scour	1790	SP9	Scour in stormwater drainageway
Rill and gully	1860	SP5	Insufficient growth medium
Rootwad under/backcut	1870	SP6	Rootwad placed too high in bank
Bank erosion/scour	2300-2320	SP3	Under bridge, poor armoring of constricted flow passage
Aggradation (bar)	1000*	SP11	Sedimentation at culvert from upstream sources
Bank undercut/scour	2647-2670	SP6	Insufficient armoring
Bank undercut/scour	2750	SP6	Insufficient armoring below bridge culvert

SP1. Scour with unattached matting (4/16/08)

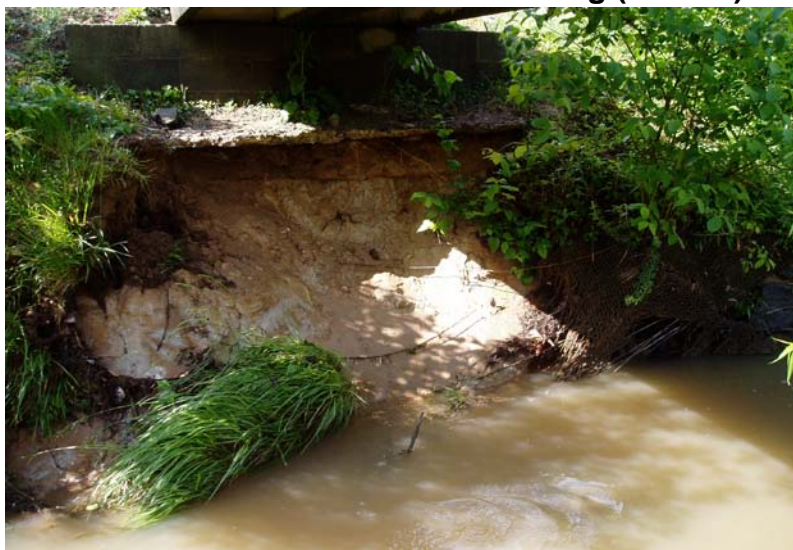
SP3. Bank scour under bridge (4/16/08)

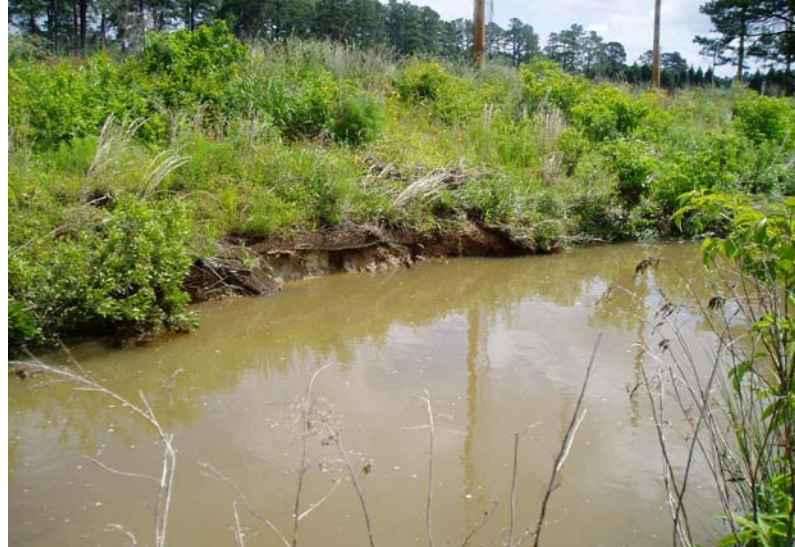
SP6. Bank slump/scour (9/18/08)

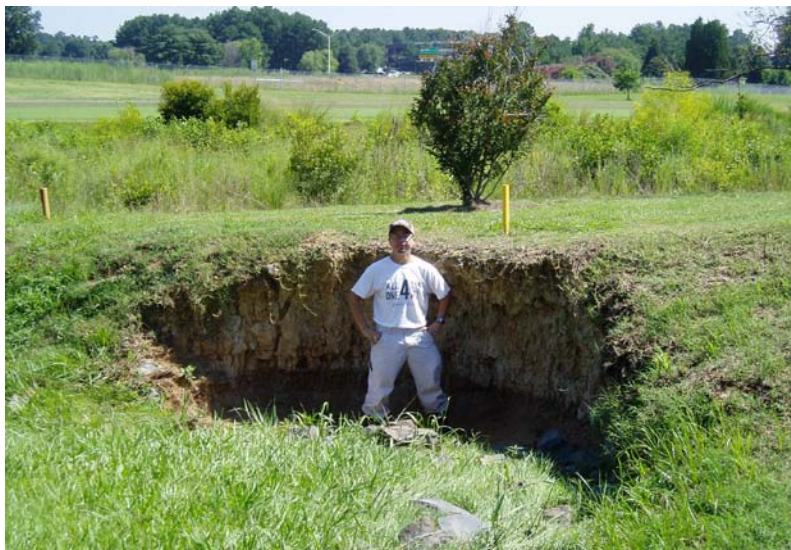
SP9. Scour in stormwater drainage (7/24/08)

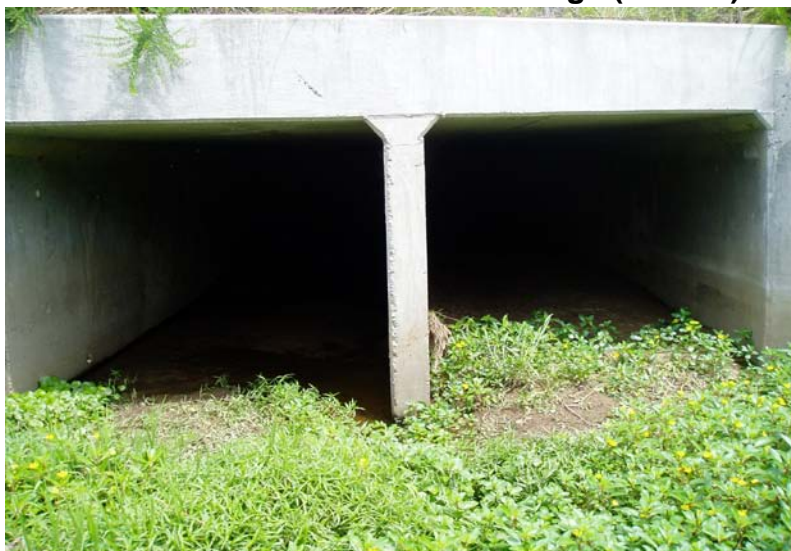
SP11. Aggregation at culvert (9/18/08)
