**ELLERBE CREEK STREAM RESTORATION – Project #127
Fifth Annual Monitoring Report - 2009 - FINAL**

Submitted on January 11, 2010 to:

North Carolina Department of
Environment and Natural Resources
Ecosystem Enhancement Program
1652 Mail Service Center
Raleigh, NC 27699-1652

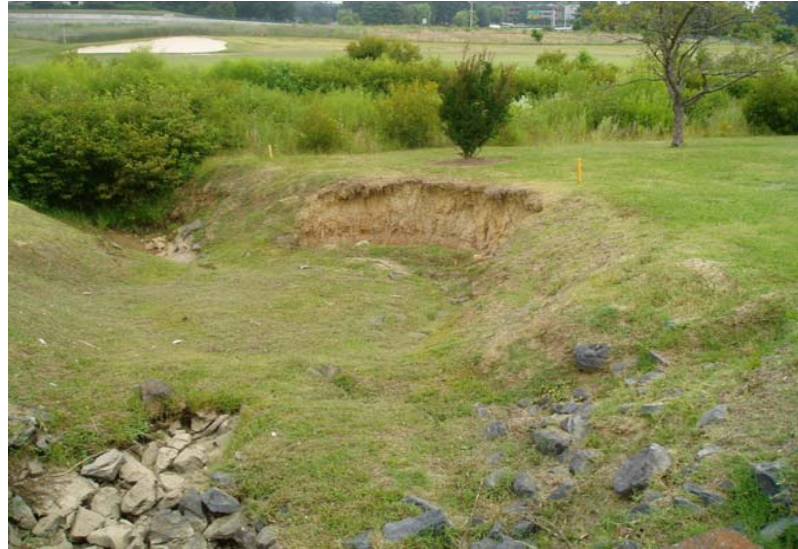
Feature/Issue	Station	Suspected Cause	Photo #
Rill and gully	1370	Insufficient growth medium	SP1
Beaverdam	1719	Beaver activity	SP8
Bank scour	1790	Scour in stormwater drainageway	SP2
Rill and gully	1860	Insufficient growth medium	SP1
Beaverdam	2060	Beaver activity	
Bank slump/scour	2060-2080	Insufficient rootwad/armoring	SP3
Beaverdam	2130	Beaver activity	SP8
Beaverdam	2219	Beaver activity	SP8
Aggradation (bar)	2220	Sedimentation due to downstream beaver dam	SP7
Bank erosion/scour	2300-2320	Under bridge, poor armoring of constricted flow passage	SP4
Aggradation (bar)	1000*	Sedimentation at culvert from upstream sources	SP7
Aggradation (bar)	1125*	Sedimentation from level spreader	SP7
Beaverdam	2415	Beaver activity	SP8
Beaverdam	2599	Beaver activity	SP8
Beaverdam	2975	Beaver activity	SP8
Beaverdam	3452	Beaver activity	SP8
Beaverdam	3992	Beaver activity	SP8
Beaverdam	4770	Beaver activity	SP8
Bank slump/scour	4955-5005	Insufficient rootwad/armoring	SP6

SP2. Scour in stormwater drainage (7/16/09)

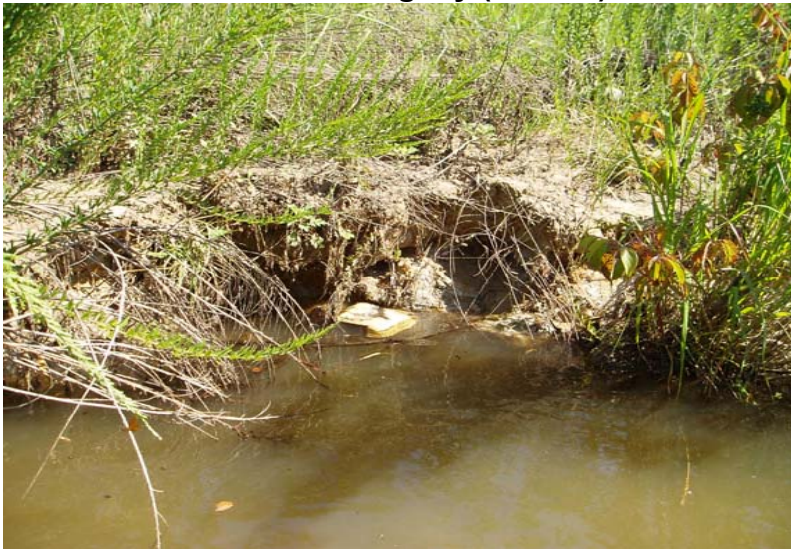
SP3. Bank scour (7/01/09)

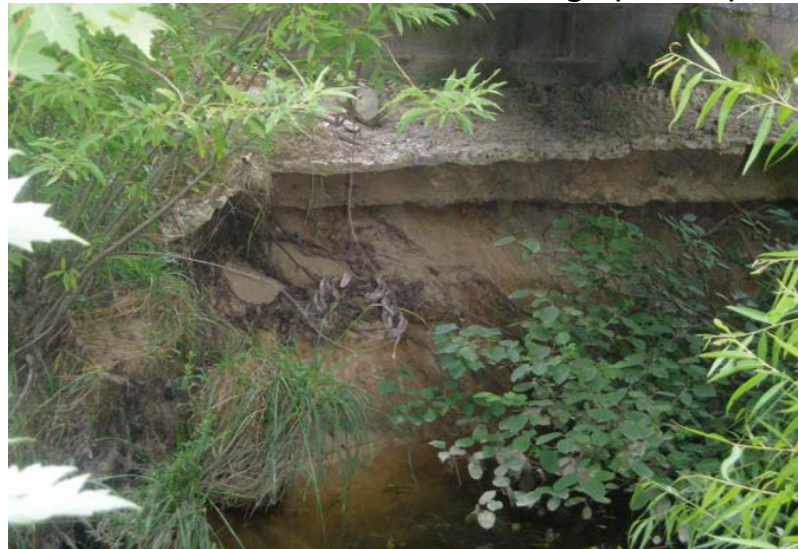
SP4. Scour under bridge footer (7/16/09)
