**ELLINGTON BRANCH STREAM RESTORATION SITE
FULL DELIVERY PROJECT
WARREN COUNTY, NORTH CAROLINA**

EEP Project No. 16-D06045

FINAL Monitoring Report #1 (Year 2008)

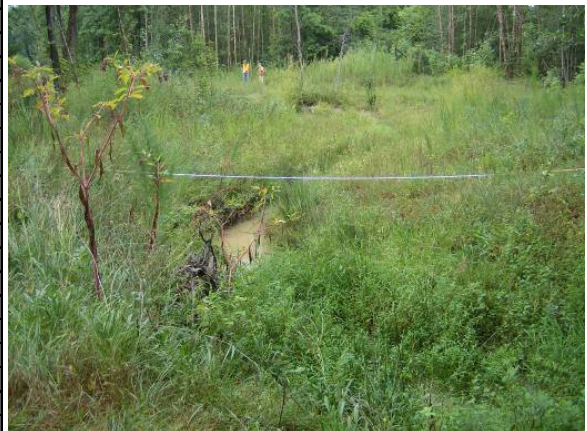
Facing downstream along Cross Section #1 (2008)

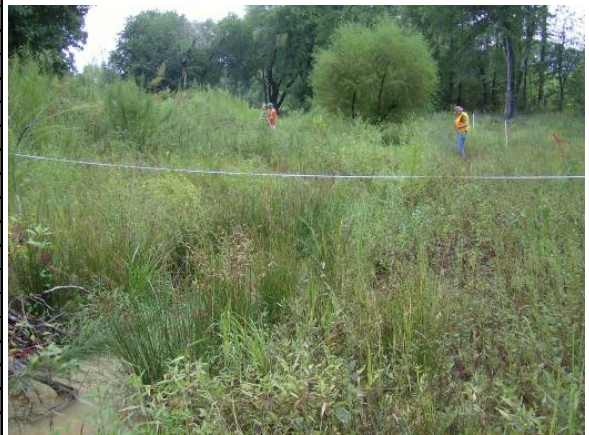
Facing downstream at Cross Section #2 (2008)

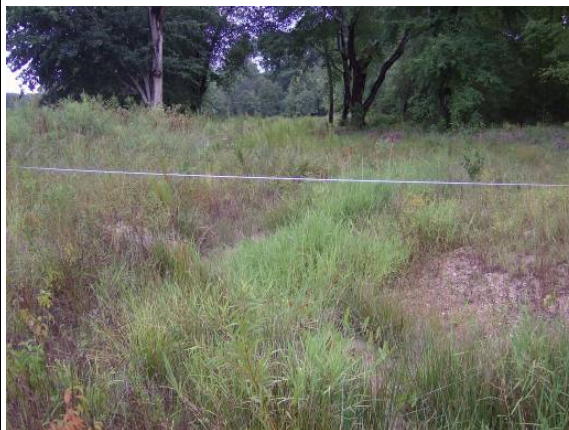
Facing downstream at Cross Section #3 (2008)

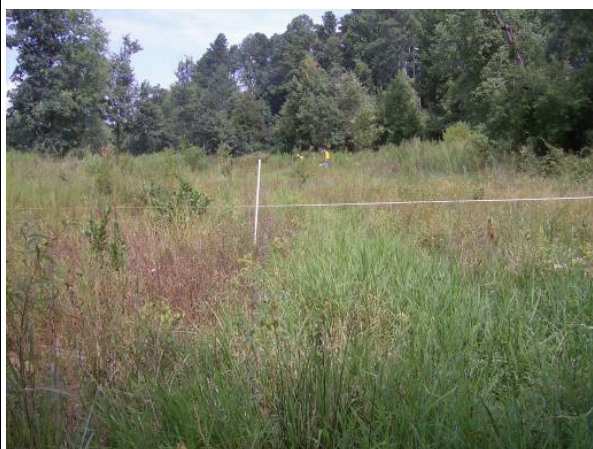
Facing downstream at Cross Section #4 (2008)

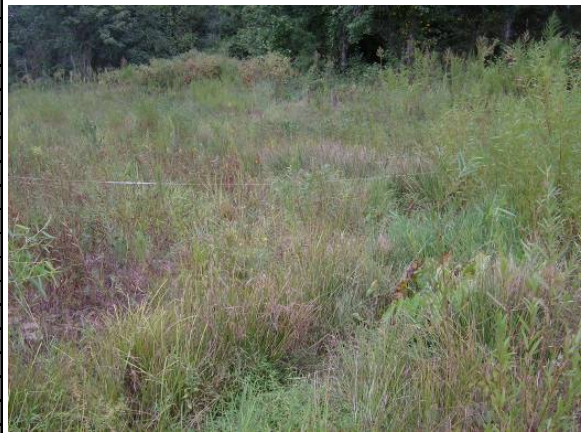
Facing downstream at Cross Section #5 (2008)

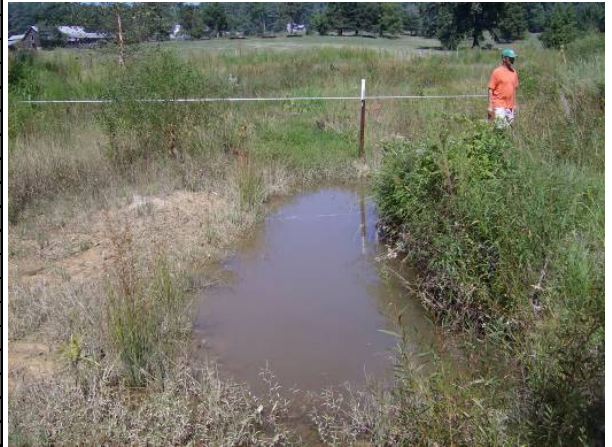
Facing downstream at Cross Section #6 (2008)

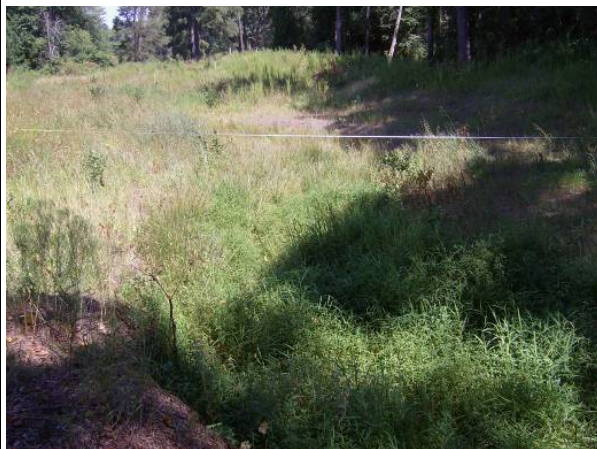
Facing downstream at Cross Section #7 (2008)

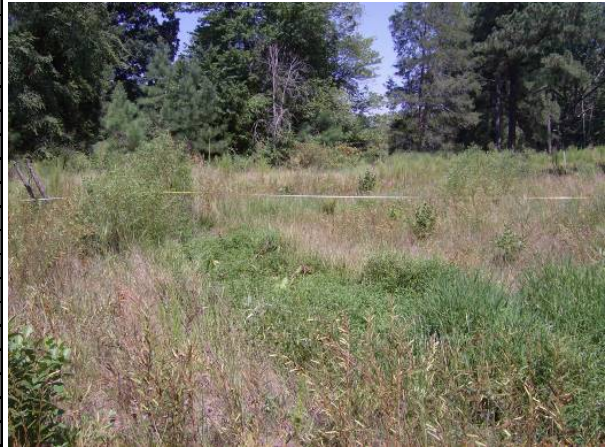
Facing downstream at Cross Section #8 (2008)

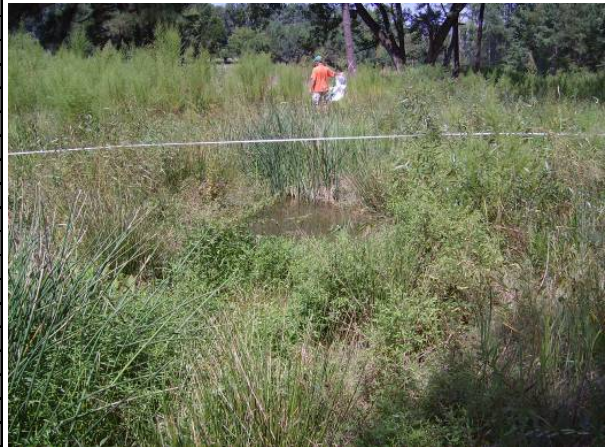
Facing downstream at Cross Section #9 (2008)

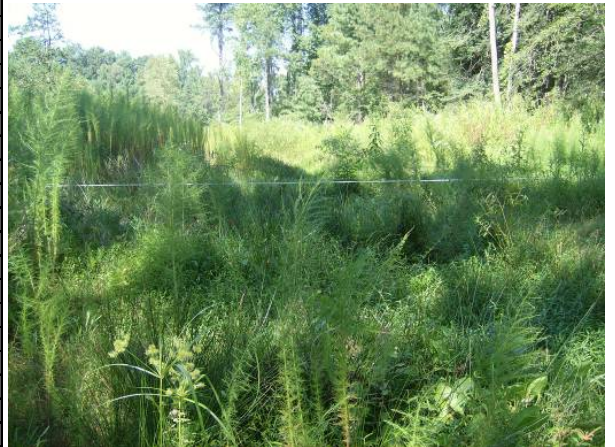
Facing downstream at Cross Section #10 (2008)

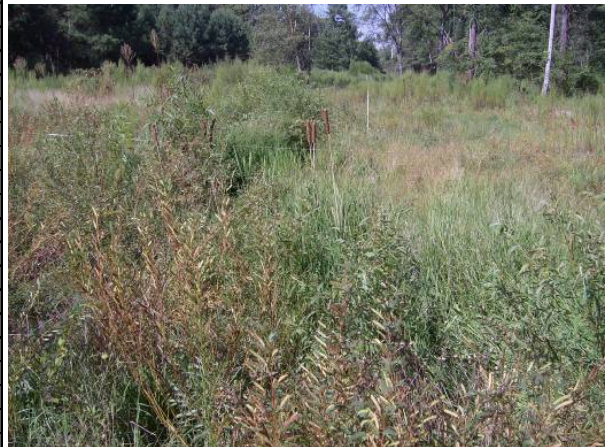
Facing downstream at Cross Section #11 (2008)

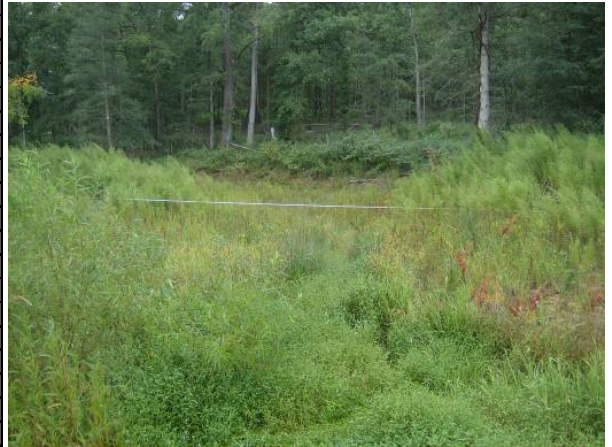
Facing downstream at Cross Section #12 (2008)

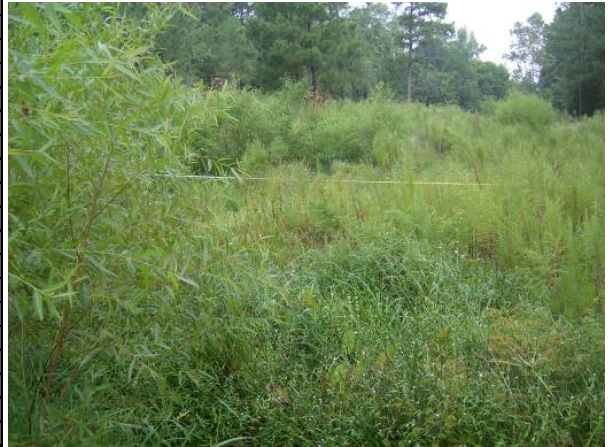
Facing downstream at Cross Section #13 (2008)

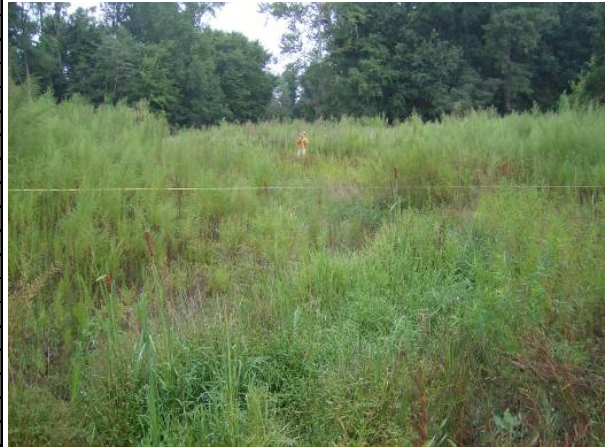
Facing downstream at Cross Section #14 (2008)

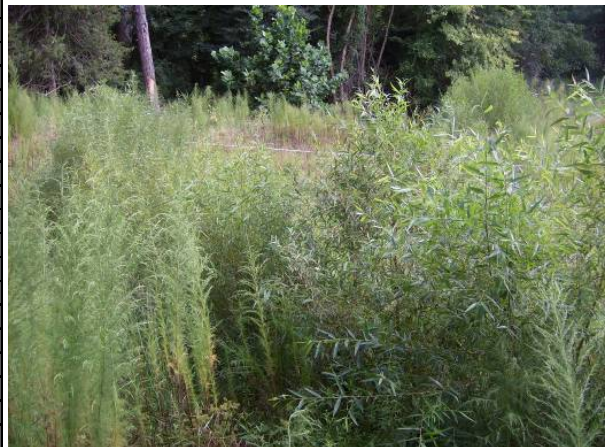
Facing downstream at Cross Section #15 (2008)

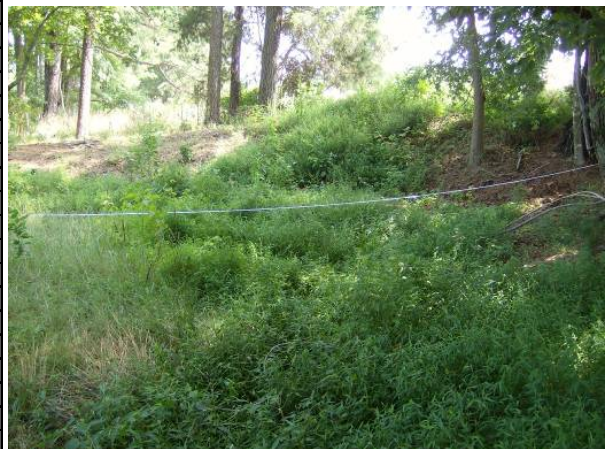
Facing downstream at Cross Section #16 (2008)

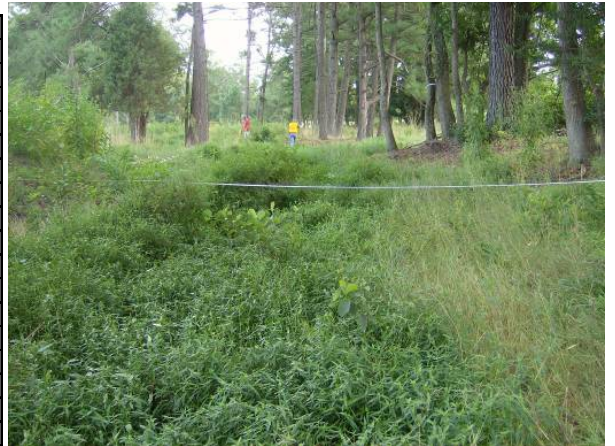
Facing downstream at Cross Section #17 (2008)

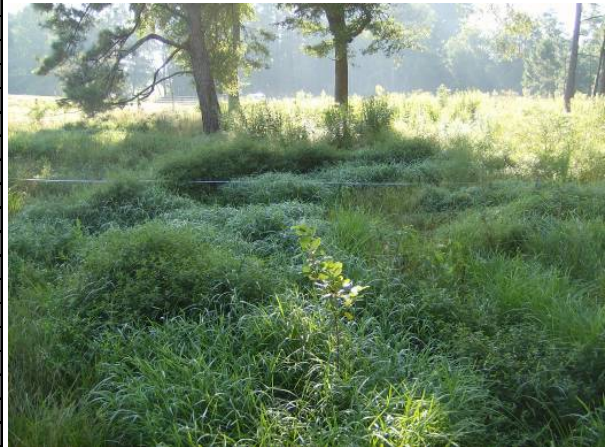
Facing downstream at Cross Section #18 (2008)

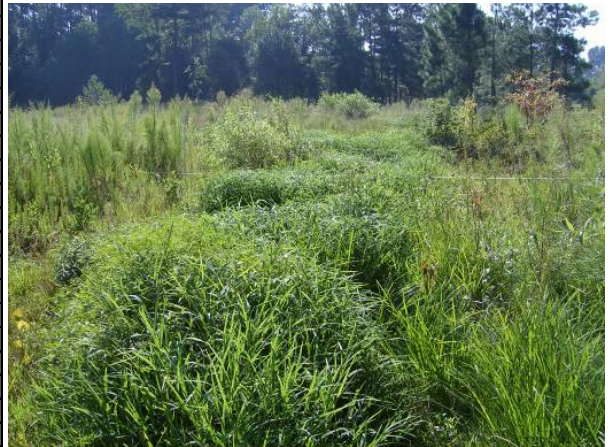
Facing downstream at Cross Section #19 (2008)
