**ELLINGTON BRANCH STREAM RESTORATION SITE
FULL DELIVERY PROJECT
WARREN COUNTY, NORTH CAROLINA**

EEP Project No. 16-D06045

Final Monitoring Report MY5 (Year 2012)

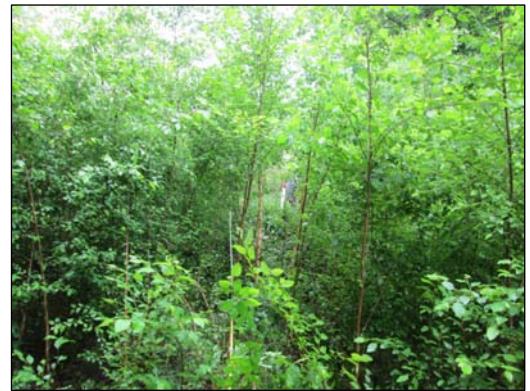
Facing west along Cross Section #1 (2012)

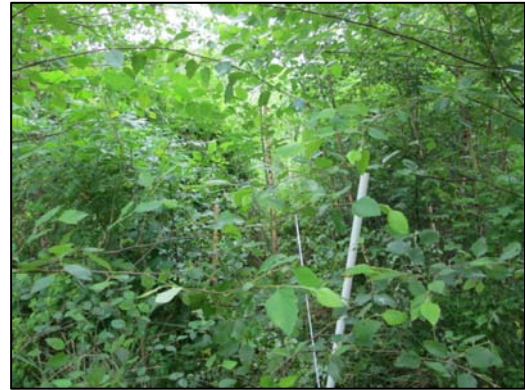
Facing west along Cross Section #3 (2012)

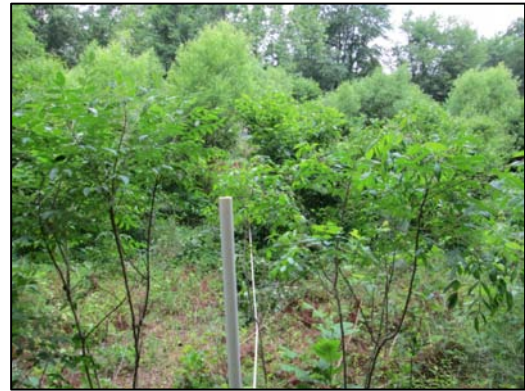
Facing west along Cross Section #7 (2012)

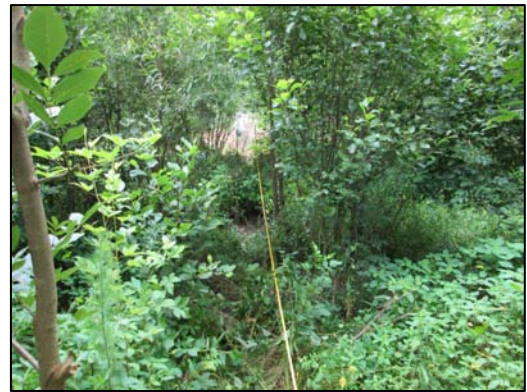
Facing west along Cross Section #9 (2012)

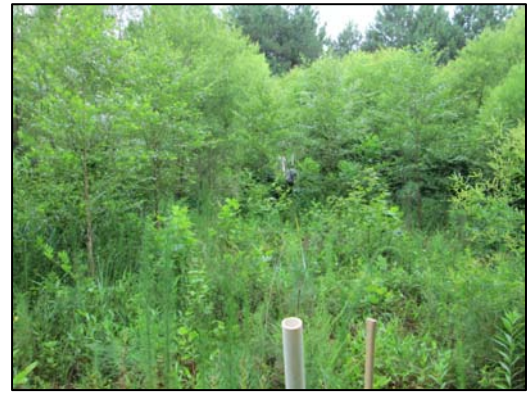
Facing west along Cross Section #13 (2012)

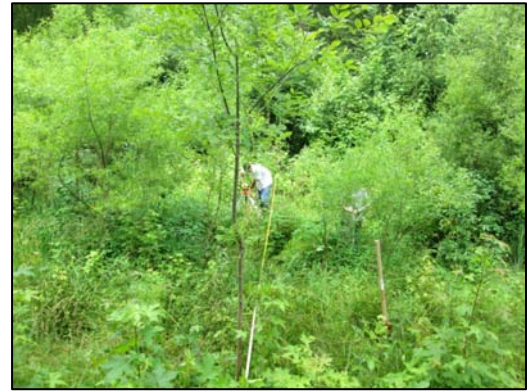
Facing west along Cross Section #14 (2012)

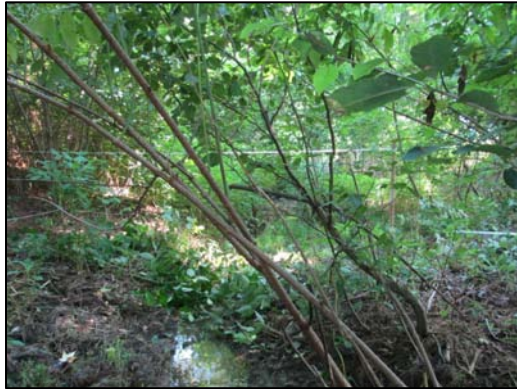
Facing east (downstream) at Cross Section #17 (2012)

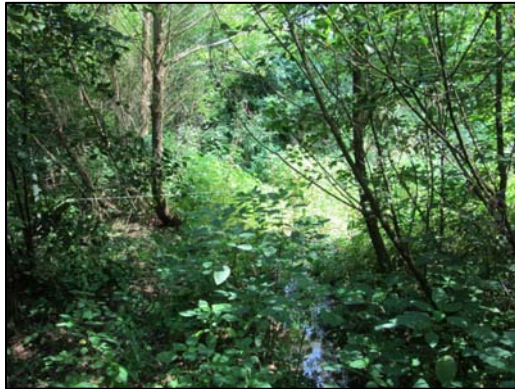
Facing east (downstream) at Cross Section #19 (2012)

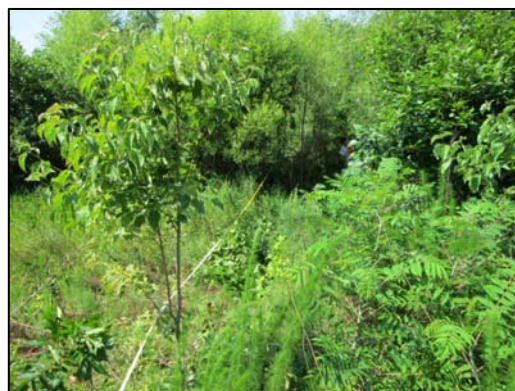
Facing west along Cross Section #21 (2012)

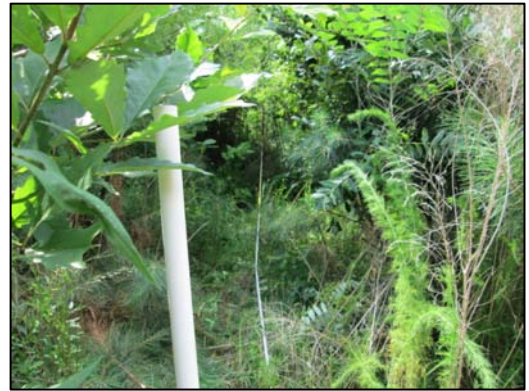
Facing west along Cross Section #22 (2012)

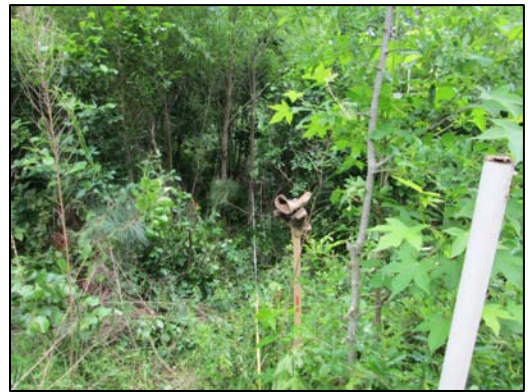
Facing west along Cross Section #23 (2012)
