**Farrar Dairy Stream and Wetland Restoration Site
Monitoring Report – MY01
Harnett County, NC**

December 2009

**Project Manager: Tim Morris
Email: tim.morris@kci.com
KCI Project No: 12065438**

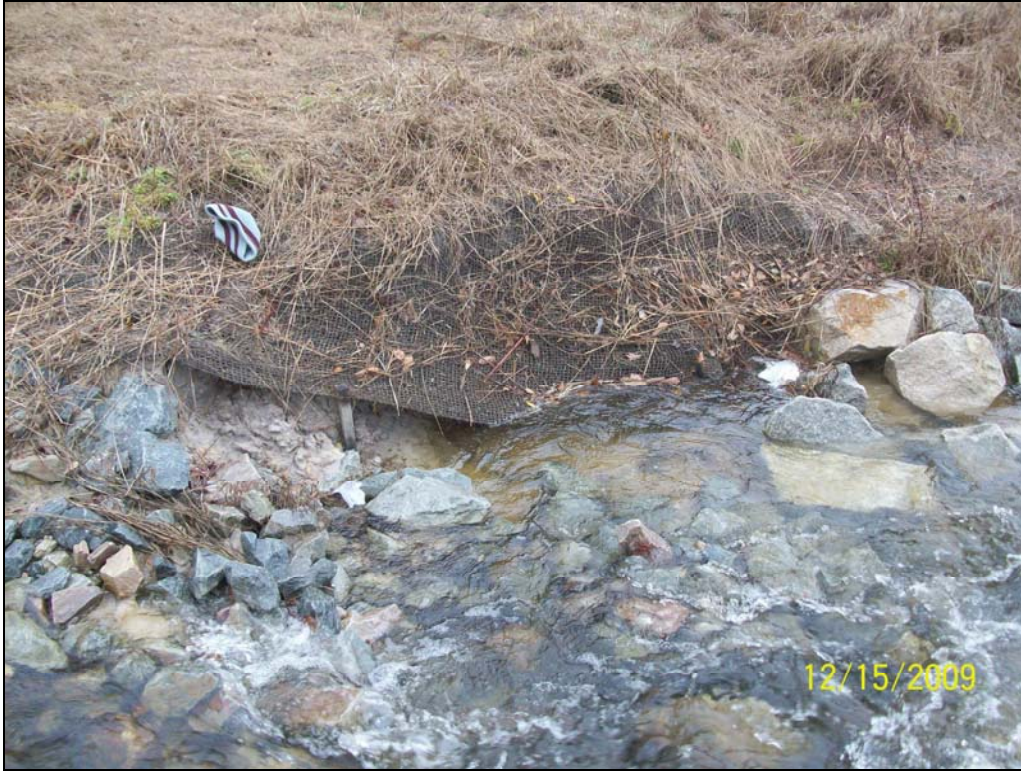
Bank erosion under coir matting near Station 12+50. MY01 – 12/15/09

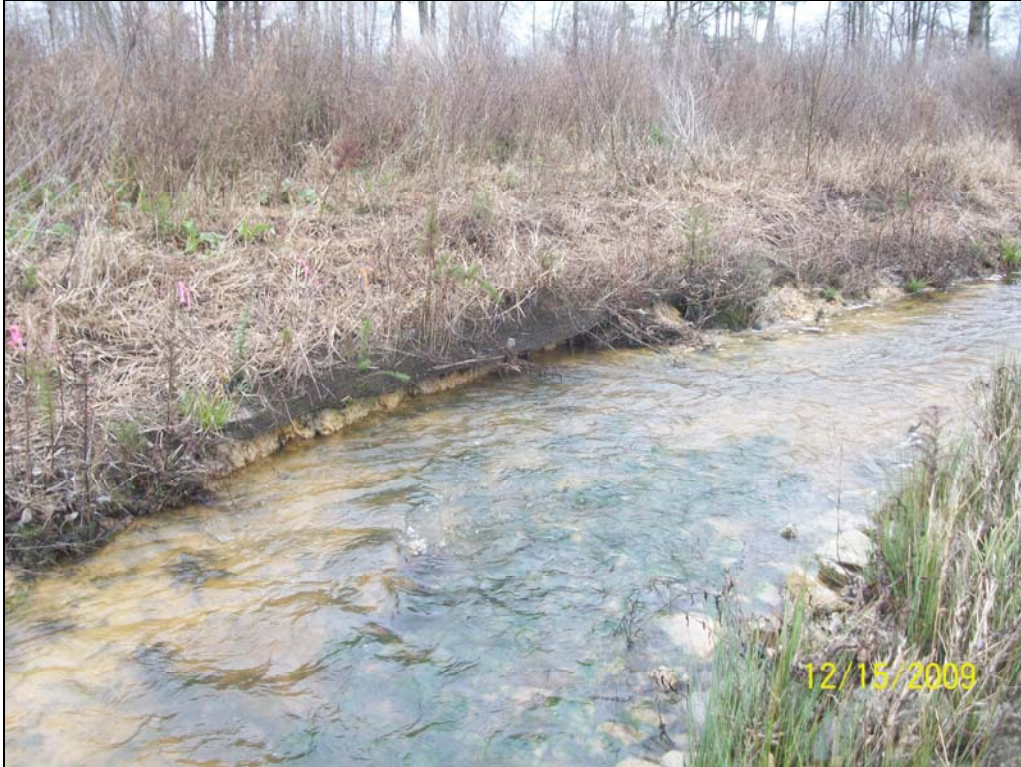
Erosion along toe of bank under coir matting near Station 55+25. MY01 – 12/15/09

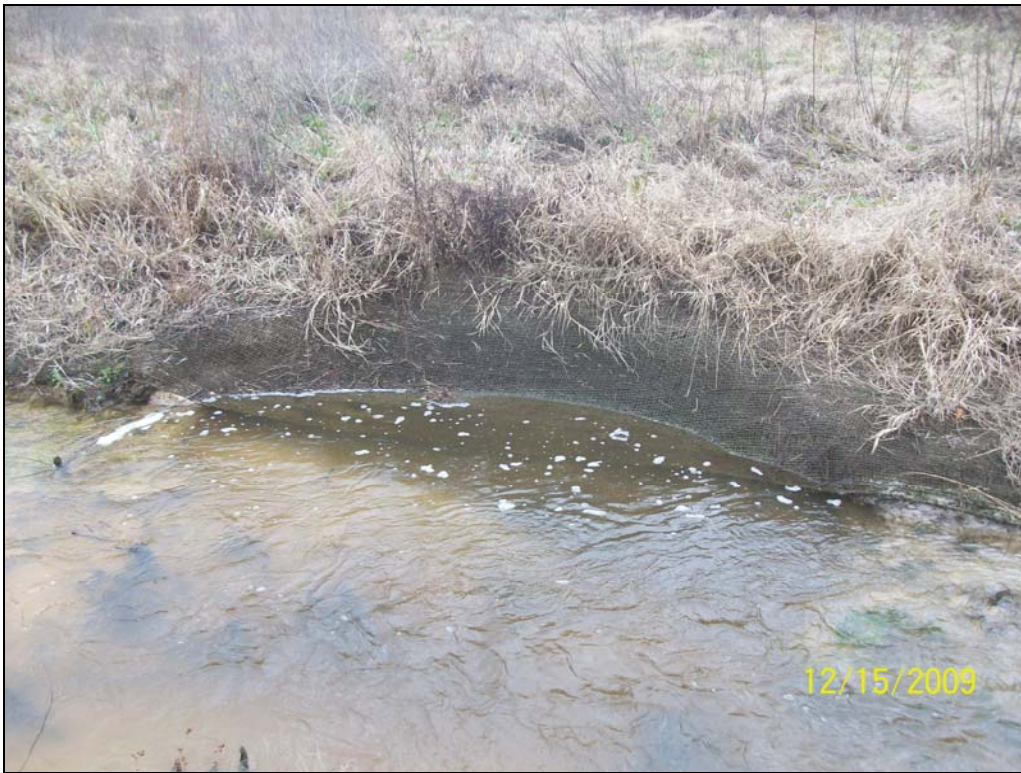
Bank erosion under coir matting near Station 56+60. MY01 – 12/15/09
