**Farrar Dairy Stream and Wetland Restoration Site
Monitoring Report – MY02
Harnett County, NC**

January 2011

**Project Manager: Tim Morris
Email: tim.morris@kci.com
KCI Project No: 12065438**

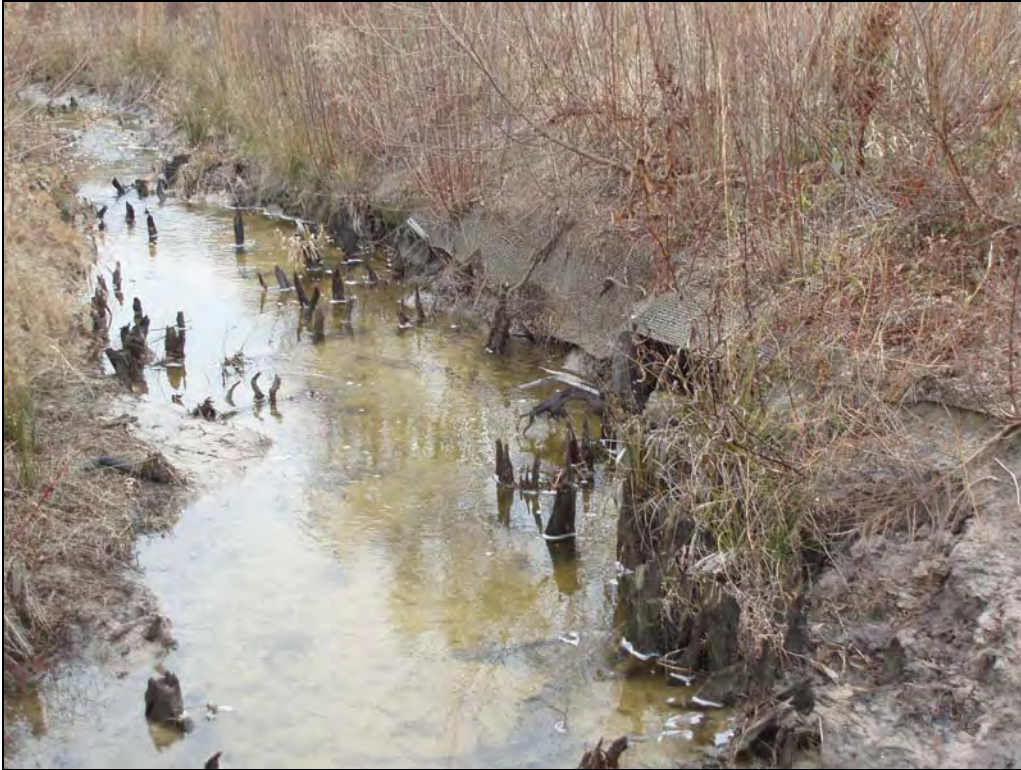
Erosion along toe of bank under coir matting near Station 60+75. MY02 – 12/22/10

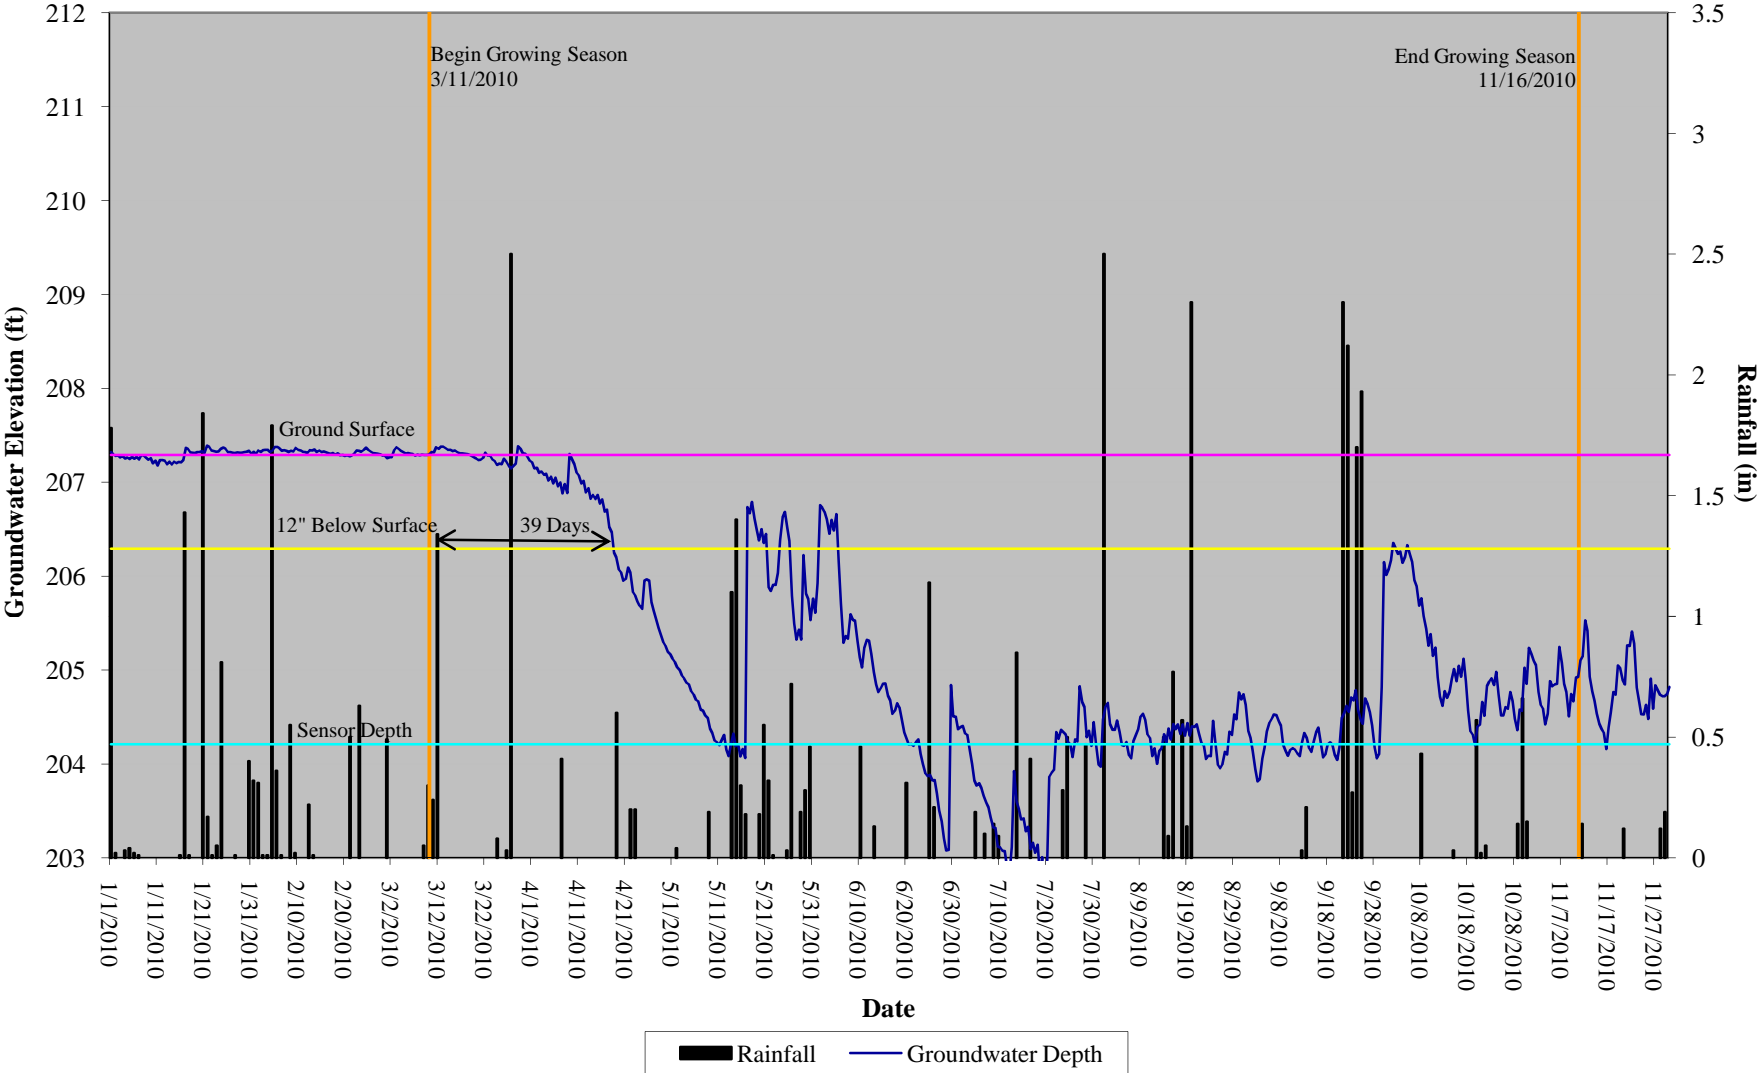
Farrar Dairy Restoration Site Hydrograph Wetland Gauge 7

*Sensor elevation higher than jurisdictional elevation. Sensor depth will be lowered for Monitoring Year 3.

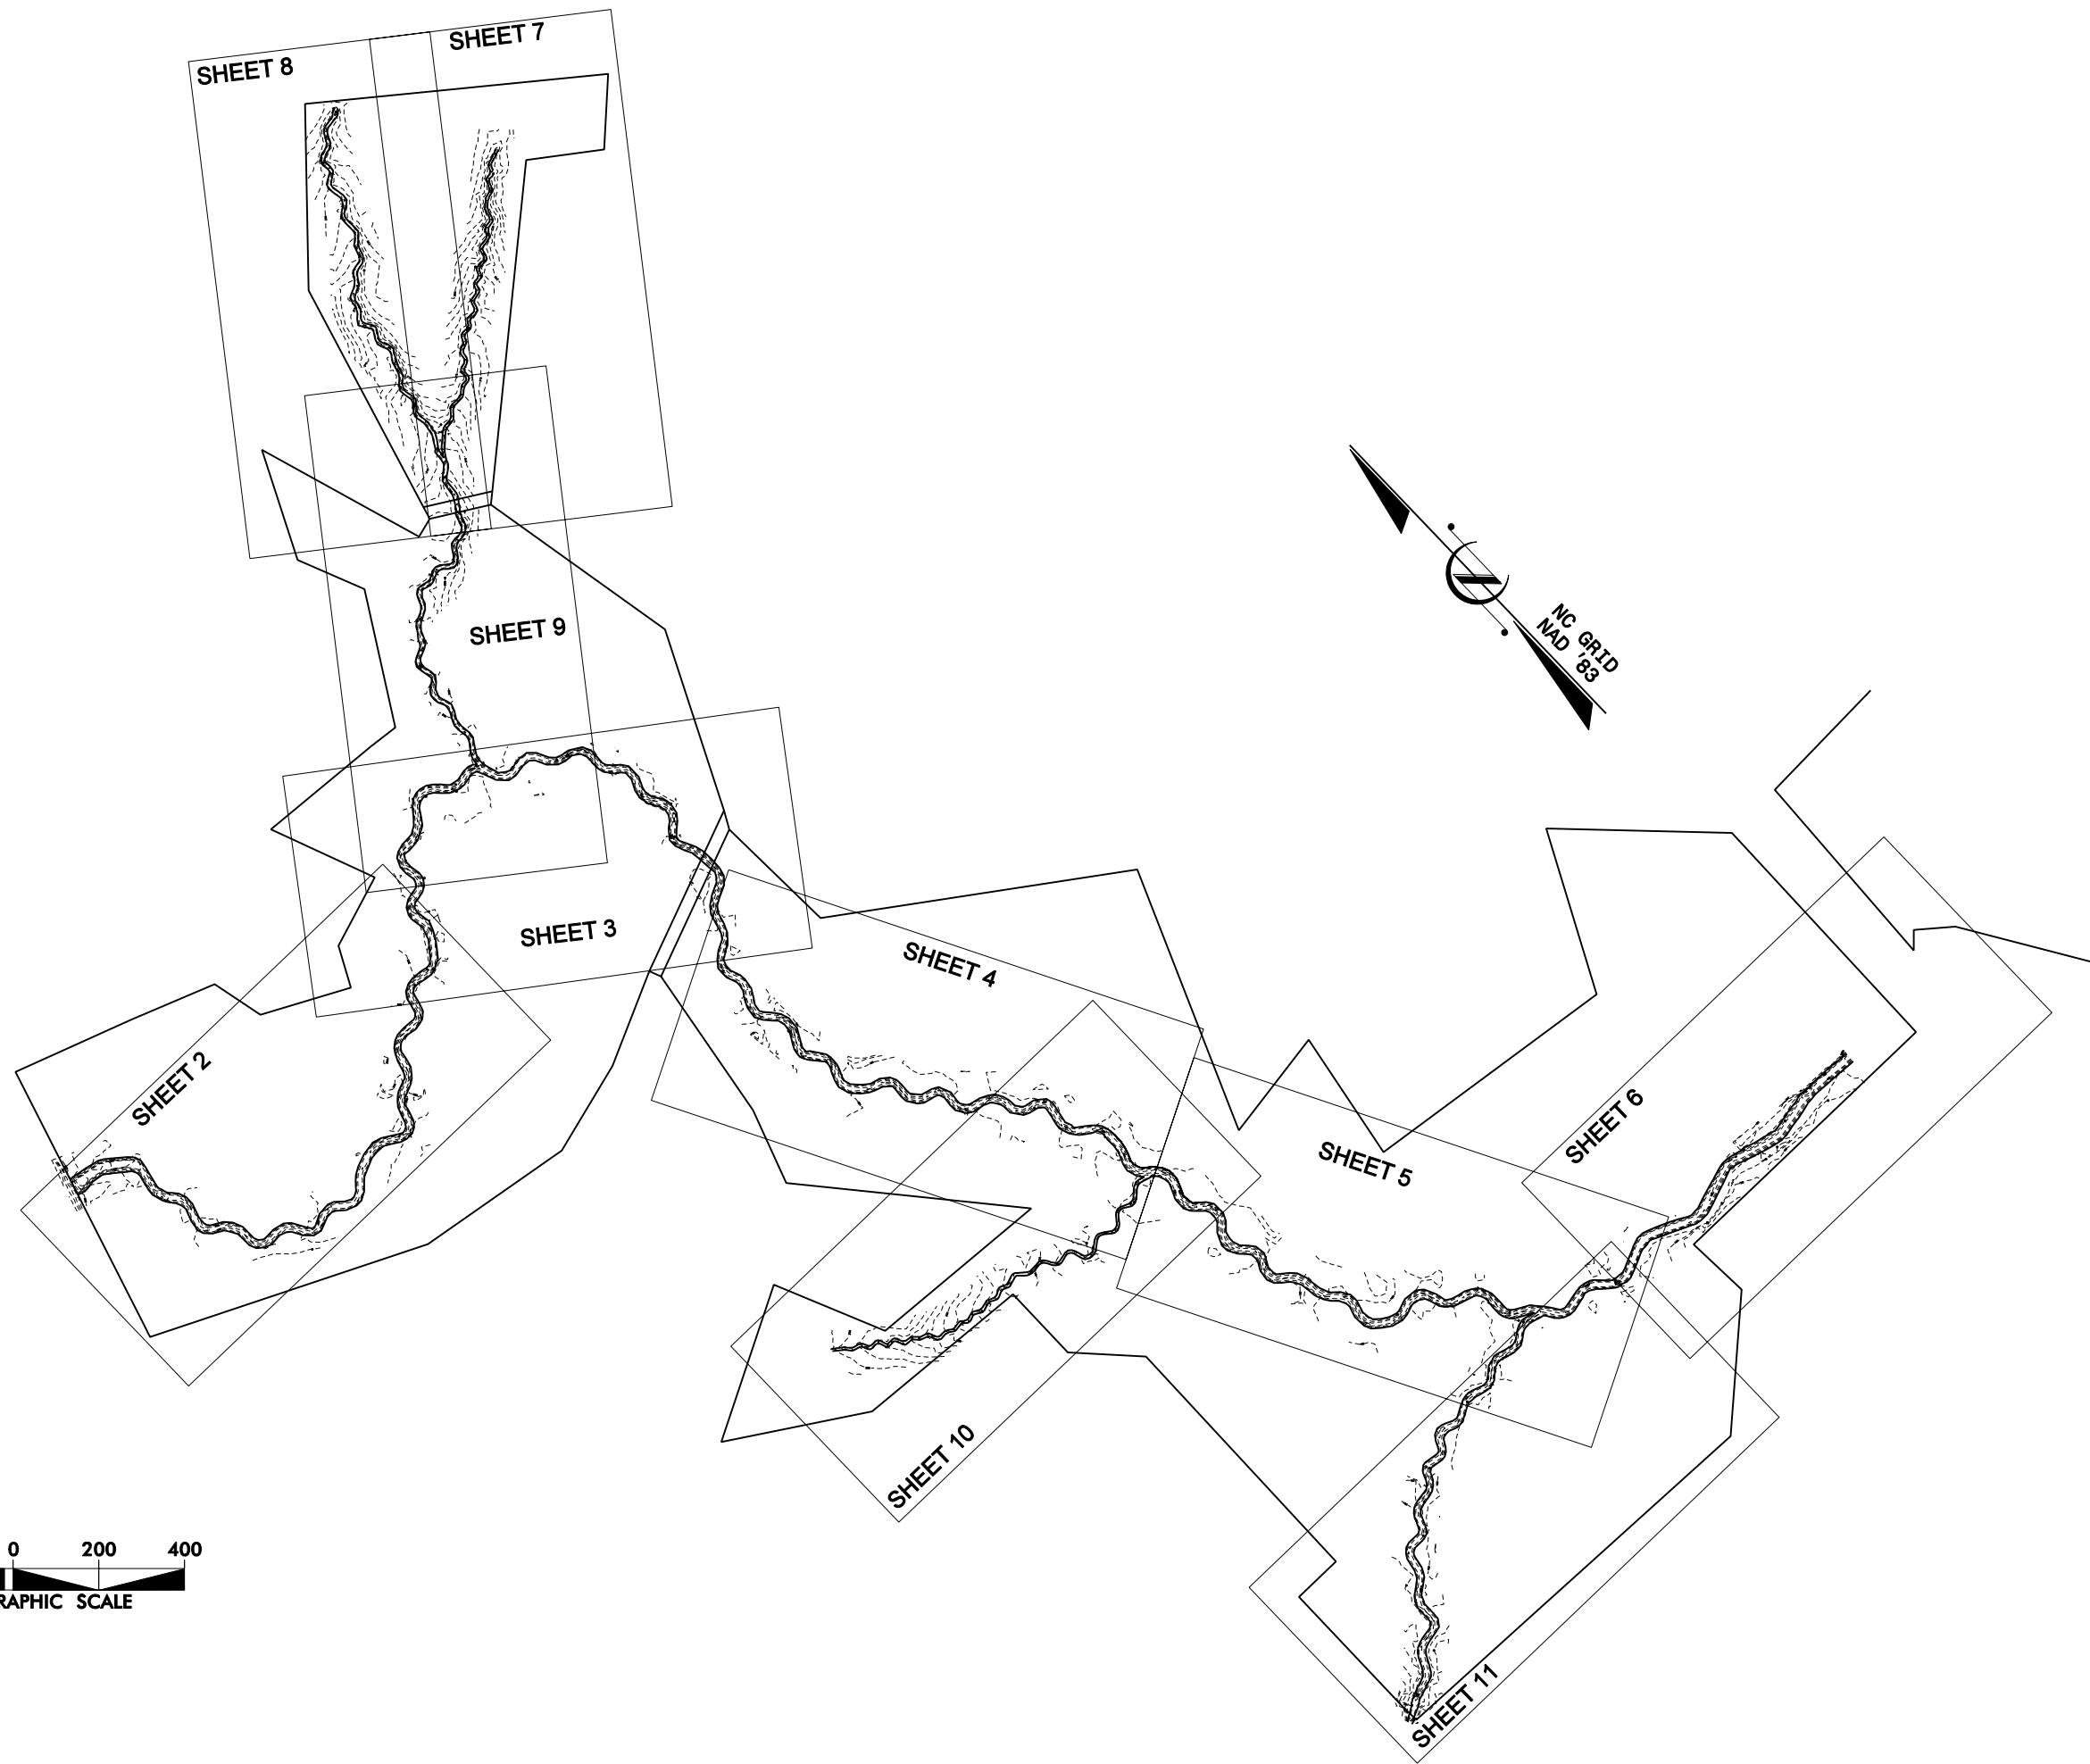
Current Condition Plan View

The stream assessment found the project streams to be stable. T1.1 and T1 experienced isolated bed degradation during the first year of monitoring, but no further migration was shown on monitoring year two. In October 2010, additional log sills were installed along T1 to provide additional grade control as preventive maintenance. The longitudinal profile and visual assessment of Tributary 3 showed aggradation in the upper part of the tributary. This aggradation is due to poor stream stability upstream of the site, which has contributed fine sediment to the stream. This is not expected to be a problem, but it will continue to be monitored. On NPAC, there are isolated areas of bank erosion, which are depicted in the CCPV. Small amounts of bed degradation have exposed old roots on the stream bottom of the lower reaches of NPAC. These roots disrupt stream flow on the stream bottom and in some cases have caused localized bed degradation. While this is not a systemic problem and is not predicted to cause widespread stream instability, KCI did conduct some maintenance in these areas to prevent these isolated problem areas from worsening. This maintenance occurred in October 201 and involved regrading and stabilizing small areas of banks erosion and bed degradation on the upper end of NPAC. All of these stream features will continue to be monitored to make sure that any observed changes are within the range of variability found in stable stream systems. The 2010 maintenance areas are shown in the CCPV.
