## **Year 1 of 5 Monitoring Report**

**Five-Mile Branch Stream and Wetland  
Restoration, Iredell County**

**NCEEP IMS ID# 92185**

Our Ref.:  
NC604017.0000  
Project Manager:  
Robert Lepsic  
Date:  
January 2014

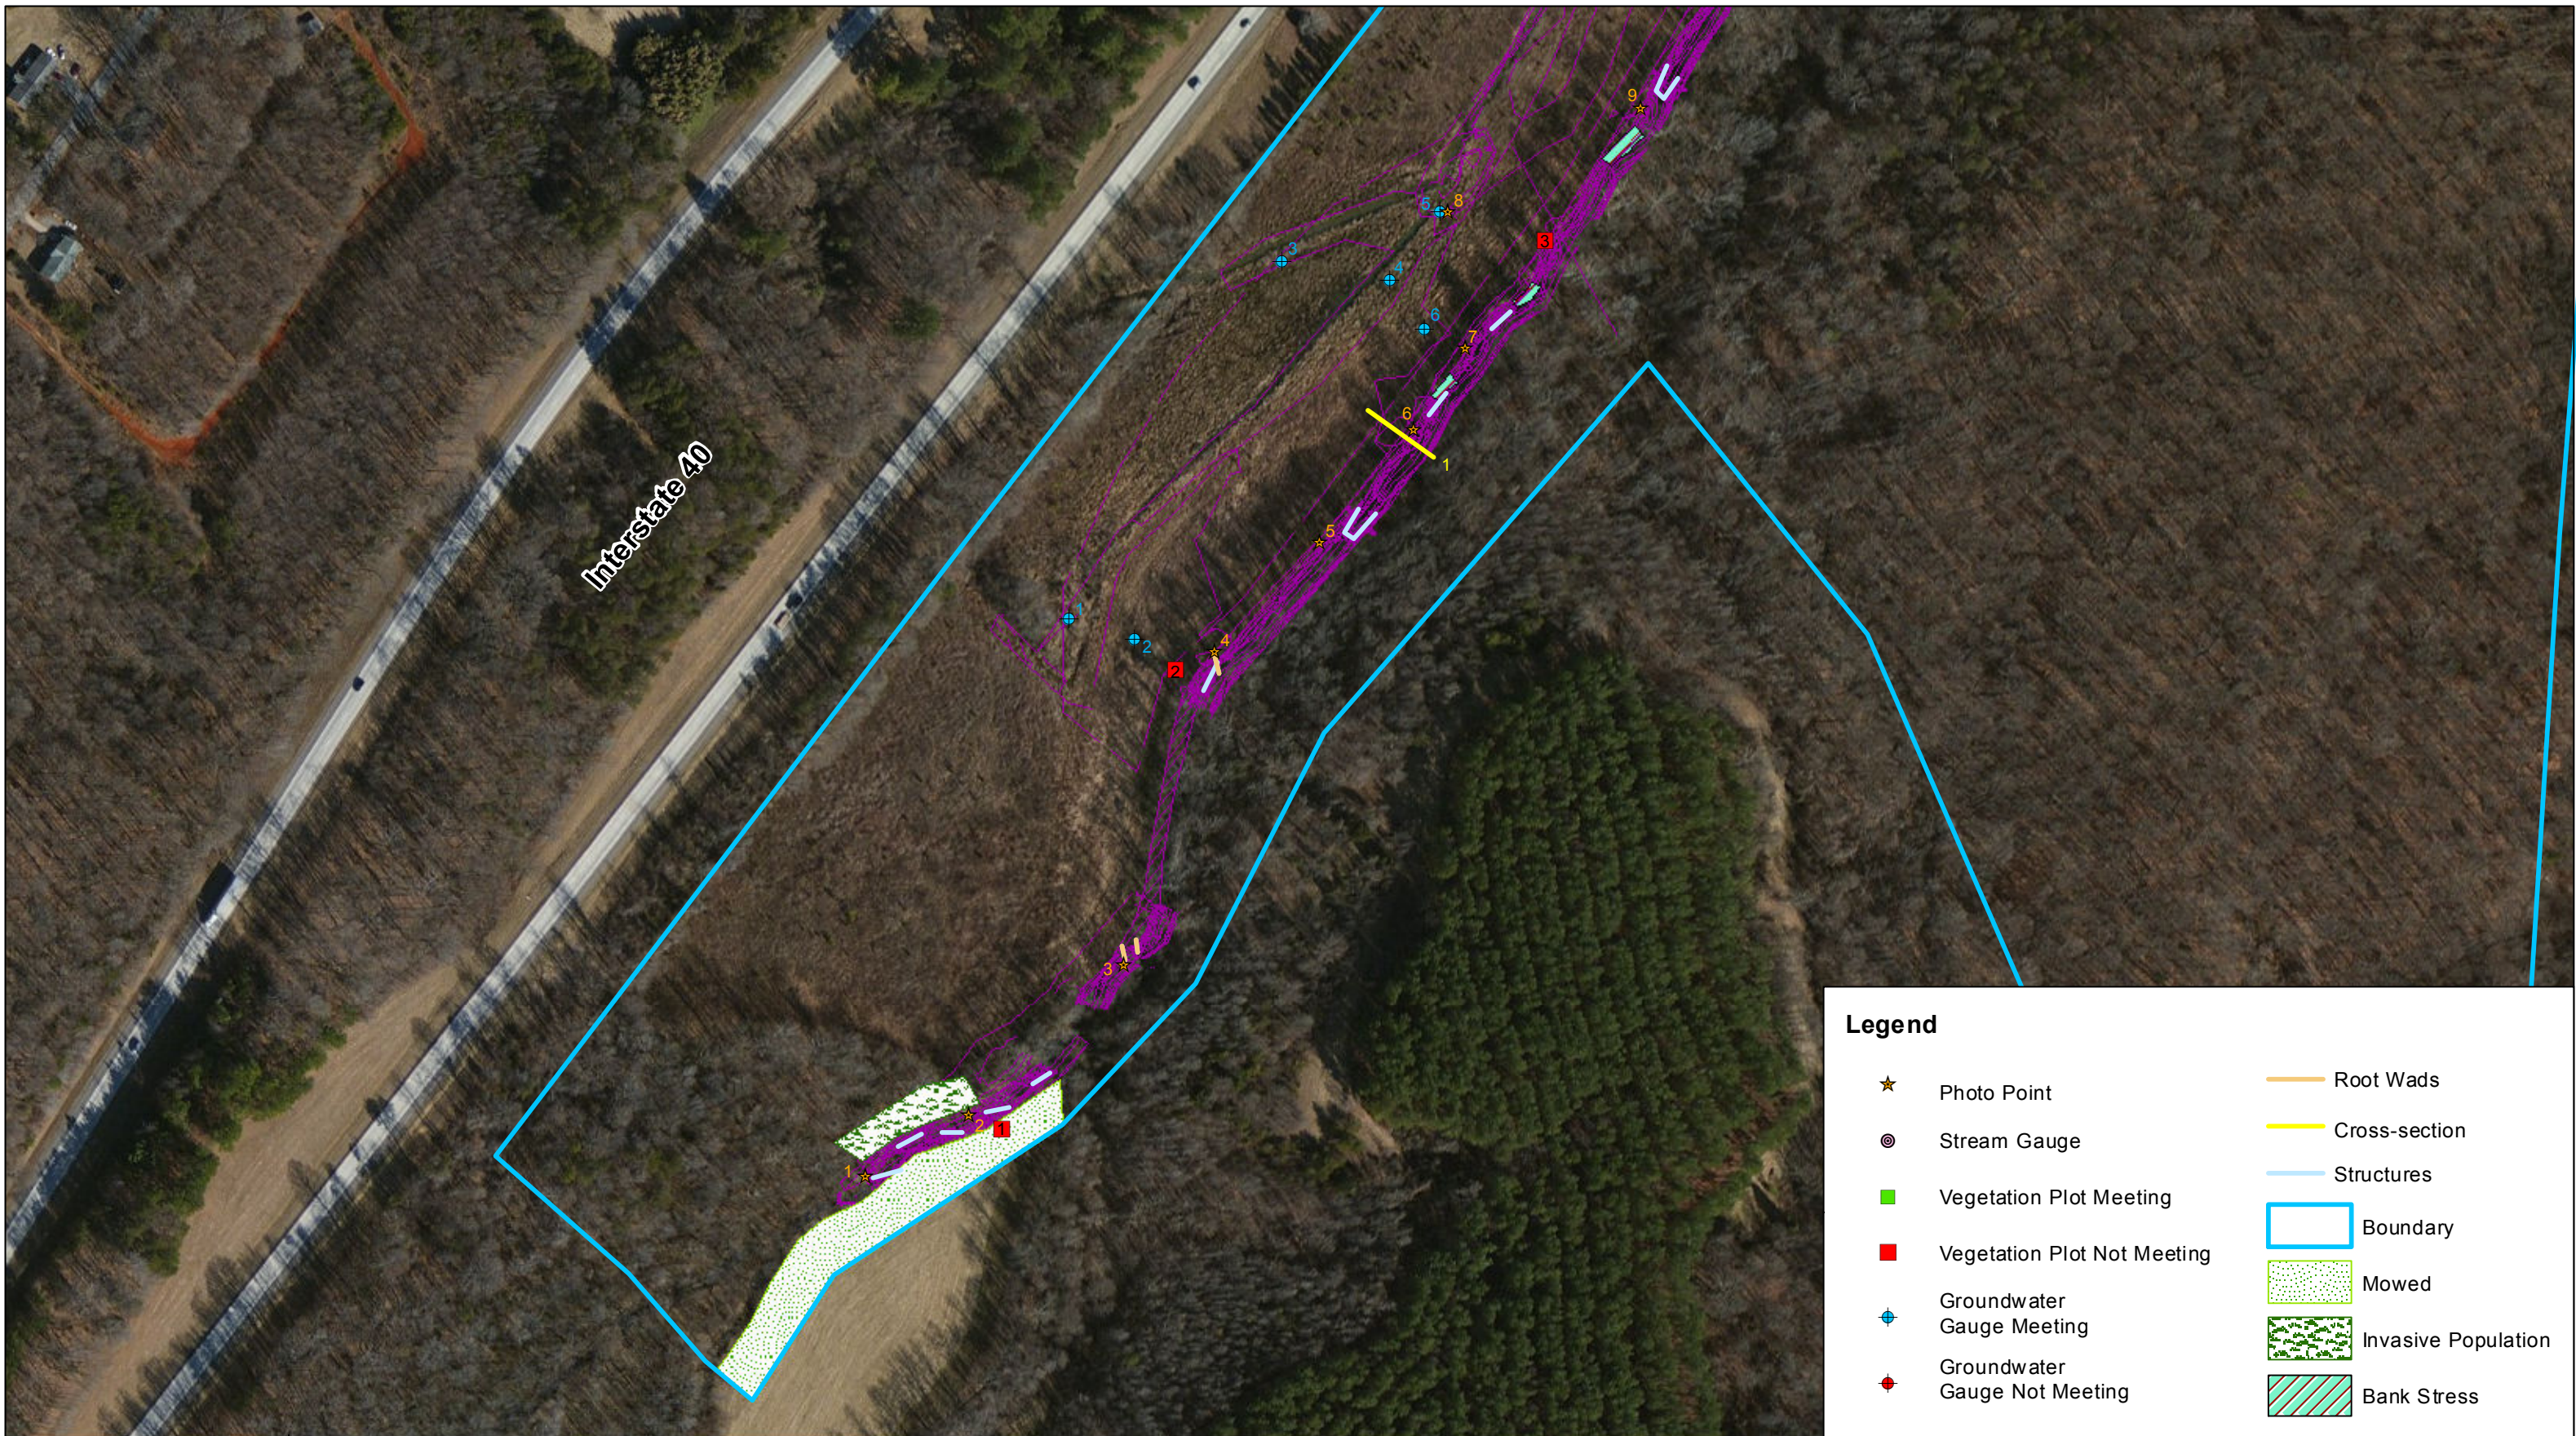
**2**

In April 2013, it was observed that two adjacent property owners mowed a portion of the buffer area, one parcel at the western end and one parcel on the eastern end. See Figure 2 CCPV. This resulted in 100% mortality of planted stems and a significant reduction in stem count totals given that plot 1 was located in the eastern parcel. Plot 1 stem counts were reduced from 10 planted stems at baseline to zero stems during year one. No vegetation monitoring plots are located in the eastern mowed parcel. NCEEP and NCDOT have made contact with the landowners. The landowners have been notified of the property violation and have been asked to stop mowing this area. NCDOT owns the western parcel fee simple and purchased an easement on the central parcel. The areas will be replanted in the 2014/2015 dormant season once the encroachments have been rectified.

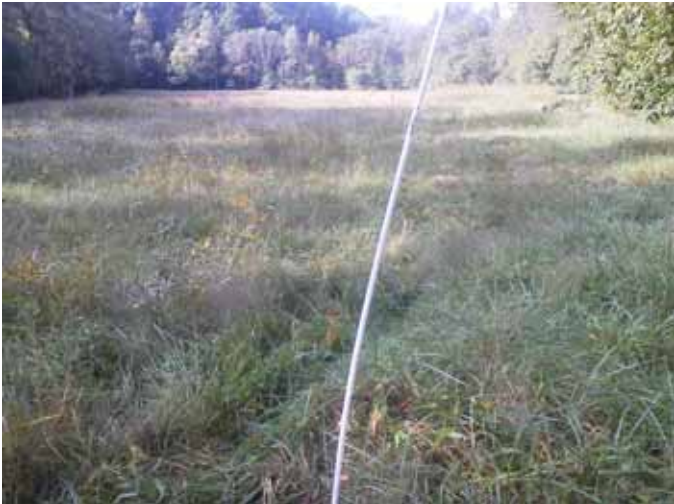
Vegetation Monitoring Plot #1 5/29/2012

When considering volunteer stems, all but five plots (1, 13, 14, 16, and 18) of the 23 are meeting the established success criteria. Plot 17 is located in a young stand of existing sycamore and river birch. There was no grading within plot 17 and it was not planted. This plot was selected to monitoring the performance of existing, established vegetation.

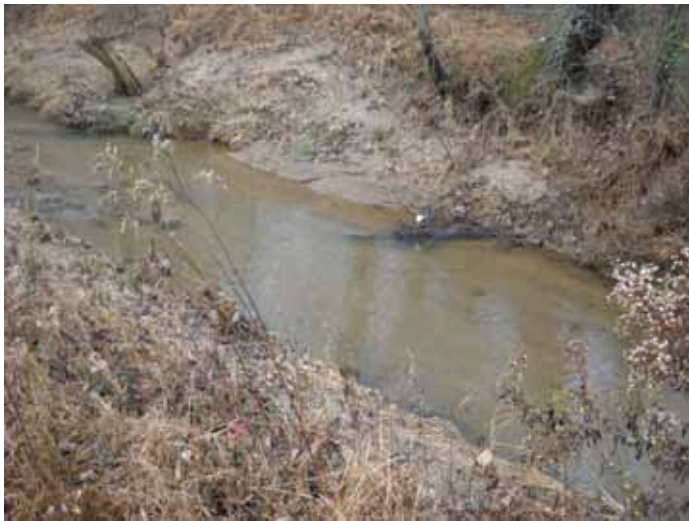
Cross Section 5 12/5/13

When looking at the plotted cross sections, several of the year one cross sections do not align with the as-built condition and several appear to have significantly changed from the as-built condition, most notable cross section 5. These apparent changes may be the result of the lack of detail in the as-built channel survey. The as-built cross sections were generated from the surface contours created from the as-built field survey, which was not surveyed by ARCADIS staff. The year one cross sections were surveyed in the field by ARCADIS staff and are likely more accurate. These discrepancies were not noticed until the year one cross sectional survey was overlaid on the as-built drawing. Several of the cross sections do align well (3, 9, 10, 11 and 13).

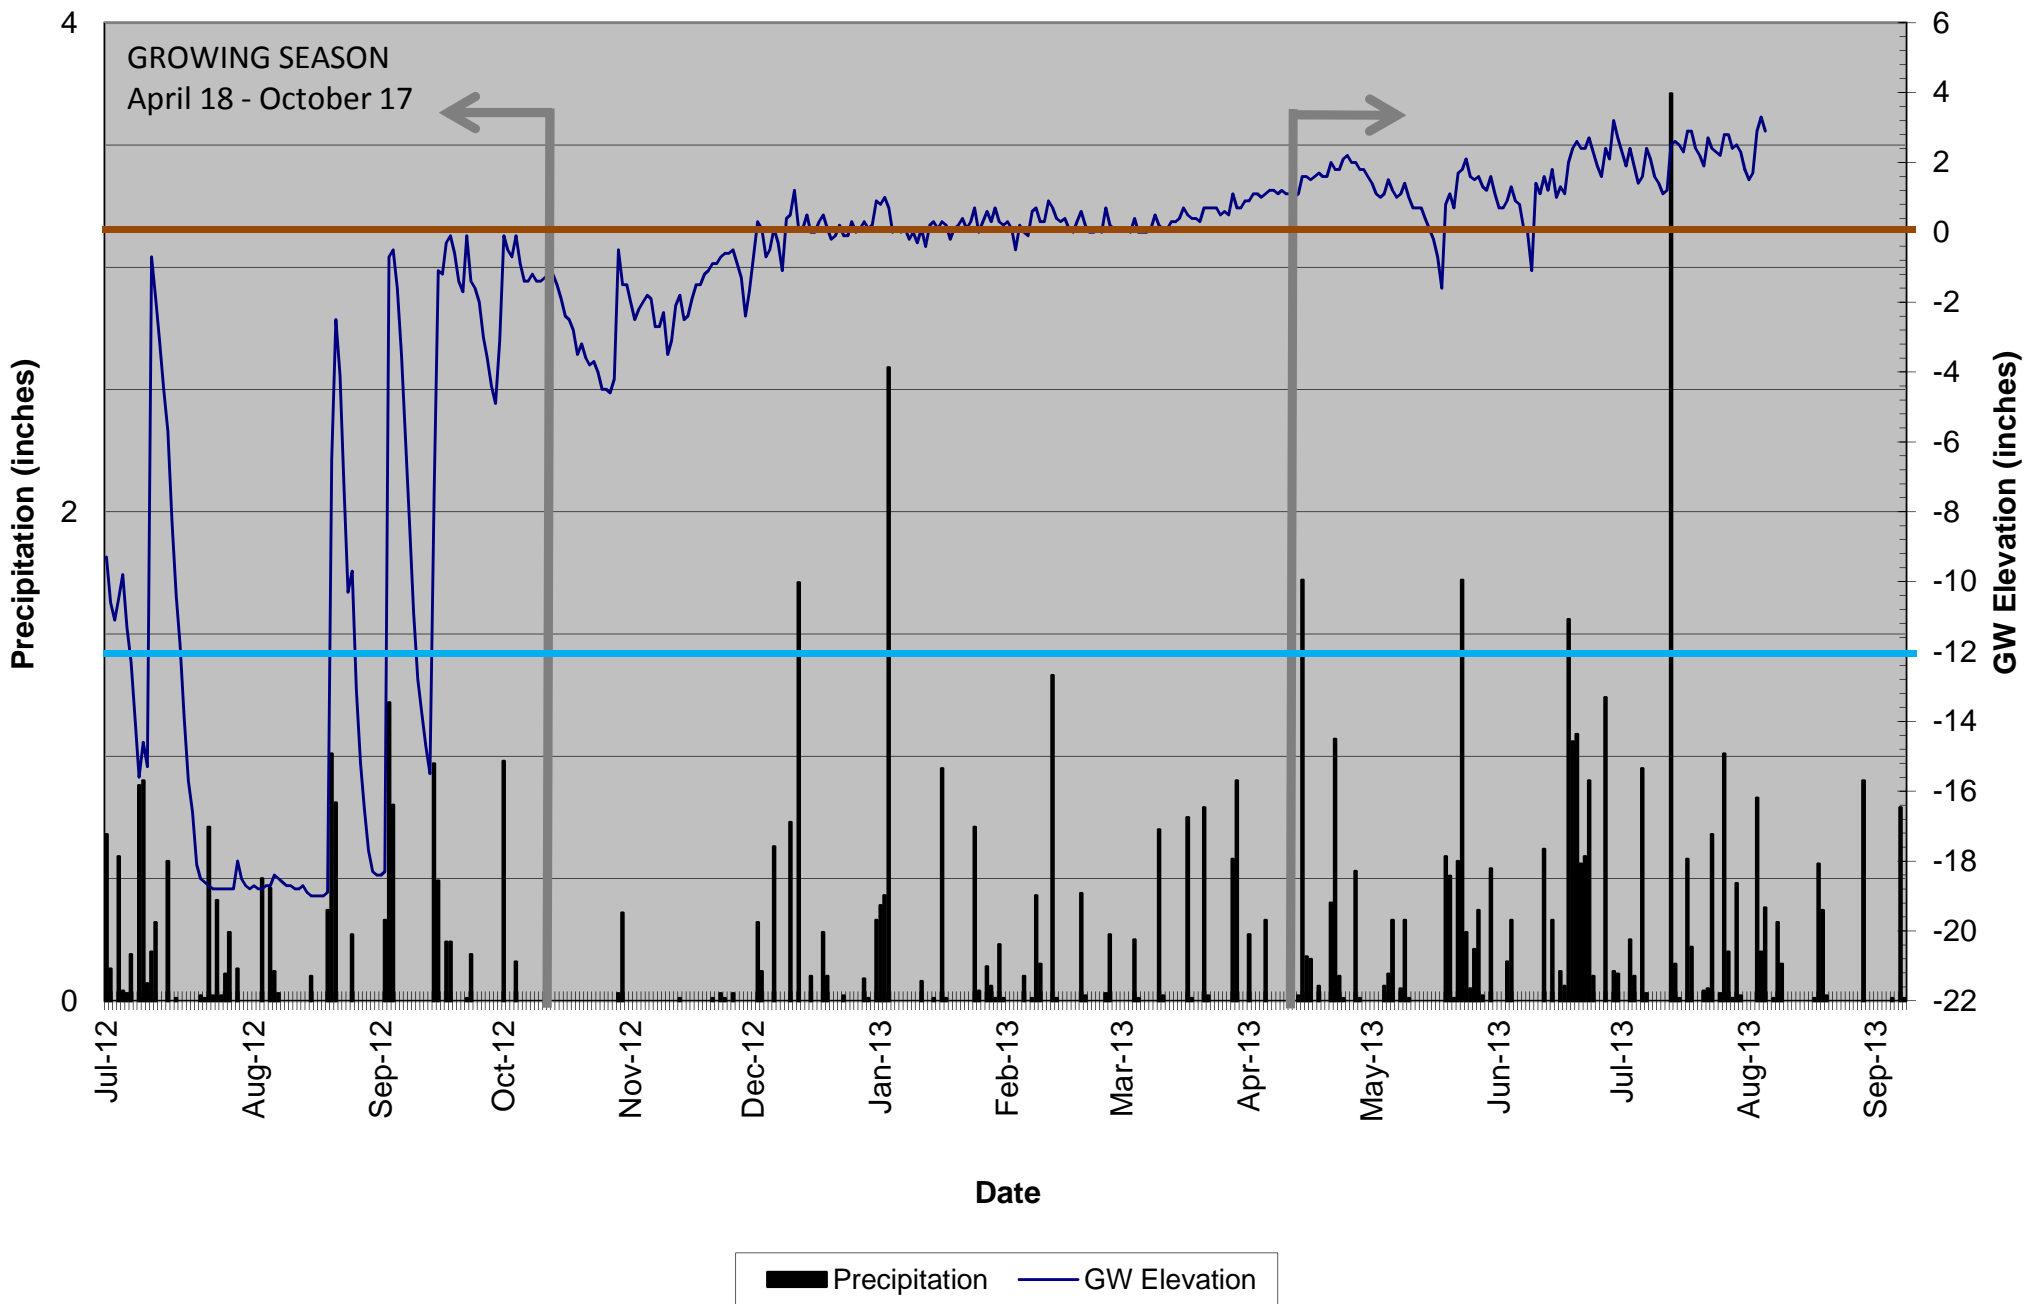
# Five Mile Branch Gauge #1 13D4B648

Number	Serial Number	Download Event Date						
		3/20/2013	4/3/2013	5/29/2013	6/4/2013	8/20/2013	12/5/2013	12/15/2013
1	13D4B648	ok	ok	Failed	No attempt.	ok	Replaced with EBD3010.	No attempt.
2	14E14322	Reprogrammed due to inconsistent logging interval.	Replaced with 12D4C9D8.	ok	No attempt.	ok	failed	No attempt.
3	1314FC9A	Failed	ok	ok	No attempt.	Failed	Replaced with 13152502.	No attempt.
4	13D49A3B	ok	ok	ok	No attempt.	ok	ok	No attempt.
5	14E16DC9	ok	ok	ok	No attempt.	ok	ok	No attempt.
6	14E1A3C5	Reprogrammed due to not downloading.	ok	ok	No attempt.	Failed	ok	No attempt.
7	13D4CA32	ok	ok	ok	No attempt.	ok	ok	No attempt.
8	13D49BC4	ok	ok	ok	No attempt.	ok	ok	No attempt.
9	136B6377	ok	ok	ok	No attempt.	Failed	Replaced with EBD20B9.	No attempt.
10	13D4B632	ok	ok	ok	No attempt.	ok	ok	No attempt.
11	14E178FC	ok	ok	ok	No attempt.	Failed	Replaced with EBD074F.	No attempt.
12	14E13DAE	ok	ok	ok	No attempt.	ok	ok	No attempt.

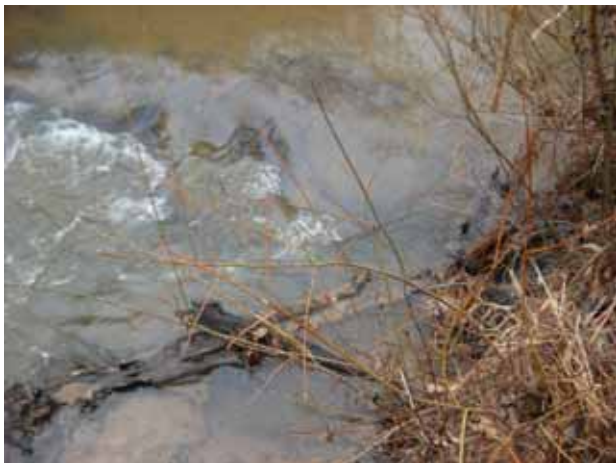
Photo Point 25. Cross Vane. Left arm scour. 12/5/13

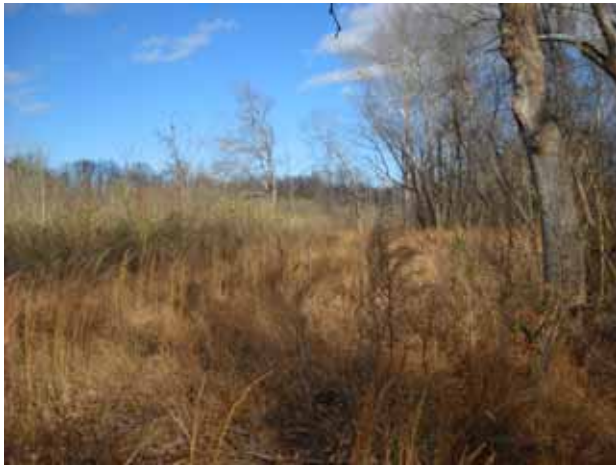
Photo Point 39. Floodplain looking east 12/15/13

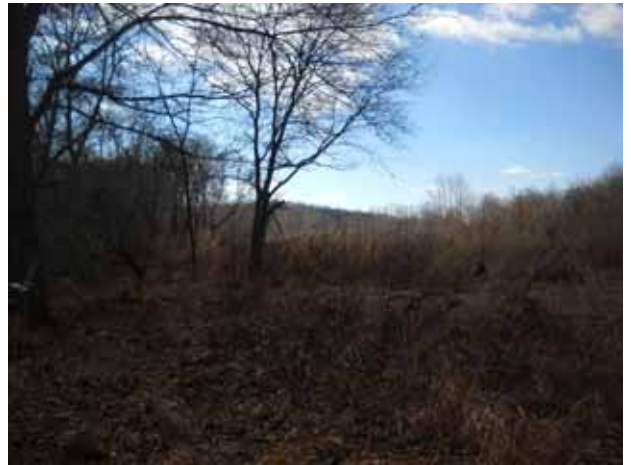
Photo Point 41. Floodplain looking west 12/15/13
