## **Year 3 of 5 Monitoring Report**

**Five-Mile Branch Stream and Wetland  
Restoration, Iredell County**

**NCDMS IMS ID# 92185  
DEQ Contract # 6036**

ARCADIS G&M of North Carolina, Inc.

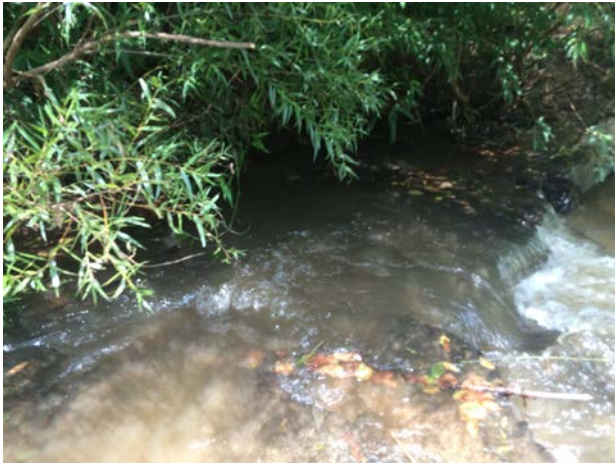
Photo Point 25. Cross Vane. Left arm scour. 08/13/15
