YEAR 4 OF 5 MONITORING REPORT - FINAL

**Five-Mile Branch Stream and Wetland Restoration, Iredell County
NCDMS IMS ID# 92185**

**North Carolina Department of Environmental Quality,
Division of Mitigation Services Raleigh North Carolina**

April 25, 2017

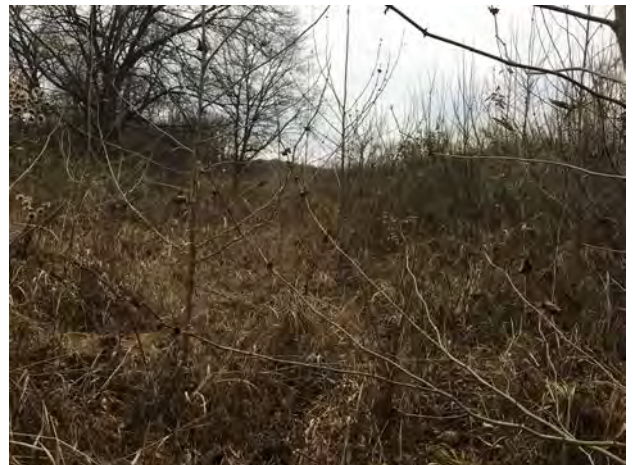
Photo Point 41. Floodplain looking west 12/08/2016

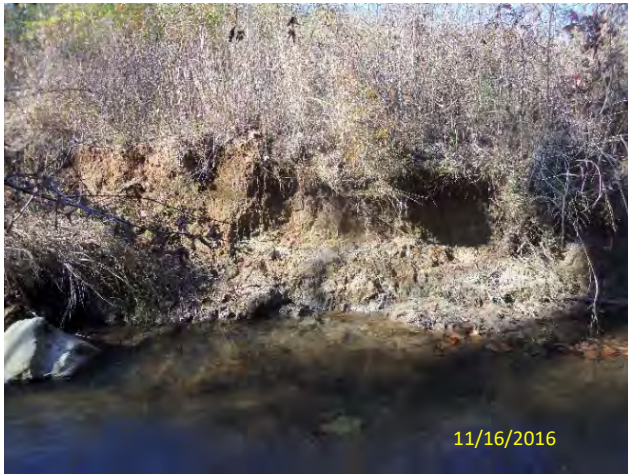
Feature	Station	Suspected Cause	Photo #
Bank Erosion	19+00 BVR	Back eddy from structure	2499
Bank Erosion	23+00 BVR		2505
Bank Erosion	27+50 BVR	Back eddy from structure	2511
Bank Erosion	29+00 BVR		2512
Bank Erosion	30+25 BVR		N/A
Bank Erosion	31+25 BVR	Back eddy from structure	N/A
Bank Erosion	34+25 BVR		2514
Bank Erosion	41+00 BVR		2519
Bank Erosion	65+75 BVR	Back eddy from structure	N/A
Structure boulder settled/fell	25+25 BVR		2502
Structure boulder settled/fell	32+50 BVR		2513
Structure boulder settled/fell	37+25 BVR		N/A
Structure boulder settled/fell	60+75 BVR		2526
Structure boulder settled/fell	68+50 BVR		N/A
Bank Erosion	11+50 FTH		N/A
Bank Erosion	14+25 FTH		2536
Bank Erosion	17+25 FTH		2542
Structure boulder settled/fell	18+75 FTH		2545
Bank Erosion	32+00 FTH	Back eddy from structure	N/A
Bank Erosion	45+00 FTH		121
Bank Erosion	52+00 FTH	Back eddy from structure	110
Bank Erosion	54+00 FTH		107
Bank Erosion	59+00 FTH		106

Bank Erosion 19+00 BVR

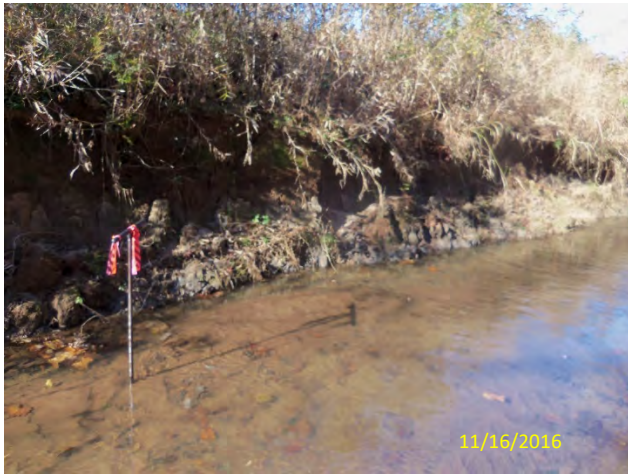
Bank Erosion 23+00 BVR

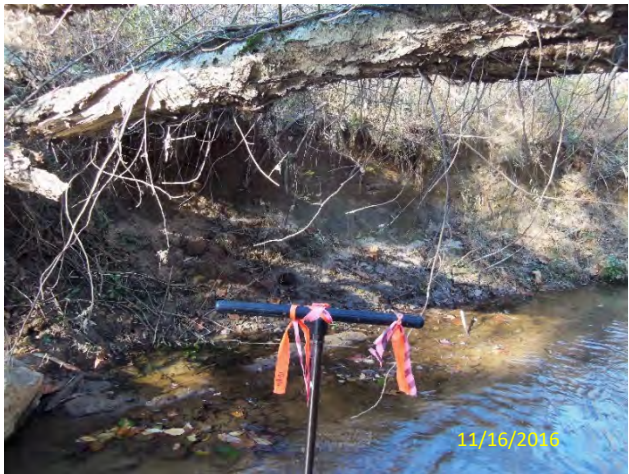
Bank Erosion 27+50 BVR

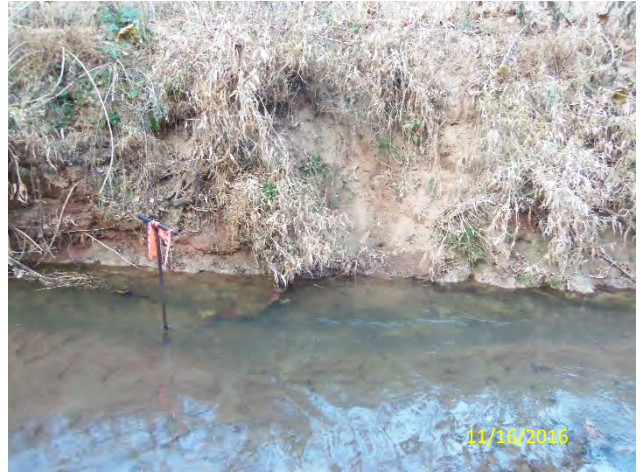
Bank Erosion 14+25 FTH

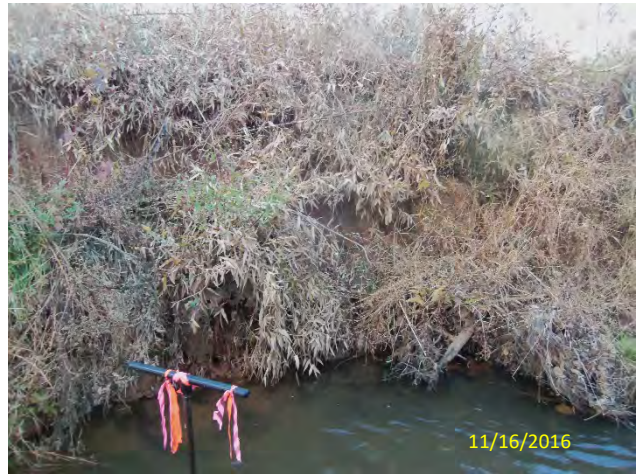
Bank Erosion 17+25 FTH

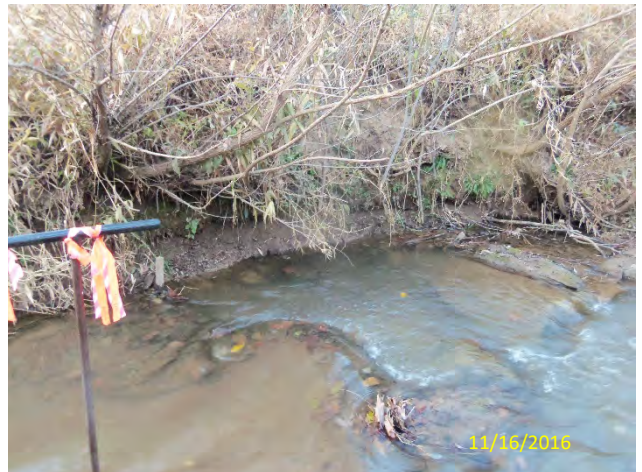
Bank Erosion 18+75 FTH

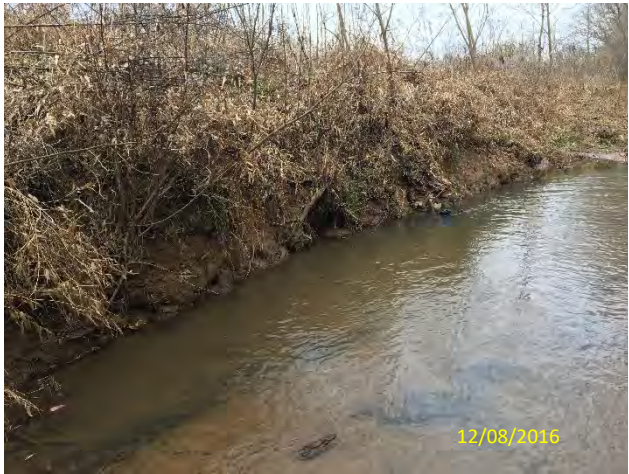
Bank Erosion 45+00 FTH

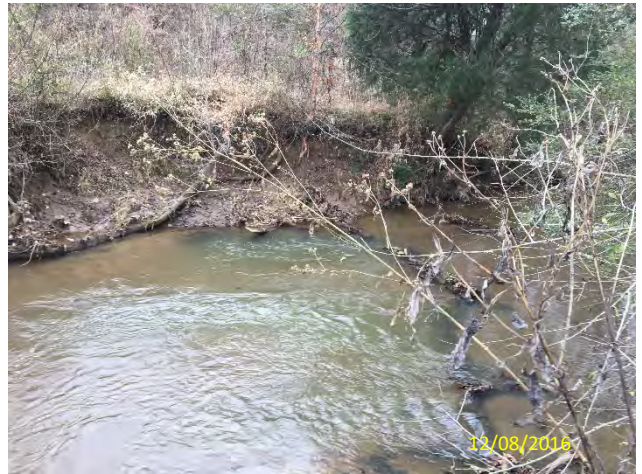
Bank Erosion 59+00 FTH

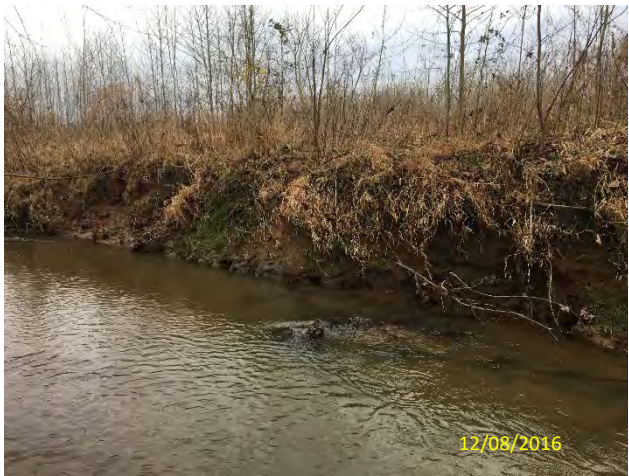
Bank Erosion 52+00 FTH

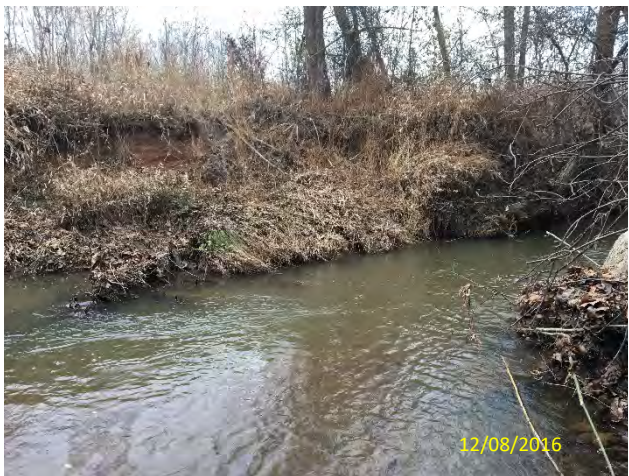
Bank Erosion 54+00 FTH
