Fletcher Stream and Wetland Mitigation Site

Annual Monitoring Report

Monitoring Year 3 of 7

Henderson County, North Carolina

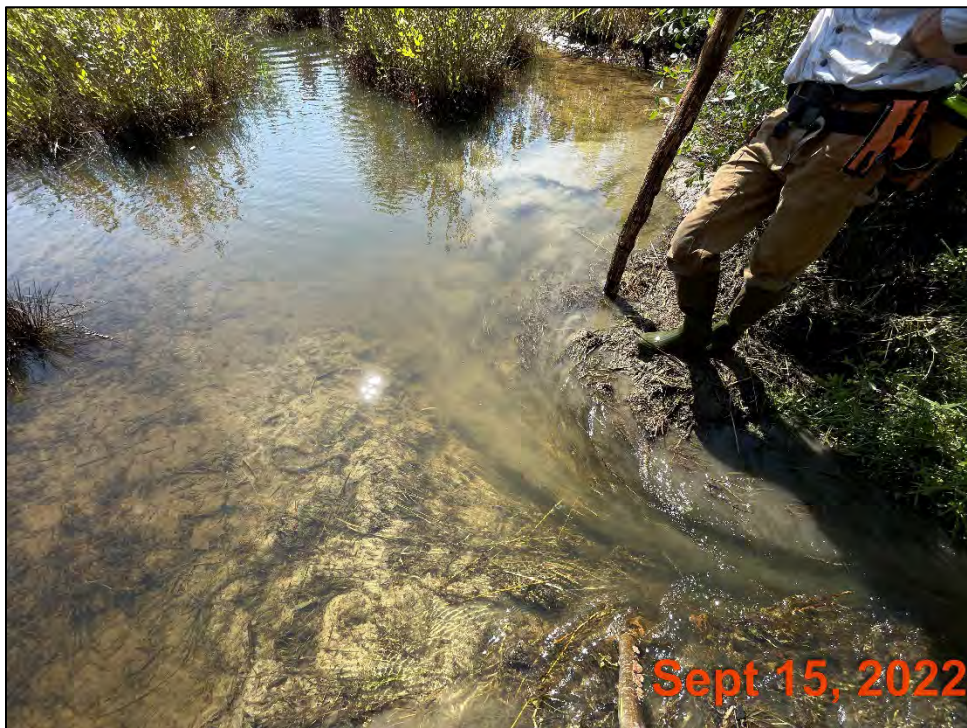
Breached Beaver Dam Weston Reach 1B, Station 424+50
