# **Fletcher Stream and Wetland Mitigation Site**

## **Annual Monitoring Report**

Monitoring Year 4 of 7

Fletcher Stream and Wetland Mitigation Site

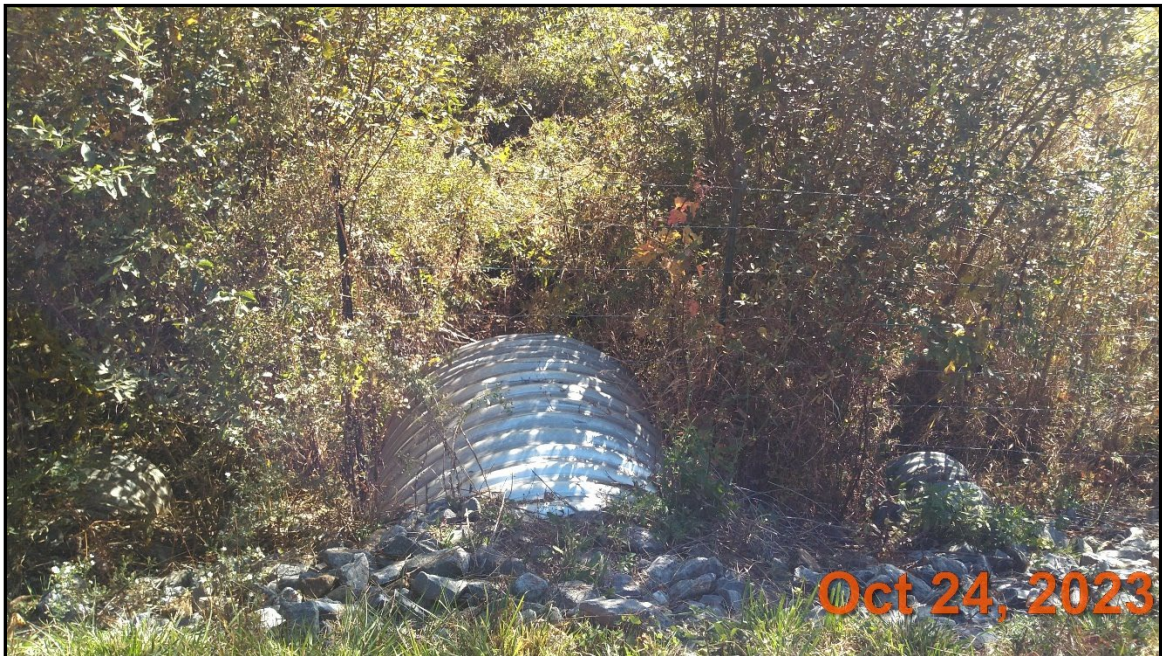
Fletcher Creek 1C – Permanent Photo Station 5  
Looking Upstream from Crossing

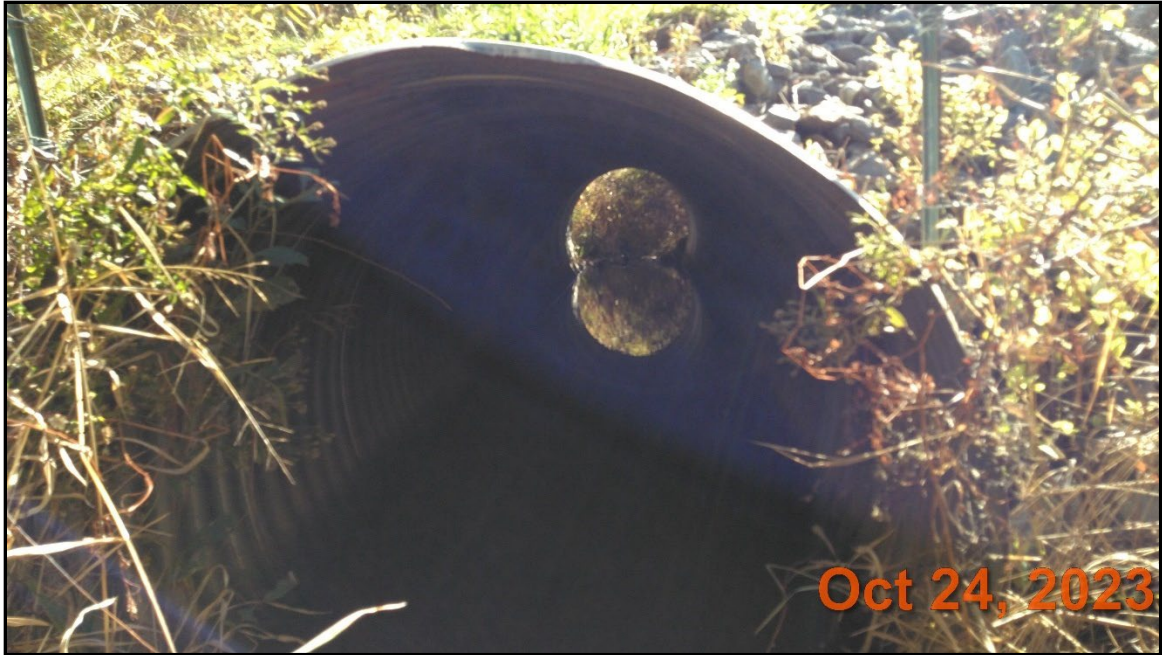
Fletcher Creek 1C – Permanent Photo Station 5  
Looking upstream through culvert

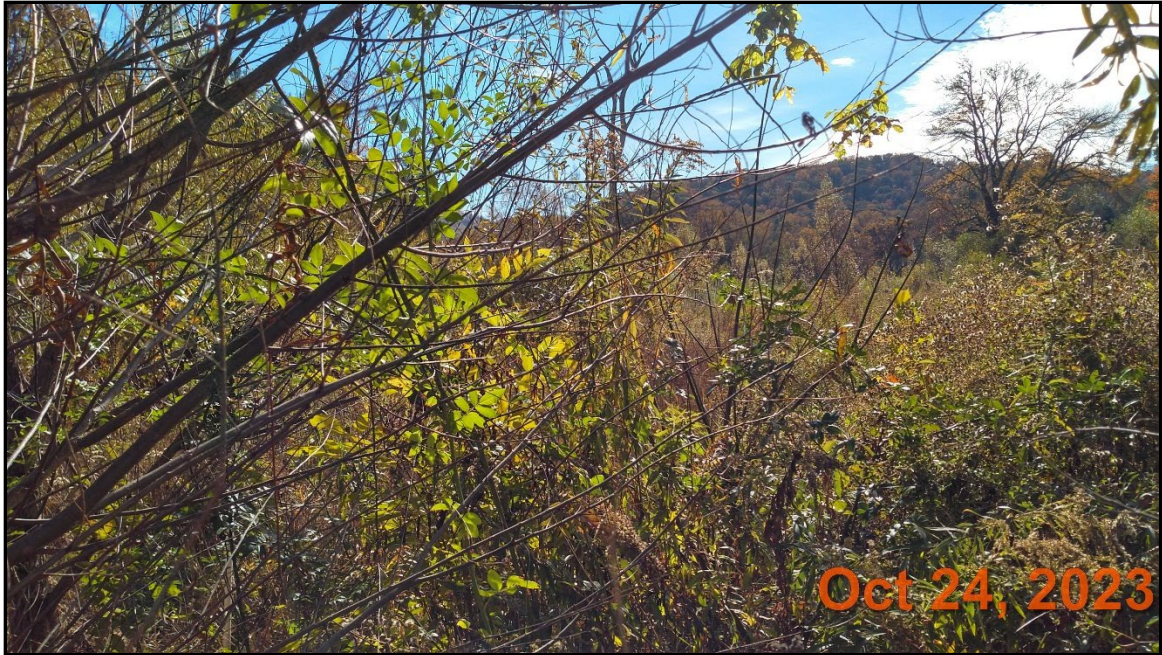
Fletcher Creek 1C – Permanent Photo Station 6  
Looking Upstream

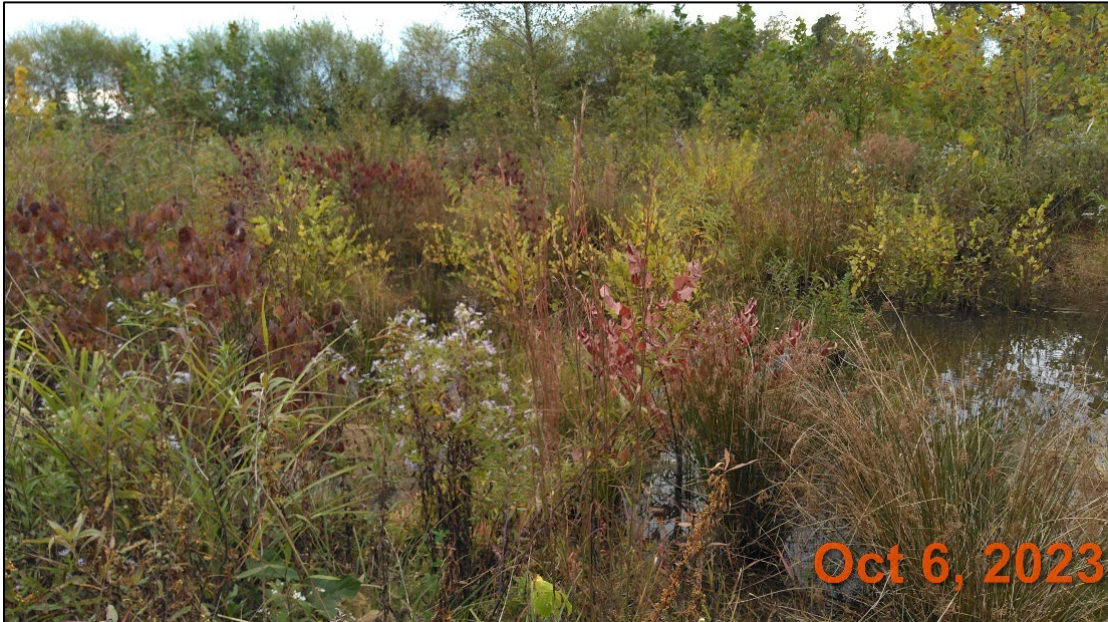
1. Beaver Dam Weston Reach 1B, Station 424+50

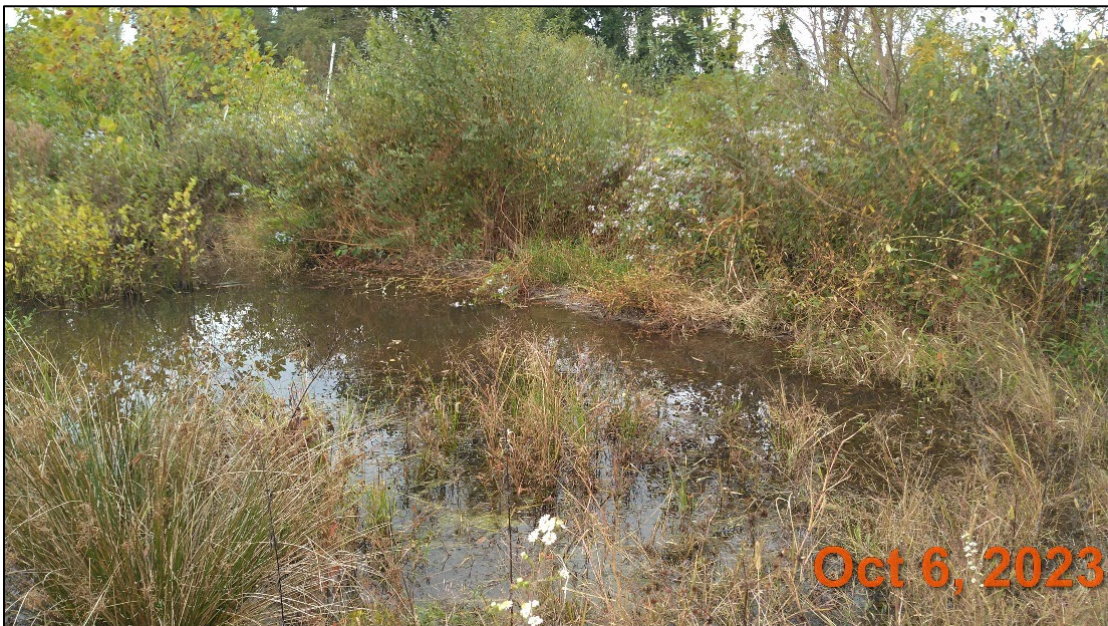
2. Beaver Dam Weston Reach 1B, Station 424+50
