**Fletcher-Meritor Site
(UT to Cane Creek) Stream and Wetland Restoration
Project No: 138**

Monitoring Report Year 2 of 5

Henderson County, North Carolina

Construction Complete: May 2012
Data Collected: May 2014
Report Submission: December 2014

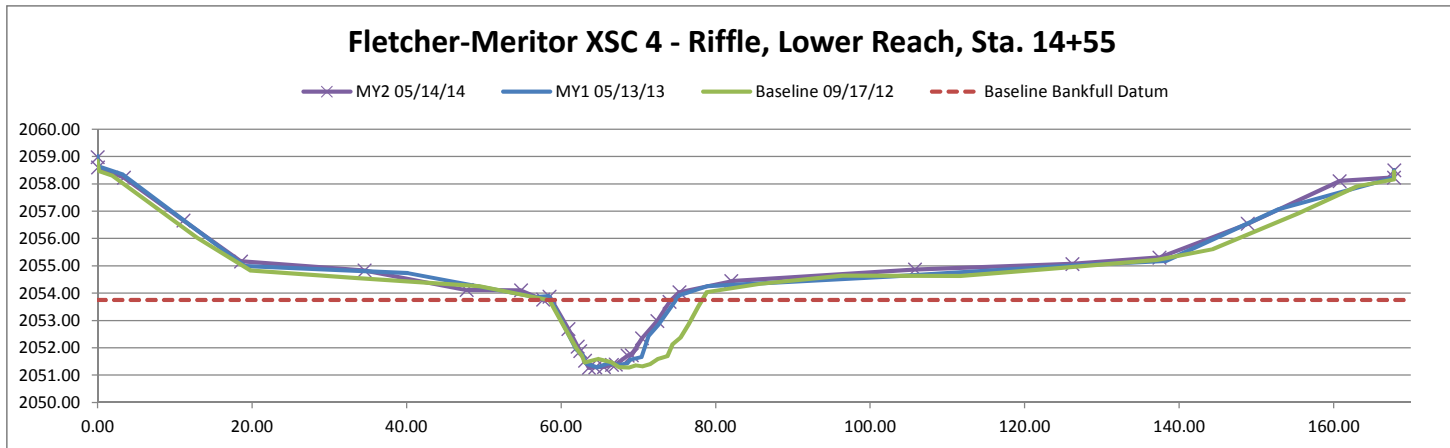
Sta. 14+55 Looking Downstream

Lower Reach values for predicted movable particle size versus D50 from pebble counts are very similar indicating stable conditions. For XSC4, the predicted movable particle size is 14mm compared to the observed D50 of 13mm. Riffle XSC6 has a predicted movable particle size of 12mm compared to an observed D50 of 17mm.

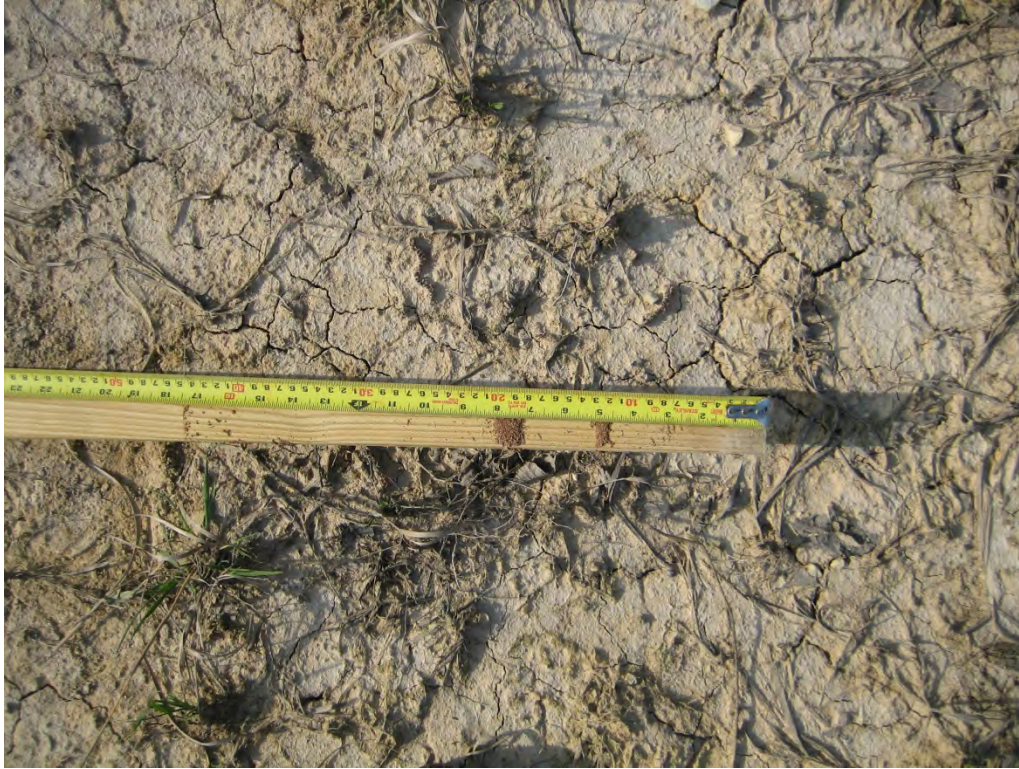
Tributary Gauge (May 2014)

| Date of Data Collection | Date of Occurrence | Method | Photo |
|---|---|---|---|
| 5/13/2014 | Unknown | Stream gauges (3 events on the tributary reach and 2 on the main reach) | See attached |
