**Fletcher-Meritor Site
(UT to Cane Creek) Stream and Wetland Restoration
Project No: 138**

Monitoring Report Year 3 of 5

Henderson County, North Carolina

HDR Engineering
555 Fayetteville Street, Suite 900
Raleigh, NC 27601

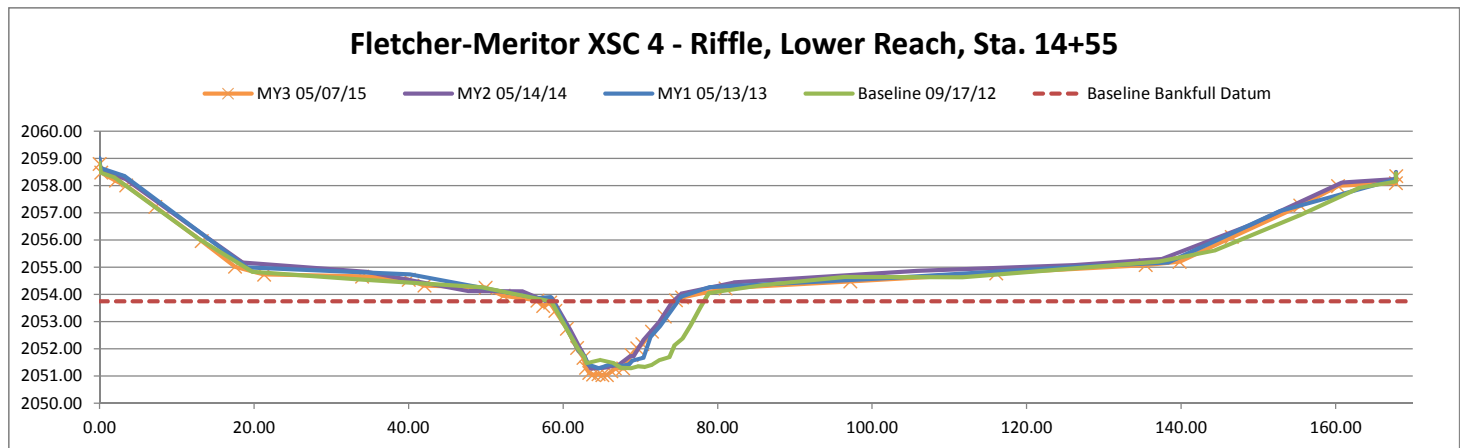
Sta. 14+55 Looking Downstream

Lower Reach values for predicted movable particle size versus D50 from pebble counts are similar indicating stable conditions. For XSC4, the predicted movable particle size is 13mm compared to the observed D50 of 20mm. Riffle XSC6 has a predicted movable particle size of 12mm compared to an observed D50 of 19mm.

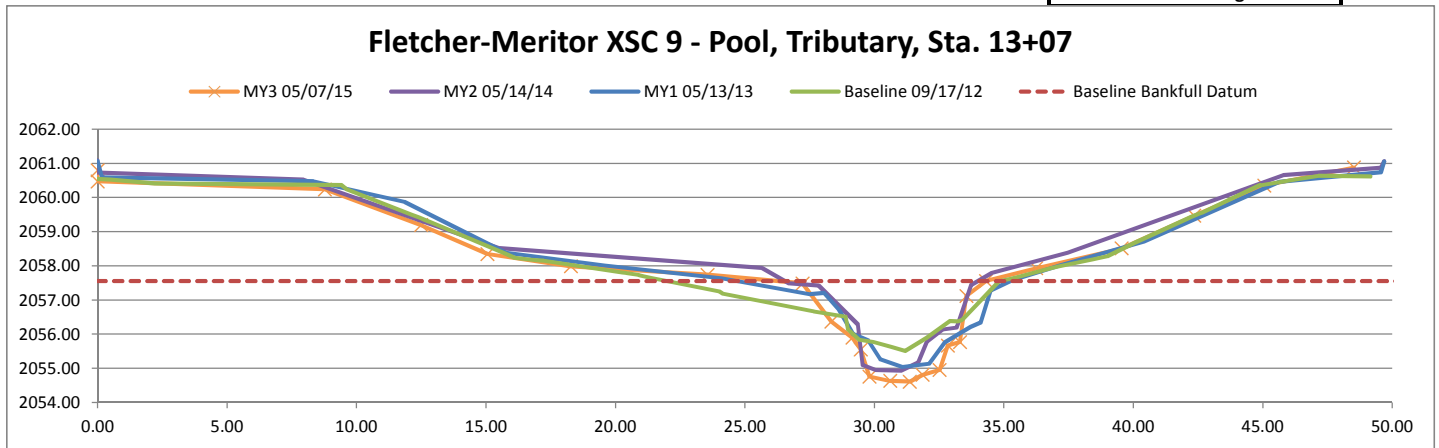
Sta. 13+07 Looking Upstream
Pool XSC in Foreground
