**Fletcher-Meritor Site  
(UT to Cane Creek) Stream and Wetland Restoration  
Project No: 138**

**Monitoring Report Year 4 of 5**

**Henderson County, North Carolina**

**Construction Complete: May 2012  
Data Collected: March, May, & December 2016  
Report Submission: January 2017**

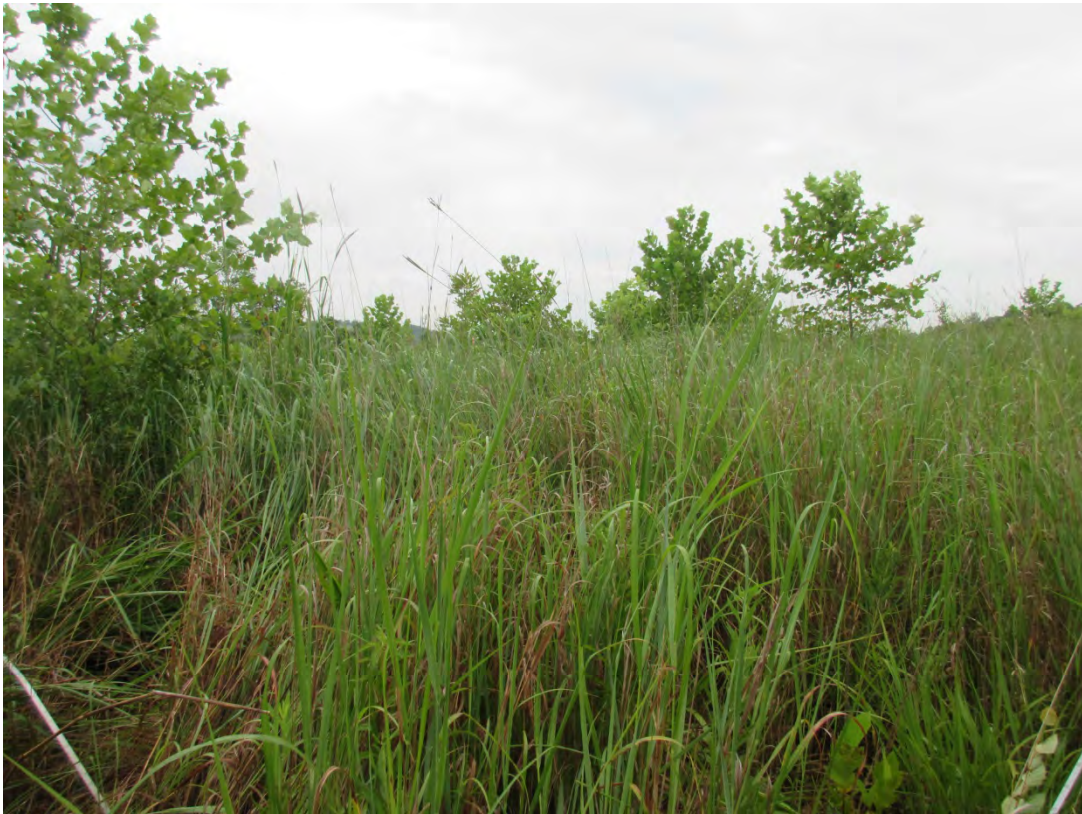
Vegetation Plot 4 – 10m x 10m (6/28/2016 Year 4)

According to the data collected, the average plant density among the 17 plots is 409 stems/acre with the range from 162 to 809 stems/acre. The highest plant density occurred in plot 4 with over 800 stems/acre. Currently, 14 of the plots are meeting the interim 3-year vegetation success criteria of 320 stems/acre. Year 4 monitoring data is provided in Appendix C. Vegetation throughout the site appears to be growing at acceptable rates and the mortality rate appears to be fairly low. Herbaceous vegetation which has been noted as sparse during previous monitoring events appears to be filling in, with the exception of a few locations noted on the CCPV. The three plots that are not meeting interim success criteria include two along the Tributary which may not have been planted at the appropriate density and the plot closest to the confluence with Cane Creek which has had backwater impacts numerous times since construction.

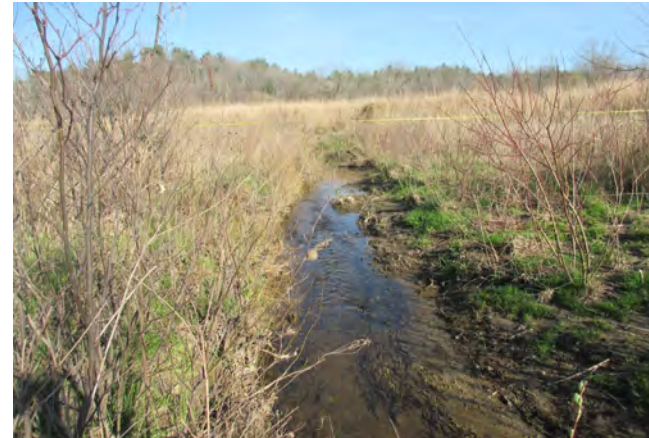
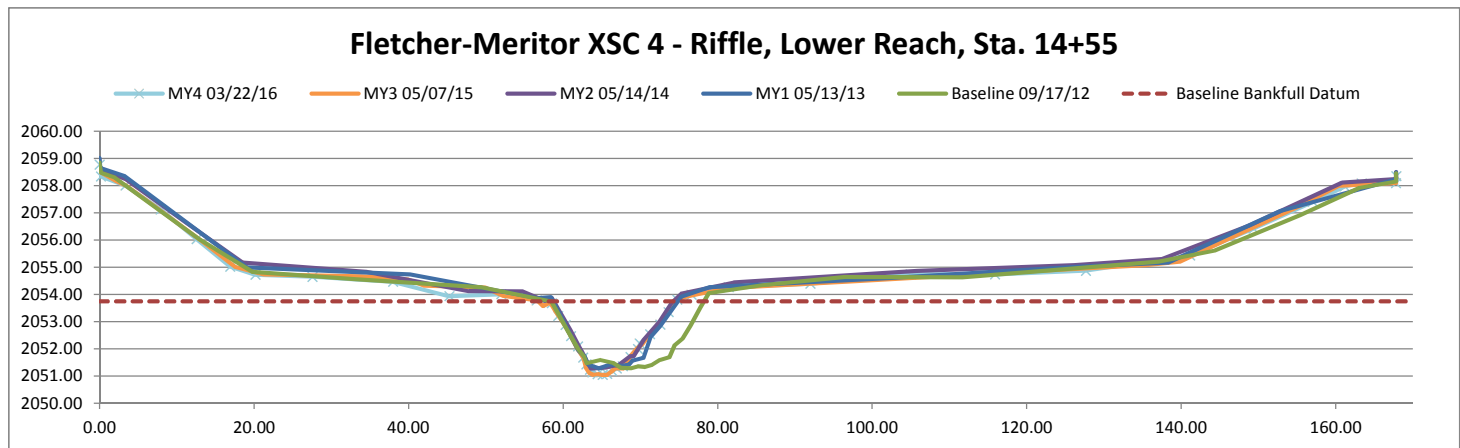
Reach	Fletcher-Meritor, Lower Reach
River Basin	French Broad
Cross Section ID	XSC-4 Riffle, Lower Reach, 14+55
Drainage Area (Sq Mi)	1.1
Date	3/22/2016
Observers	V. Miller, W. Yelverton

The Lower Reach values for predicted movable particle size versus the D50 from pebble counts are similar, indicating stable conditions. For cross-section XSC4, the predicted movable particle size is 11mm as compared to the observed D50 of 7mm. Riffle XSC6 has a predicted movable particle size of 9mm compared to an observed D50 of 7mm.

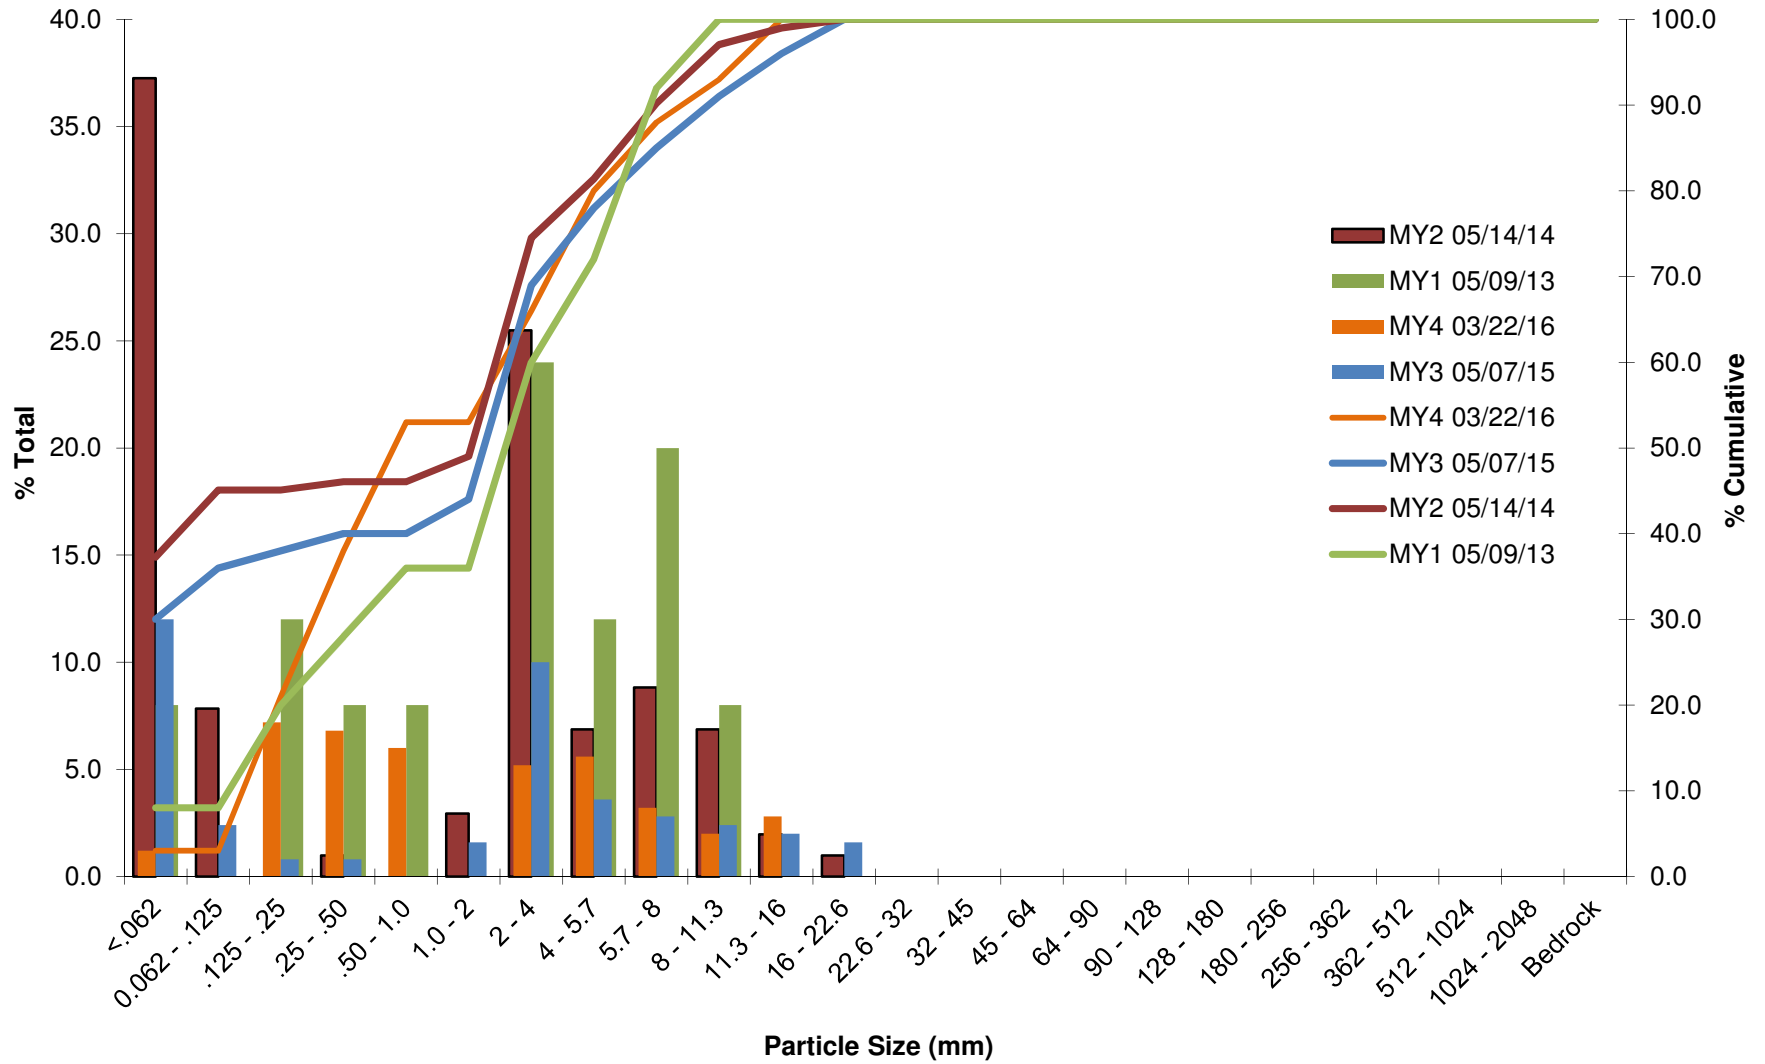
### Pebble count at XSC-1-Riffle

The pebble counts from XSC1 and XSC2 show a decrease in the D50 from the previous year, with results showing sandy bed conditions. These results are not very surprising since both permanent riffles are located on the upstream end of the Upper Reach where beaver activity has been prevalent, causing water to back up and smaller sediment to deposit.

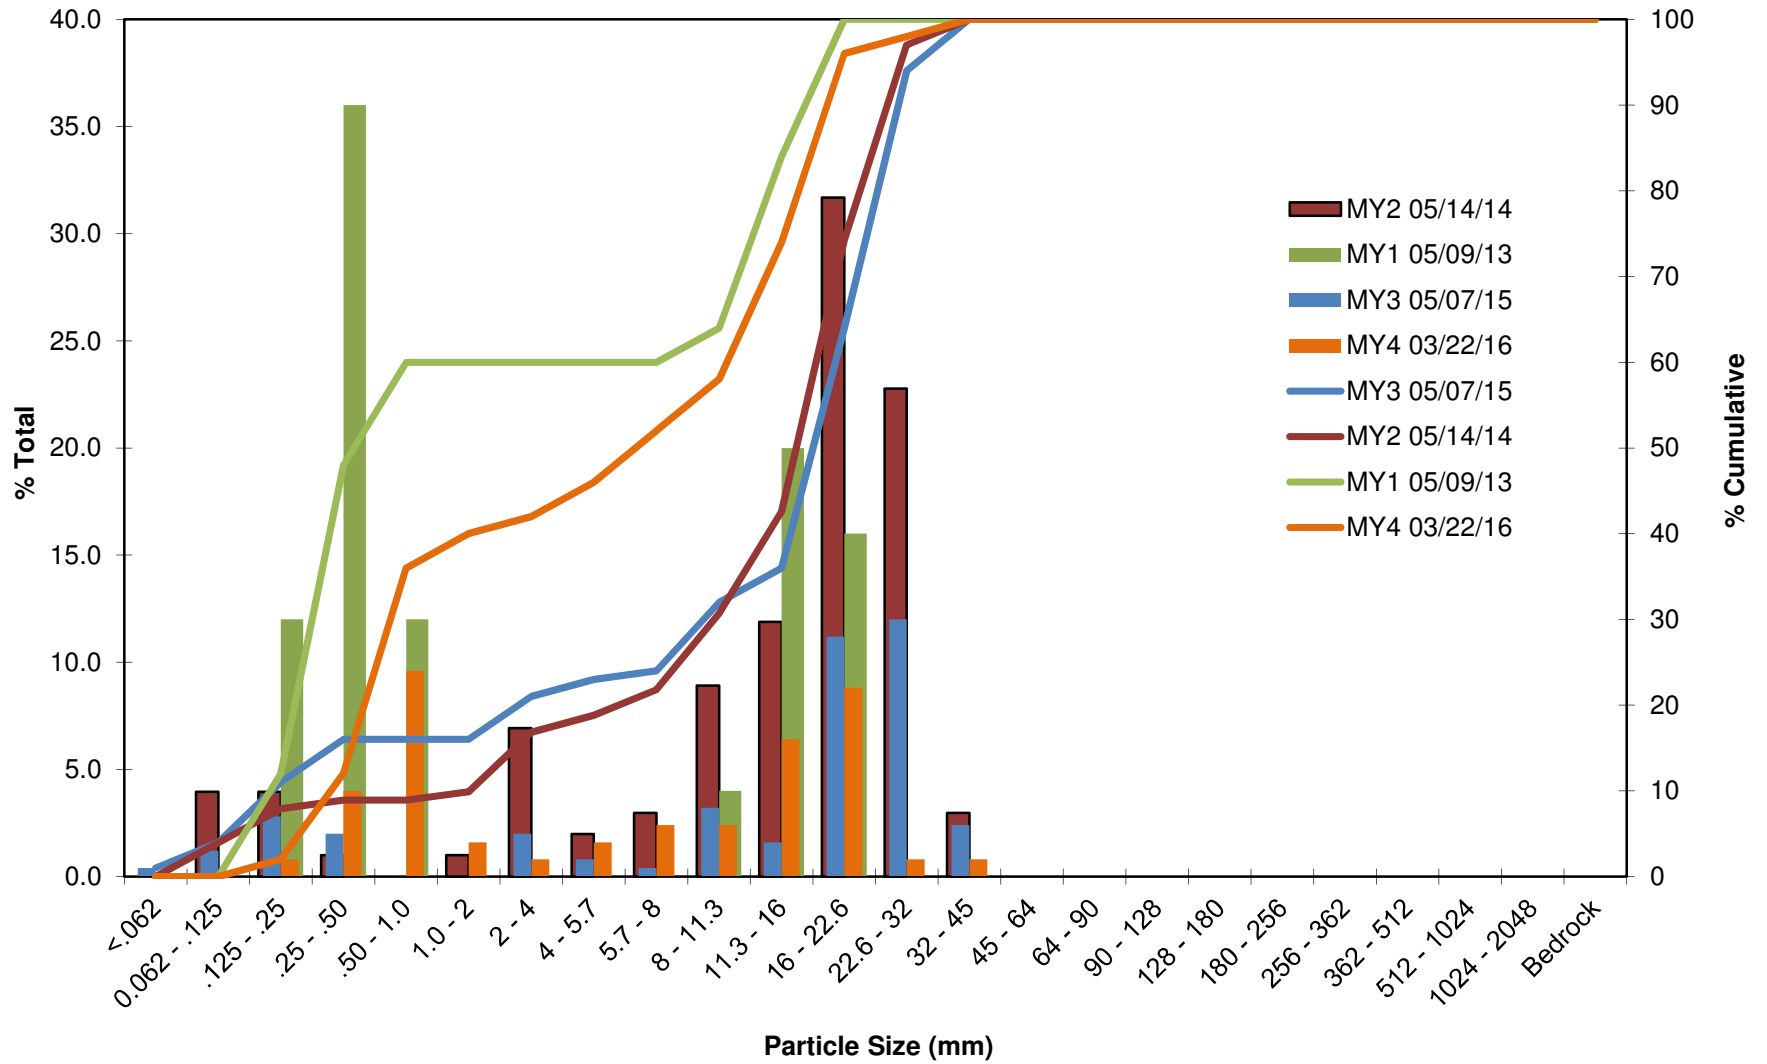
### Pebble count at XSC-6-Riffle

The Lower Reach cross sections, XSC4 and XSC6, show a smaller D50 in Year 4 compared to previous years. Deposition of finer material from beaver activity is the likely cause. The gravels seen in previous years are still present, as seen in the individual counts. However, enough smaller embedded material was seen this year that swayed the results toward more of a coarse sand.
