**Fletcher-Meritor Site
(UT to Cane Creek) Stream and Wetland Restoration
Project No: 138**

Monitoring Report Year 5 of 5

Henderson County, North Carolina

Construction Complete: May 2012
Data Collected: March, May, & November 2017
Report Submission: January 2018

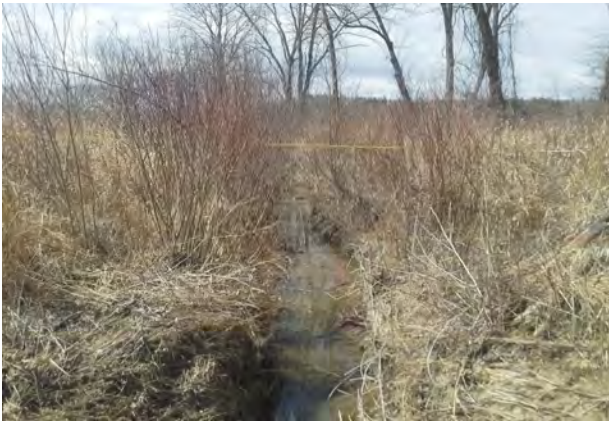
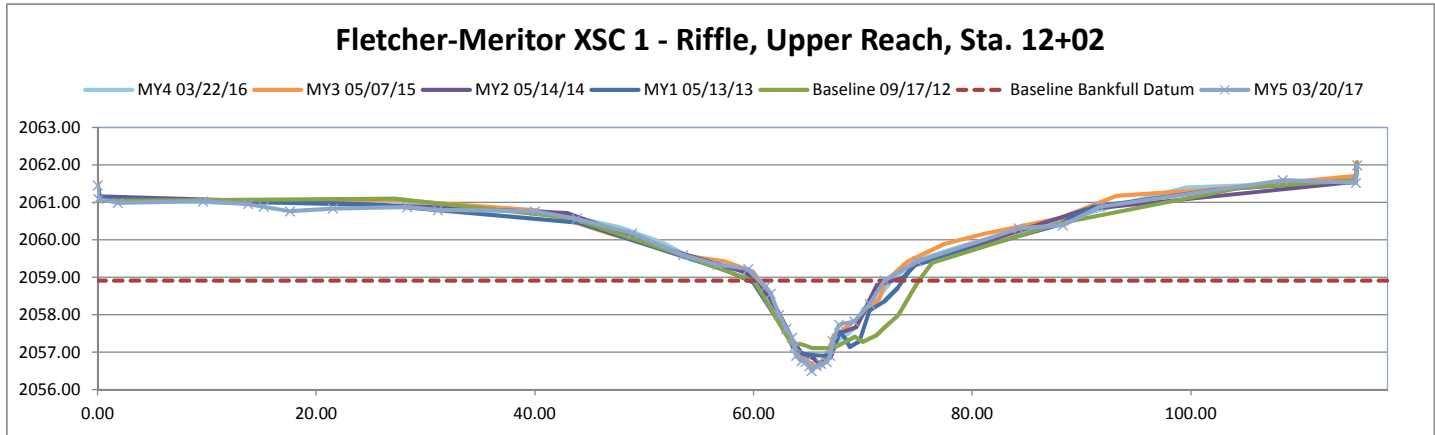
Sta. 12+02 Looking Downstream

The pebble count results from XSC1 and XSC3 were similar to those performed in the previous year. The D50 results showed sandy bed conditions. Based on counts over the past years, the bed material is decidedly a coarse sand in this portion of the stream.

Reach	Fletcher-Meritor, Upper Reach
River Basin	French Broad
Cross Section ID	XSC-1, Riffle, Upper Reach, 12+02
Drainage Area (Sq Mi)	0.75
Date	3/20/2017
Observers	V. Miller, W. Yelverton, K. Bell

SUMMARY DATA	
Bankfull Elevation, ft	2058.90
Bankfull Cross Sectional Area, ft²	14.00
Bankfull Width, ft	11.40
Max Depth at Bankfull, ft	2.41
Mean Depth at Bankfull, ft	1.23
Width/Depth Ratio	9.28
Flood Prone Width, ft	101.80
Flood Prone Area Elevation, ft	2061.31
Entrenchment Ratio	8.93
Bank Height Ratio	1.13

Stream Type C/E4

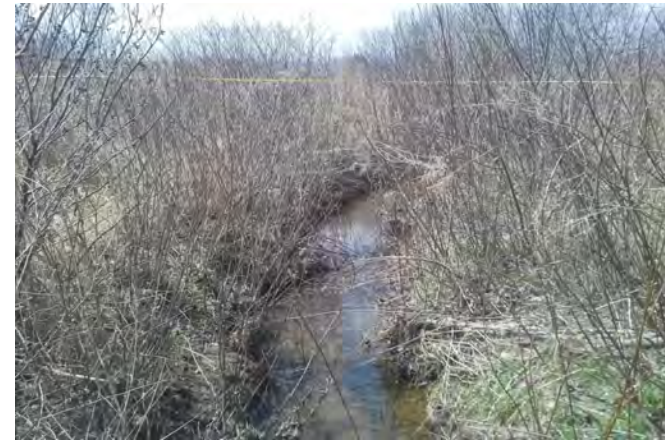
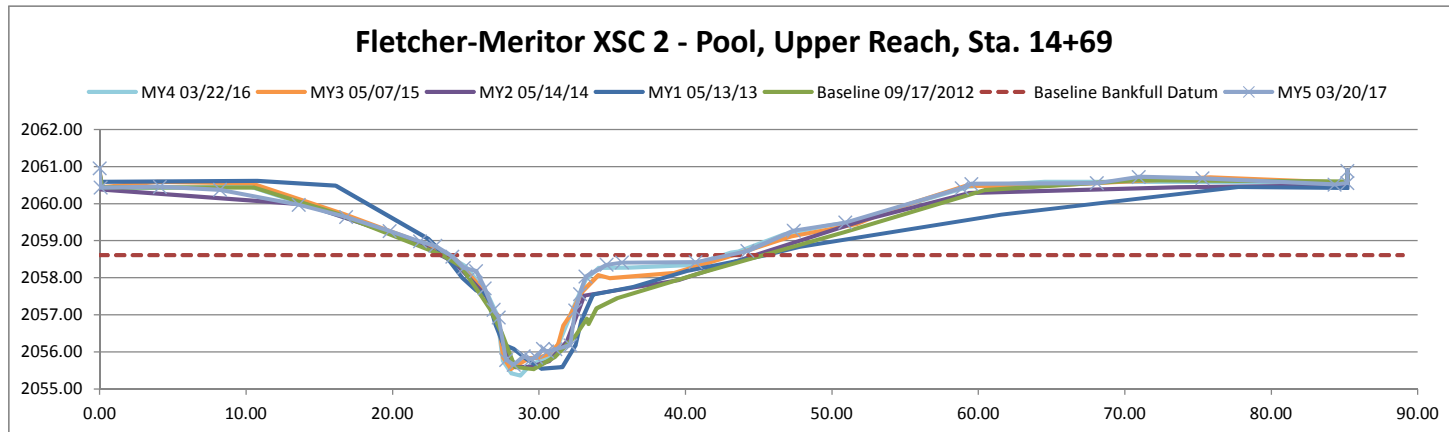
Sta. 14+69 Looking Downstream

Reach	Fletcher-Meritor, Upper Reach
River Basin	French Broad
Cross Section ID	XSC-2, Pool, Upper Reach, 14+69
Drainage Area (Sq Mi)	0.75
Date	3/20/2017
Observers	V. Miller, W. Yelverton, K. Bell

SUMMARY DATA	
Bankfull Elevation, ft	2058.61
Bankfull Cross Sectional Area, ft²	18.40
Bankfull Width, ft	19.00
Max Depth at Bankfull, ft	2.96
Mean Depth at Bankfull, ft	0.97
Width/Depth Ratio	19.62
Flood Prone Width, ft	>86.00
Flood Prone Area Elevation, ft	2061.57
Entrenchment Ratio	>4.00
Bank Height Ratio	0.93

Stream Type C/E4

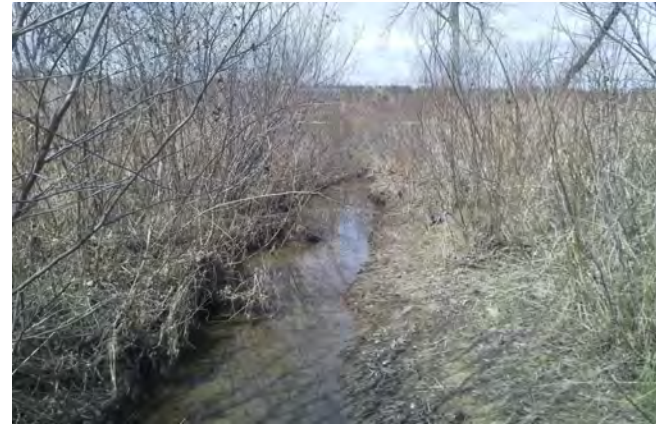
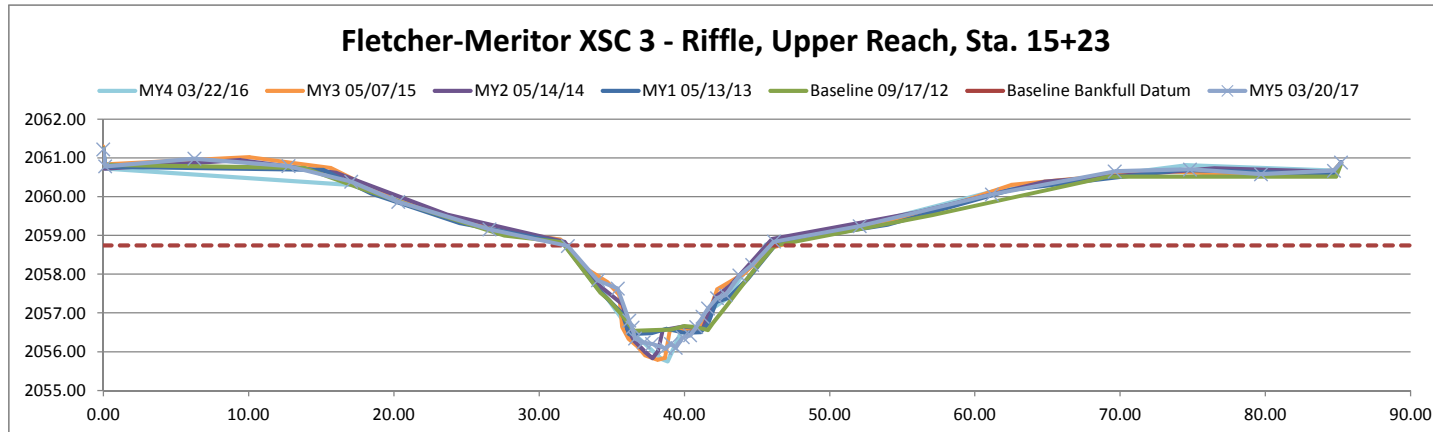
Sta. 15+23, Looking Downstream

Reach	Fletcher-Meritor, Upper Reach
River Basin	French Broad
Cross Section ID	XSC-3, Riffle, Upper Reach, 15+23
Drainage Area (Sq Mi)	0.75
Date	3/20/2017
Observers	V. Miller, W. Yelverton, K. Bell

SUMMARY DATA	
Bankfull Elevation, ft	2058.74
Bankfull Cross Sectional Area, ft²	19.90
Bankfull Width, ft	14.07
Max Depth at Bankfull, ft	2.65
Mean Depth at Bankfull, ft	1.41
Width/Depth Ratio	9.95
Flood Prone Width, ft	>86.00
Flood Prone Area Elevation, ft	2061.39
Entrenchment Ratio	>6.00
Bank Height Ratio	1.00

Stream Type C/E4

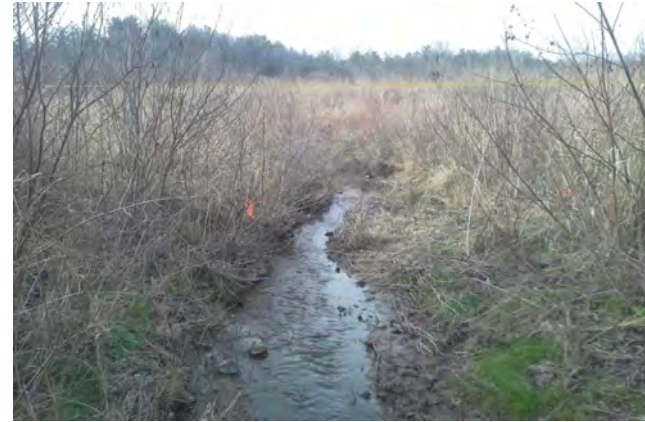
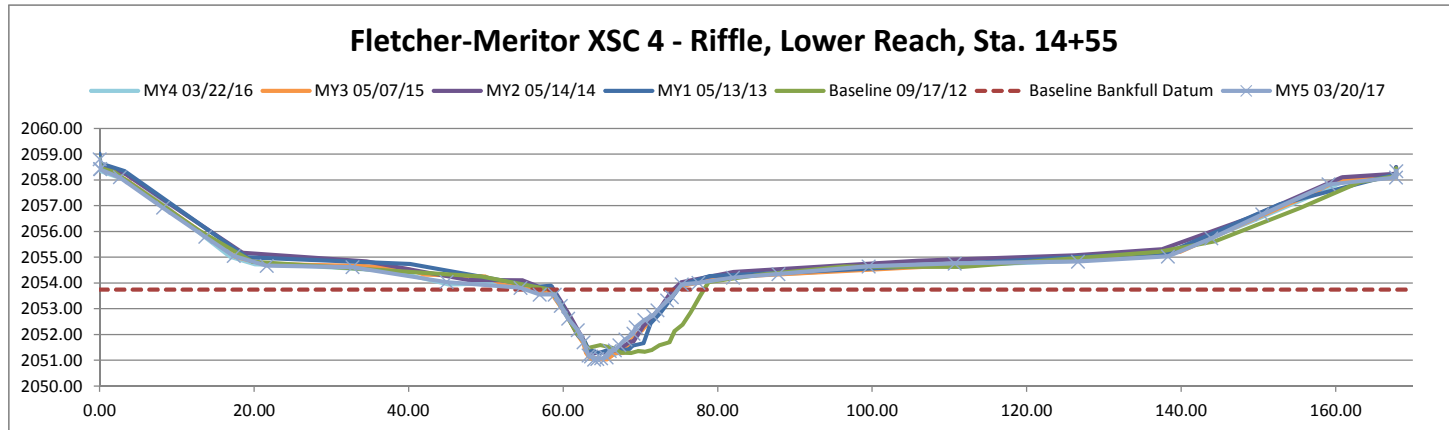
Sta. 14+55 Looking Downstream

The Lower Reach values for predicted movable particle size versus the D50 from pebble counts are similar, indicating stable conditions. For both riffle cross-sections (XSC4 and XSC6) the predicted movable particle size is 12mm as compared to the observed D50 of 10mm.

Reach	Fletcher-Meritor, Lower Reach
River Basin	French Broad
Cross Section ID	XSC-4 Riffle, Lower Reach, 14+55
Drainage Area (Sq Mi)	1.1
Date	3/20/2017
Observers	V. Miller, W. Yelverton, K. Bell

SUMMARY DATA	
Bankfull Elevation, ft	2053.74
Bankfull Cross Sectional Area, ft²	24.58
Bankfull Width, ft	19.67
Max Depth at Bankfull, ft	2.71
Mean Depth at Bankfull, ft	1.25
Width/Depth Ratio	15.74
Flood Prone Width, ft	138.50
Flood Prone Area Elevation, ft	2056.45
Entrenchment Ratio	7.04
Bank Height Ratio	0.93

Stream Type C/E4

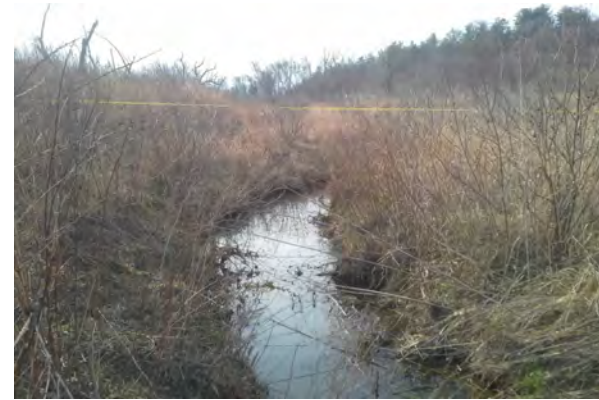
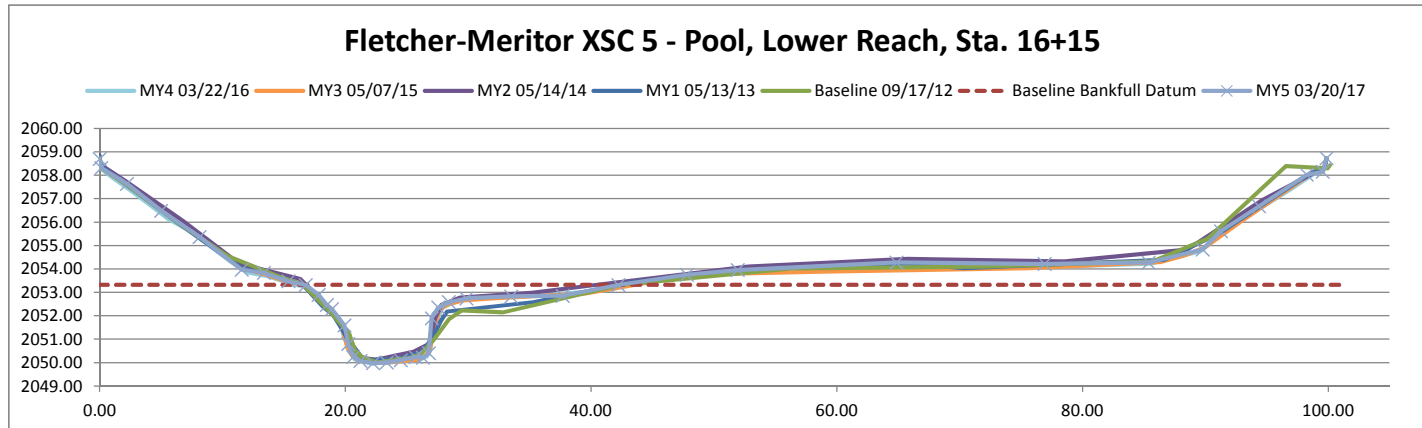
Sta. 16+15 Looking Downstream

Reach	Fletcher-Meritor, Lower Reach
River Basin	French Broad
Cross Section ID	XSC-5, Pool, Lower Reach, 16+15
Drainage Area (Sq Mi)	1.1
Date	3/20/2017
Observers	V. Miller, W. Yelverton, K. Bell

SUMMARY DATA	
Bankfull Elevation, ft	2053.32
Bankfull Cross Sectional Area, ft²	31.98
Bankfull Width, ft	25.66
Max Depth at Bankfull, ft	3.35
Mean Depth at Bankfull, ft	1.25
Width/Depth Ratio	20.59
Flood Prone Width, ft	85.20
Flood Prone Area Elevation, ft	2056.67
Entrenchment Ratio	3.32
Bank Height Ratio	1.00

Stream Type C/E4

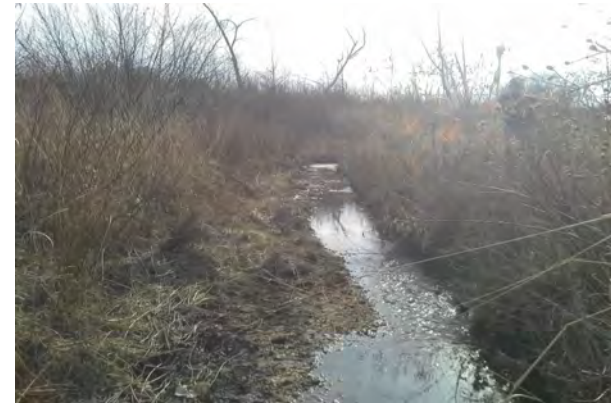
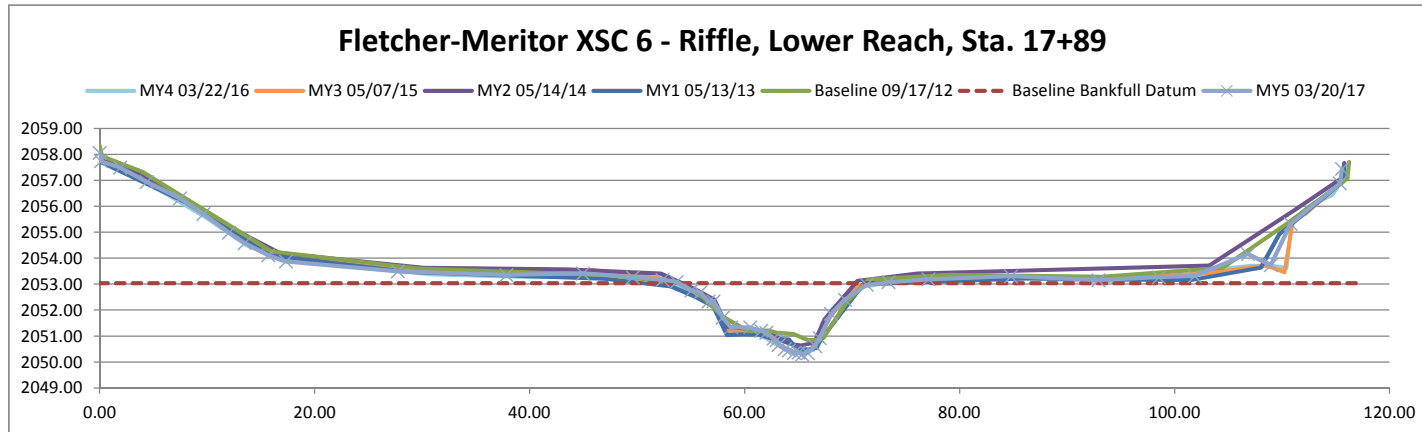
Sta. 17+89 Looking Downstream

Reach	Fletcher-Meritor, Lower Reach
River Basin	French Broad
Cross Section ID	XSC-6, Riffle, Lower Reach, 17+89
Drainage Area (Sq Mi)	1.1
Date	3/20/2017
Observers	V. Miller, W. Yelverton, K. Bell

SUMMARY DATA	
Bankfull Elevation, ft	2053.03
Bankfull Cross Sectional Area, ft²	24.70
Bankfull Width, ft	18.65
Max Depth at Bankfull, ft	2.74
Mean Depth at Bankfull, ft	1.32
Width/Depth Ratio	14.08
Flood Prone Width, ft	102.70
Flood Prone Area Elevation, ft	2055.77
Entrenchment Ratio	5.51
Bank Height Ratio	0.98

Stream Type C/E4

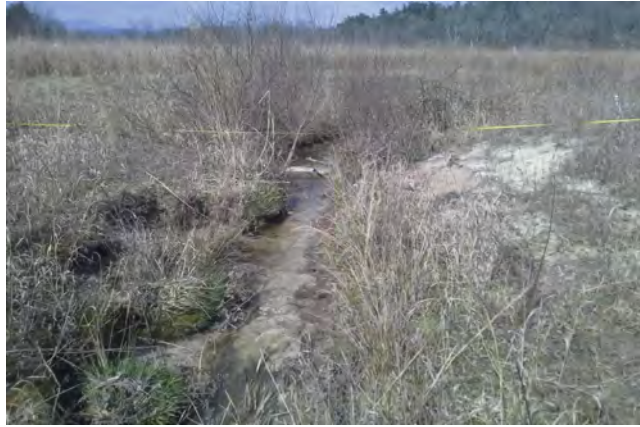
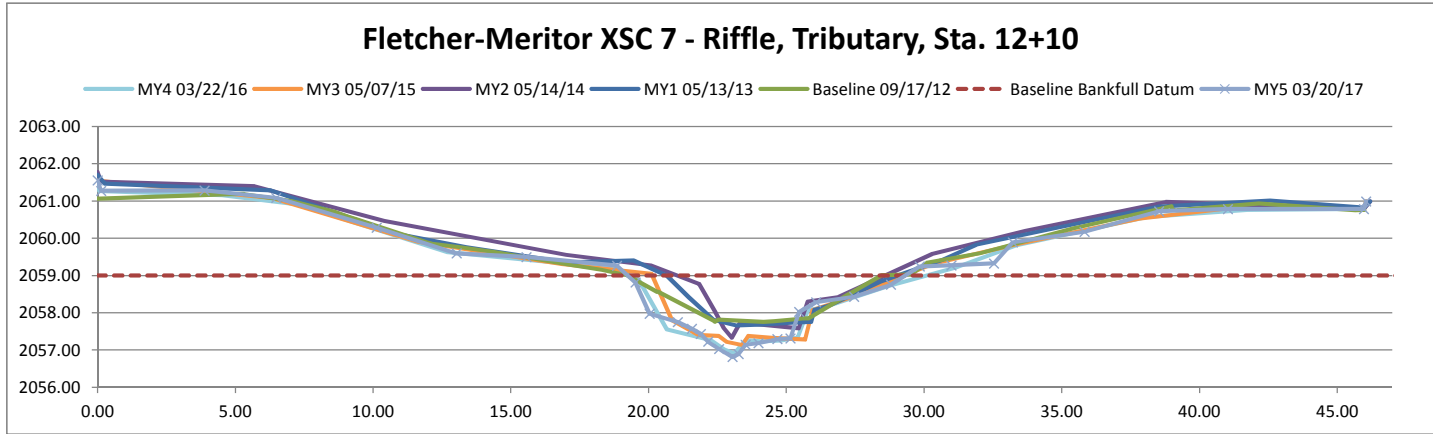
Sta. 12+10 Looking Downstream

Reach	Fletcher-Meritor, Tributary
River Basin	French Broad
Cross Section ID	XSC-7, Riffle, Tributary, 12+10
Drainage Area (Sq Mi)	0.32
Date	3/20/2017
Observers	V. Miller, W. Yelverton, K. Bell

SUMMARY DATA	
Bankfull Elevation, ft	2059.00
Bankfull Cross Sectional Area, ft²	11.18
Bankfull Width, ft	10.09
Max Depth at Bankfull, ft	2.19
Mean Depth at Bankfull, ft	1.11
Width/Depth Ratio	9.11
Flood Prone Width, ft	>46.05
Flood Prone Area Elevation, ft	2061.19
Entrenchment Ratio	>4.56
Bank Height Ratio	1.12

Stream Type C/E4

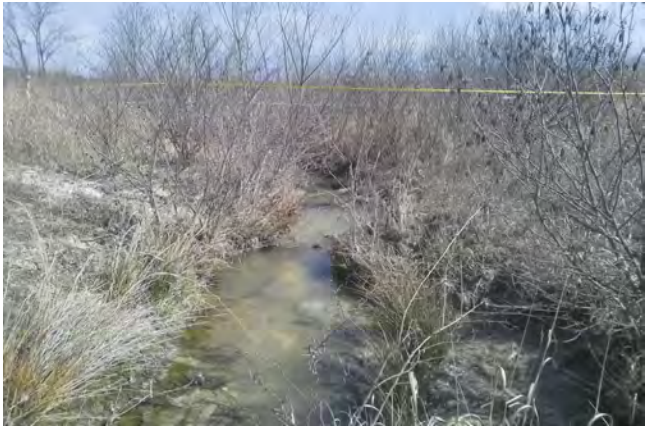
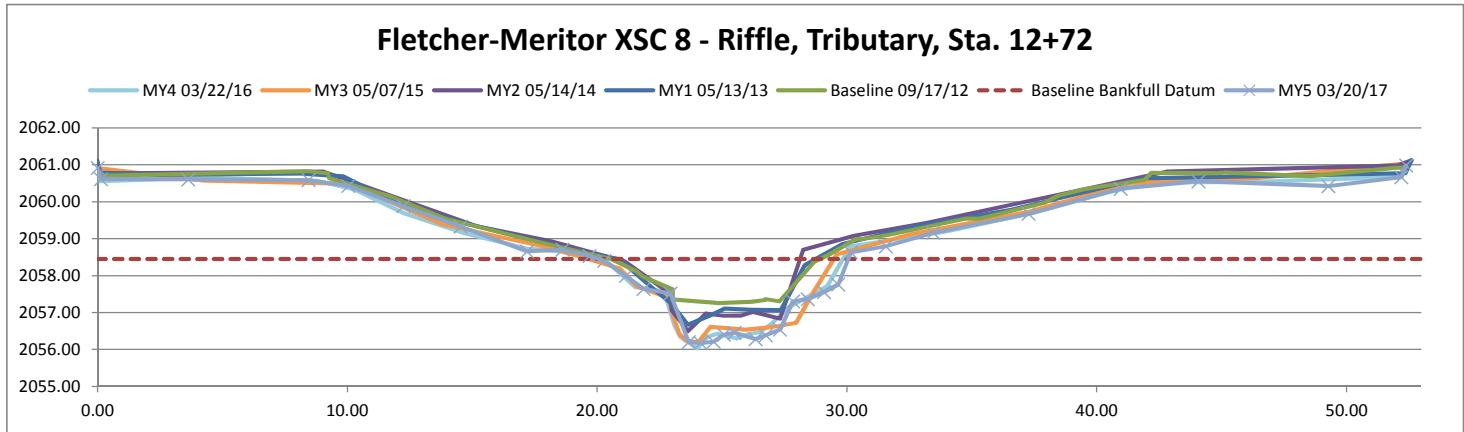
Sta. 12+72 Looking Downstream

Reach	Fletcher-Meritor, Tributary
River Basin	French Broad
Cross Section ID	XSC-8, Riffle, Tributary, 12+72
Drainage Area (Sq Mi)	0.32
Date	3/20/2017
Observers	V. Miller, W. Yelverton, K. Bell

SUMMARY DATA	
Bankfull Elevation, ft	2058.45
Bankfull Cross Sectional Area, ft ²	13.23
Bankfull Width, ft	10.00
Max Depth at Bankfull, ft	2.28
Mean Depth at Bankfull, ft	1.32
Width/Depth Ratio	7.56
Flood Prone Width, ft	52.16
Flood Prone Area Elevation, ft	2060.73
Entrenchment Ratio	5.22
Bank Height Ratio	0.98

Stream Type C/E4

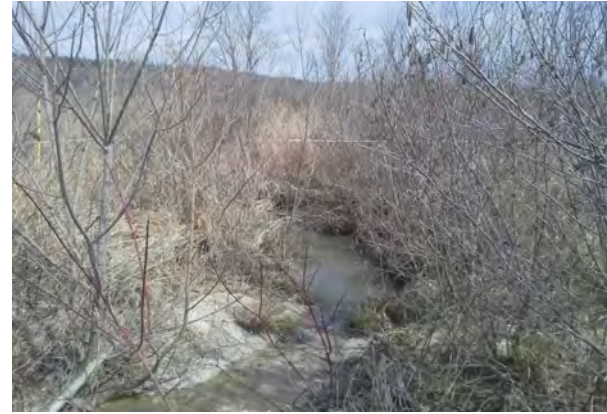
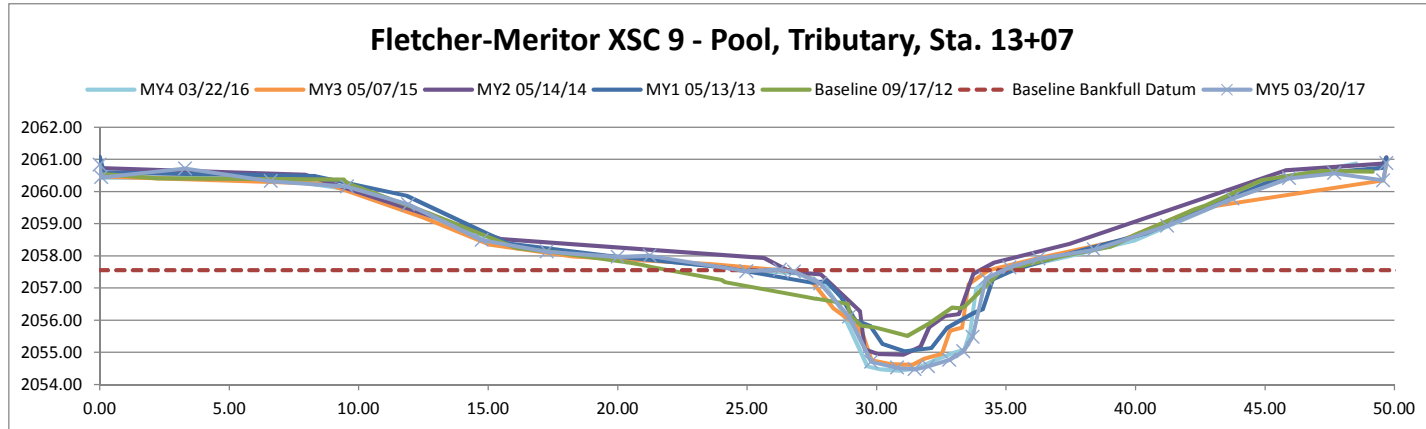
Sta. 13+07 Looking Downstream

Reach	Fletcher-Meritor, Tributary
River Basin	French Broad
Cross Section ID	XSC-9, Pool, Tributary, 13+07
Drainage Area (Sq Mi)	0.32
Date	3/20/2017
Observers	V. Miller, W. Yelverton, K. Bell

SUMMARY DATA	
Bankfull Elevation, ft	2057.55
Bankfull Cross Sectional Area, ft²	15.00
Bankfull Width, ft	9.45
Max Depth at Bankfull, ft	3.08
Mean Depth at Bankfull, ft	1.59
Width/Depth Ratio	5.95
Flood Prone Width, ft	35.00
Flood Prone Area Elevation, ft	2060.63
Entrenchment Ratio	3.70
Bank Height Ratio	0.99

Stream Type C/E4

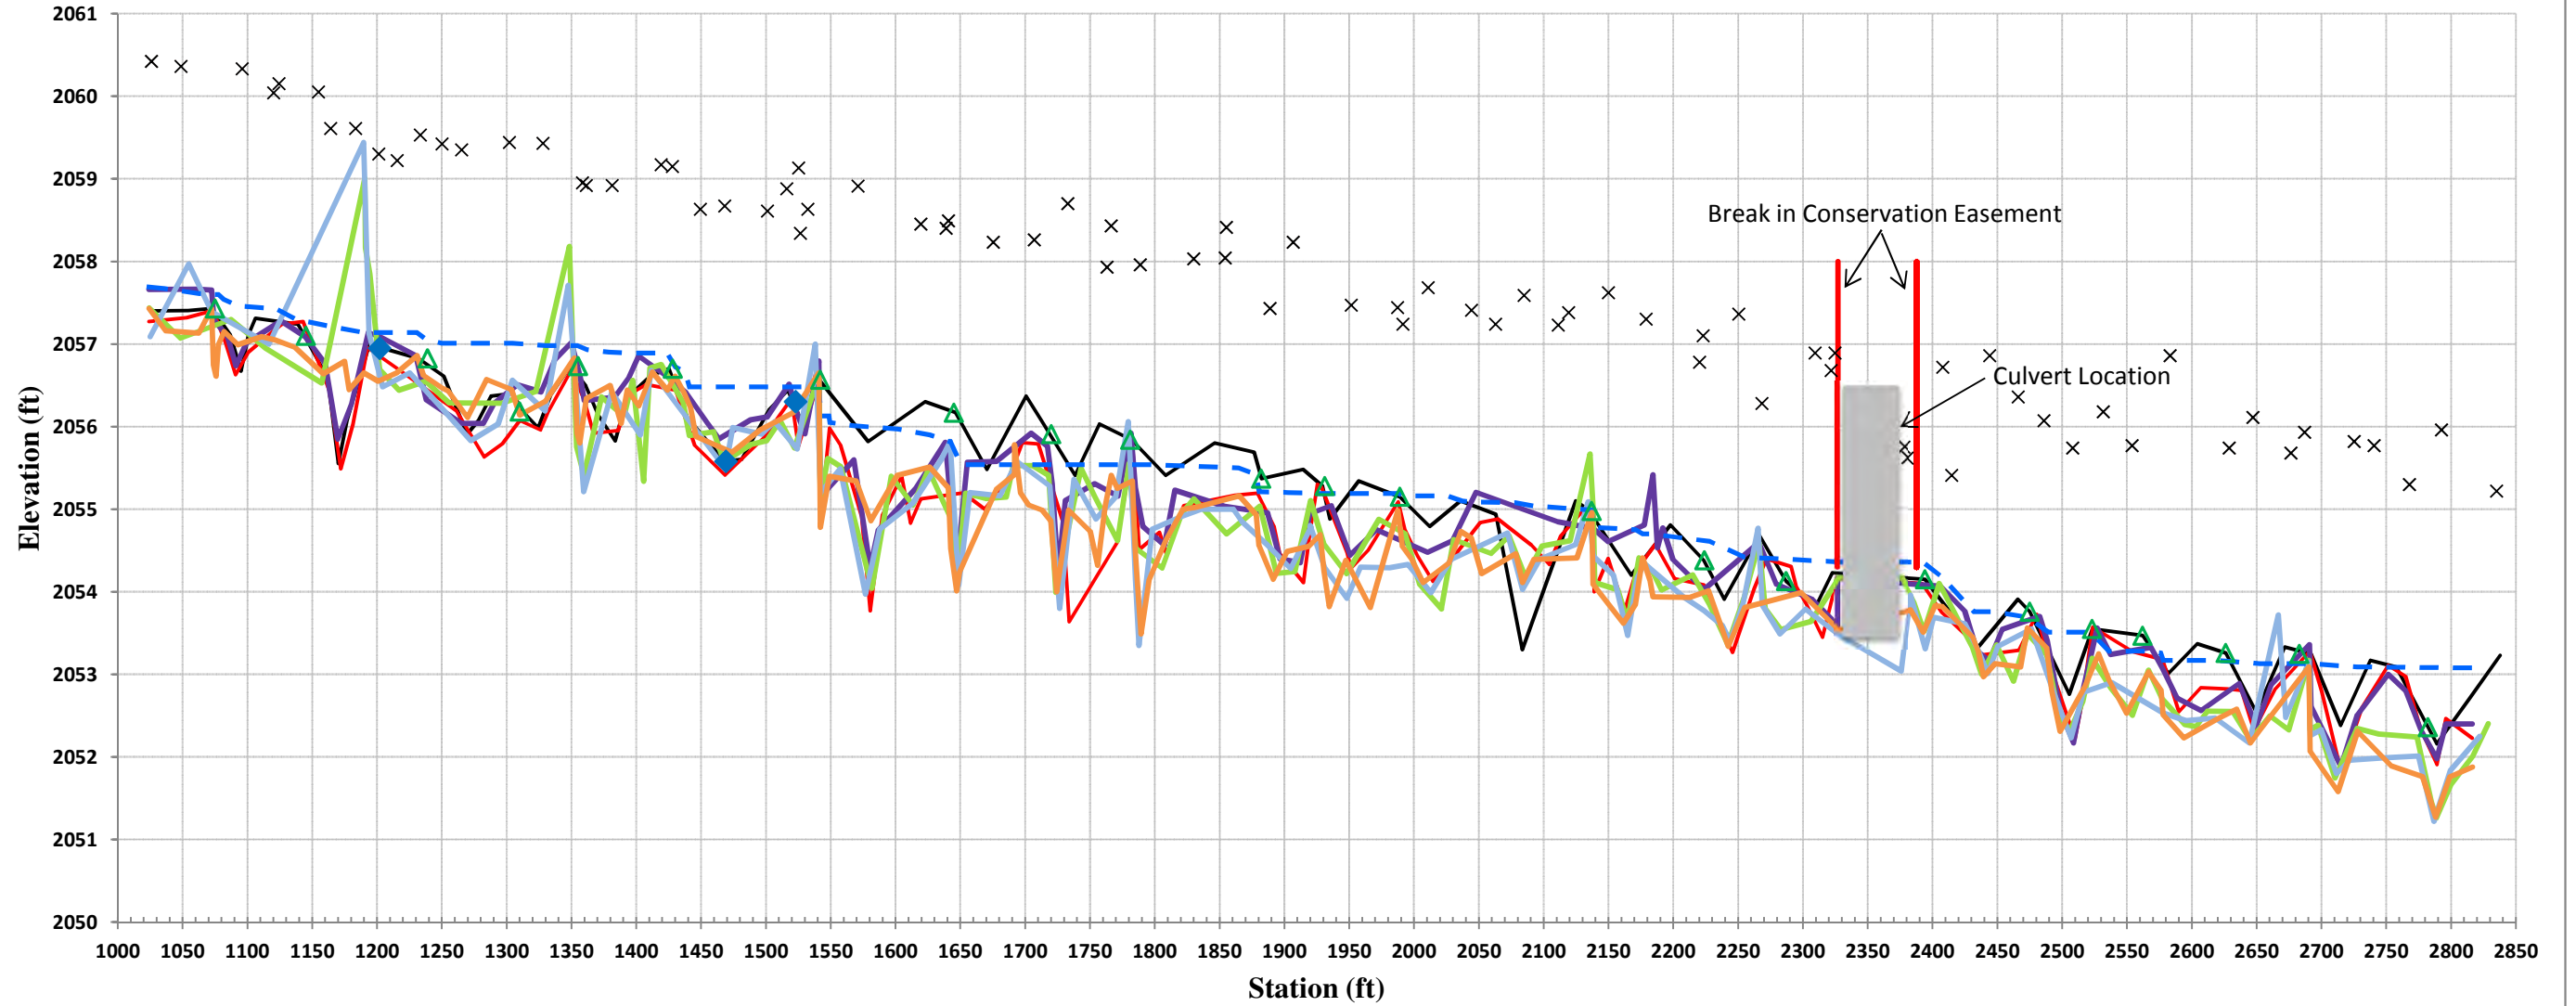
**Longitudinal Profile
Fletcher - Upper Reach
Project Number - 138
Station 10+25.00 - 28+37.86**

The beaver dams on the Upper Reach noted in previous years were absent in Year 5. As a result more riffles were observed this year and overall water surface slopes returned to values similar to those seen in years prior to Year 4. Pools on the Upper Reach retained similar depths and lengths as compared to previous years as well.

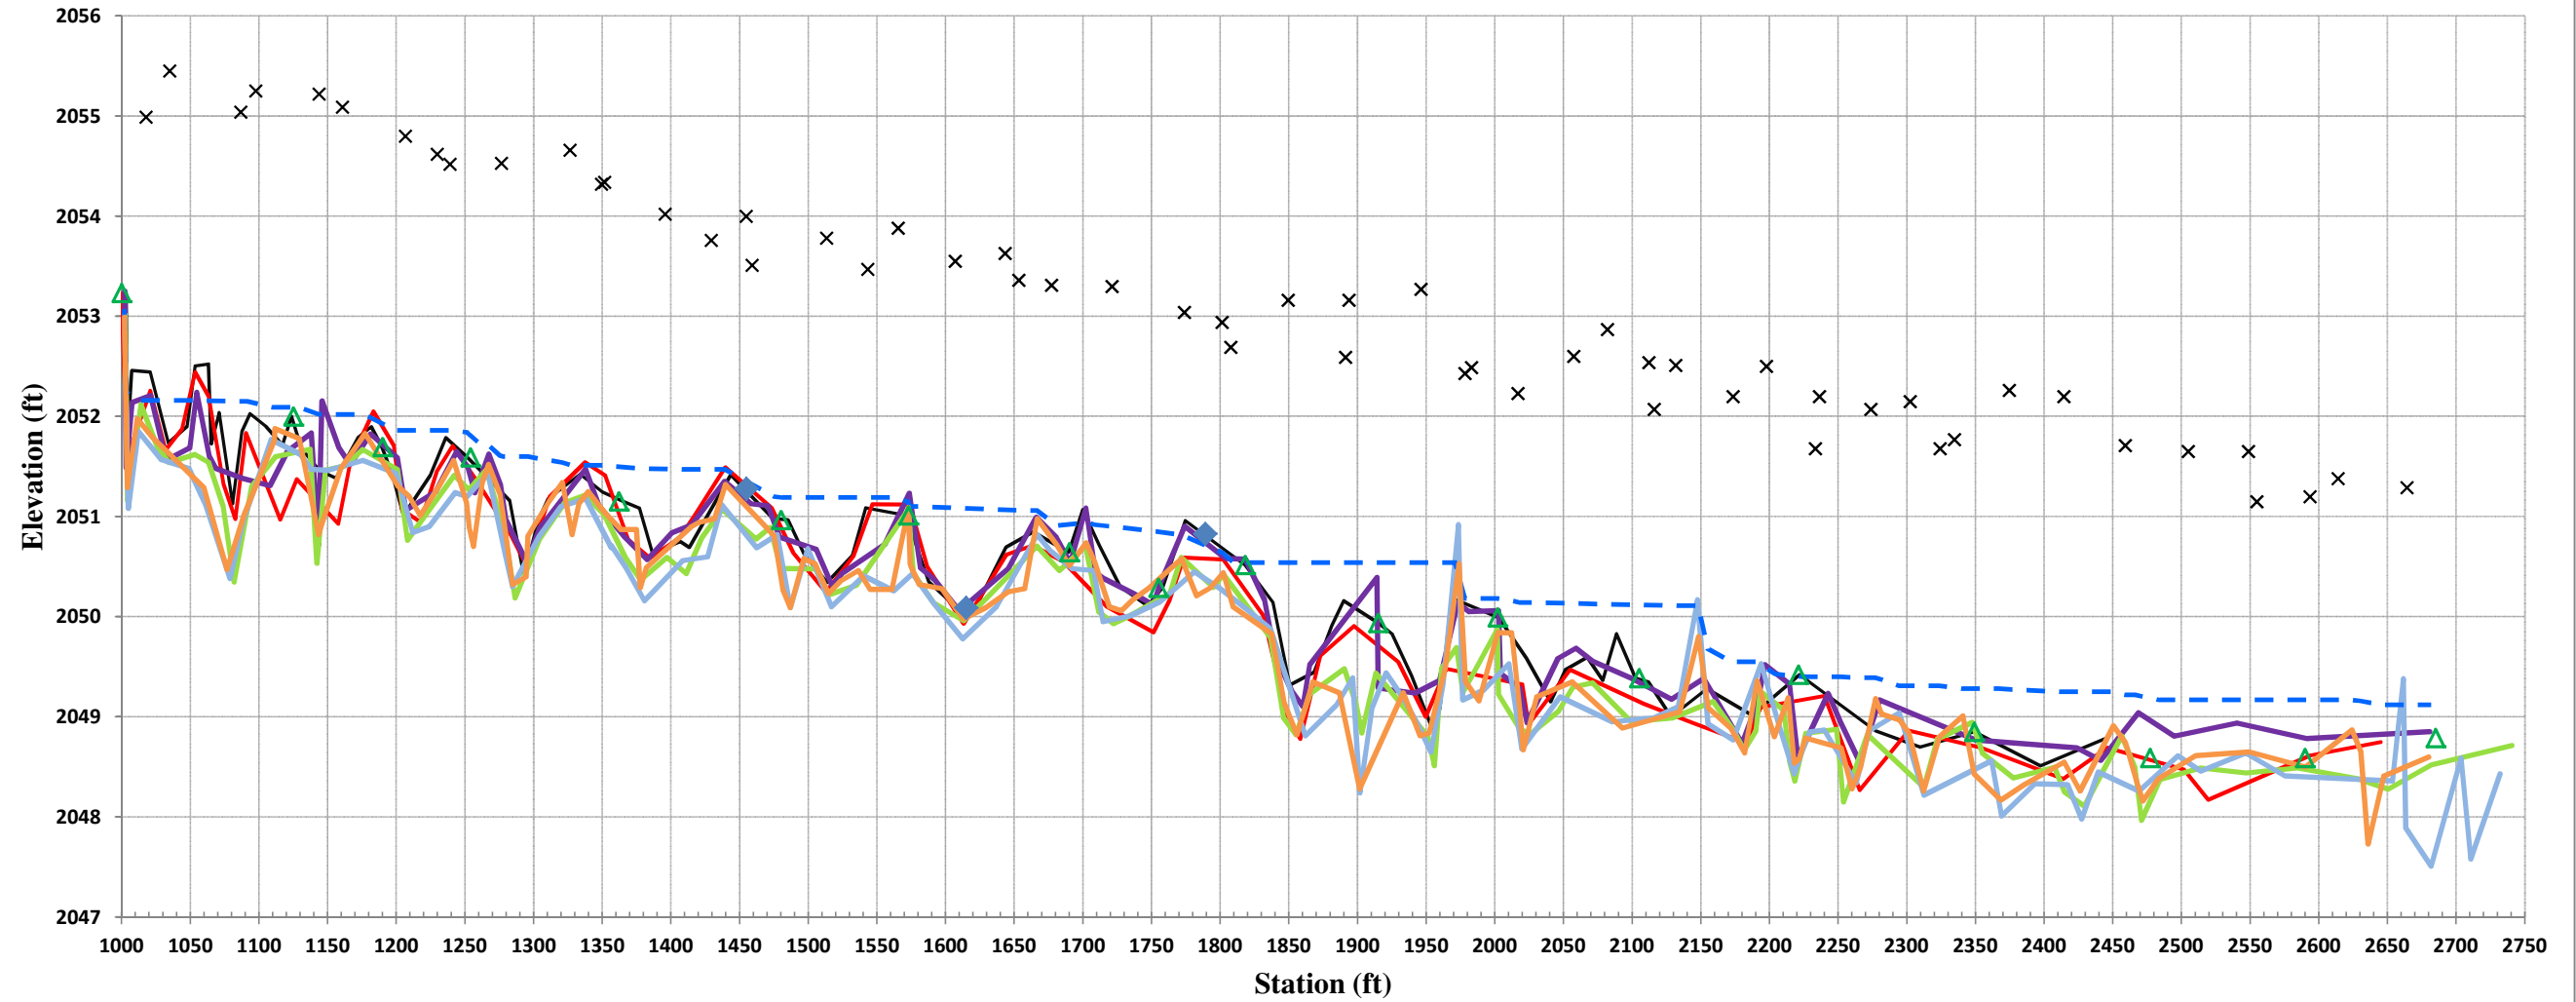
**Longitudinal Profile
Fletcher - Lower Reach
Project Number - 138
Station 10+00.00 - 26+45.00**

The beaver influences on the Lower Reach from Year 4 were also diminished in Year 5. Riffles and pools were stable overall. One item of note is that an increased number of smaller length pools were observed this year.
