**Fletcher-Meritor Site
(UT to Cane Creek) Stream and Wetland Restoration
Project No: 138**

Monitoring Report Year 6 of 6

Henderson County, North Carolina

Subject: Monitoring Year 6 (MY06) Report – Final Submittal
Fletcher-Meritor Site – DMS ID #138
DEQ Contract Number 004923

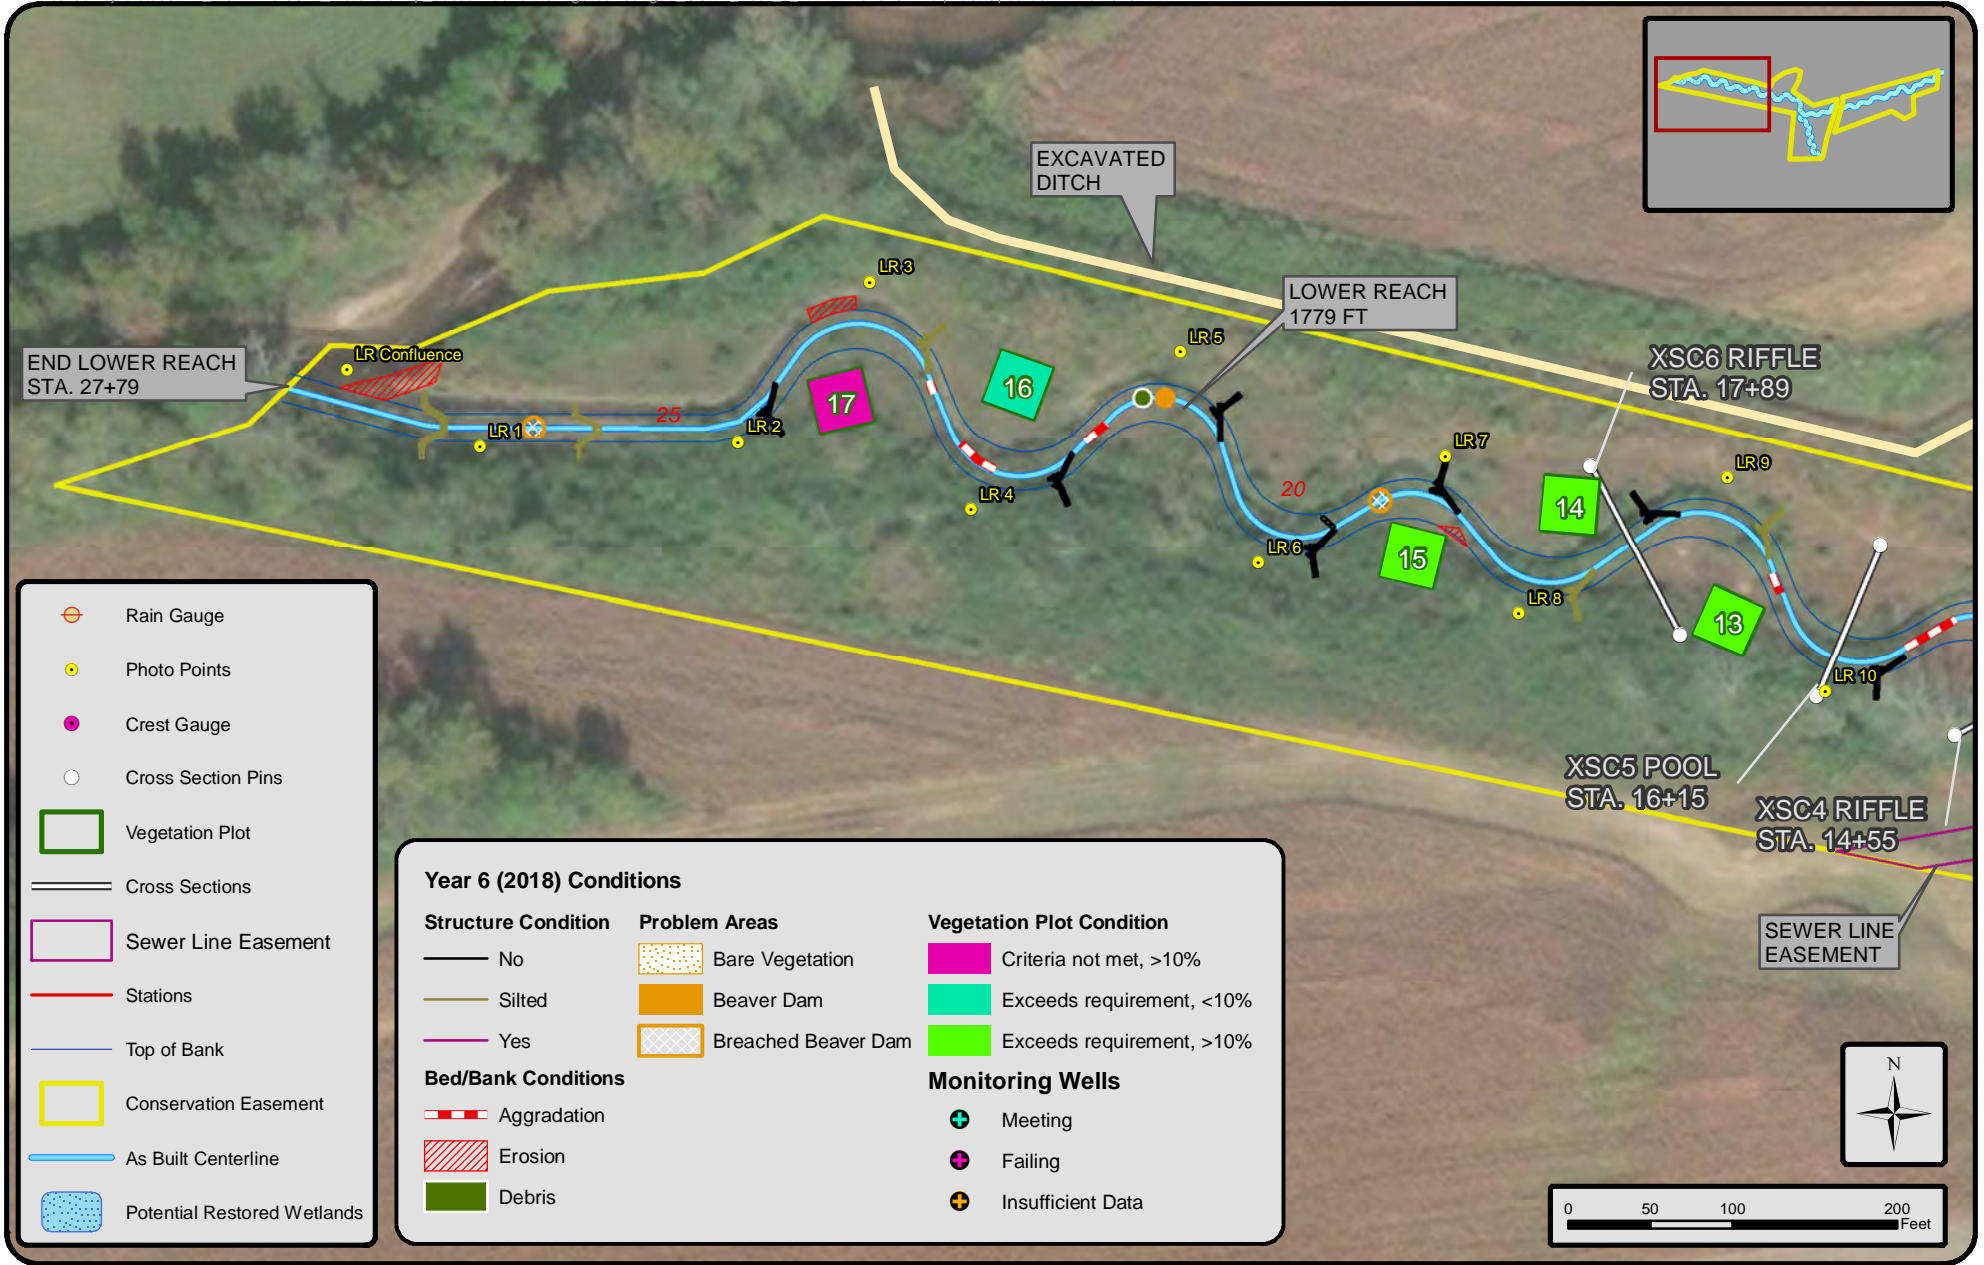
Current Conditions Plan View
Figure 3c

Figure 3c – Are the two mapped CE disturbances still a problem? Last time on site (summer 2018) these issues seem to have been rectified with additional signage. If there is no longer a concern, these polygons should be removed.

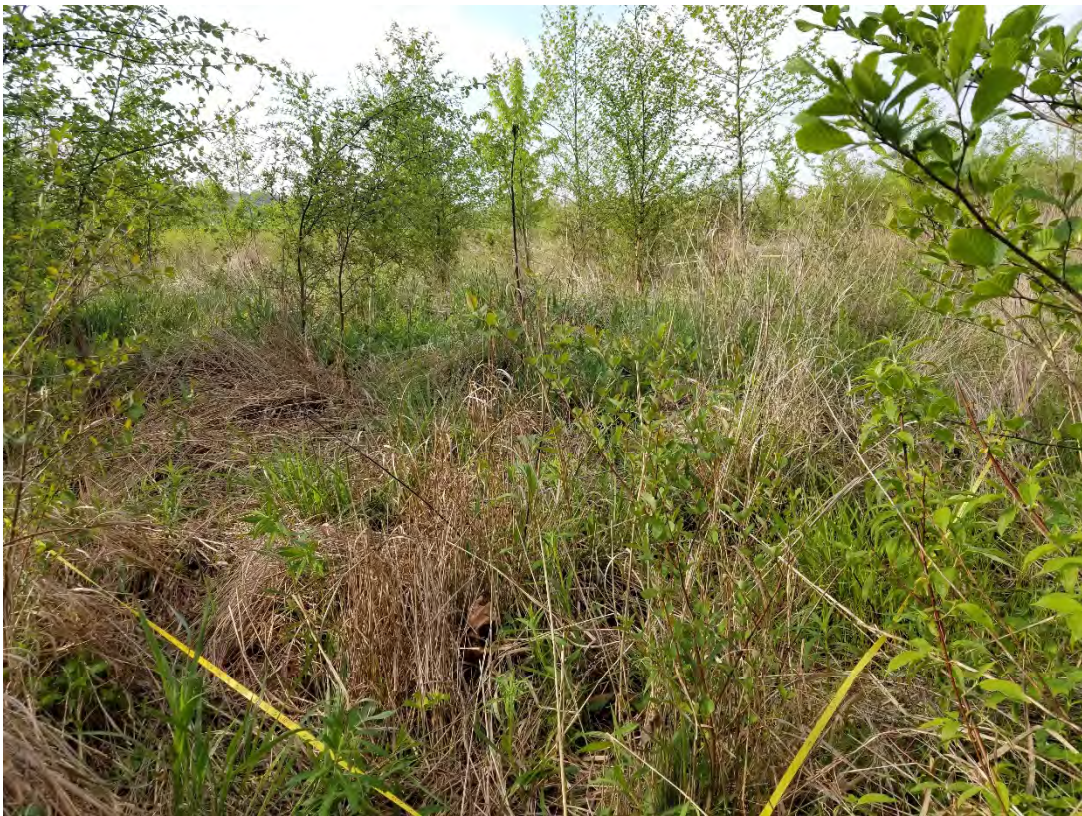
Vegetation Plot 4 – 10m x 10m (5/10/2018 Year 6)

According to the data collected, the average plant density among the 17 plots is 381 stems/acre with a range from 121 to 769 stems/acre. The highest plant density occurred in plots 4 and 7 with 769 stems/acre. Currently, 14 of the plots are meeting the vegetation success criteria of 260 stems/acre. Year 6 monitoring data is provided in Appendix C. Vegetation throughout the site appears to be growing at acceptable rates and the mortality rate appears to be fairly low. Herbaceous vegetation, which has been noted as sparse during previous monitoring events, appears to be filling in with the exception of a few locations noted on the CCPV. The three plots that are not meeting interim success criteria include two along the Tributary, which may not have been planted at the appropriate density, as well as the plot closest to the confluence with Cane Creek, which has had backwater impacts numerous times since construction. During the monitoring events there has been an unknown species that was documented during the first year and had continued to be noted. This species was not identifiable in the early years; however, has been determined to be a pussy willow or goat willow (*Salix caprea*) following observation during flowering.
