**Third Fork Creek Stream Restoration – NCEEP Project #139  
Durham, North Carolina**

**Second Annual Monitoring Report December 2006**

**THIRD FORK CREEK STREAM RESTORATION – NCEEP Project #139  
2006 MONITORING REPORT – YEAR 2**

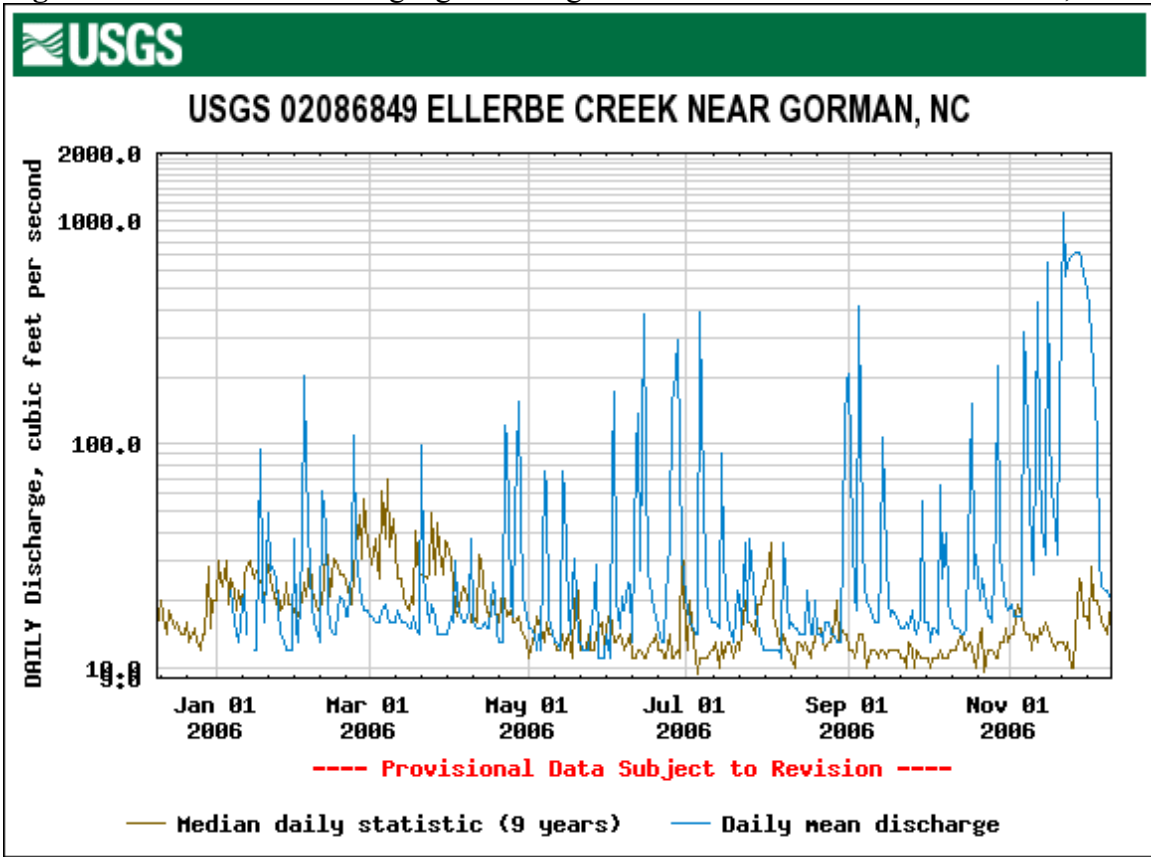
Figure 3. USGS 2006 stream gauge discharge data for Ellerbe Creek near Gorman, N.C.

Potential bankfull events were also evaluated based on USGS stream gauge discharge data for Ellerbe Creek near Gorman (USGS 02086849). This gauge is located approximately 8 miles northeast of the restoration site and has a drainage area of 21.9 square miles. According to the urban piedmont regional curve, a stream with a drainage area of 21.9 square miles would reach a bankfull discharge at 2,144.5 cubic feet per second (cfs) (Doll et al., 2002). Based on USGS data for 2006 (Figure 3), there have been no bankfull events at this gauge. The highest flow event during 2006 was 1080 cfs on November 22<sup>th</sup>, which is less than half of the bankfull discharge predicted by the urban piedmont regional curve. Using the rural piedmont regional curve, bankfull discharge is 819.7 cfs, making the high flow event on November 22<sup>nd</sup> the only bankfull event of the year.

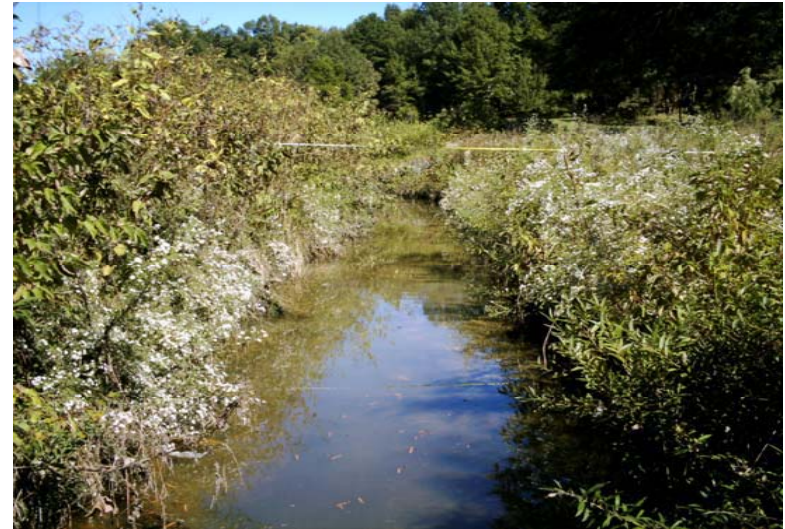
View of cross-section #1 looking upstream

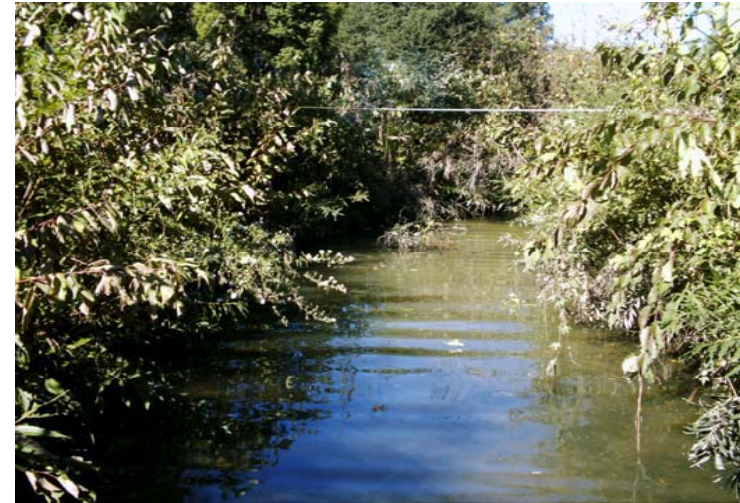
View of cross-section #2 looking upstream

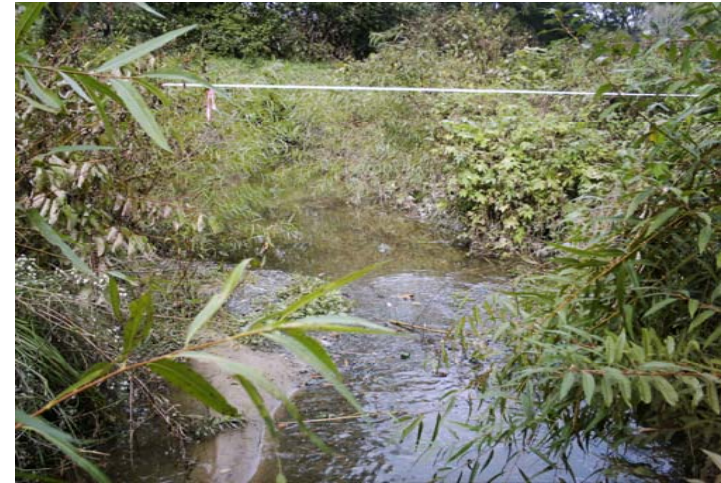
View of cross-section #3 looking upstream
