**THIRD FORK/FOREST HILLS CREEK STREAM RESTORATION – NCEEP
Project #139**

**2008 MONITORING REPORT – YEAR 4 - FINAL
January 2009**

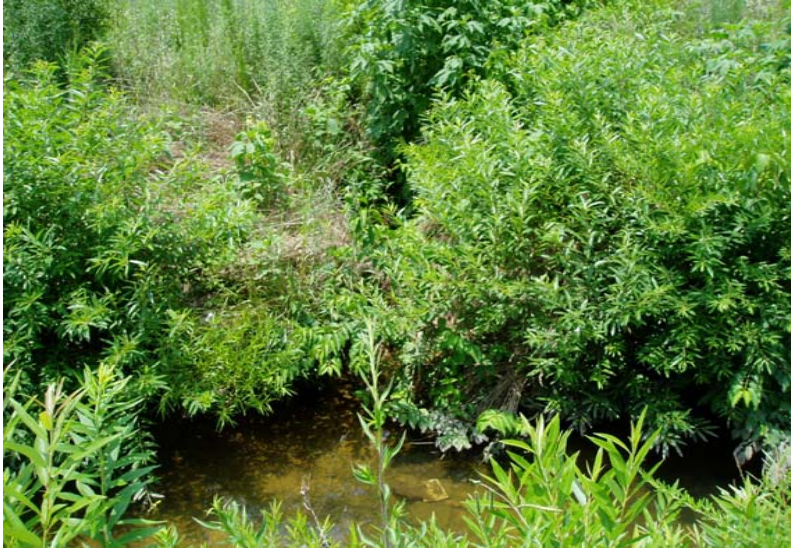
PP #3 – Ditch Entering Stream (07/16/07)

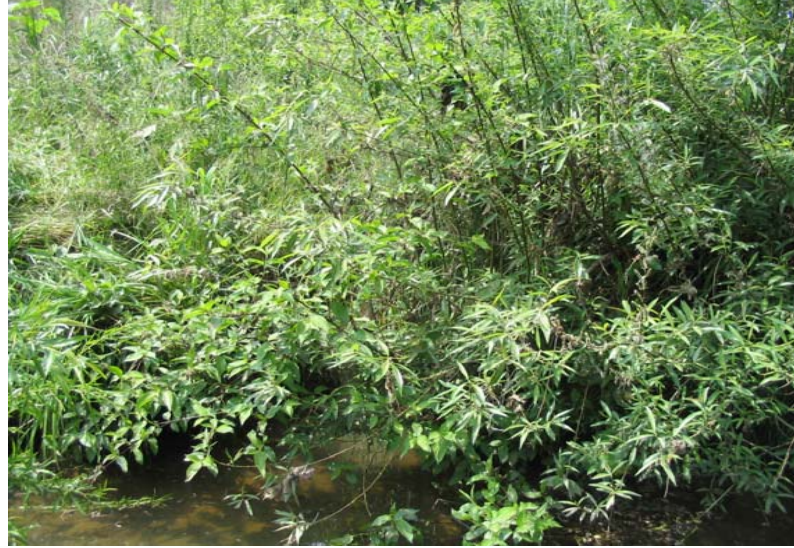
PP #3 – Ditch Entering Stream (05/06/08)

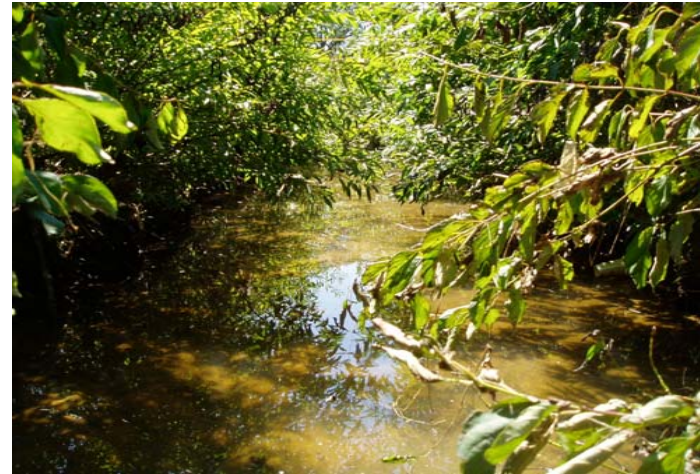
View of cross-section #1 looking downstream

Stream Type:	E5
---------------------	----
