THIRD FORK/FOREST HILLS CREEK STREAM RESTORATION–Project #139
Fifth Annual Monitoring Report – 2009 – FINAL

January 2010

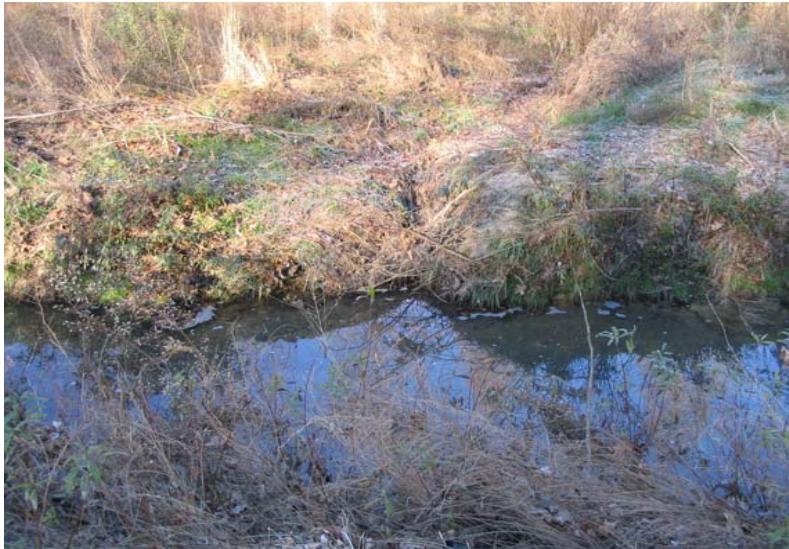
PP #3 – Ditch Entering Stream (11/20/06)

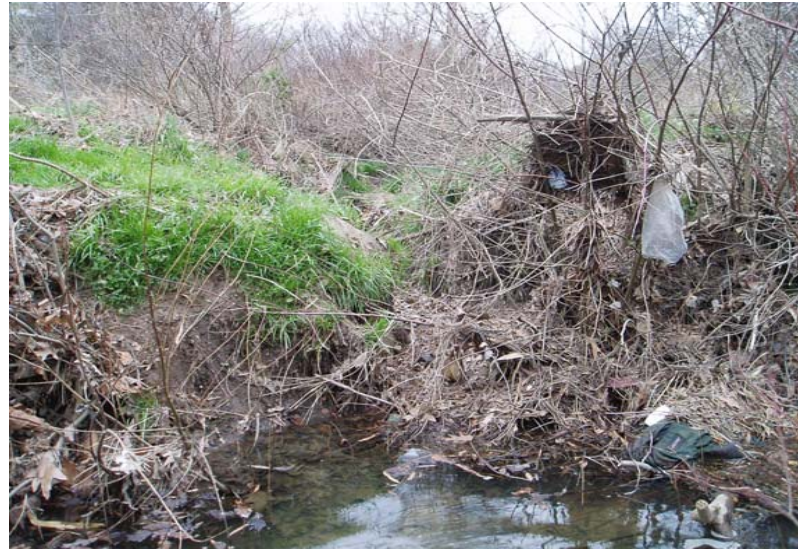
PP #3 – Ditch Entering Stream (03/11/09)
