As-built report for the Fosson Mitigation Site, Paint Fork Creek, Madison County

North Carolina Wildlife Resources Commission

October 30, 2000

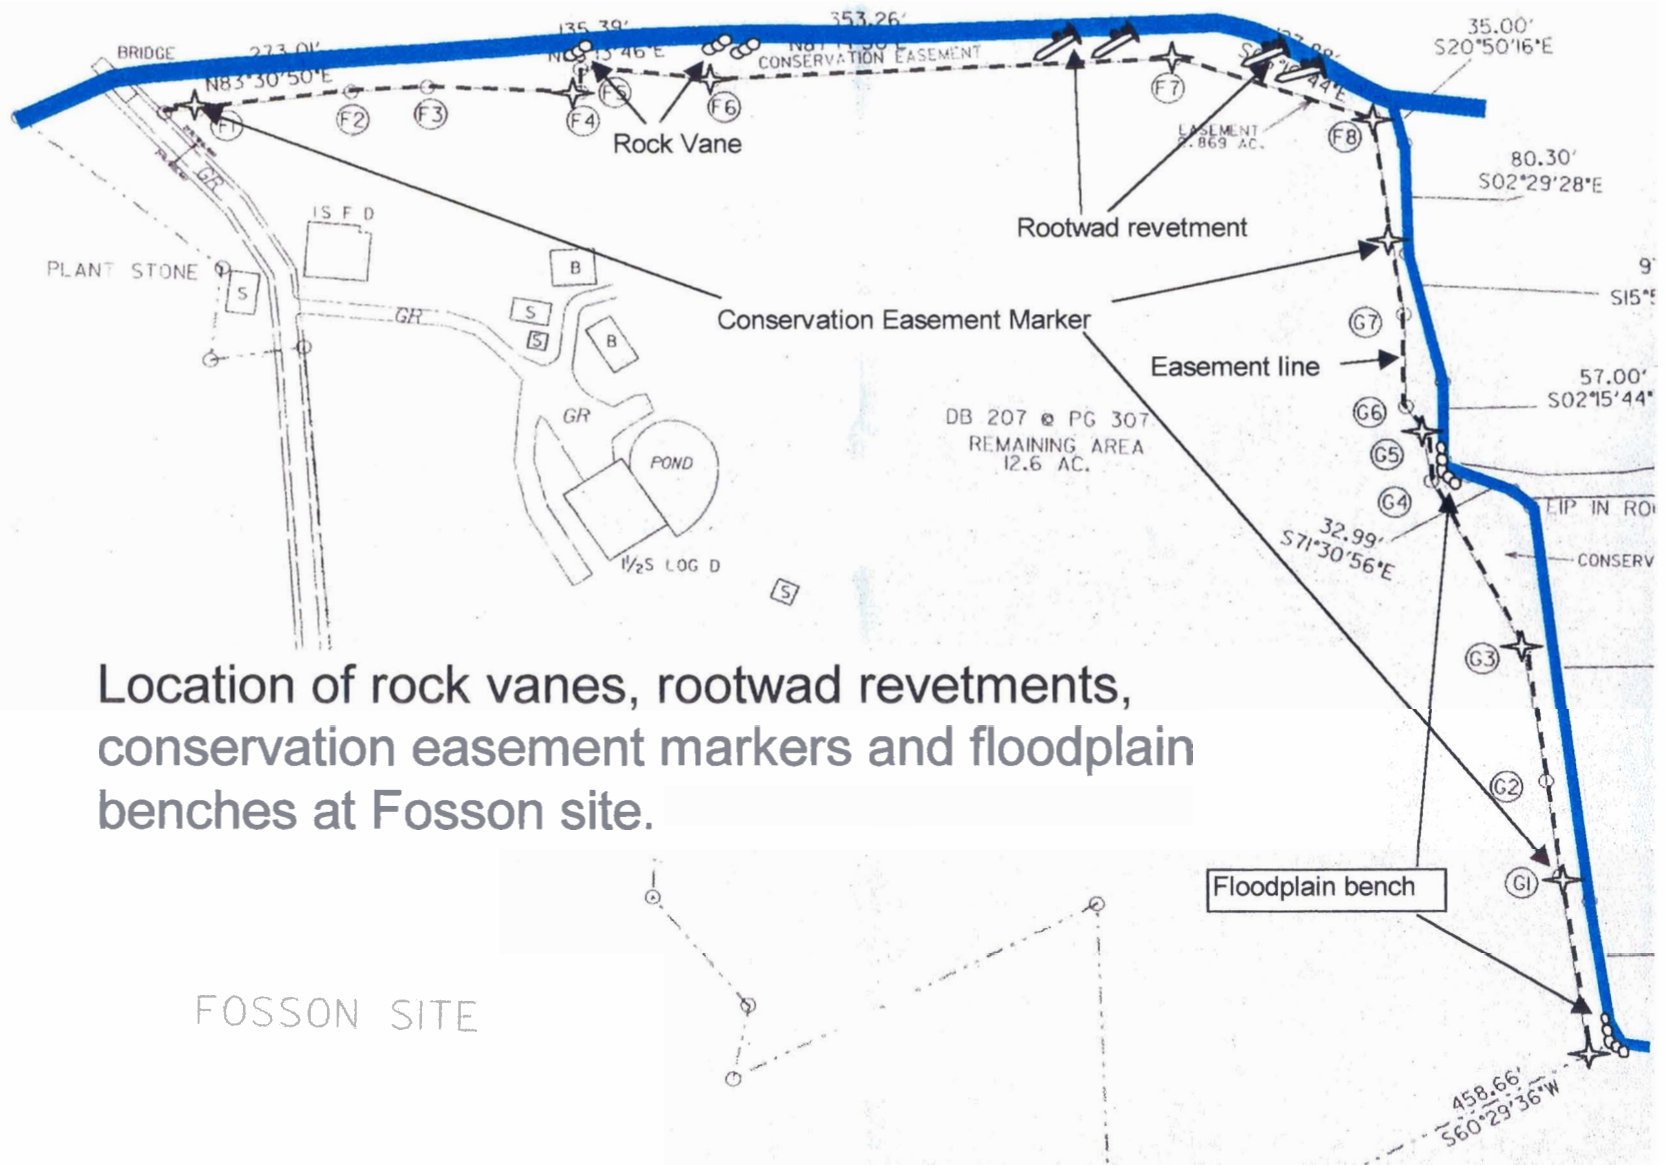
Location of rock vanes, rootwad revetments, conservation easement markers and floodplain benches at Fosson site.

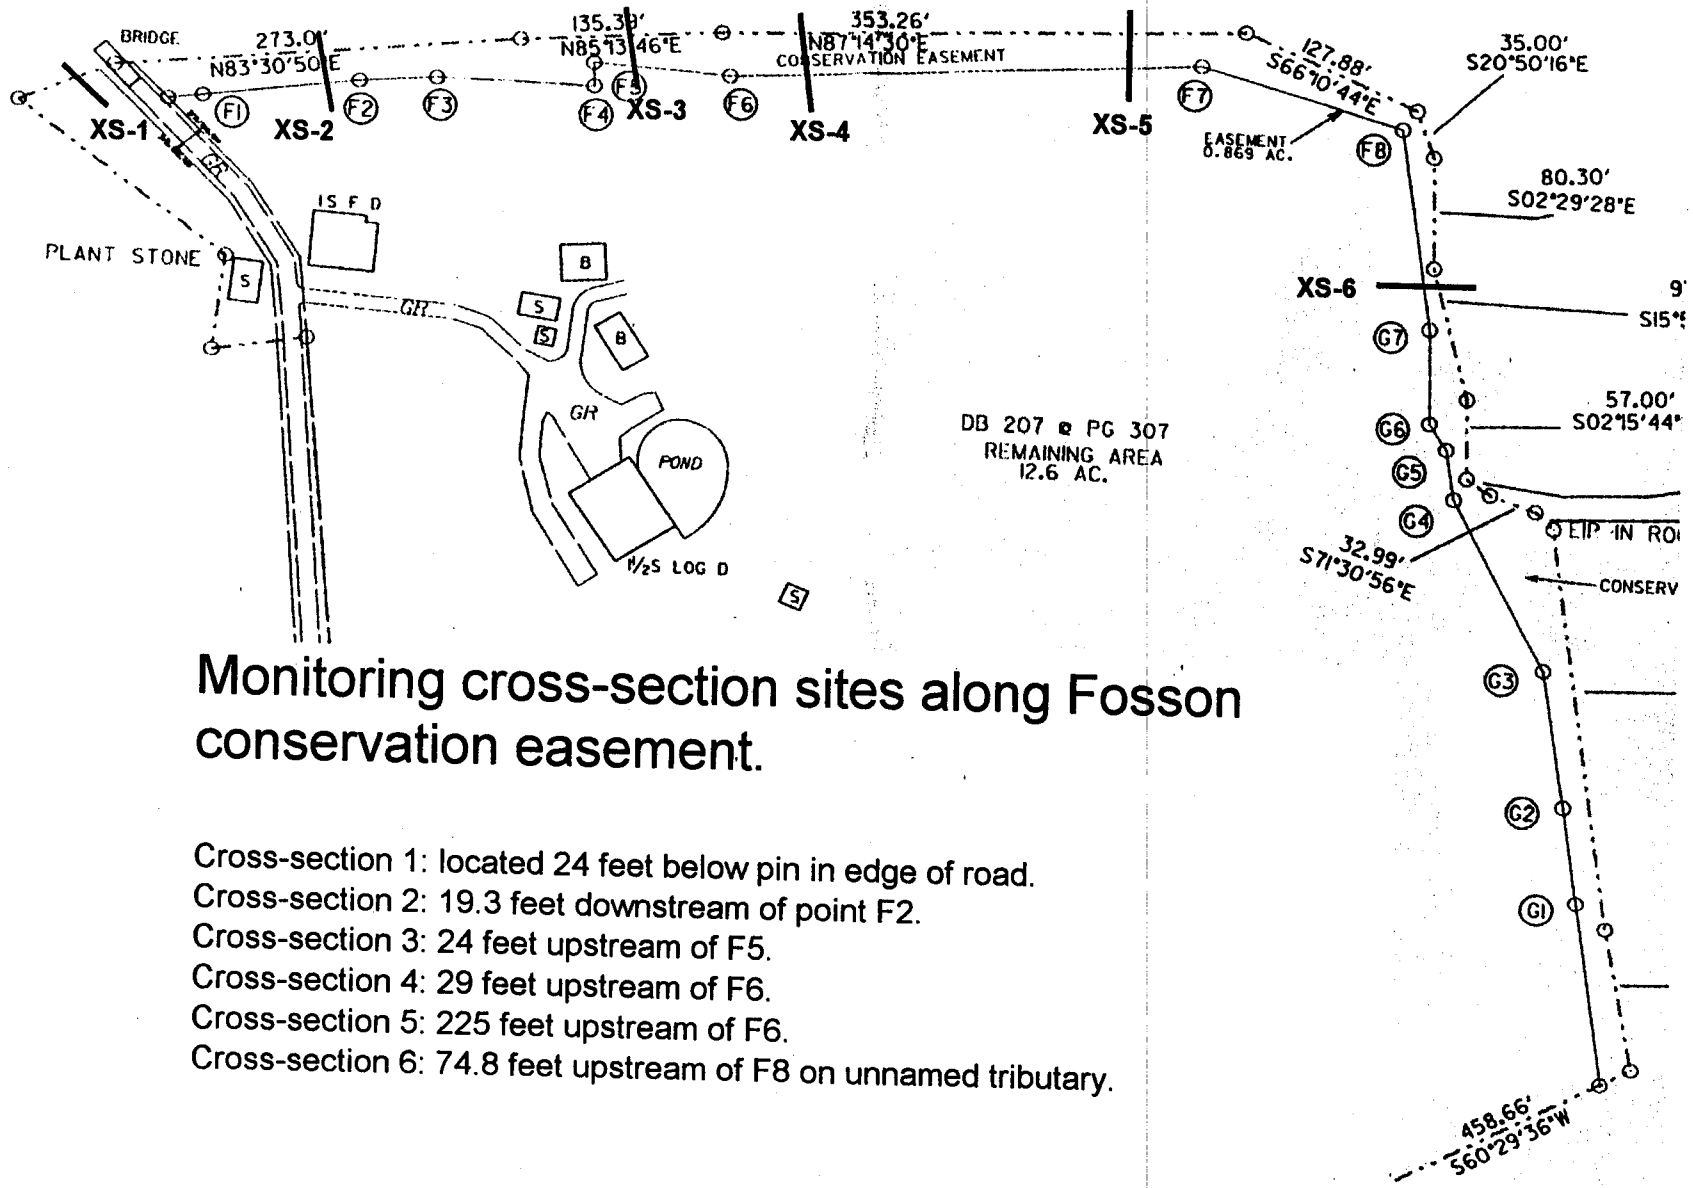
Monitoring cross-section sites along Fosson conservation easement.

- Cross-section 1: located 24 feet below pin in edge of road.
- Cross-section 2: 19.3 feet downstream of point F2.
- Cross-section 3: 24 feet upstream of F5.
- Cross-section 4: 29 feet upstream of F6.
- Cross-section 5: 225 feet upstream of F6.
- Cross-section 6: 74.8 feet upstream of F8 on unnamed tributary.
