ANNUAL REPORT FOR 2003

**Paint Fork Creek Stream Mitigation Site (Fosson Site)
Madison County
WBS Element 32573.4.1
TIP No. A-10WM**

Prepared By:
Office of Natural Environment & Roadside Environmental Unit
North Carolina Department of Transportation
December 2003

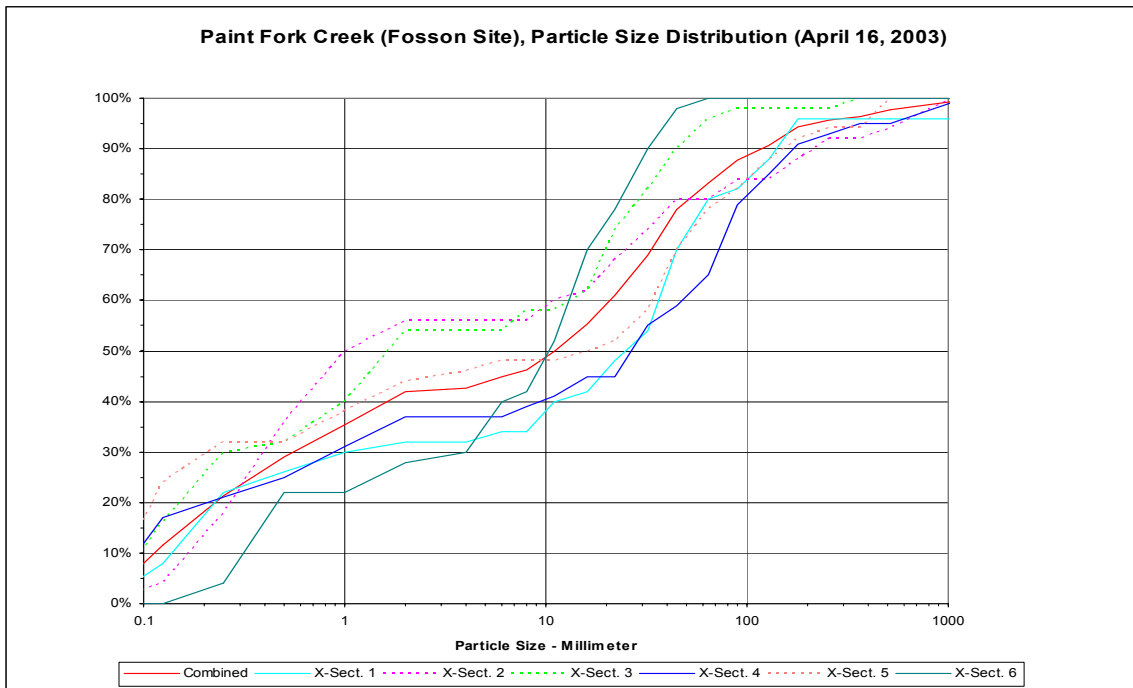
Pebble counts were taken at each cross section as a means to determine the extent of change in bed material during the monitoring period. No existing data was available Paint Fork Creek or its tributary. The comparison of pebble counts taken during the Year 2003 monitoring period noted that the combined D_{50} (50 percent of the sampled population is equal to or finer than the representative particle diameter) for the two streams was approximately 8.0 mm, which is indicative of a gravel-bed stream. The D_{50} s associated with Cross Sections #2 and #3 were 0.5 mm and 1.0 mm, respectively, and characteristic of a sand-bed stream type. However, the overall combined D_{50} of Paint Fork Creek was 11.3 mm. This is likely a result of watershed problems outside and upstream of the Fosson Site. The introduction of fine materials and the overall change in bedload across these two cross sections will be monitored. A chart depicting the particle size distributions for Paint Fork Creek and its tributary is presented below. Comparisons will be made between 2003 data and future monitoring efforts.

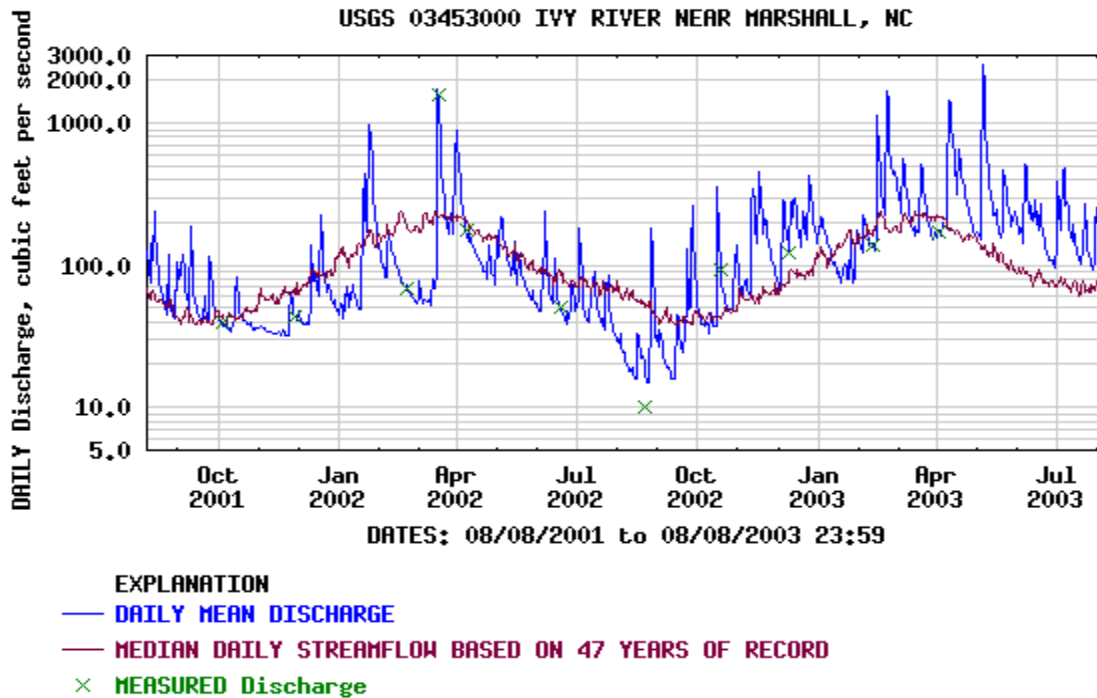
The Ivy River gage was utilized for this report since it is downstream and part of the overall watershed of Paint Fork Creek. It was also the smaller of the two gages (158 square-mile drainage area as compared to the 1,332 square-mile drainage area associated with the French Broad). The Ivy River gage more accurately reflects hydrology and precipitation in the project area. It is situated in USGS Hydrologic Unit 06010105. Datum of the gage is 1,700.41 feet above sea level NGVD29. Based on the drainage area associated with the gage, the correlated bankfull discharge according to the NC Rural Mountain Regional Curves (USACE, 2003) is between 450 and 500 cubic feet per second (cfs). A review of peak flows was conducted for the period between August 2001 and August 2003. According to the graph, there were 14 bankfull events occurring during this period, with seven of the events happening in 2003. Approximately five of these events over the two year period exceeded 1,000 cfs, well above the bankfull discharge. The USGS graph depicting these peak flows is presented below.

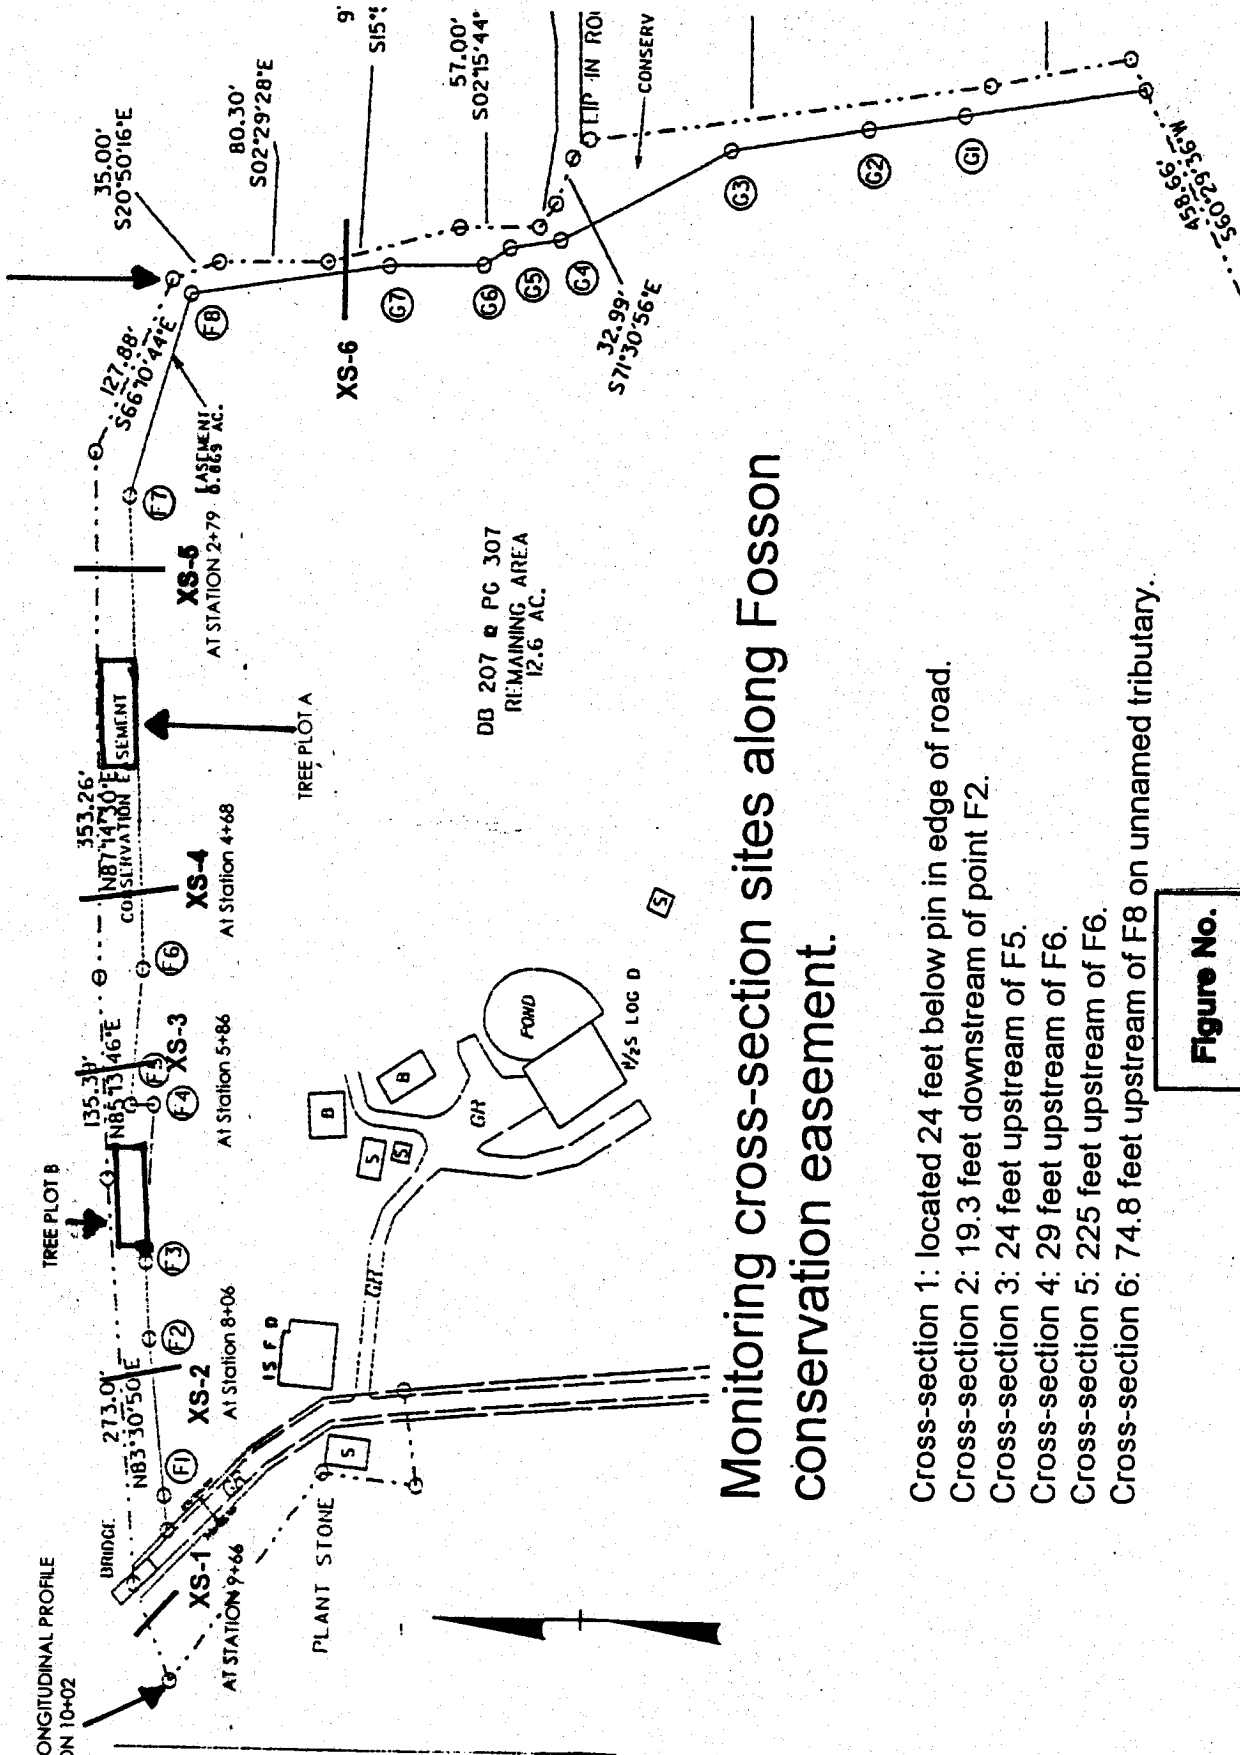
Figure No.
2

Monitoring cross-section sites along Fosson conservation easement.

- Cross-section 1: located 24 feet below pin in edge of road.
- Cross-section 2: 19.3 feet downstream of point F2.
- Cross-section 3: 24 feet upstream of F5.
- Cross-section 4: 29 feet upstream of F6.
- Cross-section 5: 225 feet upstream of F6.
- Cross-section 6: 74.8 feet upstream of F8 on unnamed tributary.

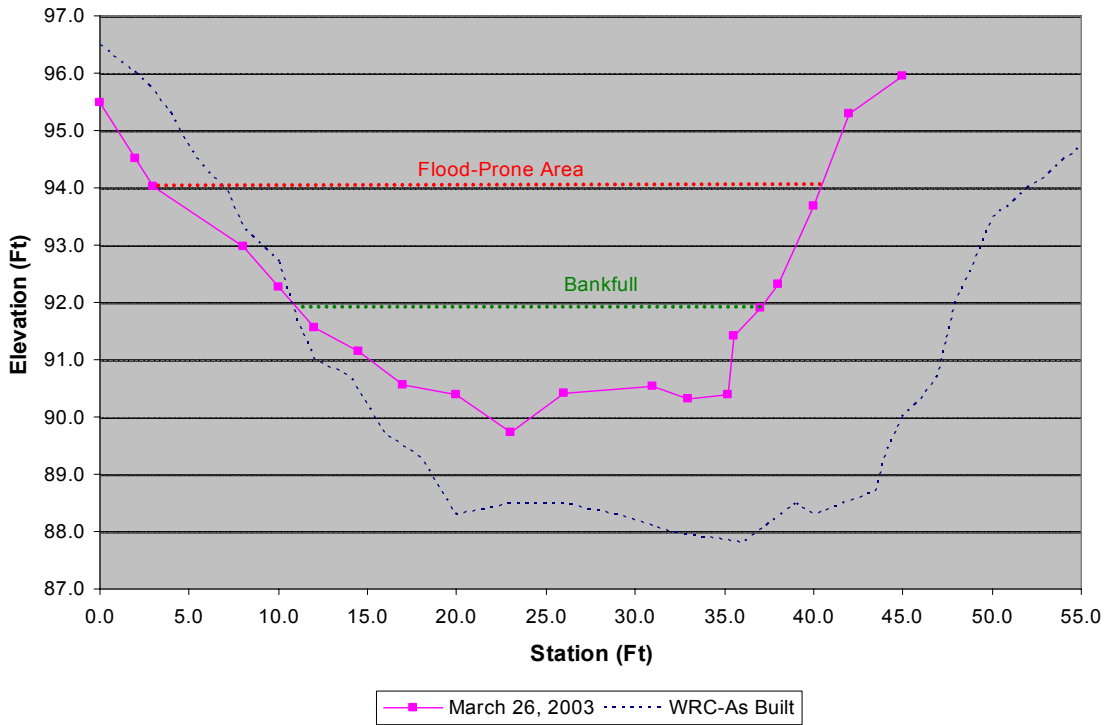
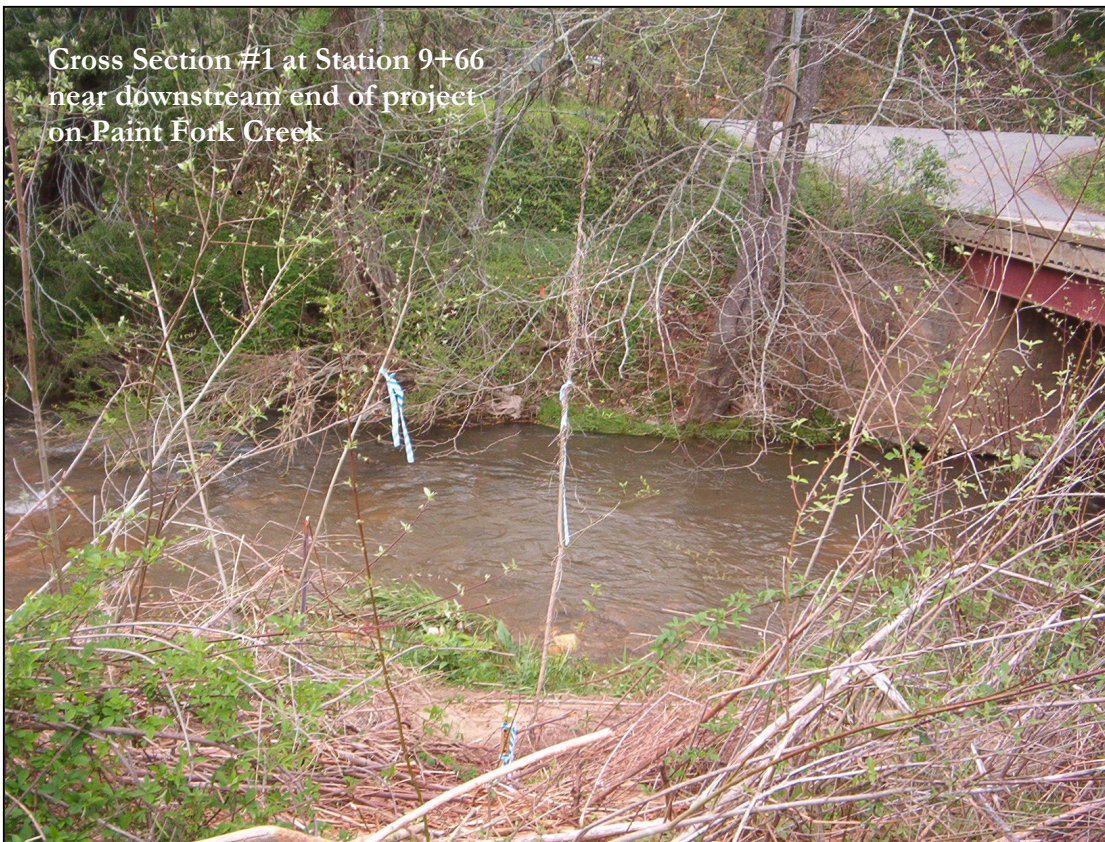
Cross Section-1, Station 9+66 (Paint Fork Creek)

All six cross sections have remained intact based on comparisons with as-built data and visual observations. Several benchmarks and existing stakes associated with the as-built surveys were not found; therefore exact data comparisons were not feasible. The Year 2003

data will be used for future comparisons. Based on the comparison of cross section survey results with the as-built sections, all six cross sections appear stable. These cross sections will be monitored during the next several years to determine the actual extent of aggradation or degradation. Survey data will also vary depending on actual location of rod placement and alignment; however, this information should remain similar in overall appearance. The cross section comparison is presented in Appendix B.

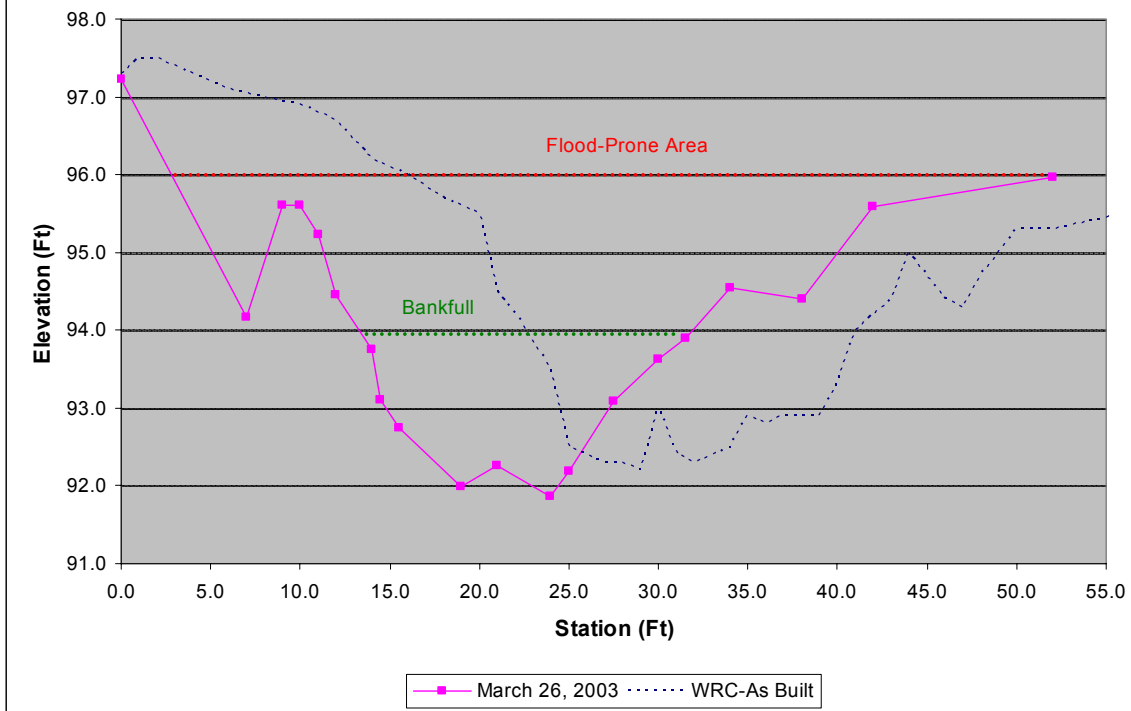
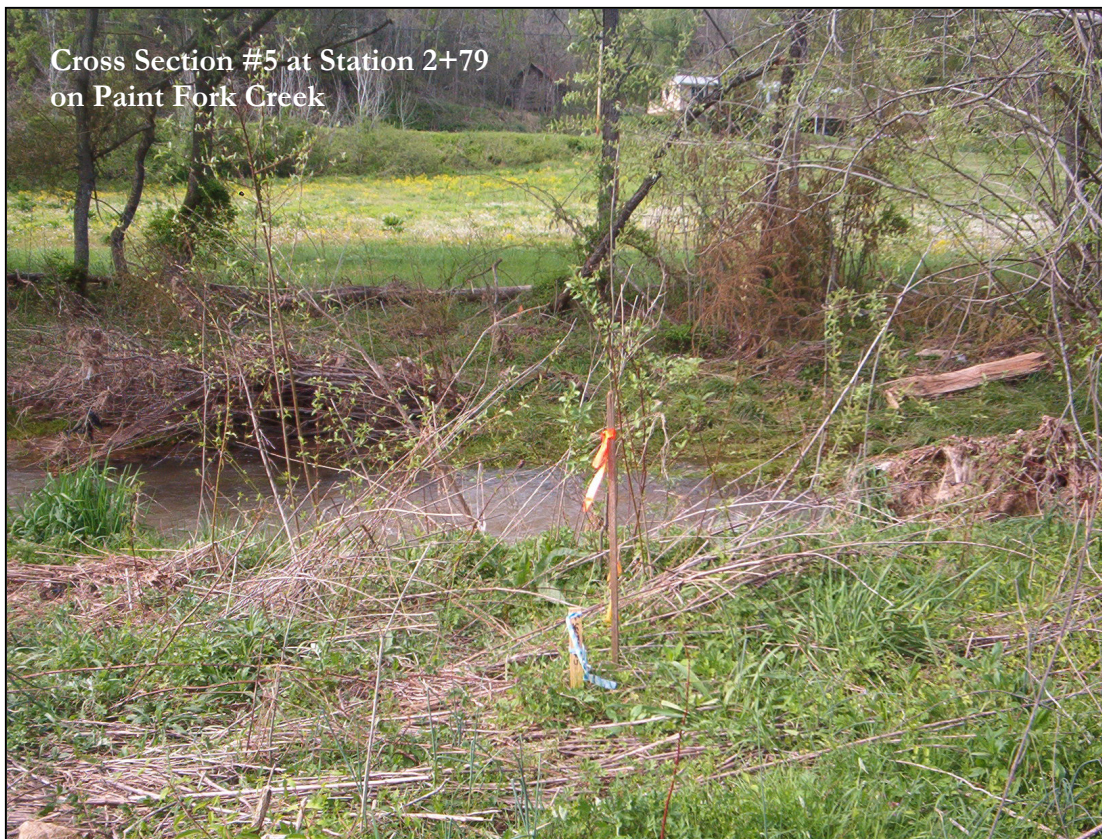
Cross Section-5, Station 2+79 (Paint Fork Creek)

- ◆ Station 2+72. Active scouring was noted around the rootwad on the left bank (facing downstream). The scour does not appear to be compromising the structure. This area should be assessed during the next monitoring period to determine remedial actions, if necessary.
- ◆ Station 4+19. A small center bar was observed during low flow conditions; however, no active erosion was noted along the adjacent stream banks. This area should be assessed during the next monitoring period to determine remedial actions, if necessary.
- ◆ Station 5+03. Active erosion was noted along both stream banks at the bedrock seam crossing the channel. This area should be assessed during the next monitoring period to determine remedial actions, if necessary.
