YEAR 3 MONITORING and CLOSEOUT REPORT
for the
FOSSON MITIGATION SITE
PAINFORK CREEK,
MADISON COUNTY, North Carolina

EEP PROJECT NUMBER 92702

December 2008

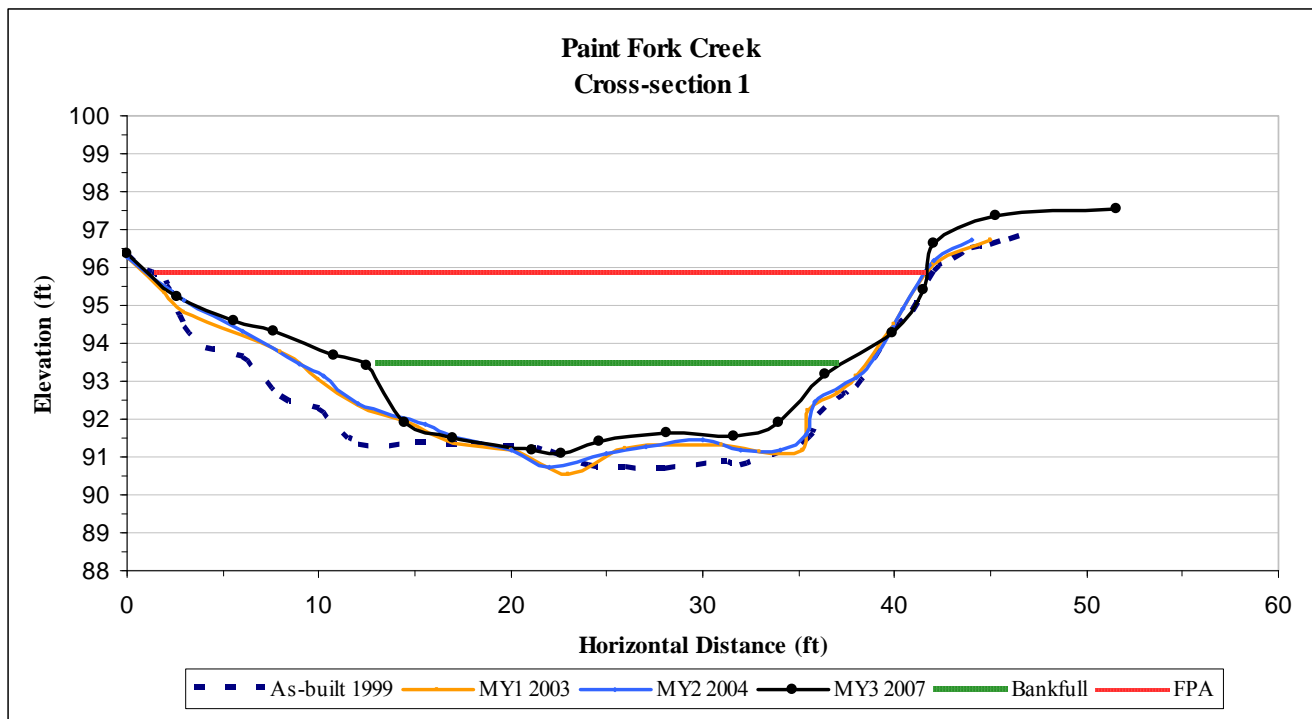
Cross-section 1 (Appendix Table A.1.1).—This cross-section transects a run. There has been little change in this cross-section from 1999 (as-built) through 2007 (MY3). Evidence of lateral channel movement (bank erosion) was not observed along either streambank. The left bank has aggraded slightly, most likely due to suspended sediments being trapped by the riparian vegetation. This aggradation has resulted in the decrease of bankfull width when compared to previous years monitoring values. Unlike the other main stem cross-sections, cross-section 1 was determined to be a Bc stream type. This is due to moderate entrenchment ratio (1.6) present at this cross-section.

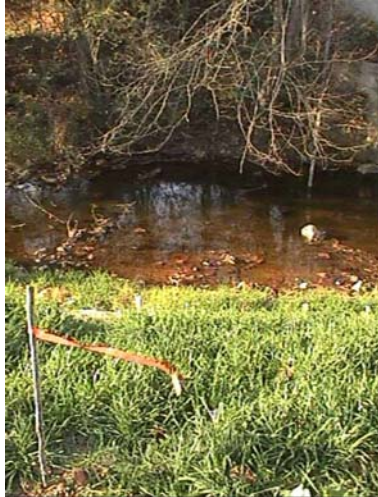
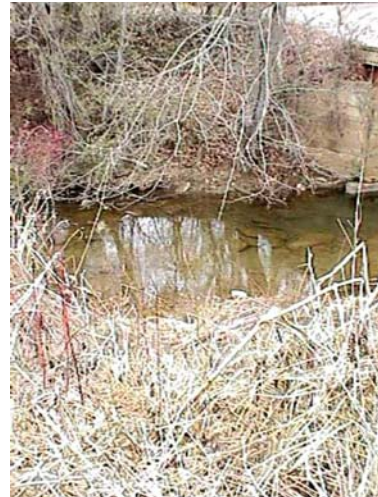
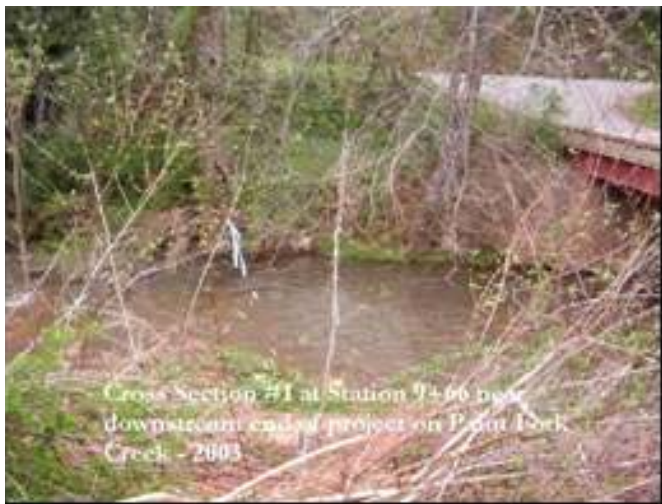
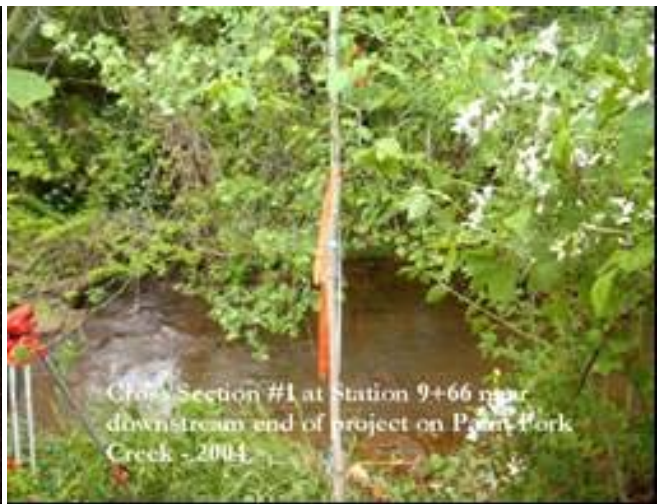
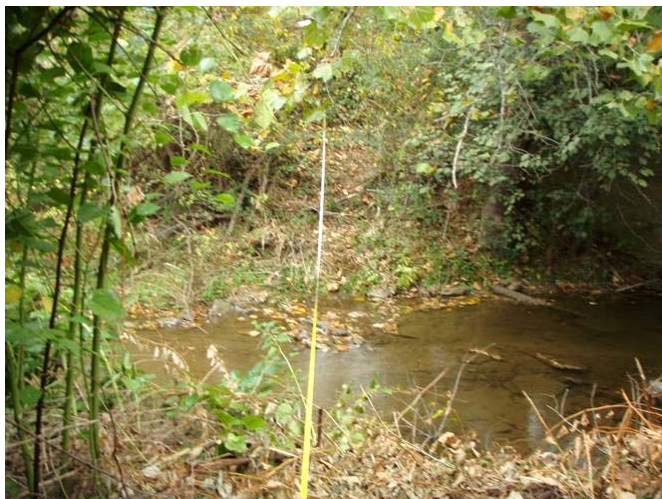
Cross-section 1, left bank to right bank, November 1999.

Cross-section 1, left bank to right bank, February 2001.

Cross-section 1, left bank to right bank, March 2003.

Cross-section 1, left bank to right bank, May 2004.

Cross-section 1, left bank to right bank, October 2007.

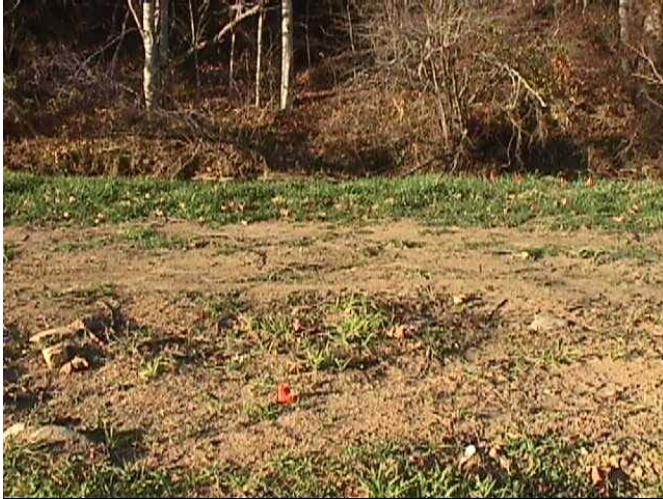
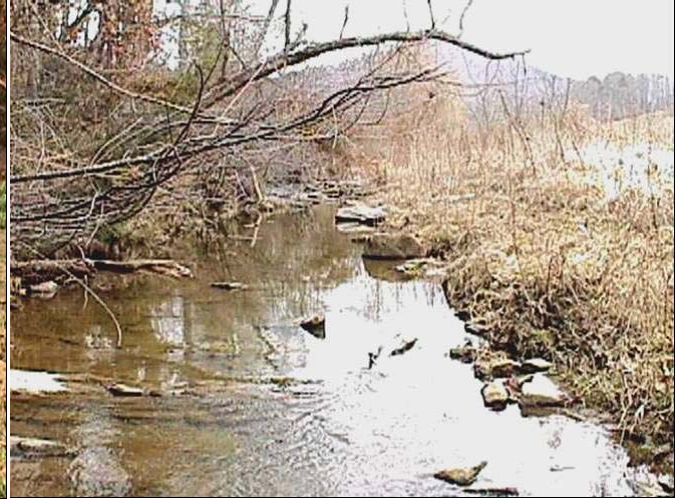
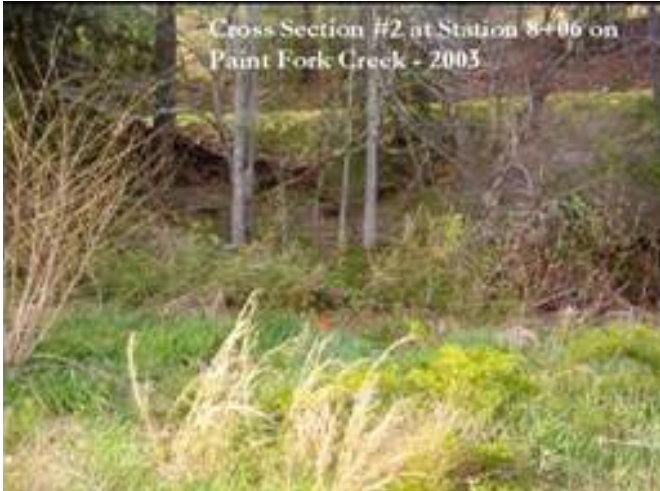
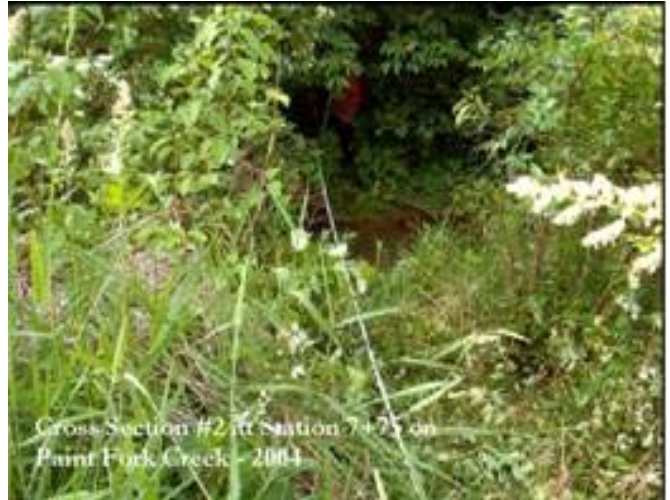
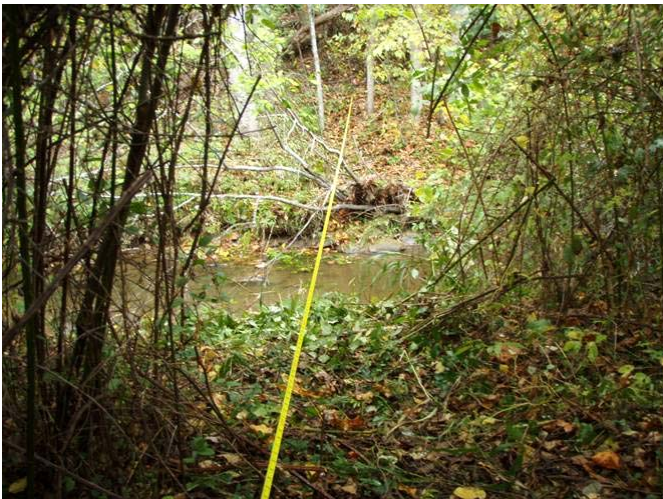
Cross-section 2, left bank to right bank, November 1999.

Cross-section 2, downstream to upstream, February 2001.

Cross-section 2, left bank to right bank, March 2003.

Cross-section 2, left bank to right bank, May 2004.

Cross-section 2, left bank to right bank, October 2007.

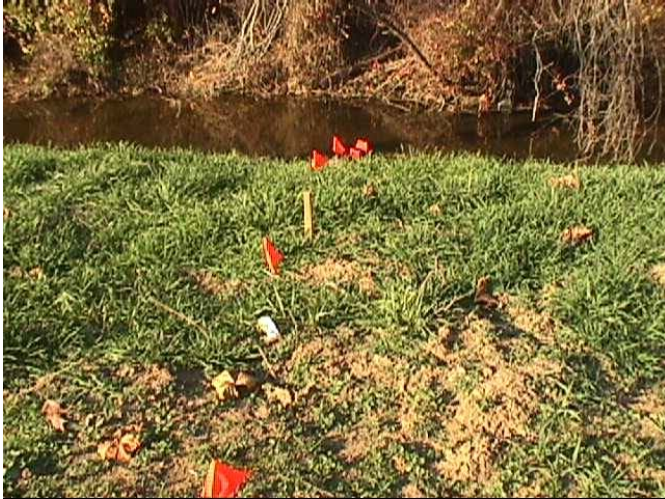
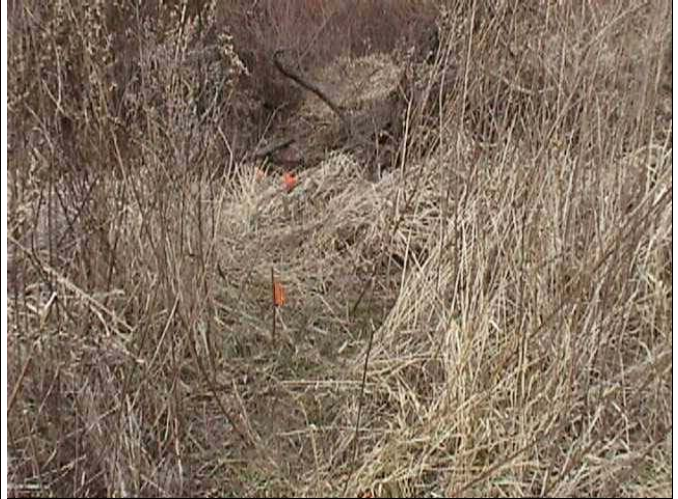
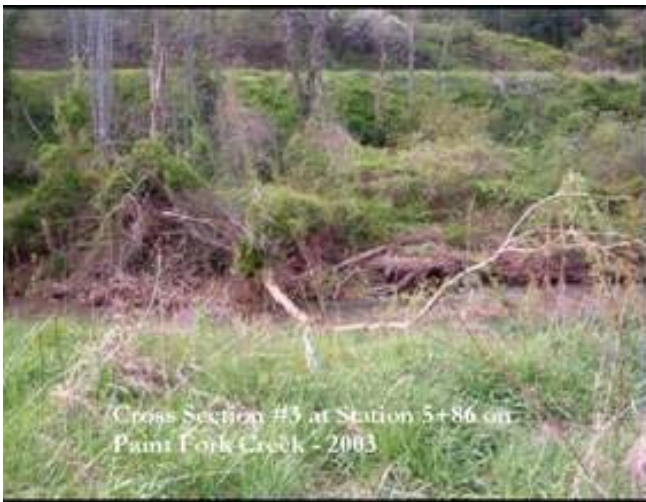
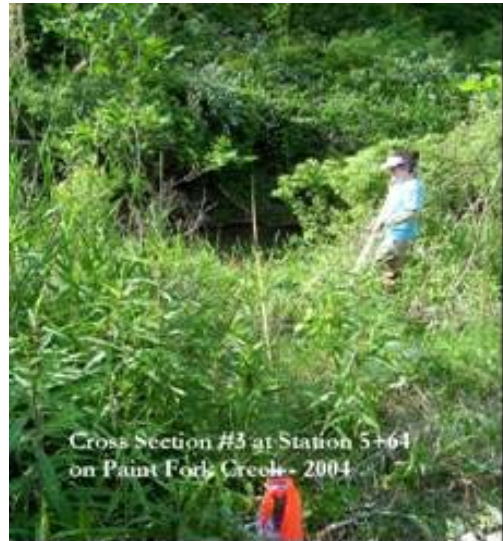
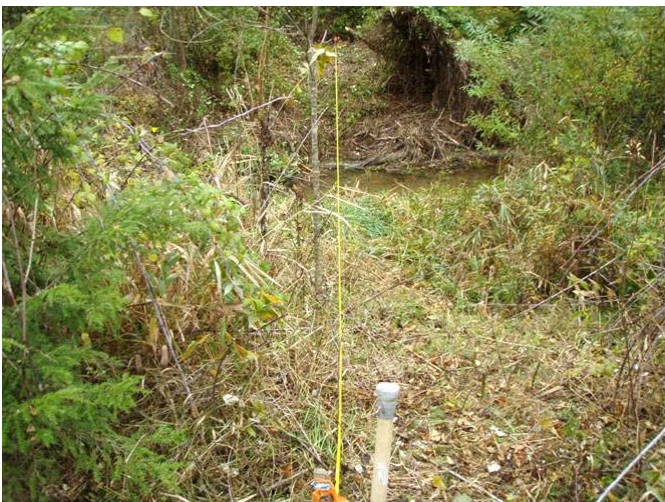
Cross-section 3 (Appendix Table A.1.3).—This cross-section transects a pool. The thalweg at cross-section 3 has shown no evidence of change over the eight years since project construction. Aggradation of the left bank has occurred, most likely due to vegetation trapping sediments during high flows, and a stable bench is present. The left and right banks are stable and well vegetated. This cross-section was noted as being a run feature in earlier surveys; however, it now contains characteristics more typical of a pool feature. The cross-section is located in a slight meander and the thalweg would be deeper and located closer to the left bank if not for the bedrock channel bed.

Cross-section 3, left bank to right bank, November 1999.

Cross-section 3, left bank to right bank, February 2001.

Cross-section 3, left bank to right bank, March 2003.

Cross-section 3, left bank to right bank, May 2004.

Cross-section 3, left bank to right bank, October 2007.

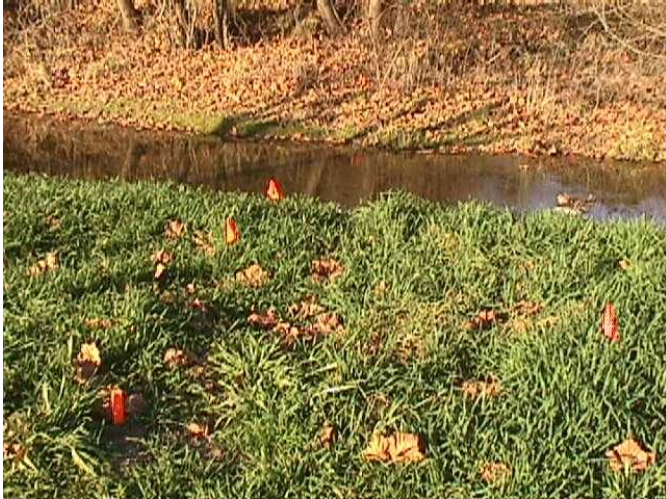
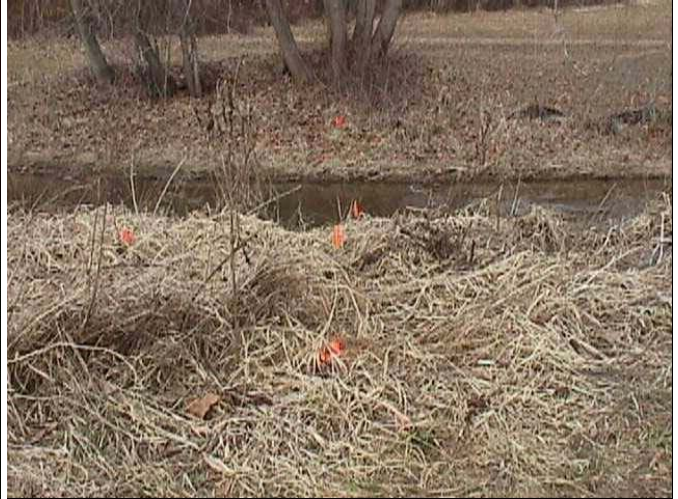
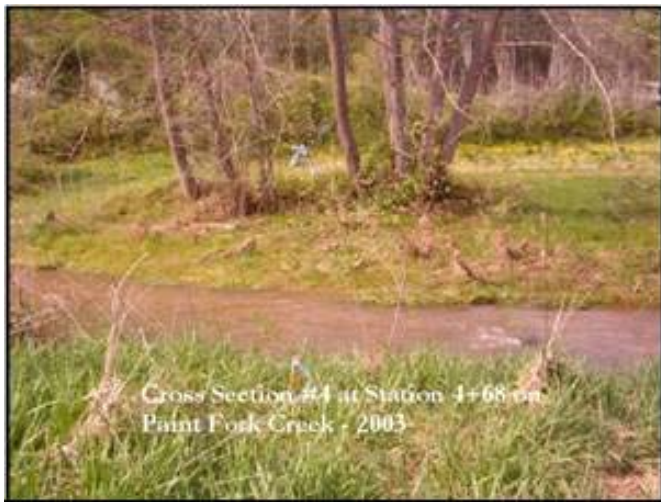
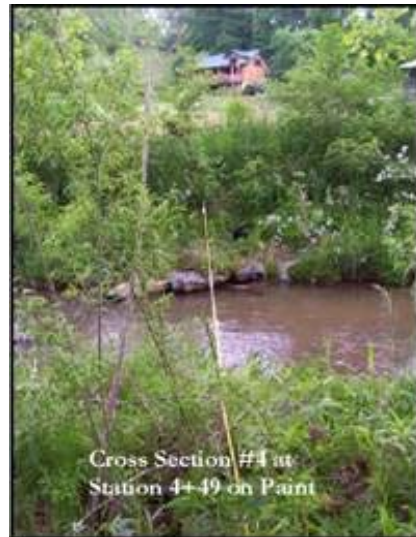
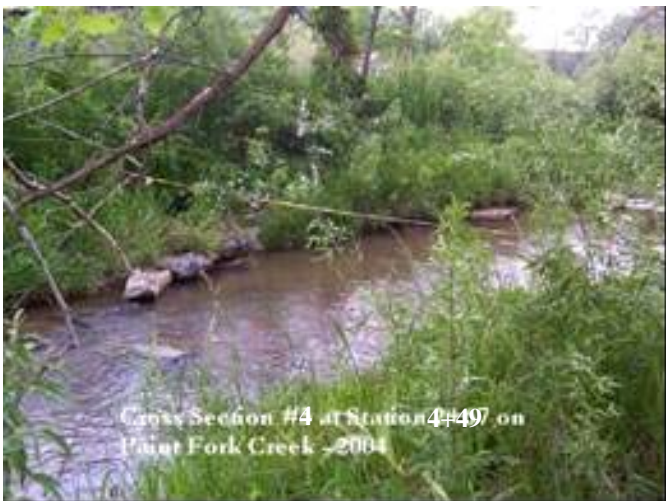
Cross-section 4 (Appendix Table A.1.4).—This cross-section transects a riffle. The thalweg at cross-section 4 has remained relatively stable following construction with only slight deepening (≈ 0.5 ft) since MY2, but the right and left channel banks have changed over the 8-year period since construction. The left bank has degraded ≈ 1.5 ft, whereas the right bank has experienced ≈ 5.0 ft of aggradation forming a stable bench that defines the bankfull channel. Currently, both the left and right channel banks are stable and well vegetated with woody species.

Cross-section 4, left bank to right bank, November 1999.

Cross-section 4, left bank to right bank, February 2001.

Cross-section 4, left bank to right bank, March 2003.

Cross-section 4, right bank to left bank, May 2004.

Cross-section 4, upstream to downstream, May 2004.

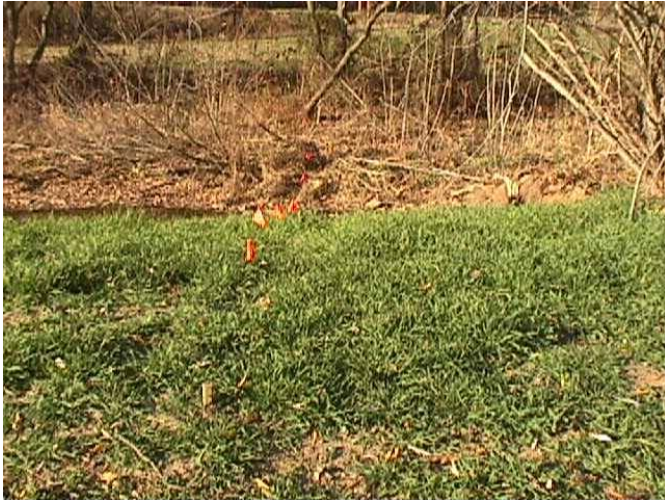
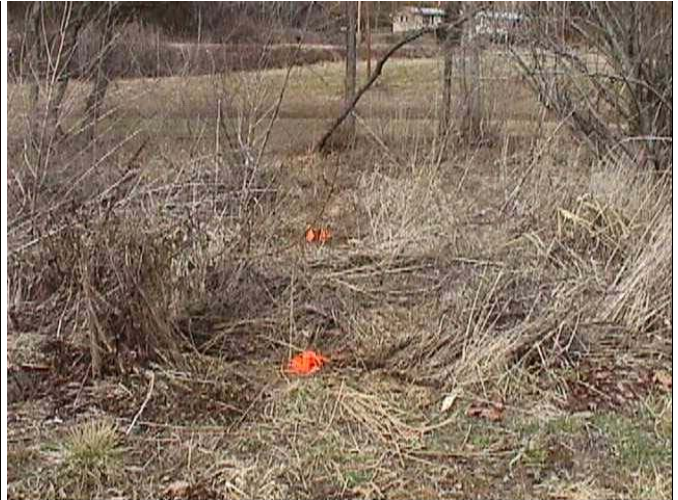
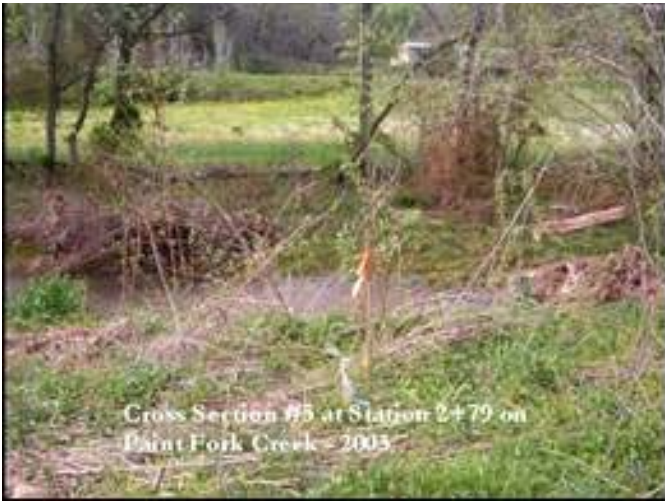
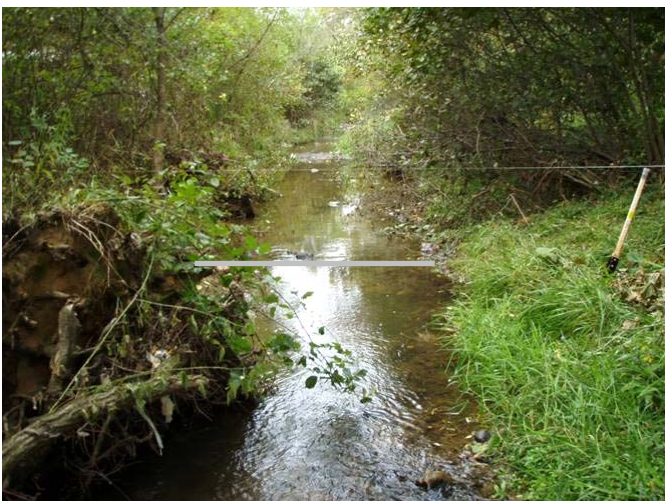
Cross-section 5 (Appendix Table A.1.5).—This cross-section transects a run. The thalweg at cross-section 5 is situated near the center line of the channel, very similar to its location when compared with previous surveys. The left channel bank appears to have degraded slightly (≈ 0.5 ft) since project completion. The right channel bank has aggraded ≈ 1.0 ft since the as-built survey was conducted in 1999. Both the left and right channel banks appeared well vegetated and stable during the MY3 survey.

Cross-section 5, left bank to right bank, November 1999.

Cross-section 5, left bank to right bank, February 2001.

Cross-section 5, left bank to right bank, March 2003.

Cross-section 5, looking downstream, October 2007.

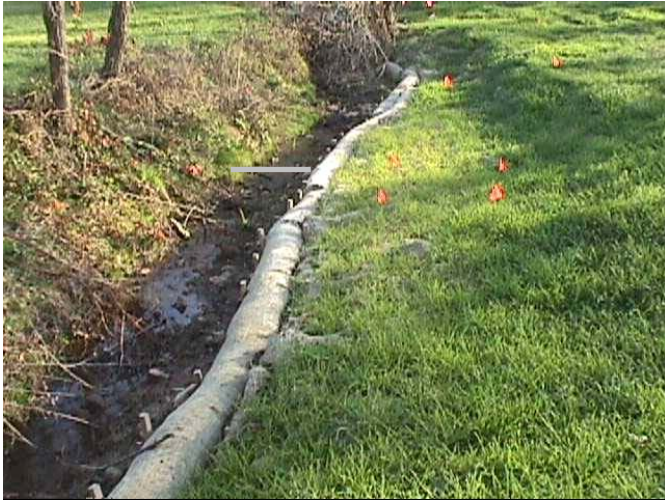
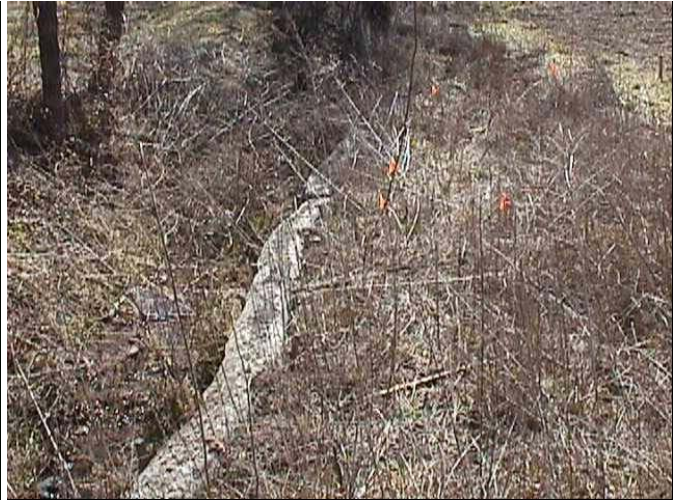
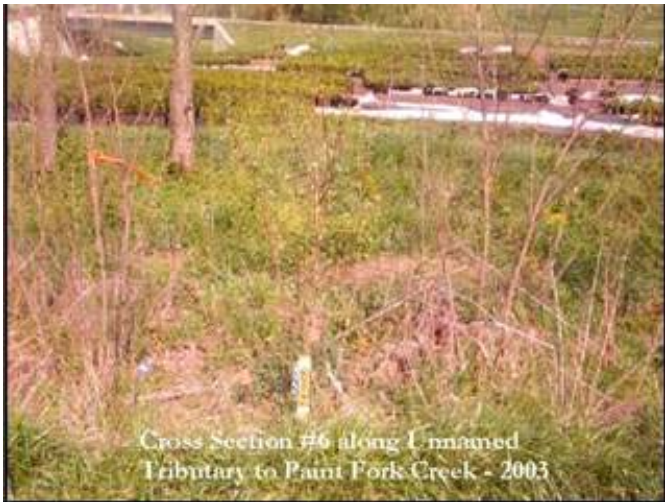
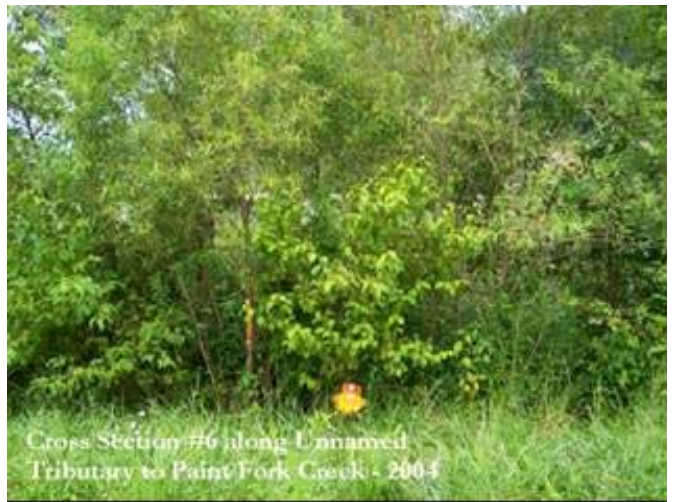
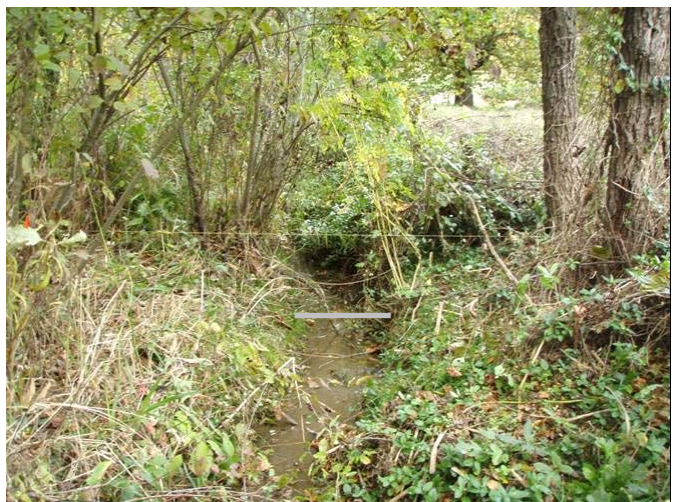
Cross-section 6, downstream to upstream, November 1999.

Cross-section 6, downstream to upstream, February 2001.

Cross-section 6, left bank to right bank, March 2003.

Cross-section 6, left bank to right bank, May 2004.

Cross-section 6, upstream to downstream, October 2007.

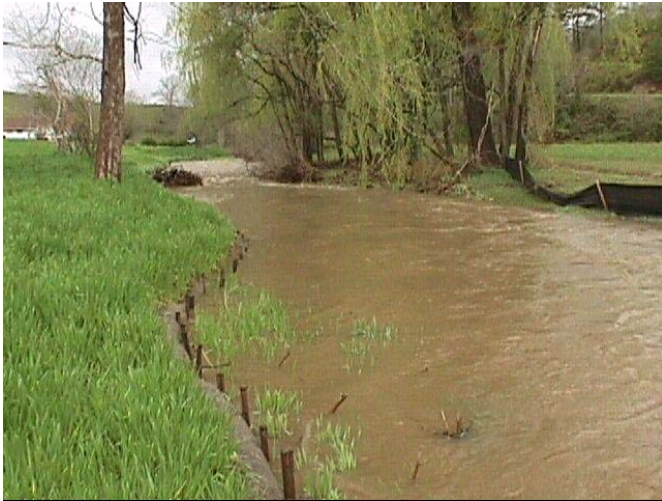
Bankfull photo, downstream at photo sta. 1, April 4, 2000.

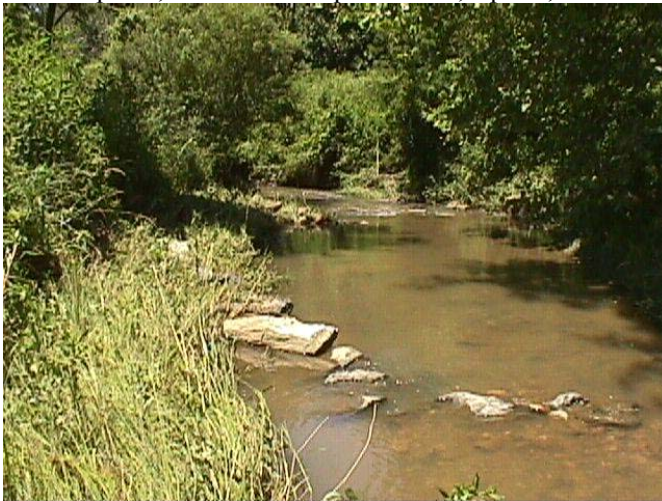
Bankfull photo, downstream at cross-section 4, July 29-30, 2001.

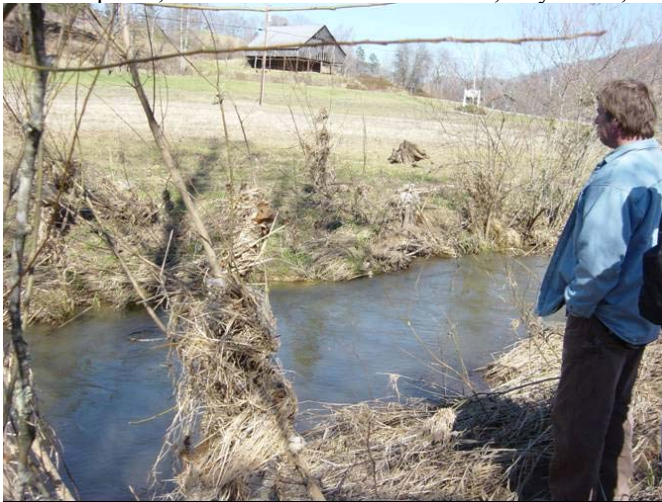
Bankfull photo, wrack line in trees, February 22-23, 2003.

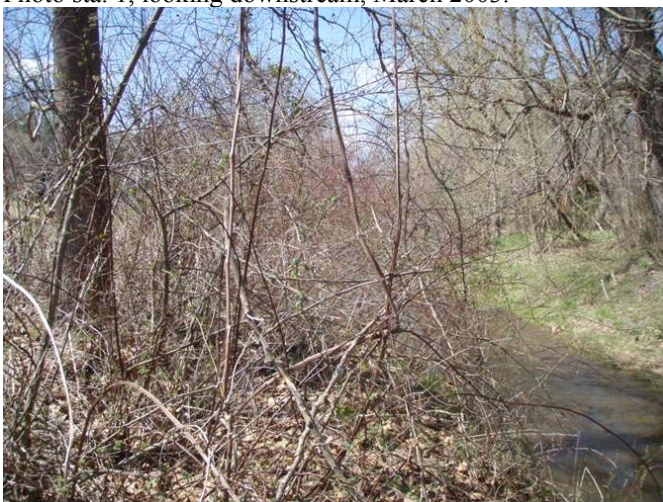
Photo sta. 1, looking downstream, March 2008.

Four fixed station photo locations document project site conditions from 1999 (before construction) through 2007 (Appendix A.6.). The planted vegetation along the left bank has become well established over the eight years since installation. Although outside the project extent, the adjoining landowner has allowed the right bank vegetation to mature. Planted woody vegetation is \geq 15 ft in height and has enhanced stability of both channel banks. With a protected riparian buffer on each side of the channel corridor, channel banks have stabilized and tree foliage is now blocking direct sun light to the channel, which should help reduce daytime water temperature increases.

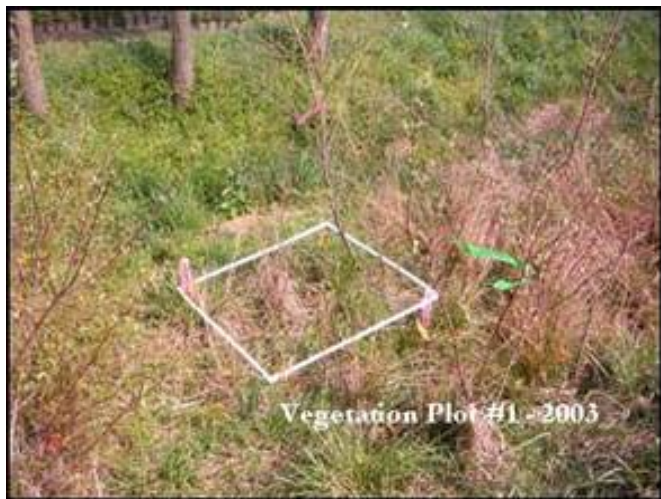
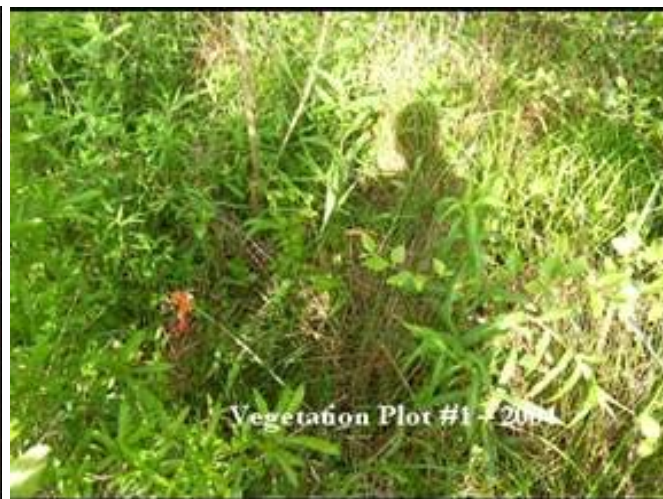
Vegetation plot 1, unnamed trib, left bank, March 2003.

Vegetation Plot 1 unnamed tributary.—One black willow and two silky dogwoods were observed during MY3, with one of the silky dogwood recruited since MY2. The herbaceous layer consisted of a goldenrod *Solidago* sp. mixed with tall fescue *Festuca* sp.

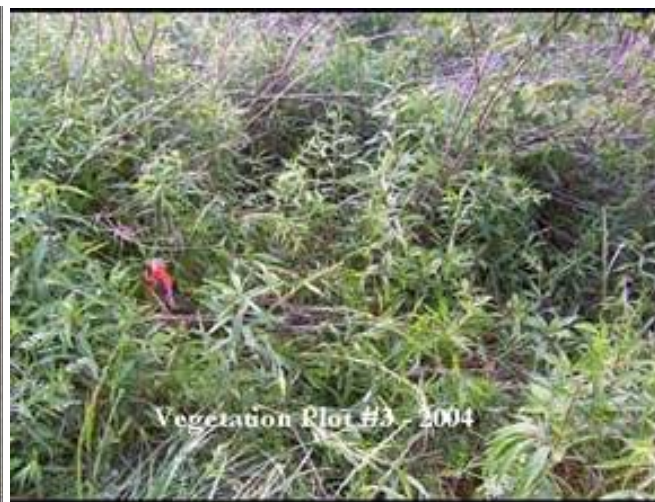
Vegetation [lot 3, left bank, May 2004.

Vegetation Plot 3.—Woody stem density was unchanged in Vegetation Plot 3 from MY2 to MY3. One silky dogwood was observed in the plot. The herbaceous layer consisted of goldenrod mixed in with tall fescue.
