MONITORING YEAR 1 ANNUAL REPORT Final

FOUST CREEK MITIGATION SITE

Alamance County, NC

DMS Project Number 95715

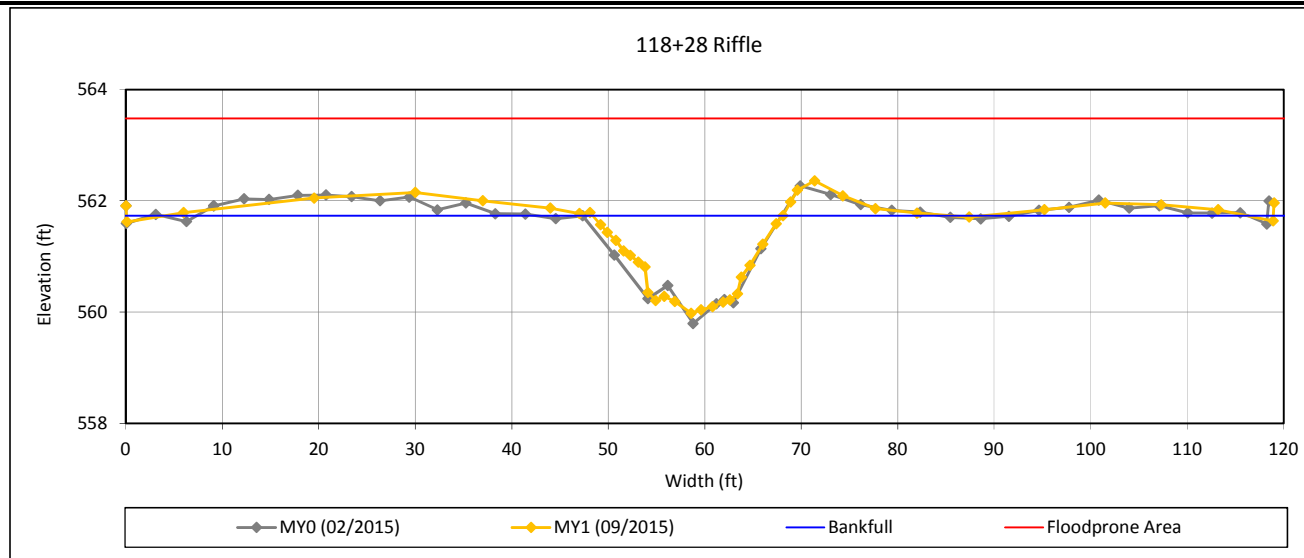
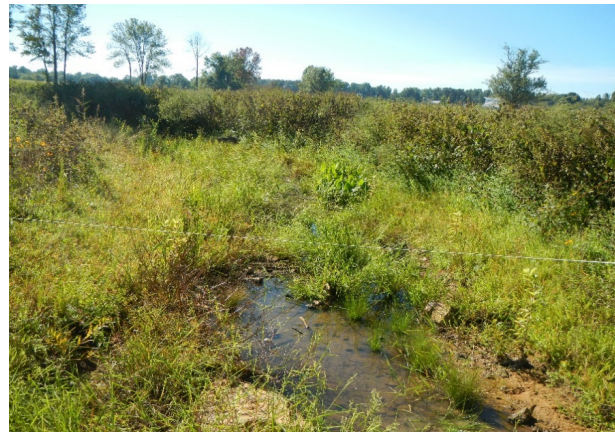
Cross Section 1- Foust Creek Reach 2

20.5	x-section area (ft.sq.)
19.7	width (ft)
1.0	mean depth (ft)
1.8	max depth (ft)
20.3	wetted parimeter (ft)
1.0	hyd radi (ft)
19.0	width-depth ratio
150.0	W flood prone area (ft)
7.6	entrenchment ratio
1.0	low bank height ratio

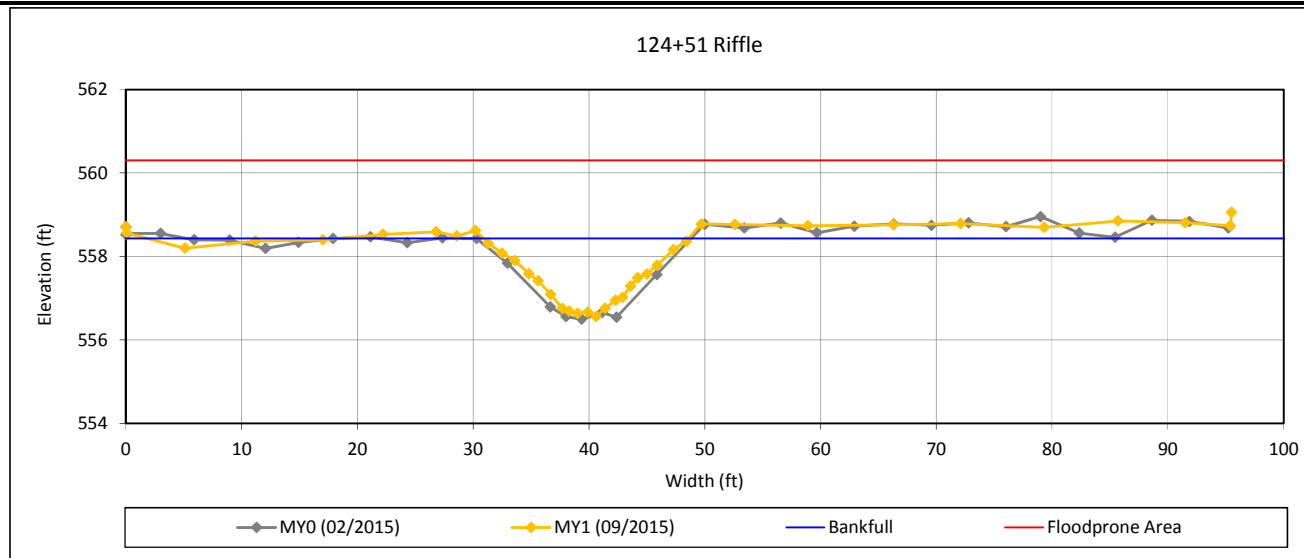
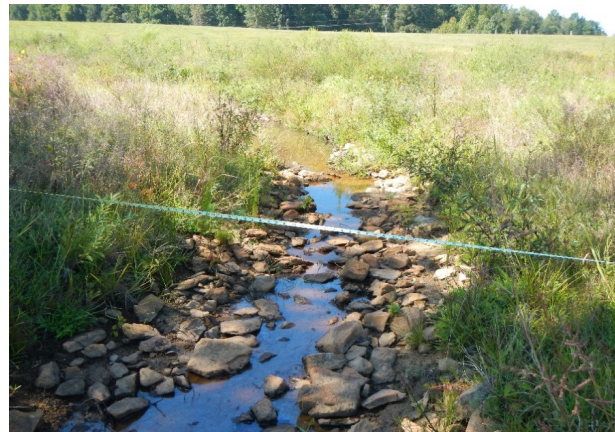
Cross Section 3- Foust Creek Reach 2

- 17.7 x-section area (ft.sq.)
- 17.7 width (ft)
- 1.0 mean depth (ft)
- 1.9 max depth (ft)
- 18.2 wetted parimeter (ft)
- 1.0 hyd radi (ft)
- 17.7 width-depth ratio
- 150.0 W flood prone area (ft)
- 8.5 entrenchment ratio
- 1.0 low bank height ratio

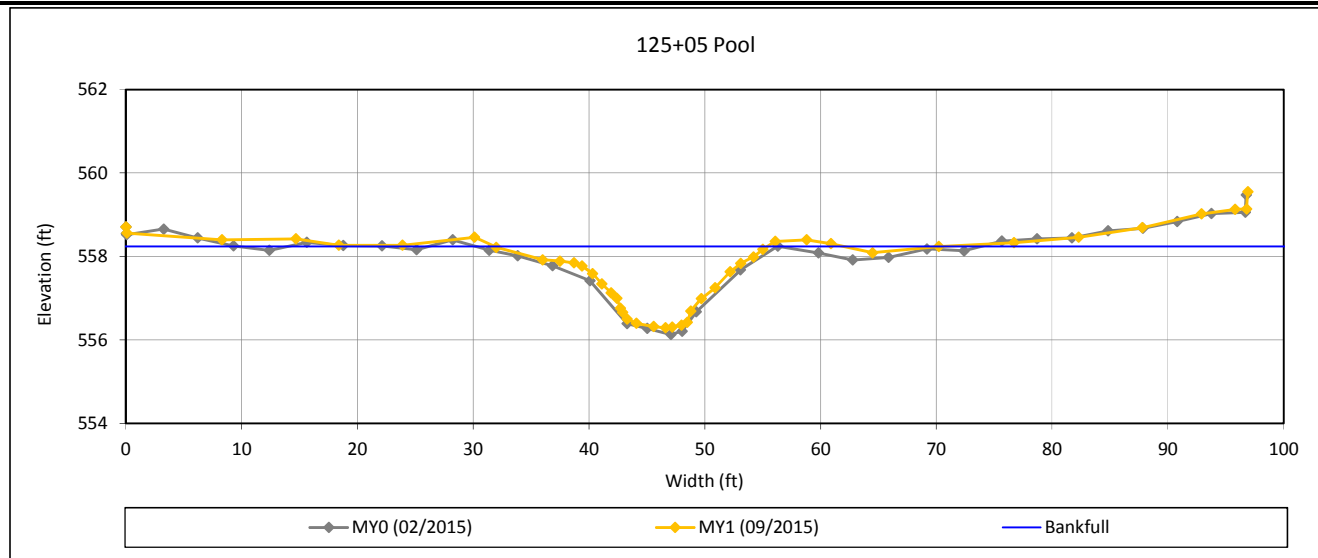
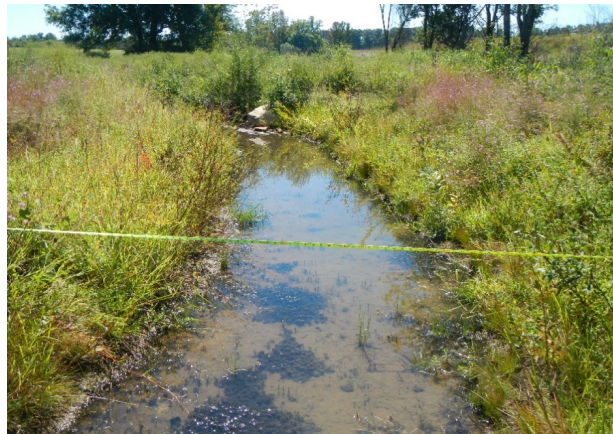
Cross Section 4- Foust Creek Reach 2

20.7	x-section area (ft.sq.)
23.6	width (ft)
0.9	mean depth (ft)
2.0	max depth (ft)
24.1	wetted parimeter (ft)
0.9	hyd radi (ft)
26.8	width-depth ratio

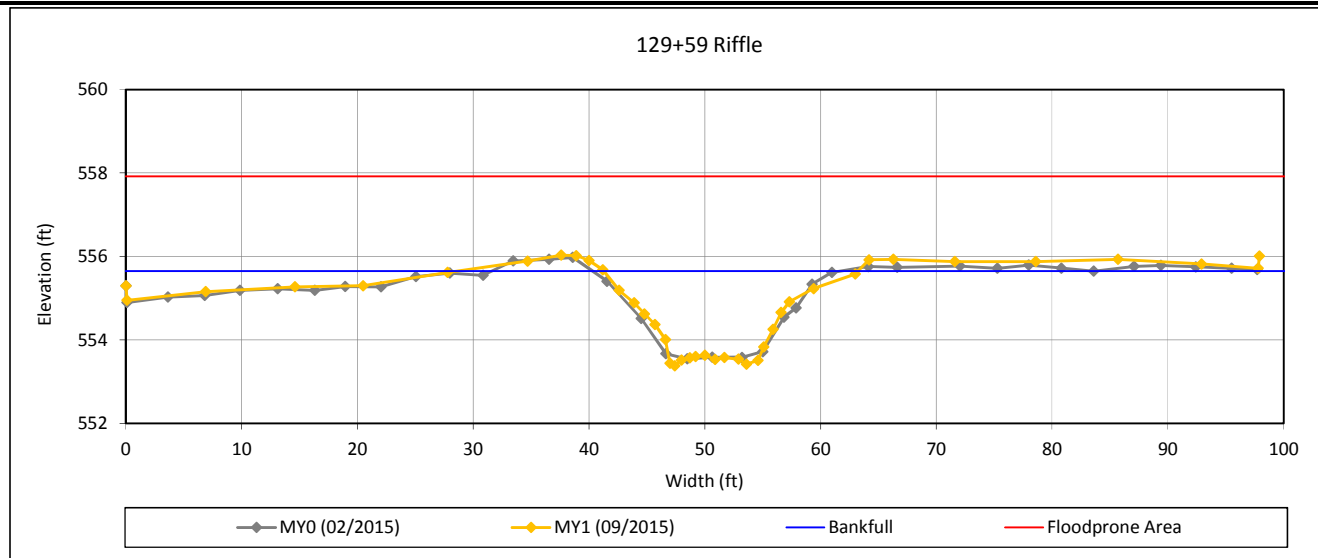
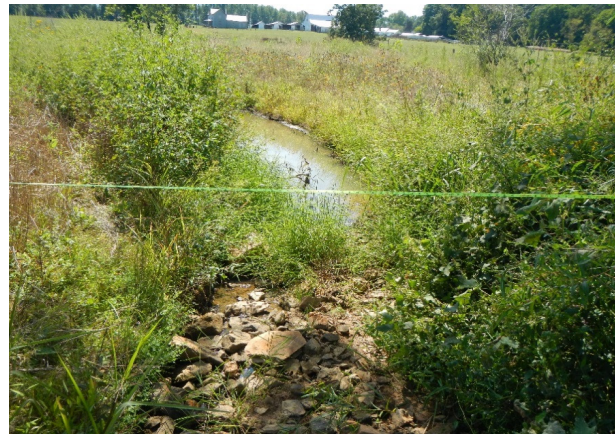
Cross Section 5- Foust Creek Reach 2

27.0	x-section area (ft.sq.)
22.0	width (ft)
1.2	mean depth (ft)
2.3	max depth (ft)
23.0	wetted parimeter (ft)
1.2	hyd radi (ft)
17.9	width-depth ratio
150.0	W flood prone area (ft)
6.8	entrenchment ratio
1.0	low bank height ratio

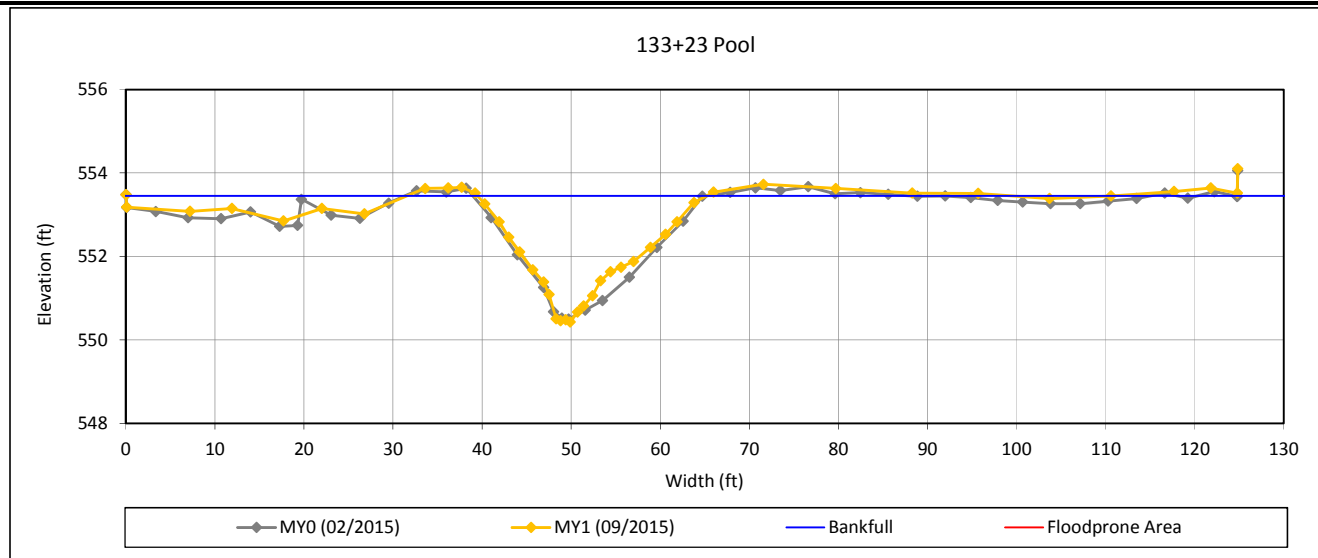
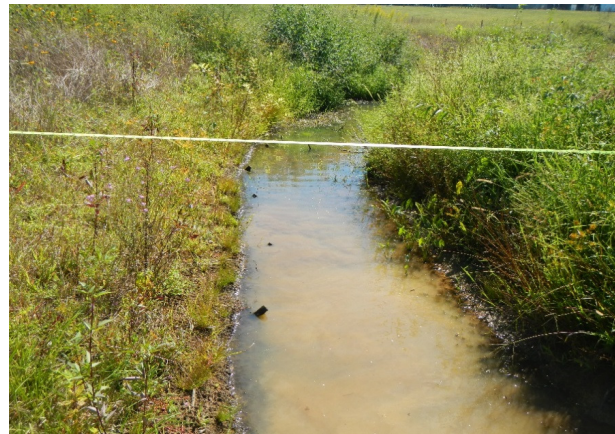
Cross Section 6- Foust Creek Reach 2

37.4	x-section area (ft.sq.)
25.7	width (ft)
1.5	mean depth (ft)
3.0	max depth (ft)
26.6	wetted parimeter (ft)
1.4	hyd radi (ft)
17.7	width-depth ratio

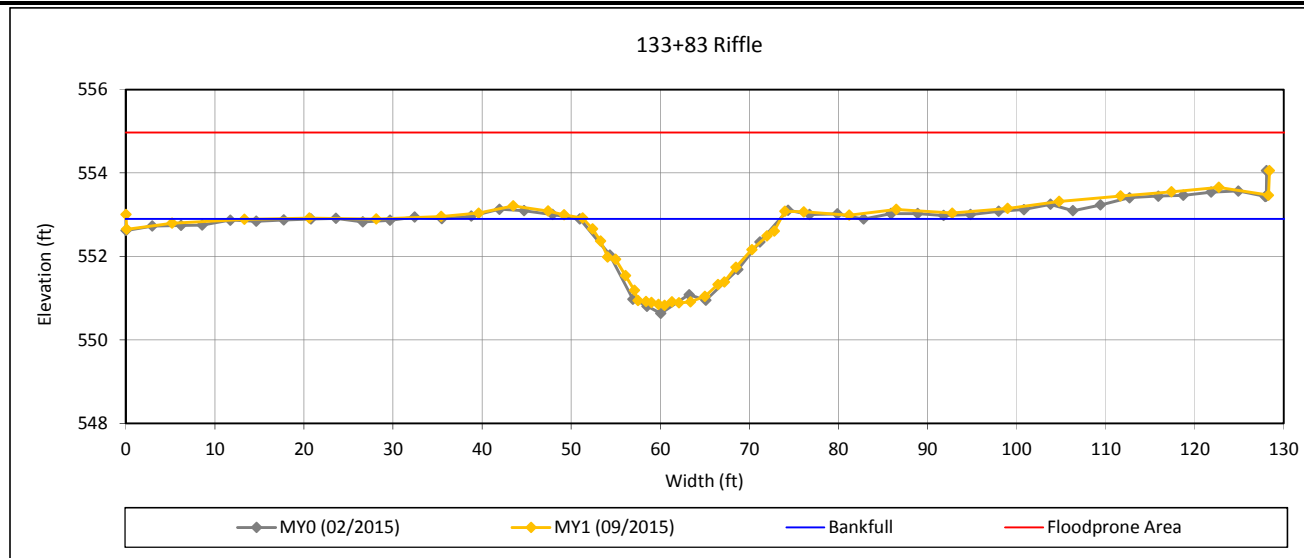
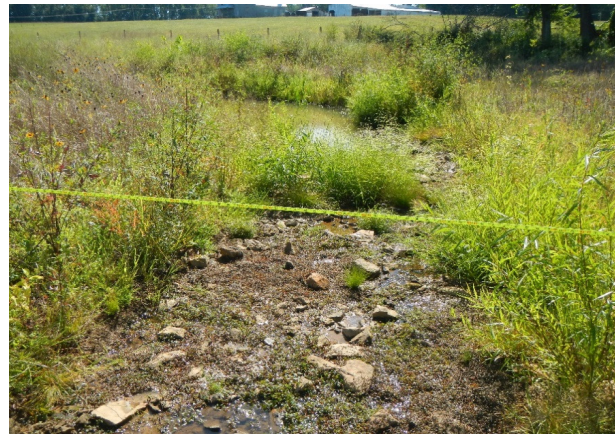
Cross Section 7- Foust Creek Reach 2

28.8	x-section area (ft.sq.)
22.2	width (ft)
1.3	mean depth (ft)
2.1	max depth (ft)
22.7	wetted parimeter (ft)
1.3	hyd radi (ft)
17.0	width-depth ratio
150.0	W flood prone area (ft)
6.8	entrenchment ratio
1.0	low bank height ratio

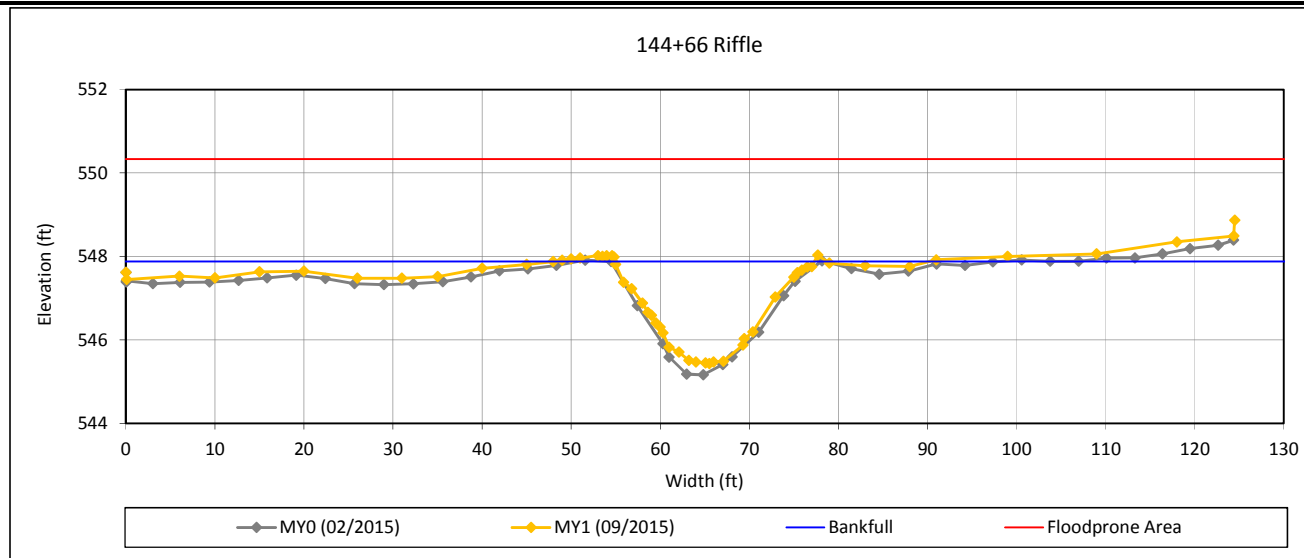
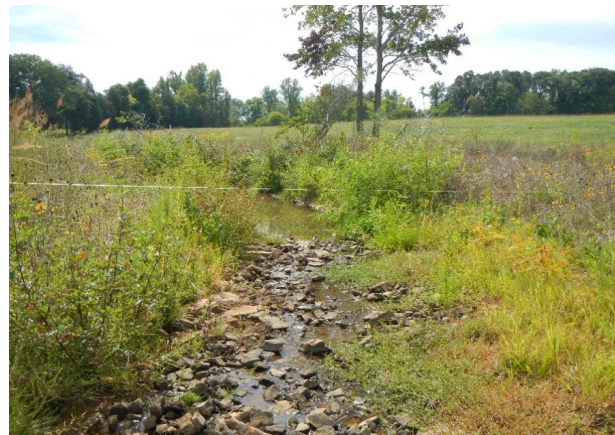
Cross Section 8- Foust Creek Reach 3B

- 32.1 x-section area (ft.sq.)
- 22.7 width (ft)
- 1.4 mean depth (ft)
- 2.5 max depth (ft)
- 23.4 wetted parimeter (ft)
- 1.4 hyd radi (ft)
- 16.0 width-depth ratio
- 150.0 W flood prone area (ft)
- 6.6 entrenchment ratio
- 1.0 low bank height ratio

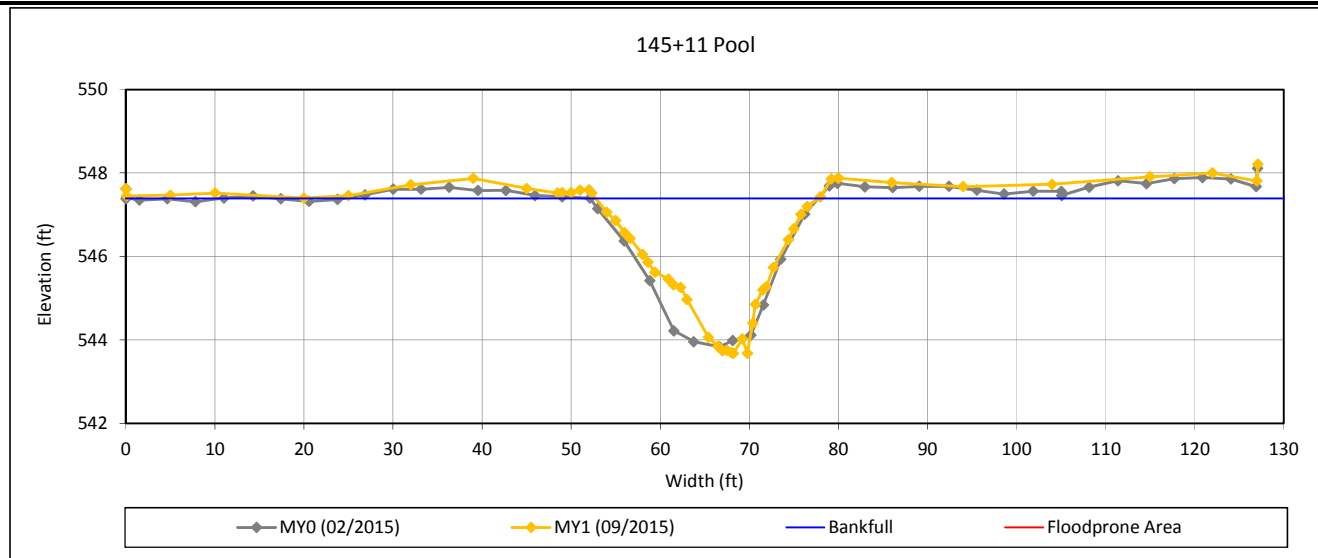
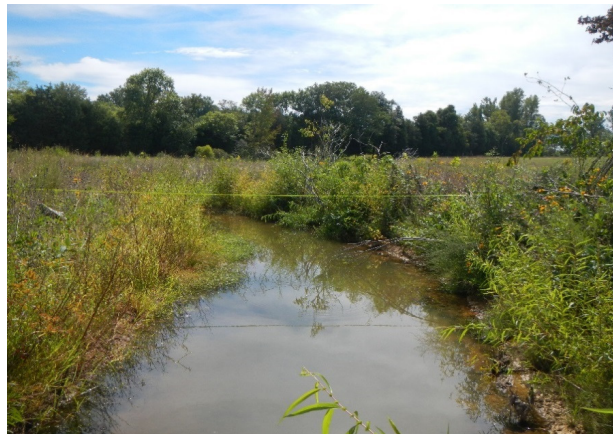
Cross Section 9- Foust Creek Reach 3B

46.1	x-section area (ft.sq.)
25.0	width (ft)
1.8	mean depth (ft)
3.7	max depth (ft)
26.7	wetted parimeter (ft)
1.7	hyd radi (ft)
13.5	width-depth ratio

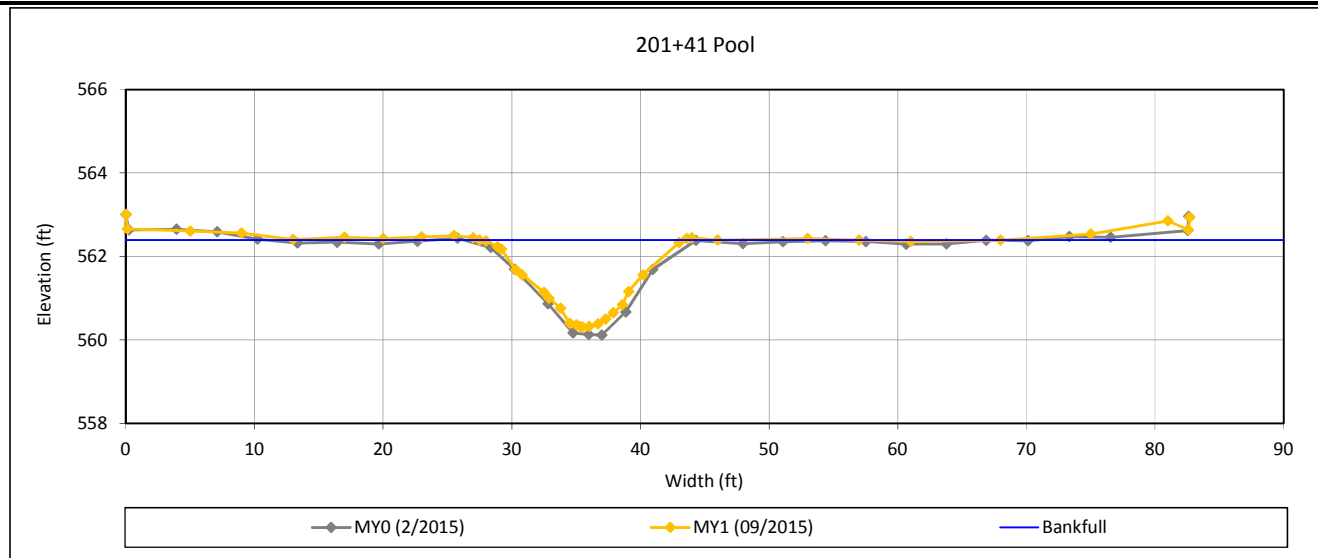
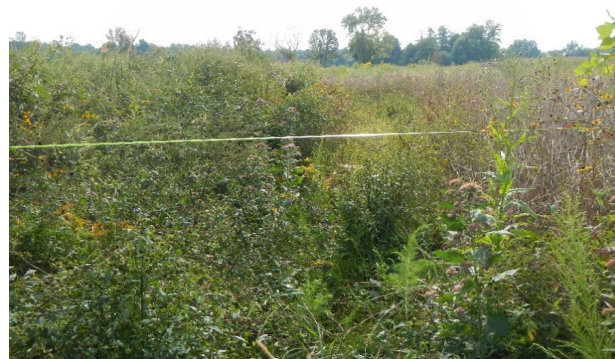
Cross Section 10-UT1

17.0	x-section area (ft.sq.)
15.9	width (ft)
1.1	mean depth (ft)
2.1	max depth (ft)
16.5	wetted parimeter (ft)
1.0	hyd radi (ft)
14.8	width-depth ratio

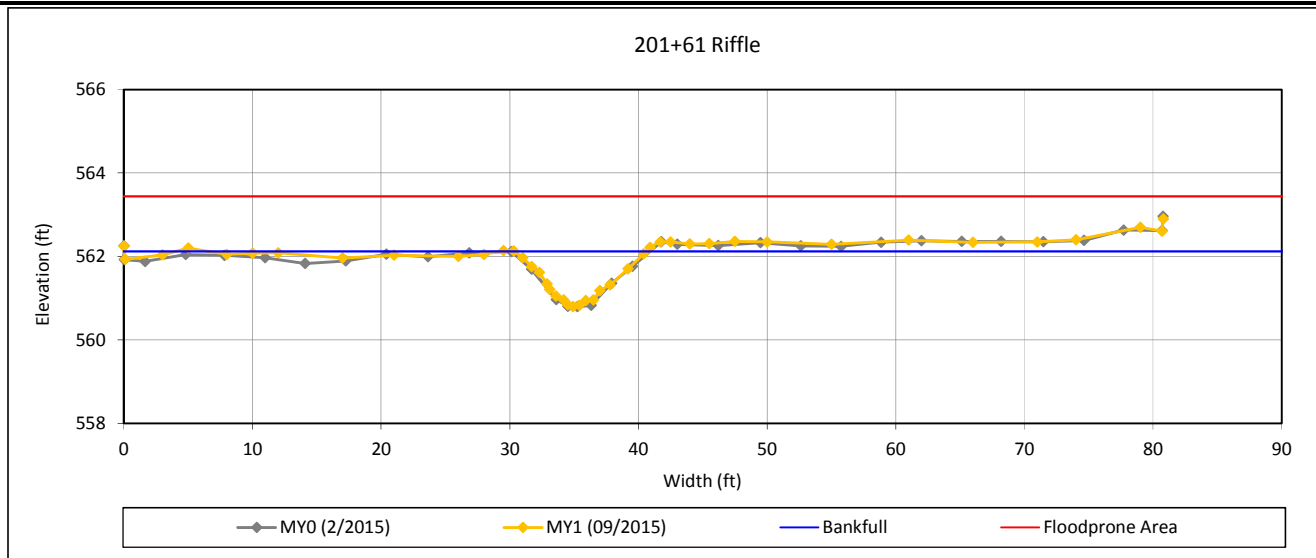
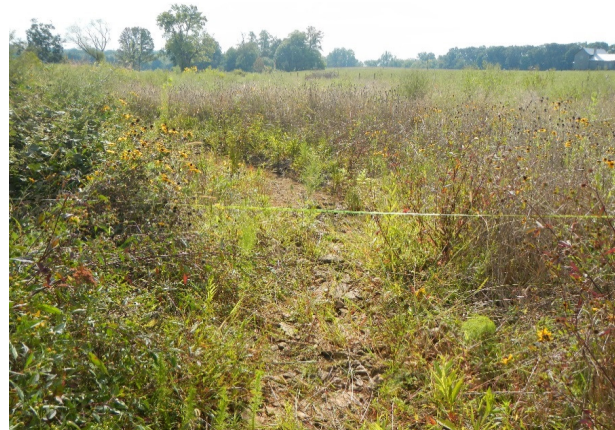
Cross Section 11-UT1

7.4	x-section area (ft.sq.)
10.2	width (ft)
0.7	mean depth (ft)
1.3	max depth (ft)
10.6	wetted parimeter (ft)
0.7	hyd radi (ft)
14.1	width-depth ratio
150.0	W flood prone area (ft)
14.6	entrenchment ratio
1.0	low bank height ratio

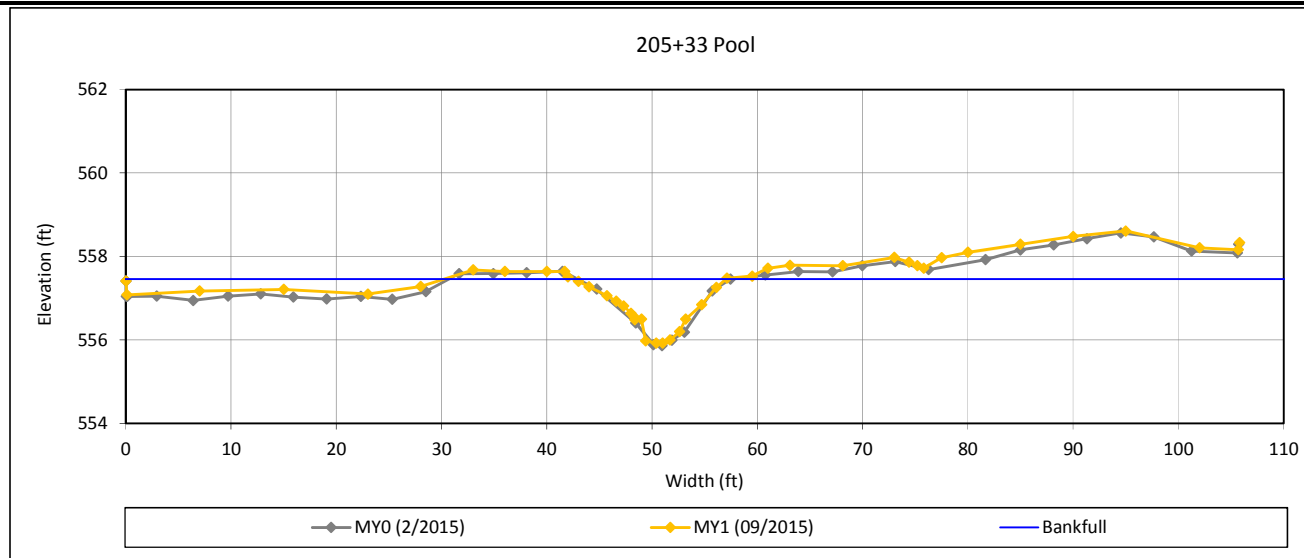
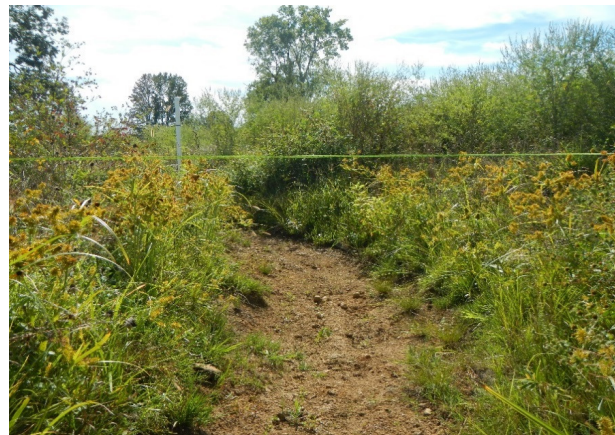
Cross Section 12-UT1

10.6	x-section area (ft.sq.)
14.6	width (ft)
0.7	mean depth (ft)
1.5	max depth (ft)
15.1	wetted parimeter (ft)
0.7	hyd radi (ft)
19.9	width-depth ratio

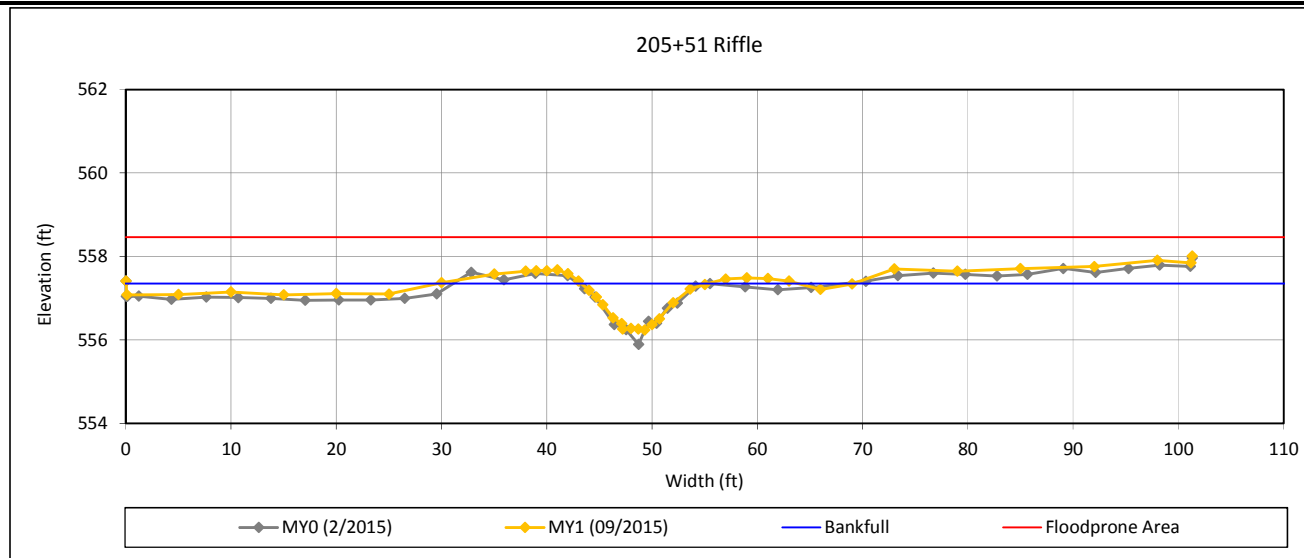
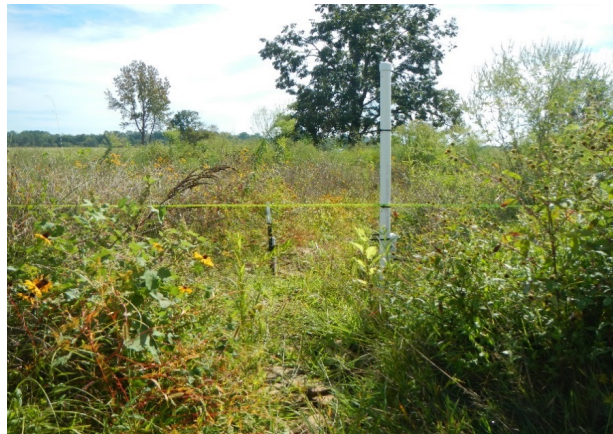
Cross Section 13-UT1

7.0	x-section area (ft.sq.)
12.0	width (ft)
0.6	mean depth (ft)
1.1	max depth (ft)
12.3	wetted parimeter (ft)
0.6	hyd radi (ft)
20.6	width-depth ratio
150.0	W flood prone area (ft)
12.5	entrenchment ratio
1.0	low bank height ratio
