MONITORING YEAR 2 ANNUAL REPORT Final

FOUST CREEK MITIGATION SITE

Alamance County, NC
NCDEQ Contract 004954
DMS Project Number 95715

Data Collection Period: March 2016 - October 2016
Draft Submission Date: November 18, 2016
Final Submission Date: December 2, 2016

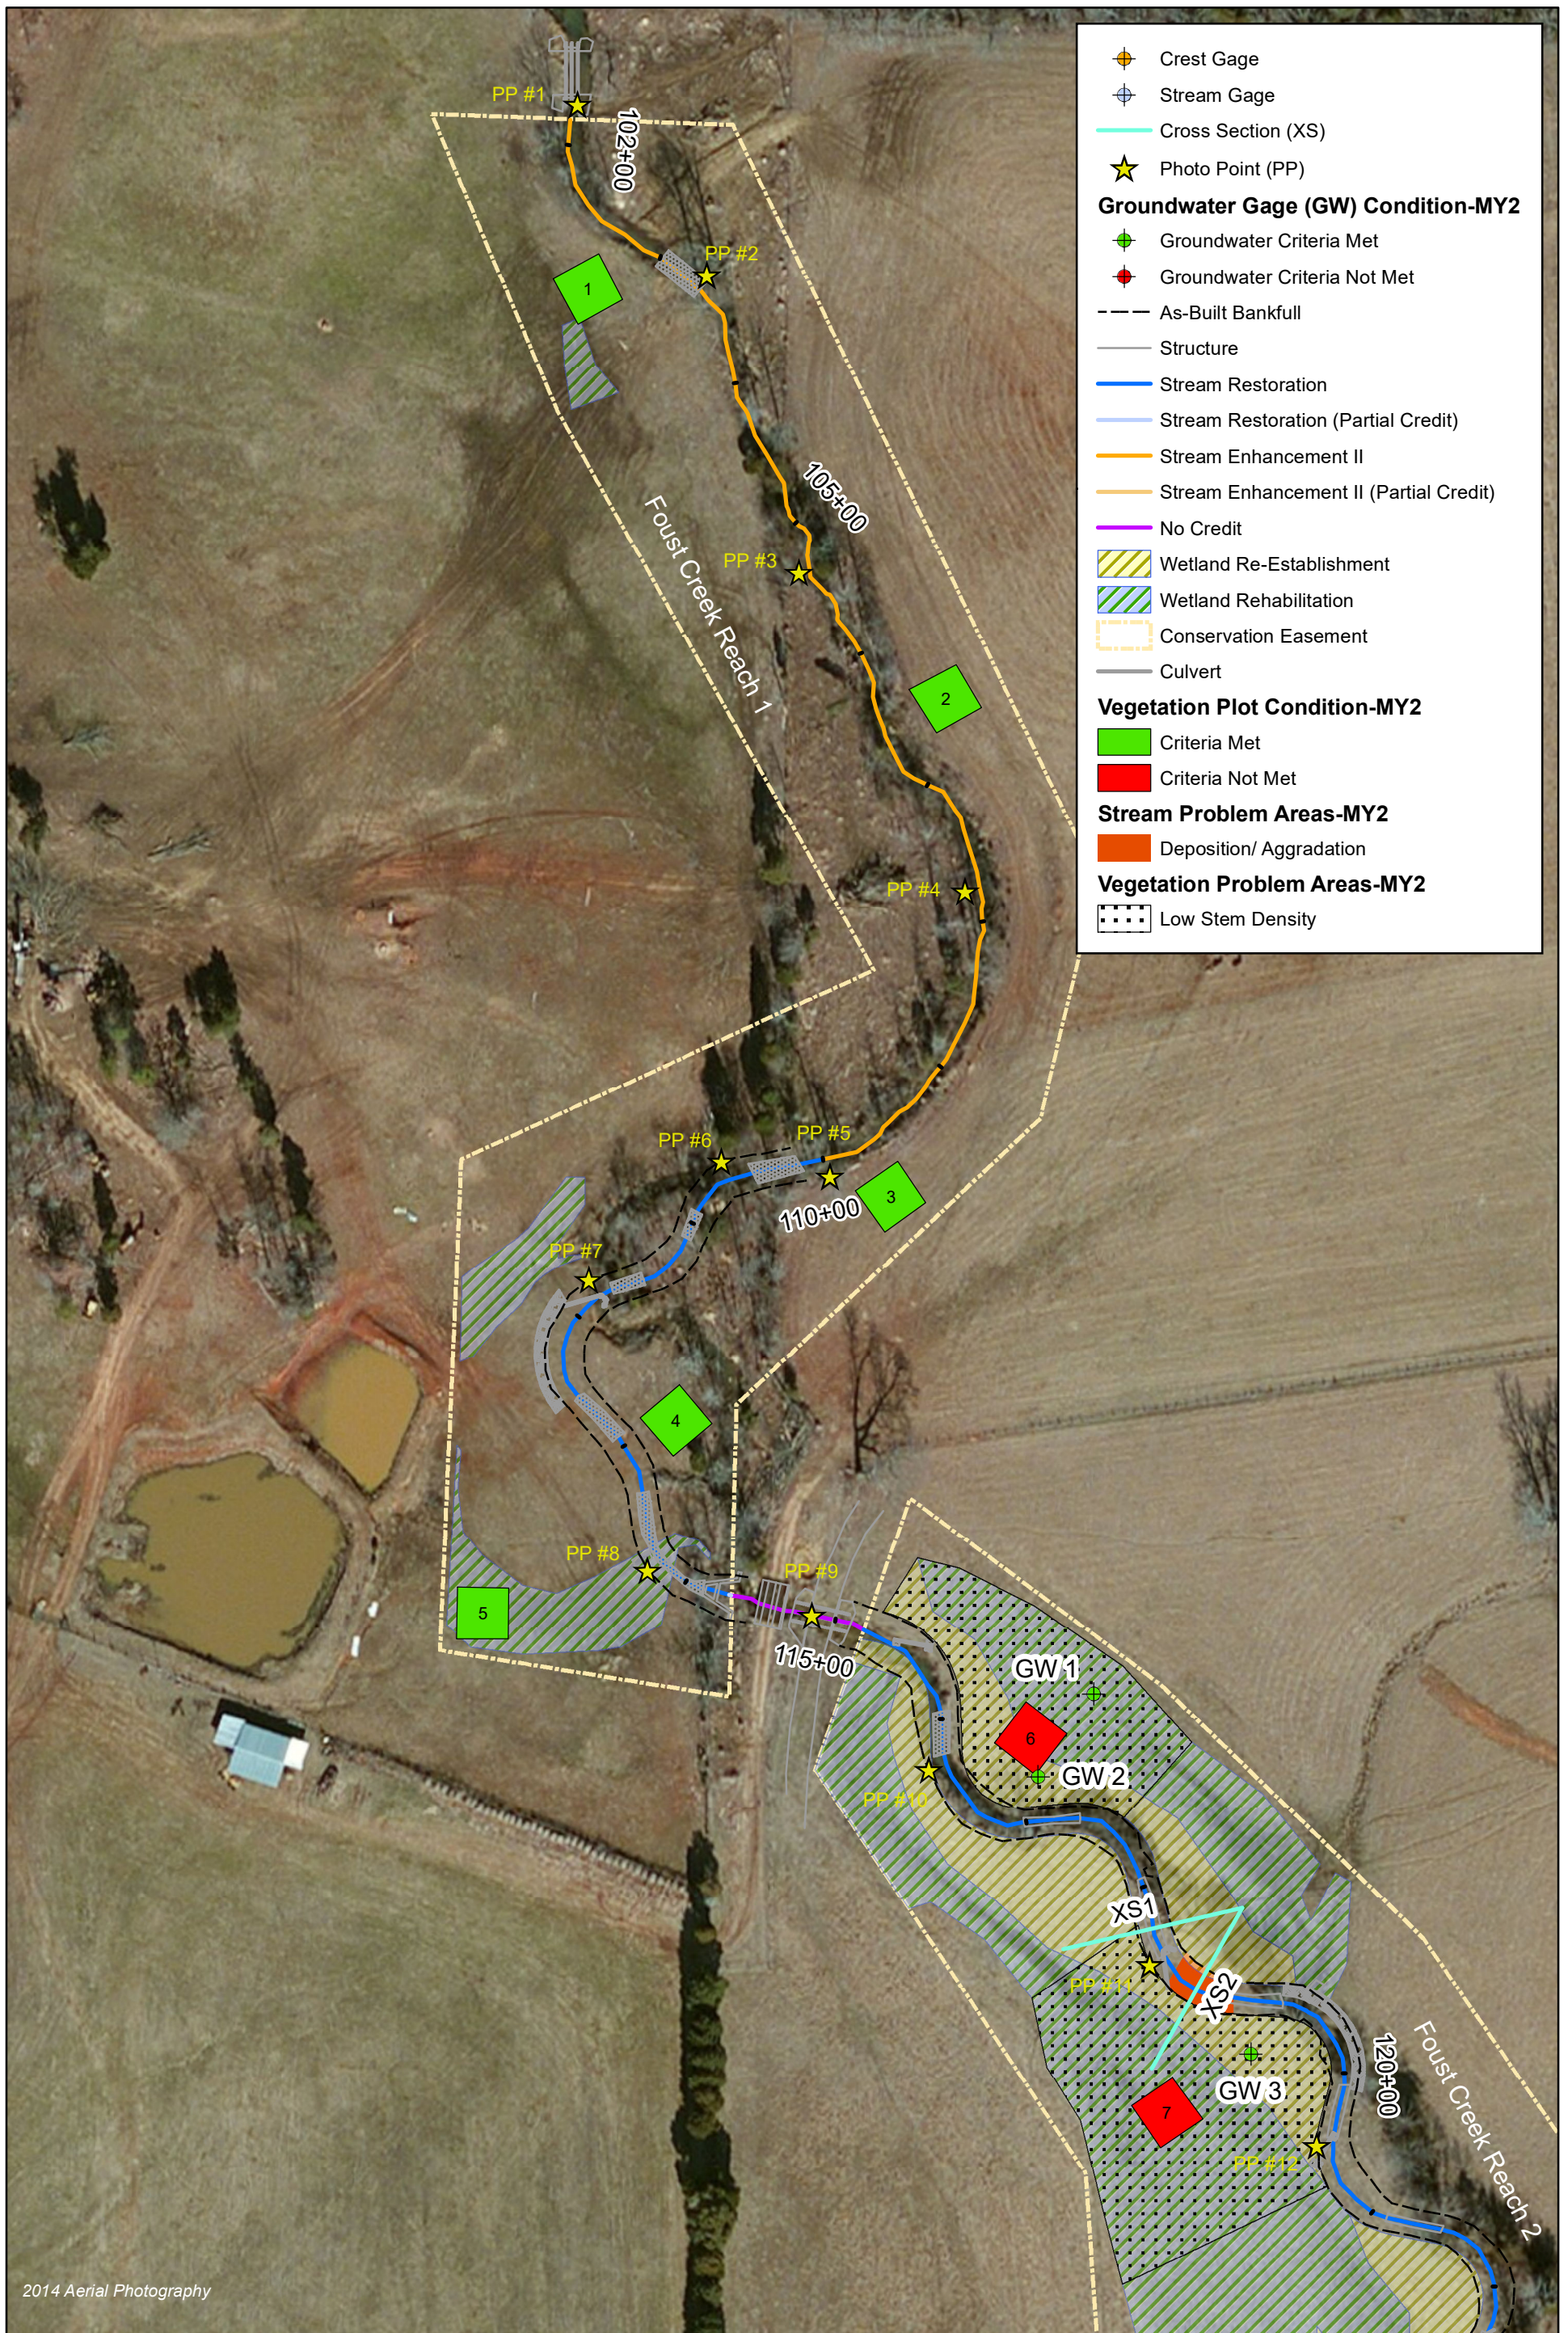
Figure 3.1 Integrated Current Condition Plan View (Sheet 1 of 3)

All streams within the Site are stable and functioning as designed. The deposition that was on Foust Creek at cross section 2 during MY1 has begun to flush out. This area will be monitored for any future issues and a maintenance plan will be prepared if necessary. The average stem density for the Site is on track to meeting the MY7 success criteria; 15 of 17 vegetation plots meet the MY2 success criteria as noted in the CCPV map. The other two plots meet success criteria when volunteer trees were counted. Supplemental tree planting will be completed during the winter of 2016/2017. Both streams on site have recorded at least one bankfull event. A total of 9 out of 10 groundwater gages met the wetland hydrology success criteria.

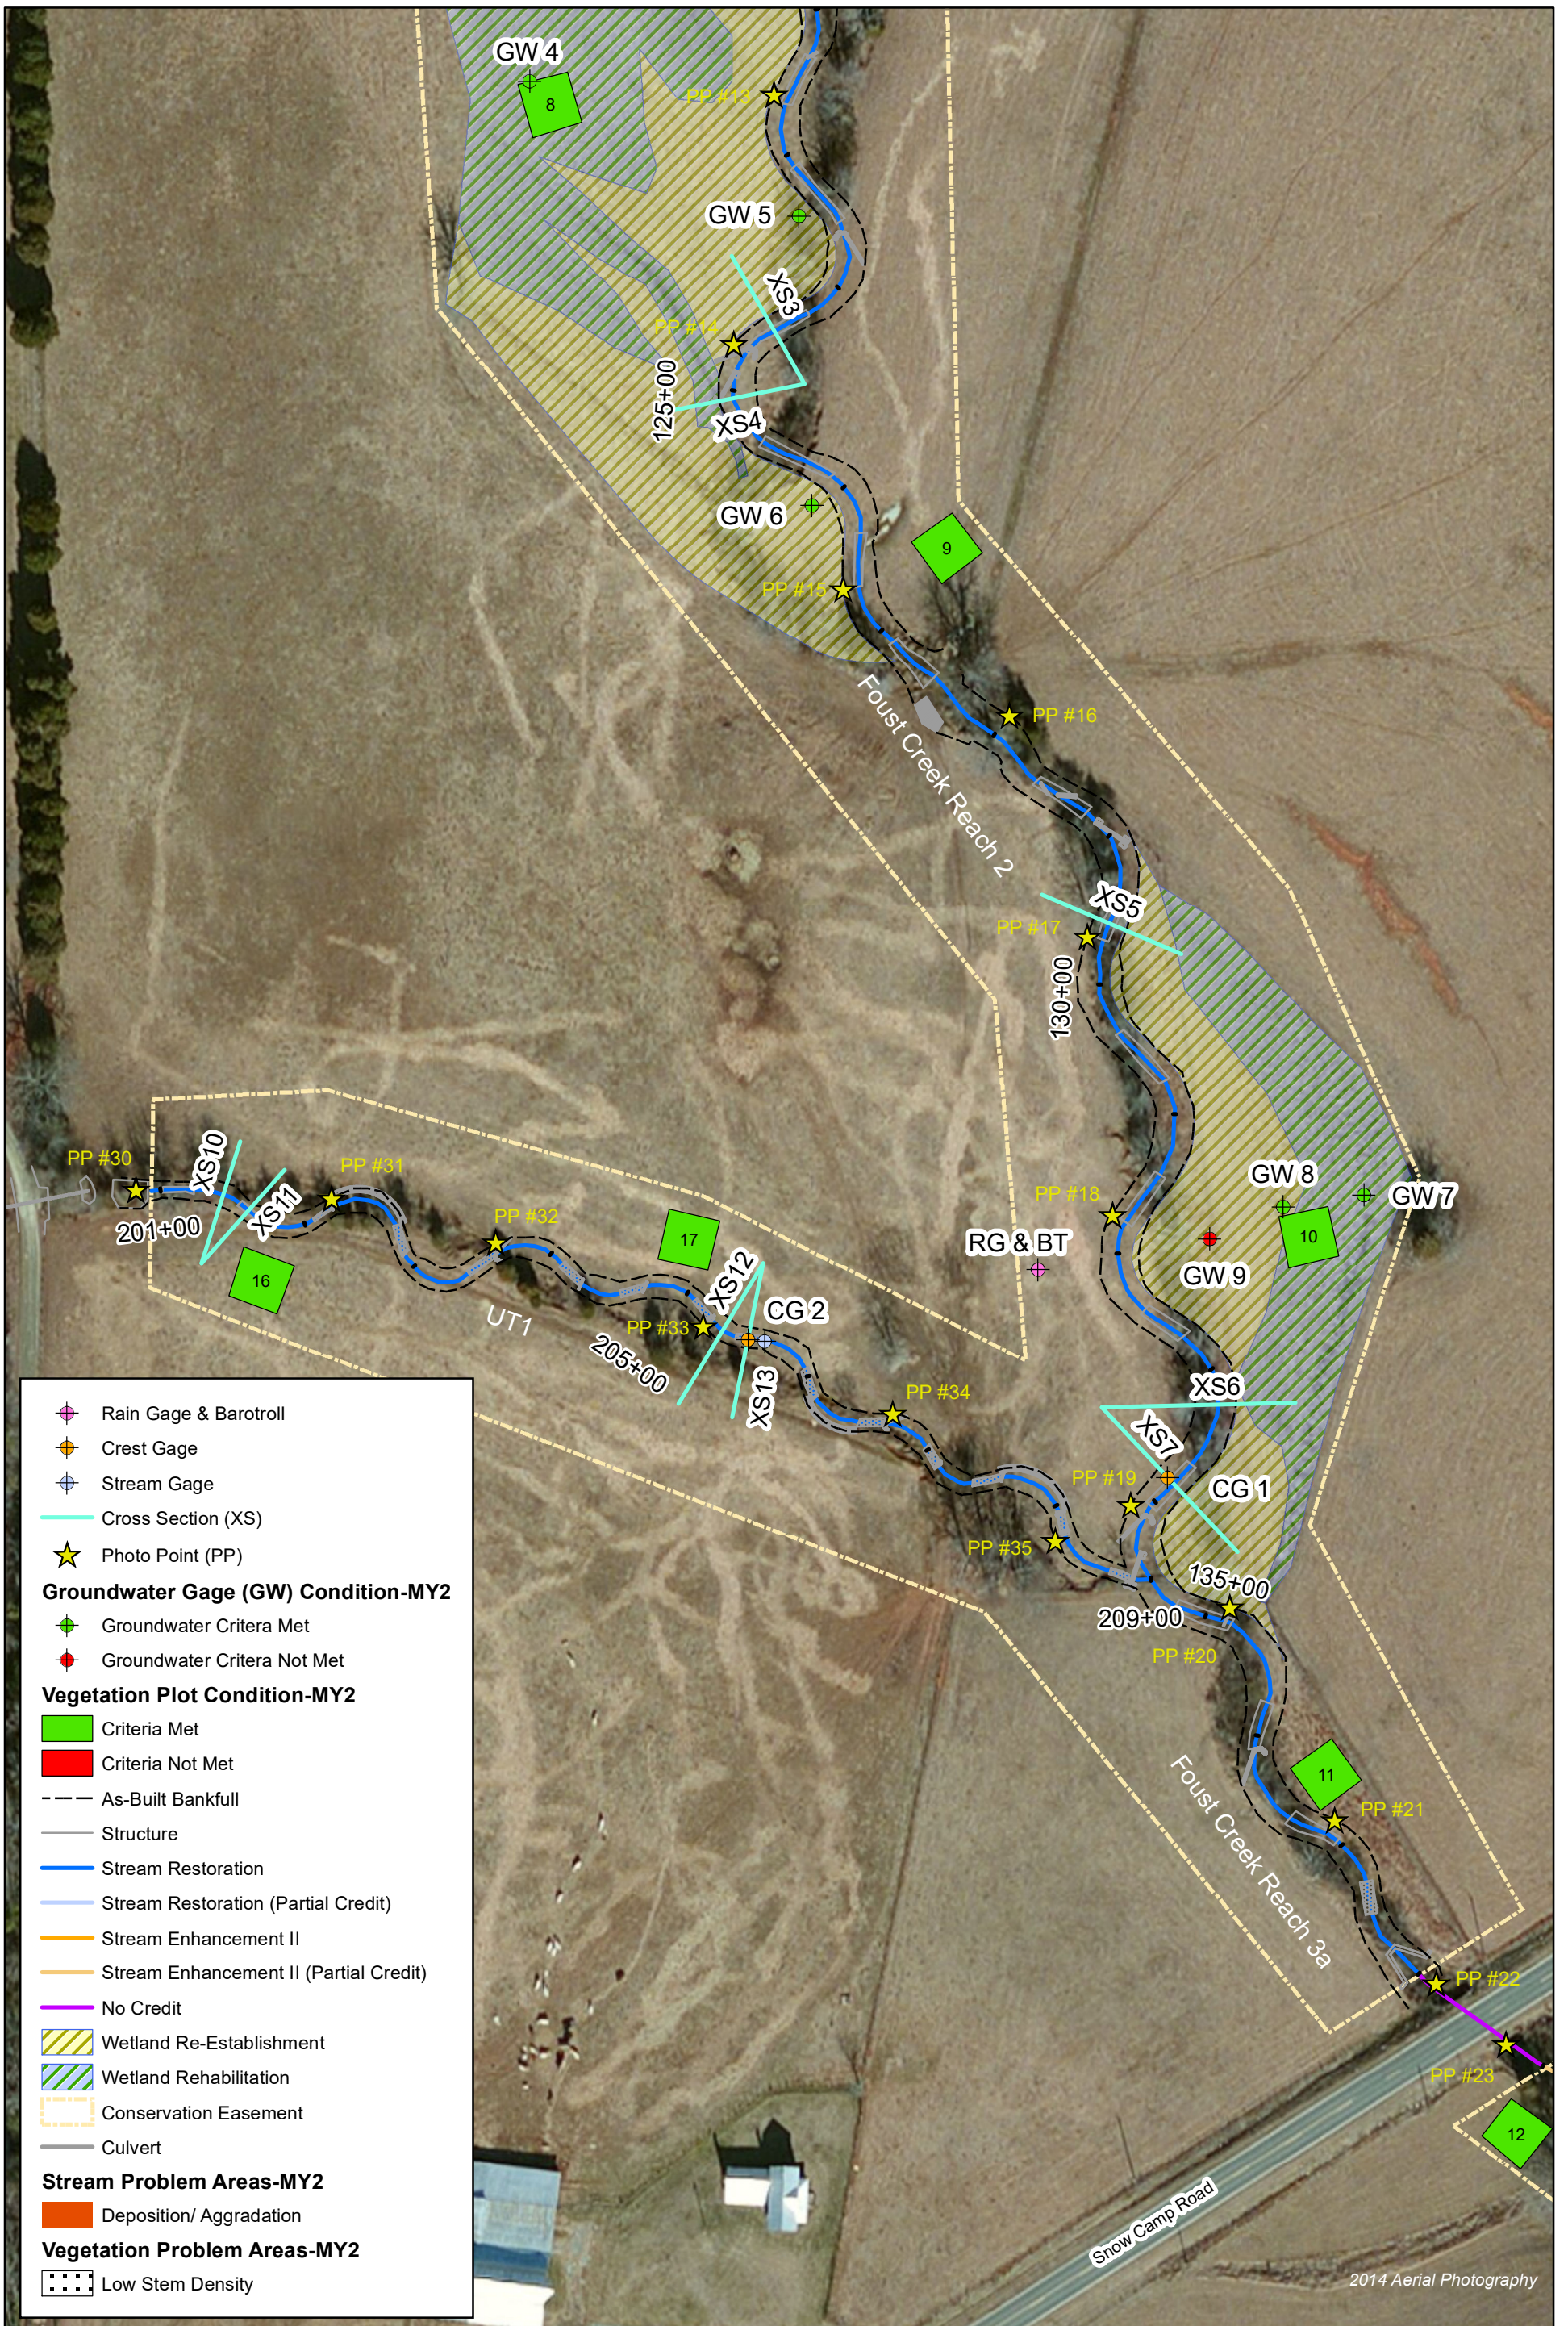
Figure 3.2 Integrated Current Condition Plan View
 (Sheet 2 of 3)
 Foust Creek Stream Restoration Site
 DMS Project No. 95715
 Monitoring Year 2 - 2016
 Alamance County, NC

Low planted stem density was observed around vegetation plots six and seven. These areas stay wet for most of the year and trees have not become well established in the wet conditions. Supplemental planting will be performed in these areas with native tree species that are more tolerant of the wetter conditions. See Current Condition Plan View (CCPV) map in Appendix 2 for areas of low stem density that will have supplemental planting completed in the winter of 2016/2017.

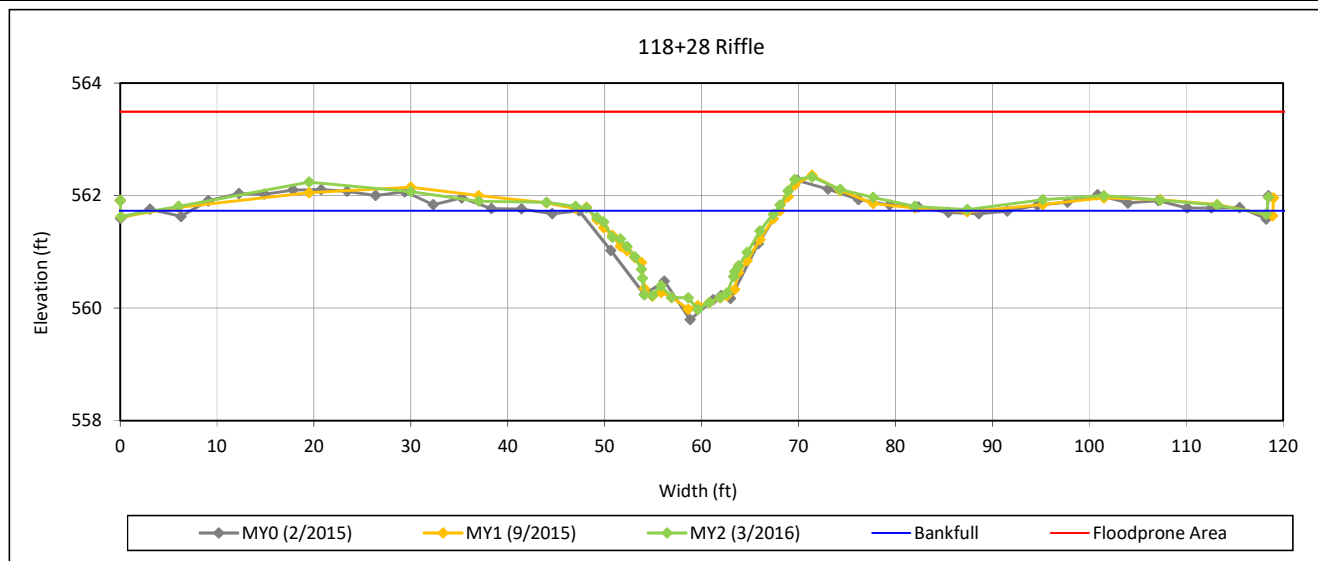
Cross Section 1- Foust Creek Reach 2

20.5	x-section area (ft.sq.)
20.0	width (ft)
1.0	mean depth (ft)
1.8	max depth (ft)
20.8	wetted parimeter (ft)
1.0	hyd radi (ft)
19.4	width-depth ratio
150.0	W flood prone area (ft)
7.5	entrenchment ratio
1.0	low bank height ratio

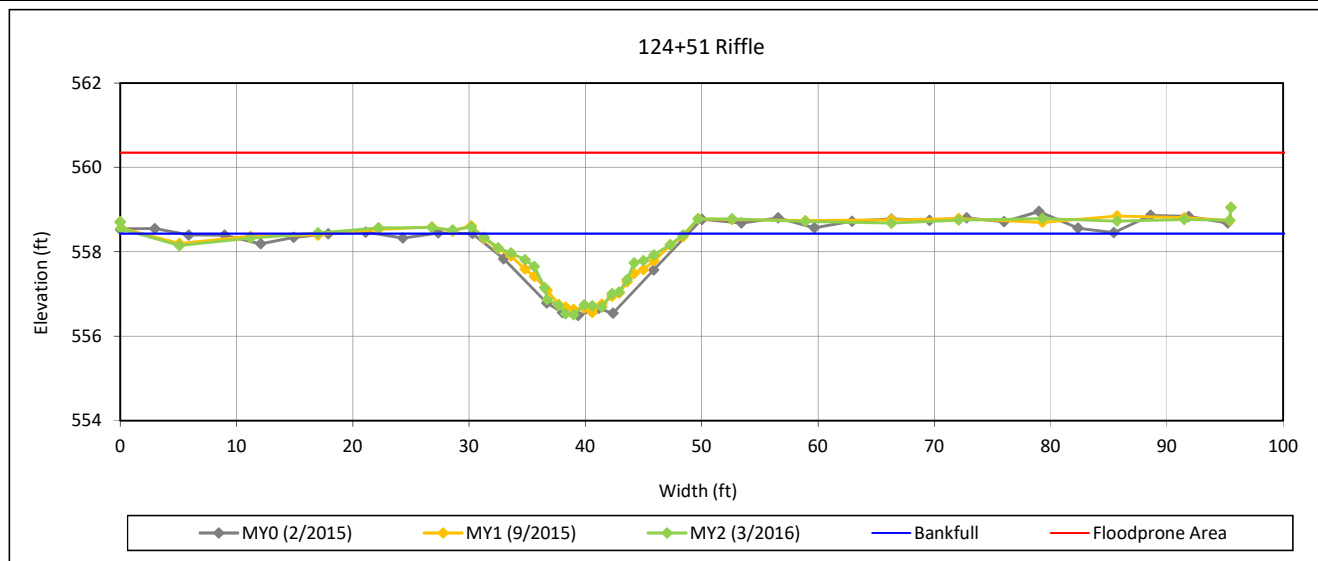
Cross Section 3- Foust Creek Reach 2

16.8	x-section area (ft.sq.)
17.6	width (ft)
1.0	mean depth (ft)
1.9	max depth (ft)
18.3	wetted parimeter (ft)
0.9	hyd radi (ft)
18.5	width-depth ratio
150.0	W flood prone area (ft)
8.5	entrenchment ratio
1.0	low bank height ratio

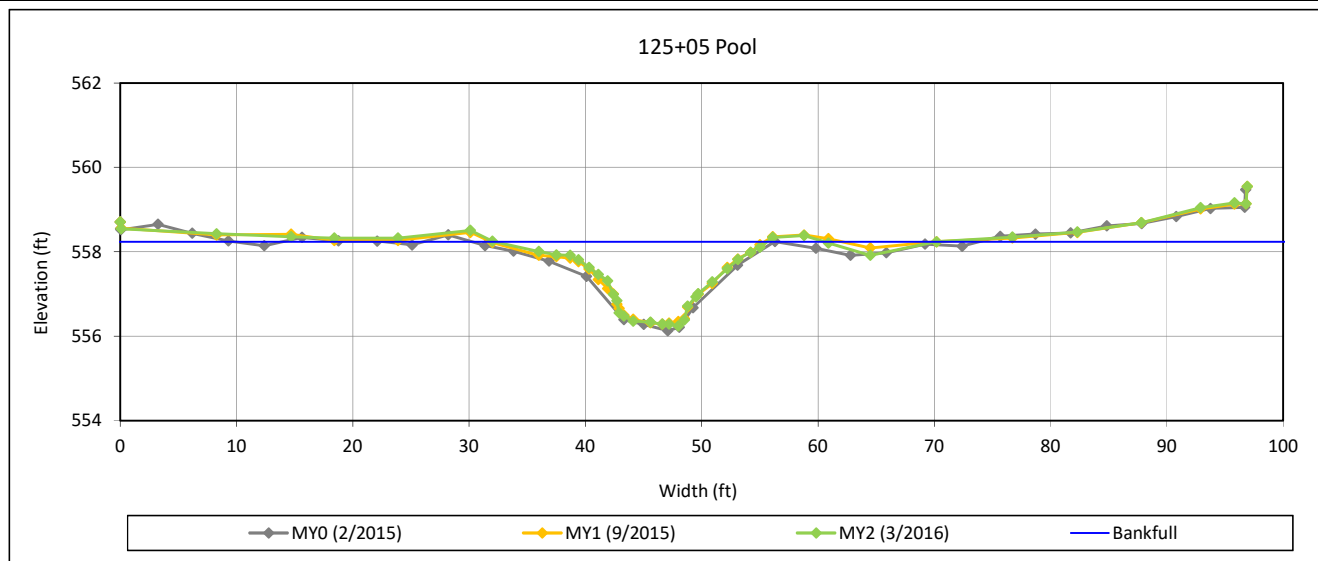
Cross Section 4- Foust Creek Reach 2

20.2	x-section area (ft.sq.)
23.5	width (ft)
0.9	mean depth (ft)
2.0	max depth (ft)
24.2	wetted parimeter (ft)
0.8	hyd radi (ft)
27.2	width-depth ratio

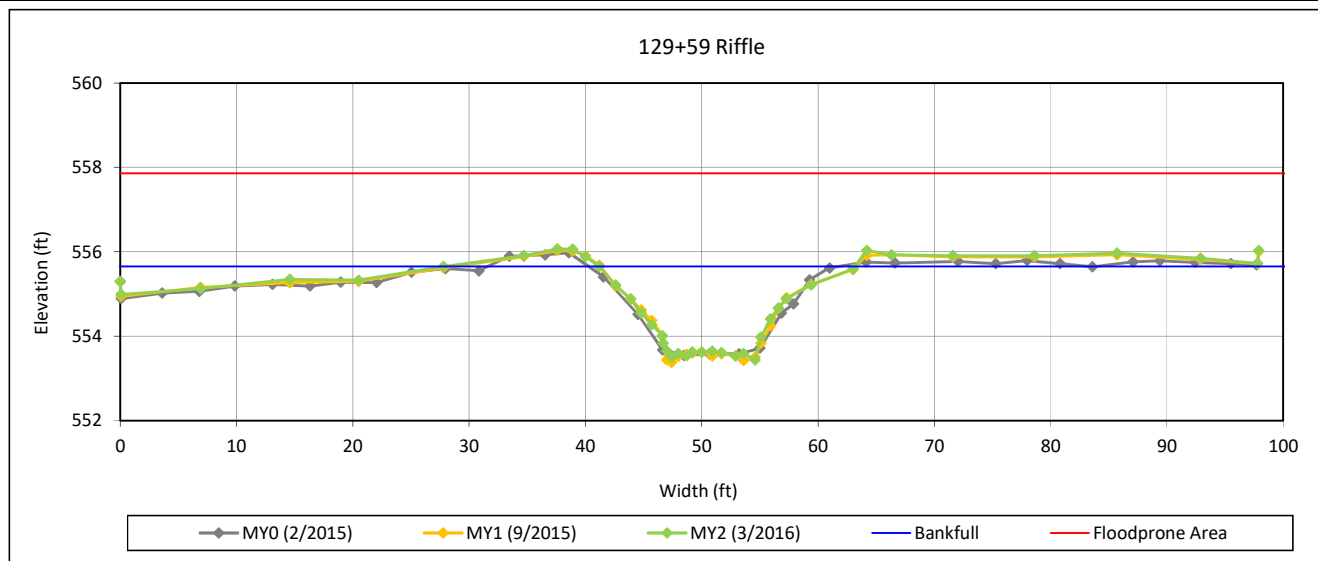
Cross Section 5- Foust Creek Reach 2

26.6	x-section area (ft.sq.)
22.0	width (ft)
1.2	mean depth (ft)
2.2	max depth (ft)
22.9	wetted parimeter (ft)
1.2	hyd radi (ft)
18.2	width-depth ratio
150.0	W flood prone area (ft)
6.8	entrenchment ratio
1.0	low bank height ratio

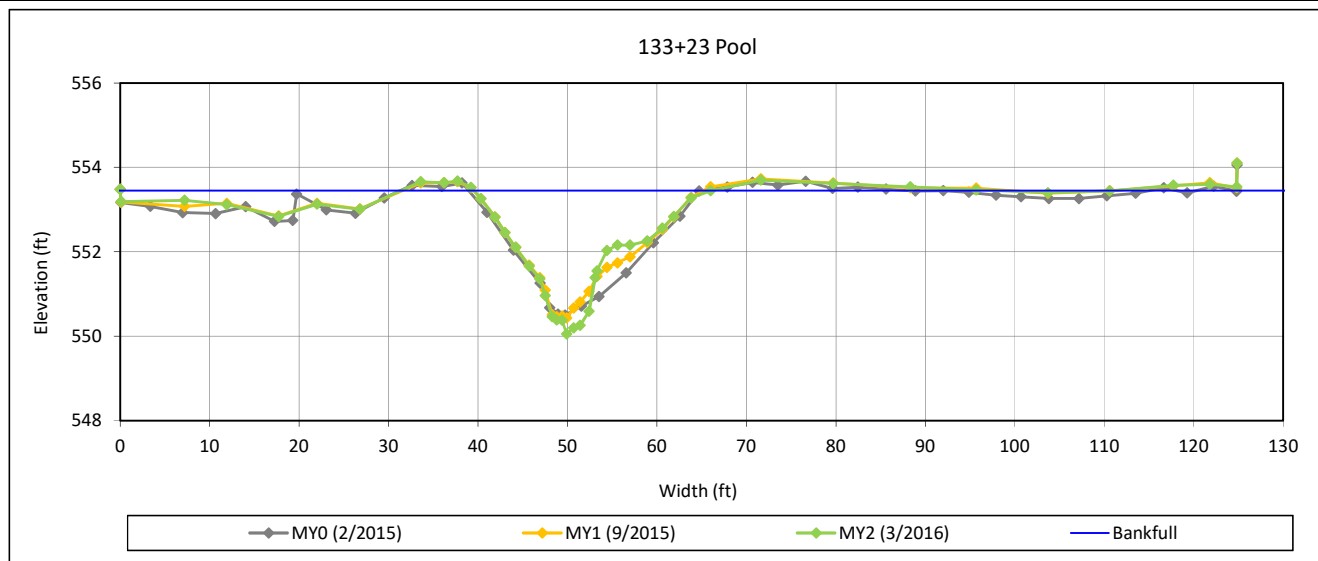
Cross Section 6- Foust Creek Reach 2

37.6	x-section area (ft.sq.)
26.5	width (ft)
1.4	mean depth (ft)
3.4	max depth (ft)
27.8	wetted parimeter (ft)
1.3	hyd radi (ft)
18.7	width-depth ratio

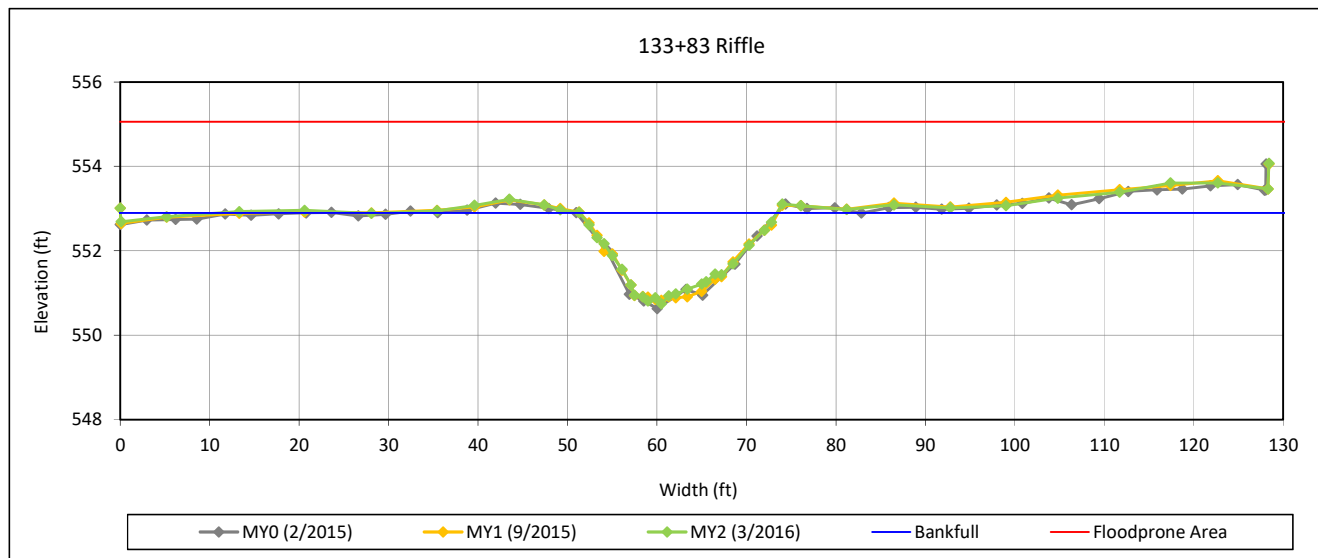
Cross Section 7- Foust Creek Reach 2

28.2	x-section area (ft.sq.)
22.1	width (ft)
1.3	mean depth (ft)
2.2	max depth (ft)
22.7	wetted parimeter (ft)
1.2	hyd radi (ft)
17.3	width-depth ratio
150.0	W flood prone area (ft)
6.8	entrenchment ratio
1.0	low bank height ratio

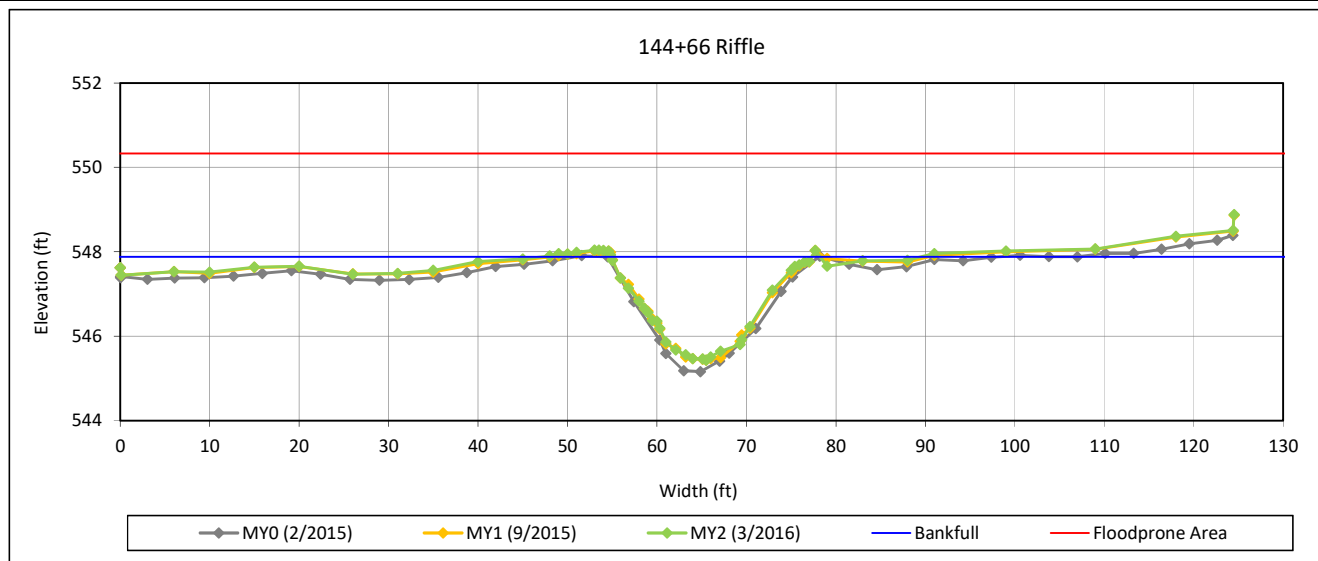
Cross Section 8- Foust Creek Reach 3B

31.9	x-section area (ft.sq.)
23.2	width (ft)
1.4	mean depth (ft)
2.5	max depth (ft)
24.0	wetted parimeter (ft)
1.3	hyd radi (ft)
16.9	width-depth ratio
150.0	W flood prone area (ft)
6.5	entrenchment ratio
1.0	low bank height ratio

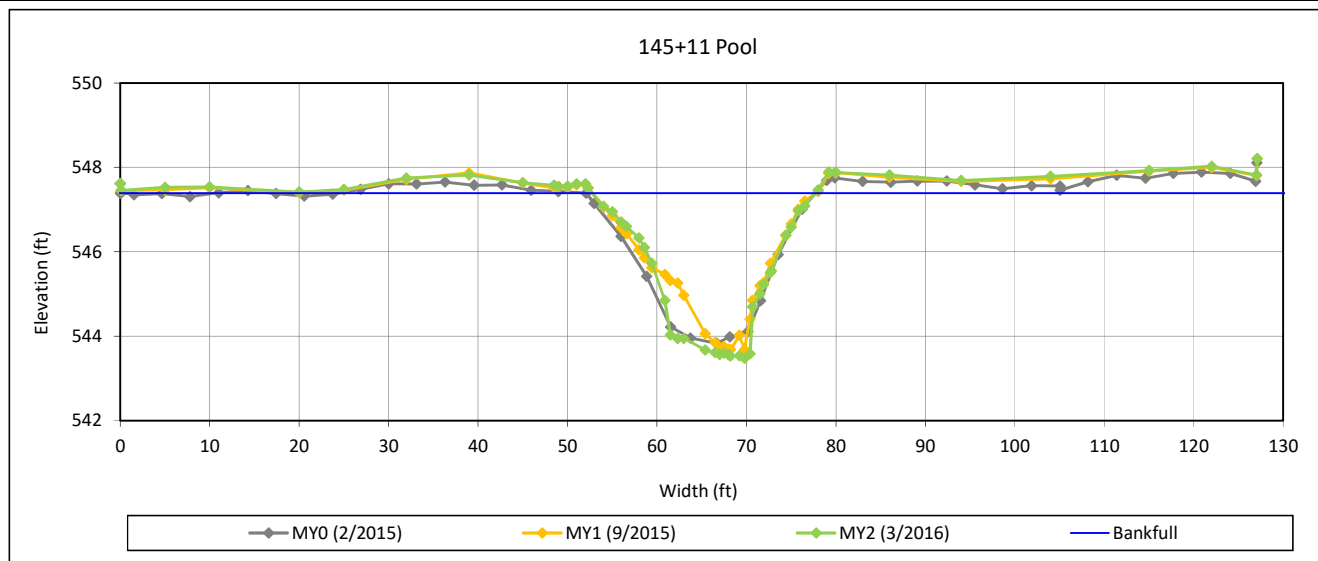
Cross Section 9- Foust Creek Reach 3B

51.9	x-section area (ft.sq.)
24.9	width (ft)
2.1	mean depth (ft)
3.9	max depth (ft)
27.2	wetted parimeter (ft)
1.9	hyd radi (ft)
11.9	width-depth ratio

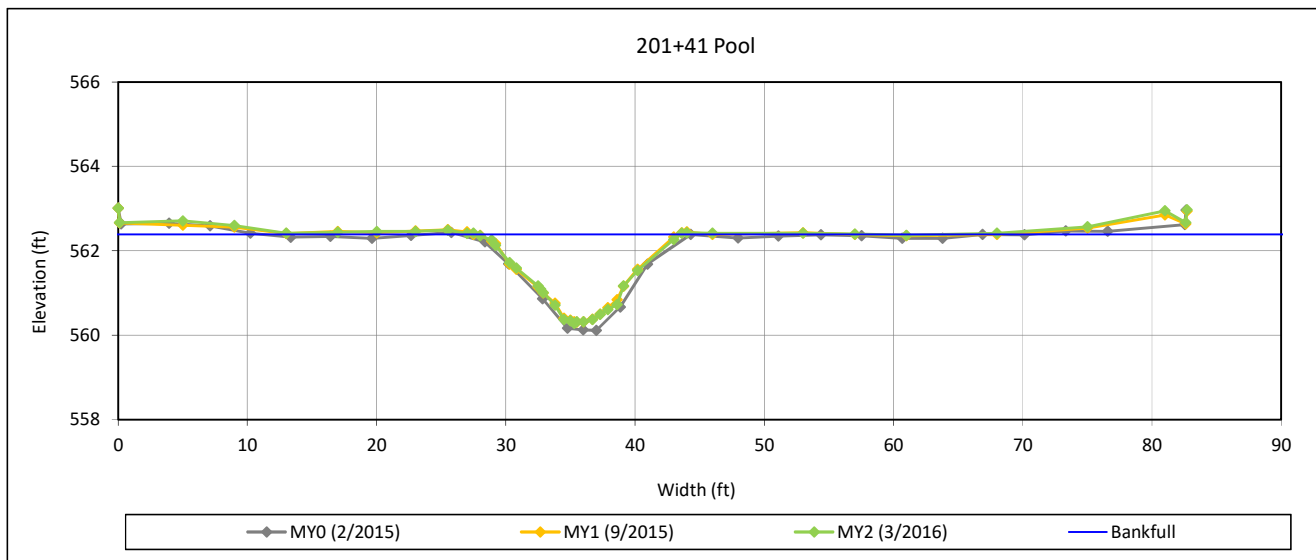
Cross Section 10-UT1

17.2	x-section area (ft.sq.)
15.7	width (ft)
1.1	mean depth (ft)
2.1	max depth (ft)
16.4	wetted parimeter (ft)
1.0	hyd radi (ft)
14.4	width-depth ratio

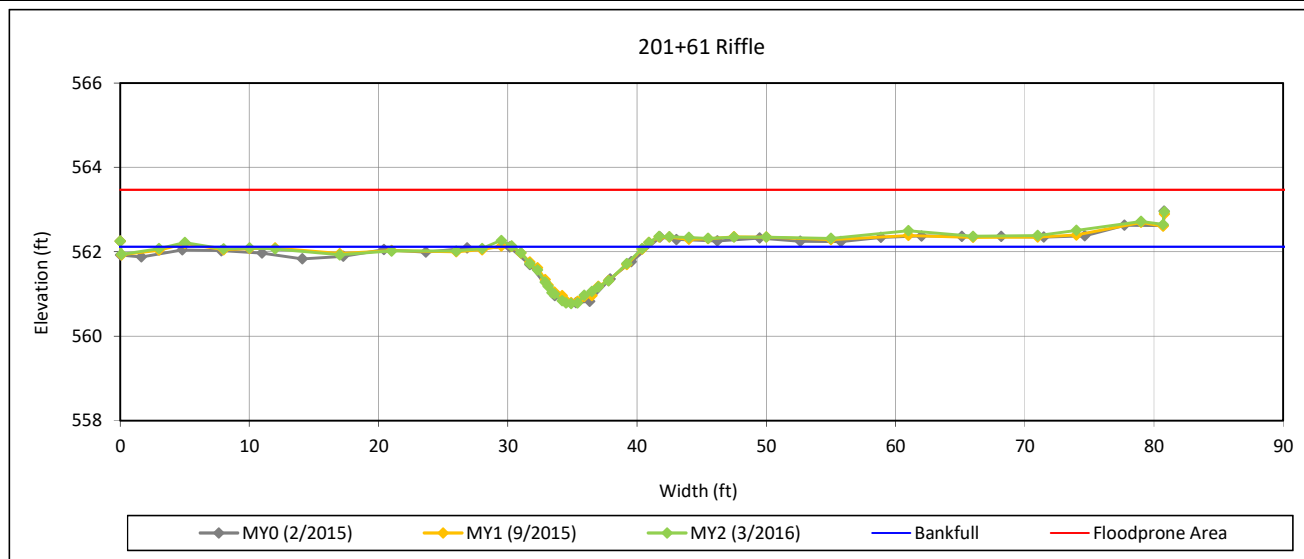
Cross Section 11-UT1

7.6	x-section area (ft.sq.)
10.2	width (ft)
0.7	mean depth (ft)
1.4	max depth (ft)
10.6	wetted parimeter (ft)
0.7	hyd radi (ft)
13.6	width-depth ratio
150.0	W flood prone area (ft)
14.8	entrenchment ratio
1.0	low bank height ratio

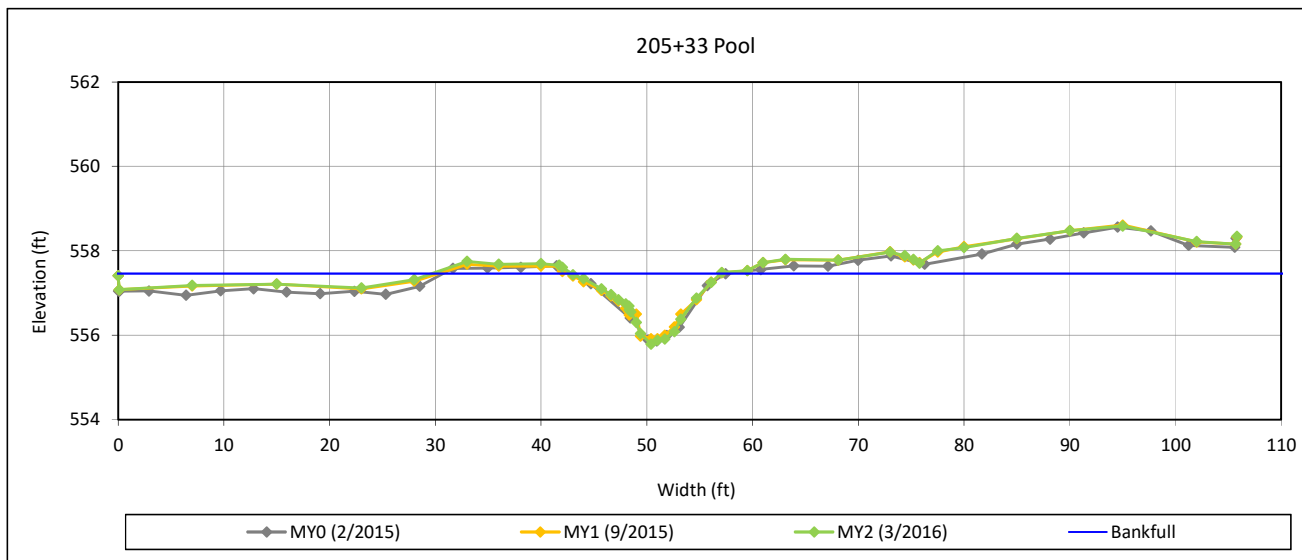
Cross Section 12-UT1

10.7	x-section area (ft.sq.)
14.1	width (ft)
0.8	mean depth (ft)
1.7	max depth (ft)
14.7	wetted parimeter (ft)
0.7	hyd radi (ft)
18.6	width-depth ratio

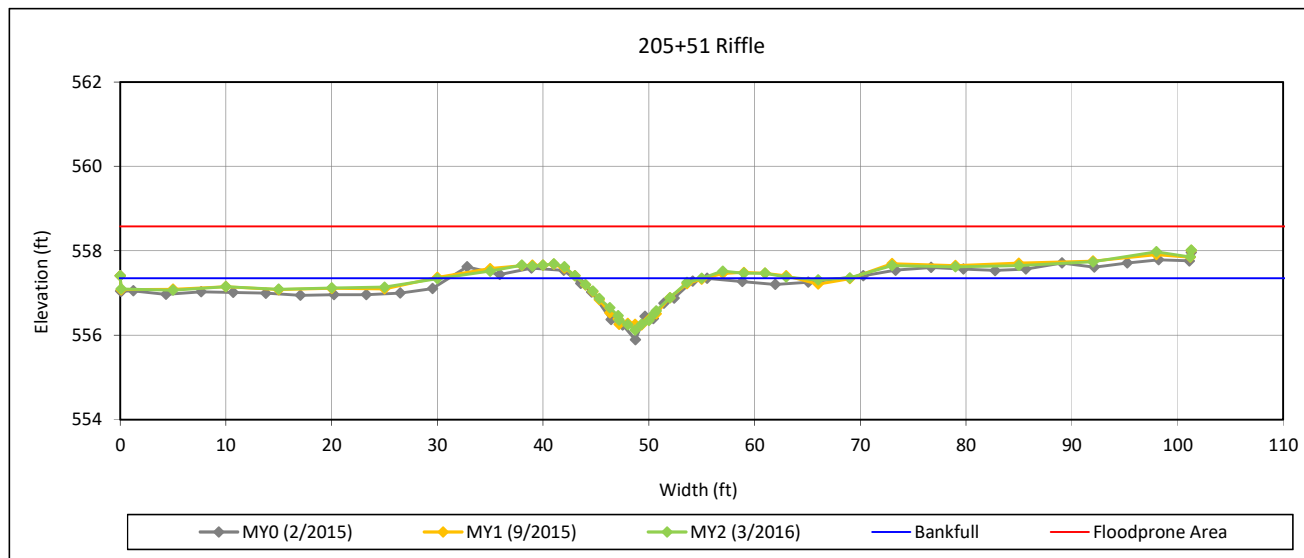
Cross Section 13-UT1

6.8	x-section area (ft.sq.)
11.7	width (ft)
0.6	mean depth (ft)
1.2	max depth (ft)
12.0	wetted perimeter (ft)
0.6	hyd radi (ft)
20.2	width-depth ratio
150.0	W flood prone area (ft)
12.8	entrenchment ratio
1.0	low bank height ratio

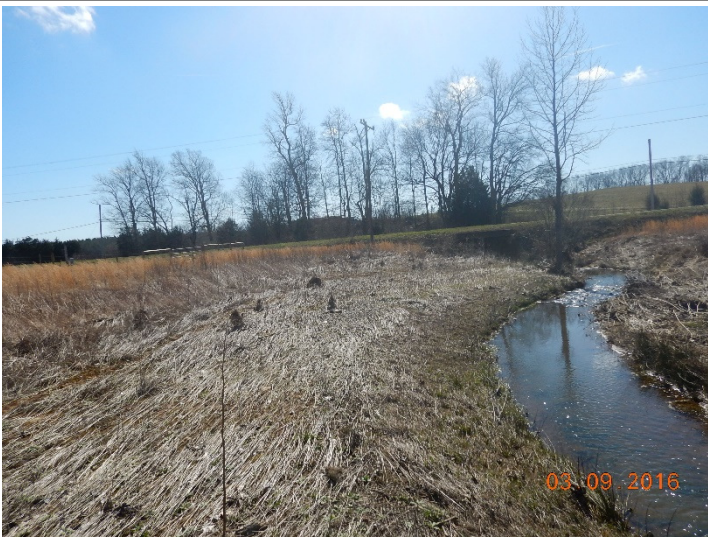
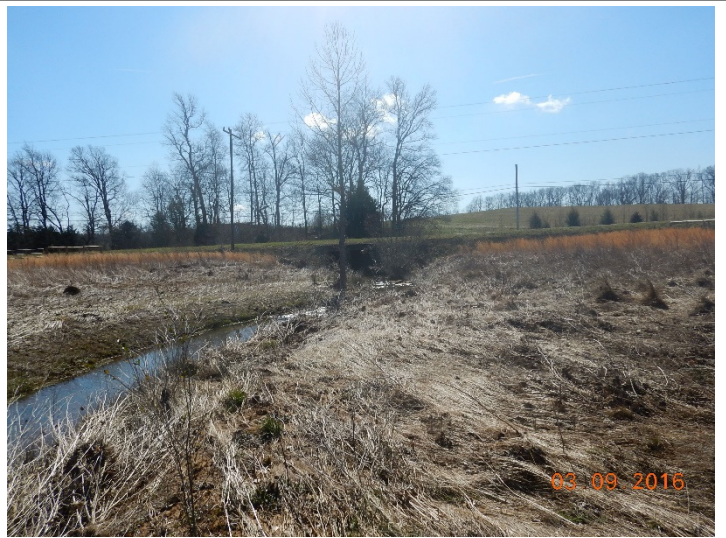
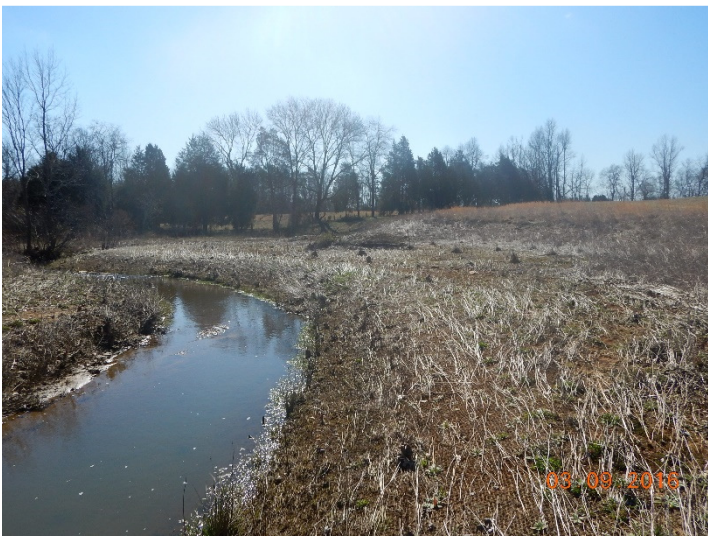
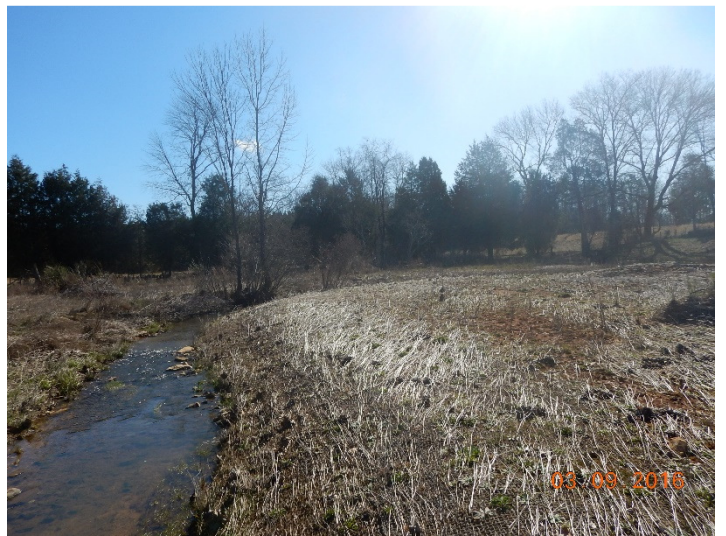
Foust Creek – (3/9/2016)

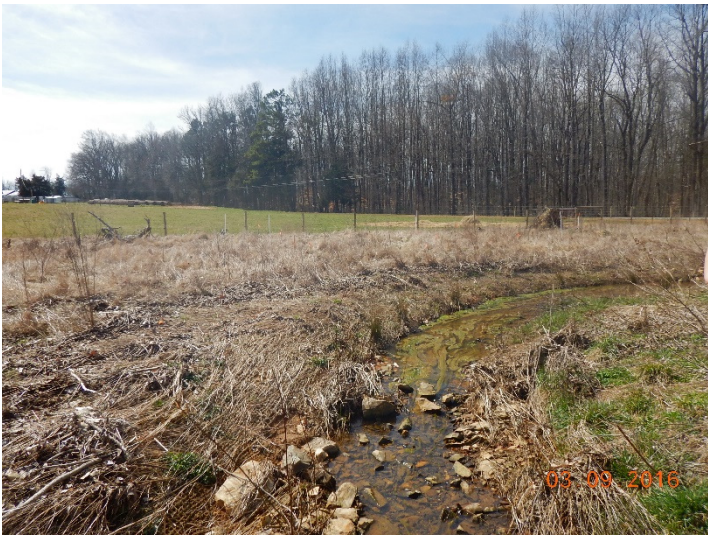
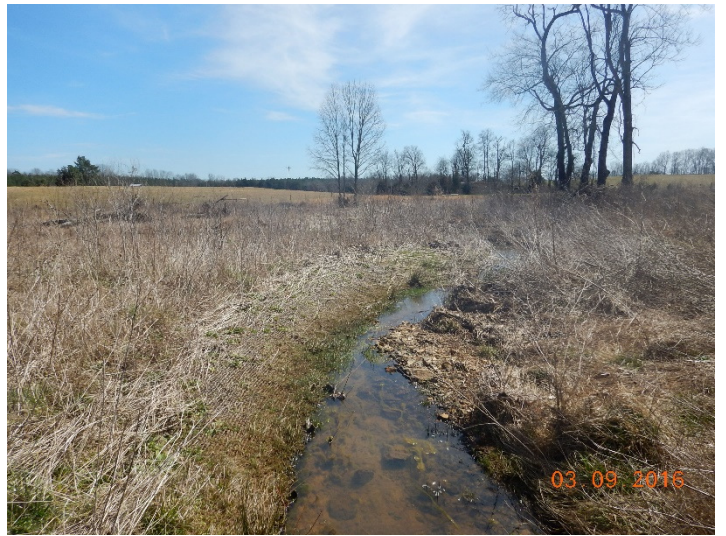
UT1 – (3/9/2016)
